## Terrestrial Television Baseline Survey Report

Etihad Campus

Manchester City Football Club

February 2026

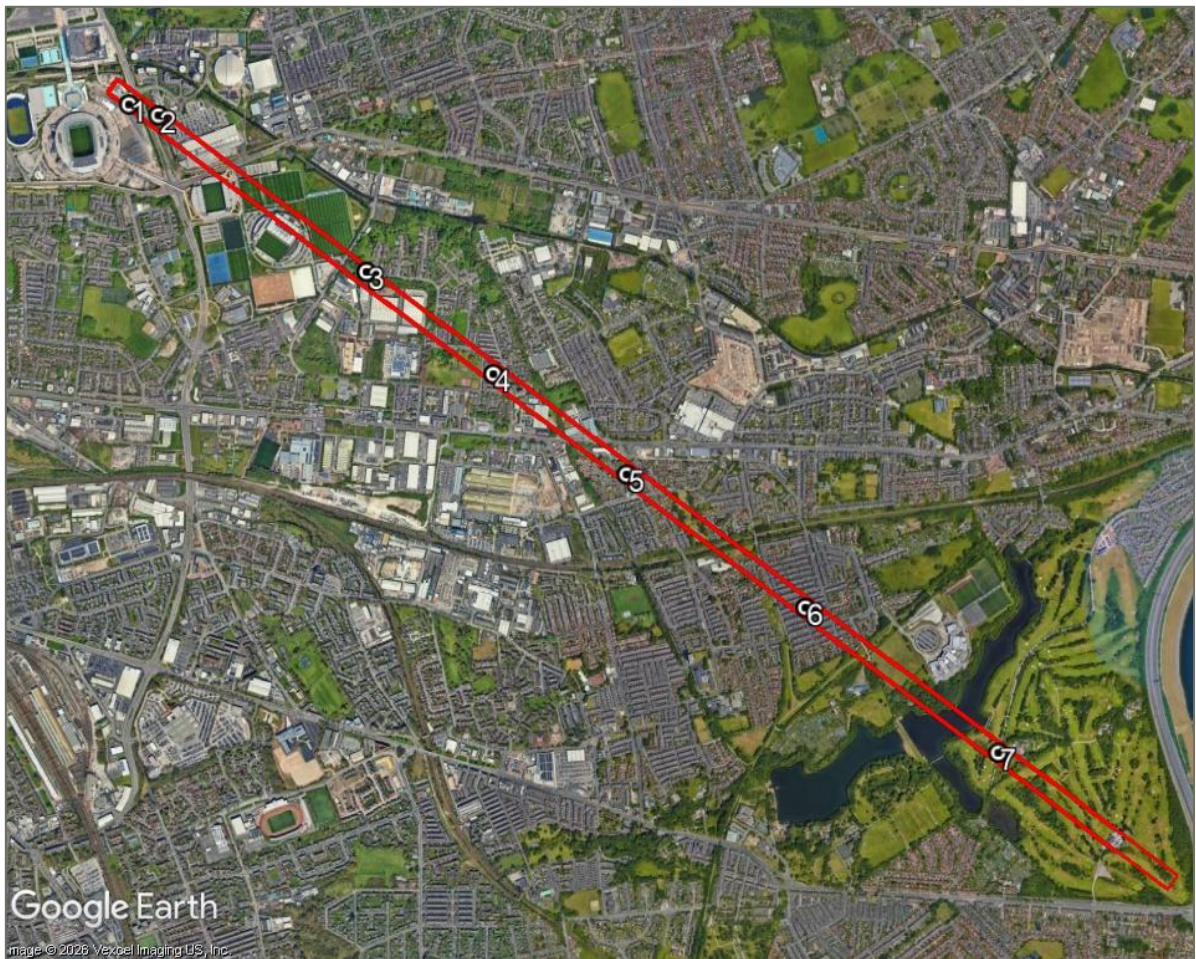
Figure 6 Survey locations

Figure 6 below shows the survey locations overlaid onto aerial photography. The development location and the shadow zone are also shown. More readings are typically carried out closer to the building. This is because interference is generally more likely the closer the location is to the obstruction. Survey locations were chosen pre-survey (within the shadow zone); however, safe and available access influenced the specific position on the day. The locations in Figure 6 below show the actual survey locations. Television measurements were taken at survey locations 1 to 7.

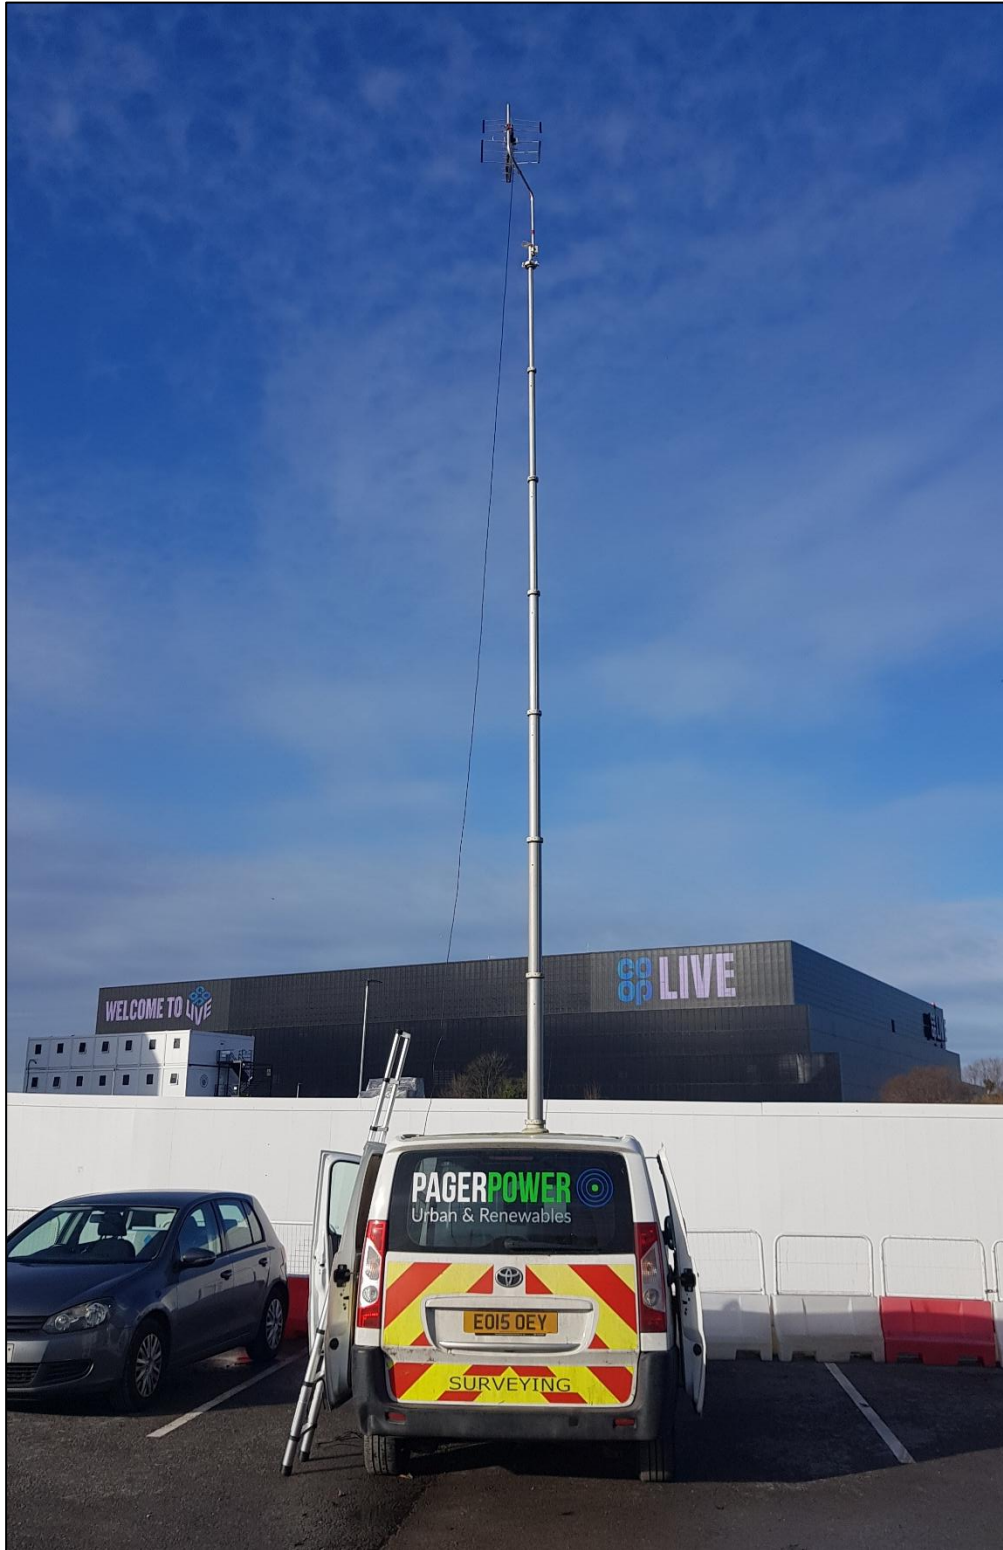
Location 1

| Location | Average Measured Signal Strength (dB) | Remarks | High Level Conclusion |
|---|---|---|---|
| 1 | <p>Overall average:<br/><b>57.2 (Very Good)</b></p> <p>Main TV MUX<sup>6</sup>:<br/><b>62.9 (Very Good)</b></p> <p>Local TV MUX:<br/><b>40.0 (Moderate)</b></p> | <p>One horizontally polarised aerial was observed at this location.</p> <p>All main multiplexes displayed fine picture and audio quality. An average of moderate signal strength and signal fluctuations of less than or equal to 0.3dB.</p> <p>Both local multiplexes displayed fine picture and audio quality. An average of low signal strength and signal fluctuations of less than or equal to 0.4dB.</p> | <p>The survey location is approximately 100m from the development and within its shadow zone.</p> <p>Predominately multistorey commercial buildings adjacent to this location.</p> <p>A reduction in signal strength is possible based on the proximity to the development. Effects in this area cannot be entirely ruled out, particularly for the local multiplexes.</p> |

Notes: One horizontally polarised aerial observed.

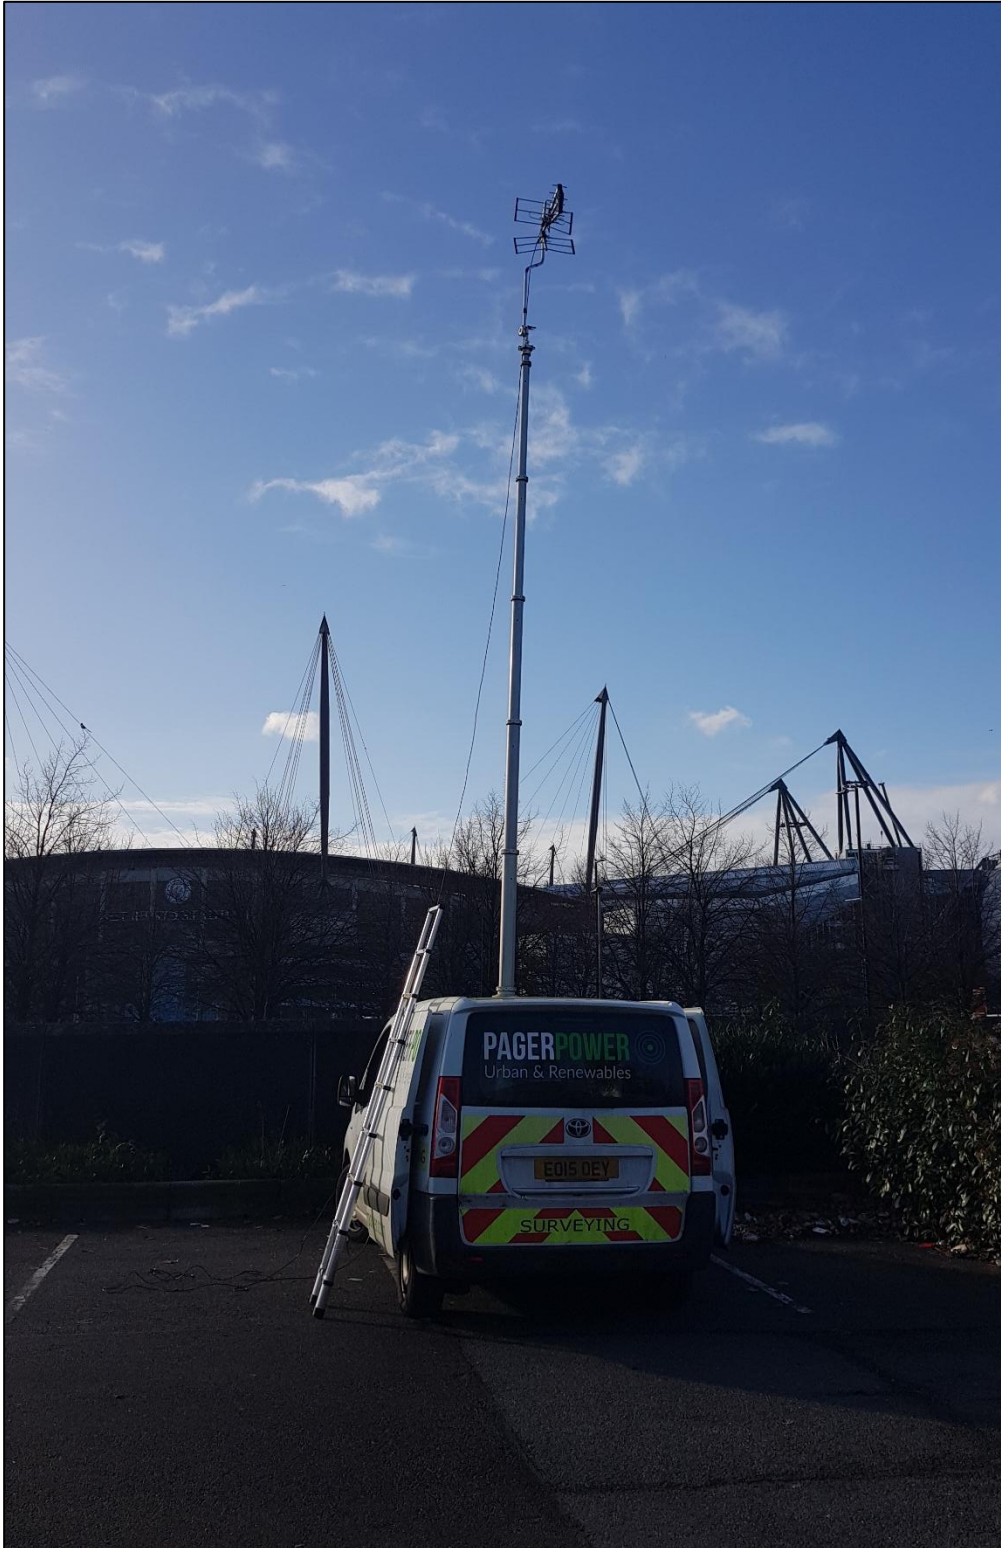
Location 2

| Location | Average Measured Signal Strength (dB) | Remarks | High Level Conclusion |
|---|---|---|---|
| 2 | <p>Overall average:<br/><b>55.5 (Very Good)</b></p> <p>Main TV MUX:<br/><b>60.0 (Very Good)</b></p> <p>Local TV MUX:<br/><b>42.0 (Moderate)</b></p> | <p>No aerials or satellite dishes were observed at this location.</p> <p>All main multiplexes displayed fine picture and audio quality. An average of moderate signal strength and signal fluctuations of less than or equal to 0.3dB.</p> <p>Both local multiplexes displayed fine picture and audio quality. An average of low signal strength and signal fluctuations of less than or equal to 0.2dB.</p> | <p>The survey location is approximately 215m from the development and within its shadow zone.</p> <p>Predominately multistorey commercial buildings adjacent to this location.</p> <p>A reduction in signal strength is possible based on the proximity to the development. Effects in this area cannot be entirely ruled out, particularly for the local multiplexes.</p> |

Notes: No satellites dishes or aerials observed.

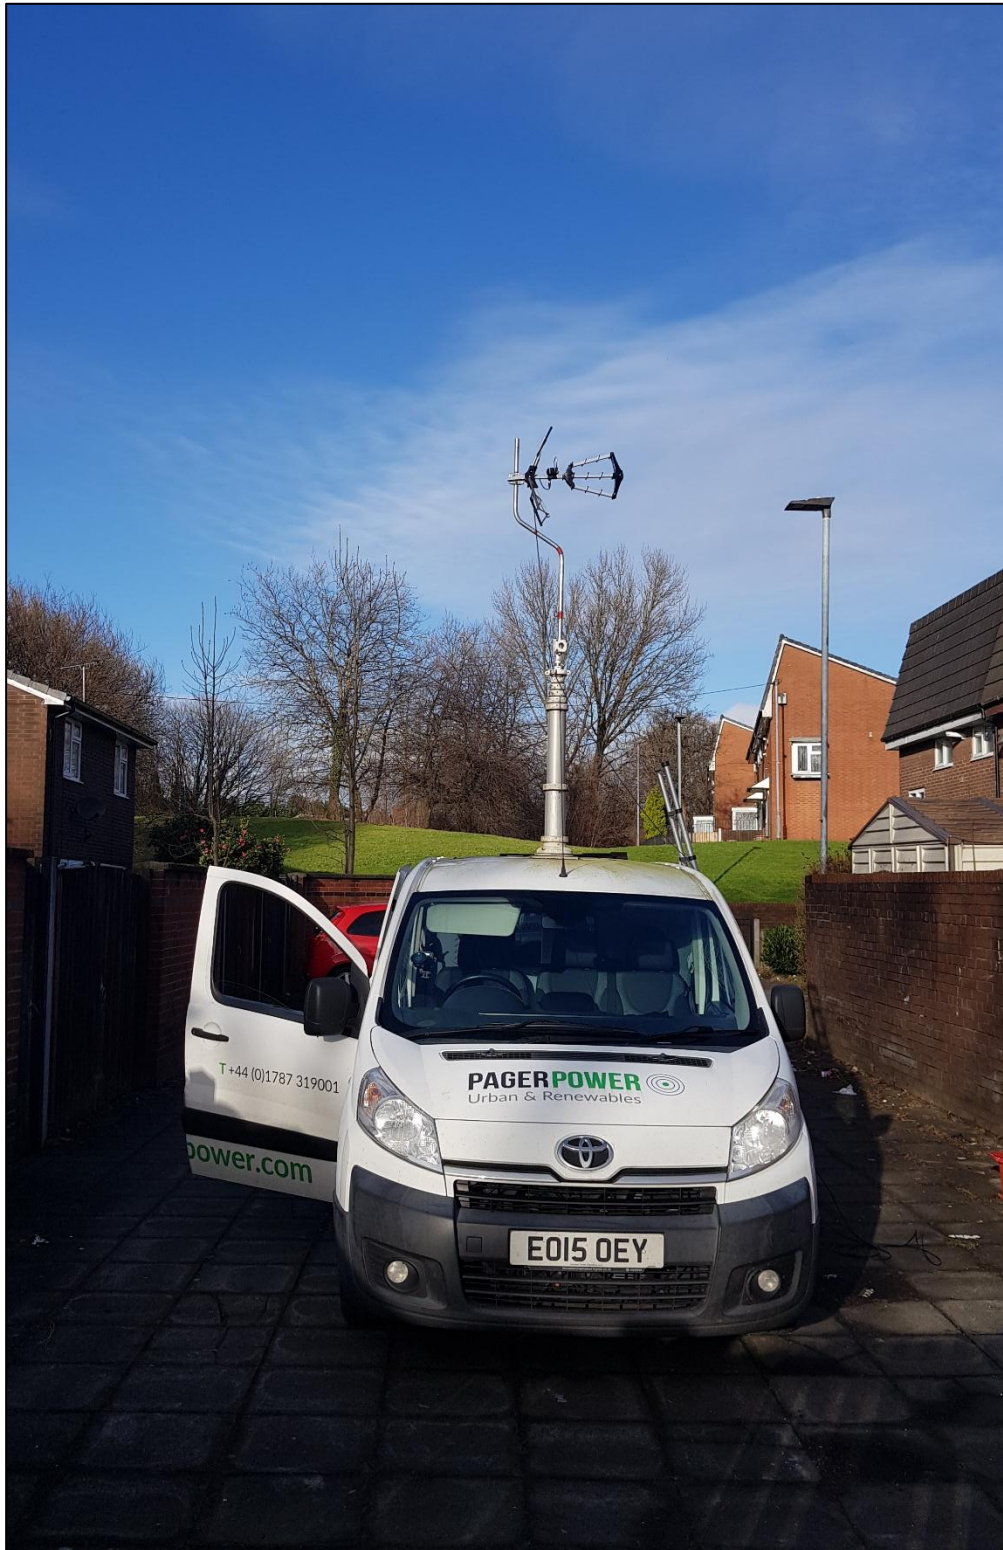
Location 3

| Location | Average Measured Signal Strength (dB) | Remarks | High Level Conclusion |
|---|---|---|---|
| 3 | <p>Overall average:<br/><b>54.5 (Good)</b></p> <p>Main TV MUX:<br/><b>58.5 (Very Good)</b></p> <p>Local TV MUX:<br/><b>42.0 (Moderate)</b></p> | <p>Multiple horizontally polarised aerials and satellite dishes were observed at this location.</p> <p>All main multiplexes displayed fine picture and audio quality. An average of moderate signal strength and signal fluctuations of less than or equal to 1.0dB.</p> <p>Both local multiplexes displayed fine picture and audio quality. An average of low signal strength and signal fluctuations of less than or equal to 0.2dB.</p> | <p>The survey location is approximately 1.19km from the development and within its shadow zone.</p> <p>Predominately low-rise residential housing adjacent to this location.</p> <p>Effects at this range are likely to be relatively small based on previous experience. Based on the current signal quality, effects are unlikely to be noticeable for the main multiplexes. Effects upon local multiplexes are considered possible due to current signal strength.</p> |

Notes: Multiple horizontally polarised aerials and satellites dishes observed.

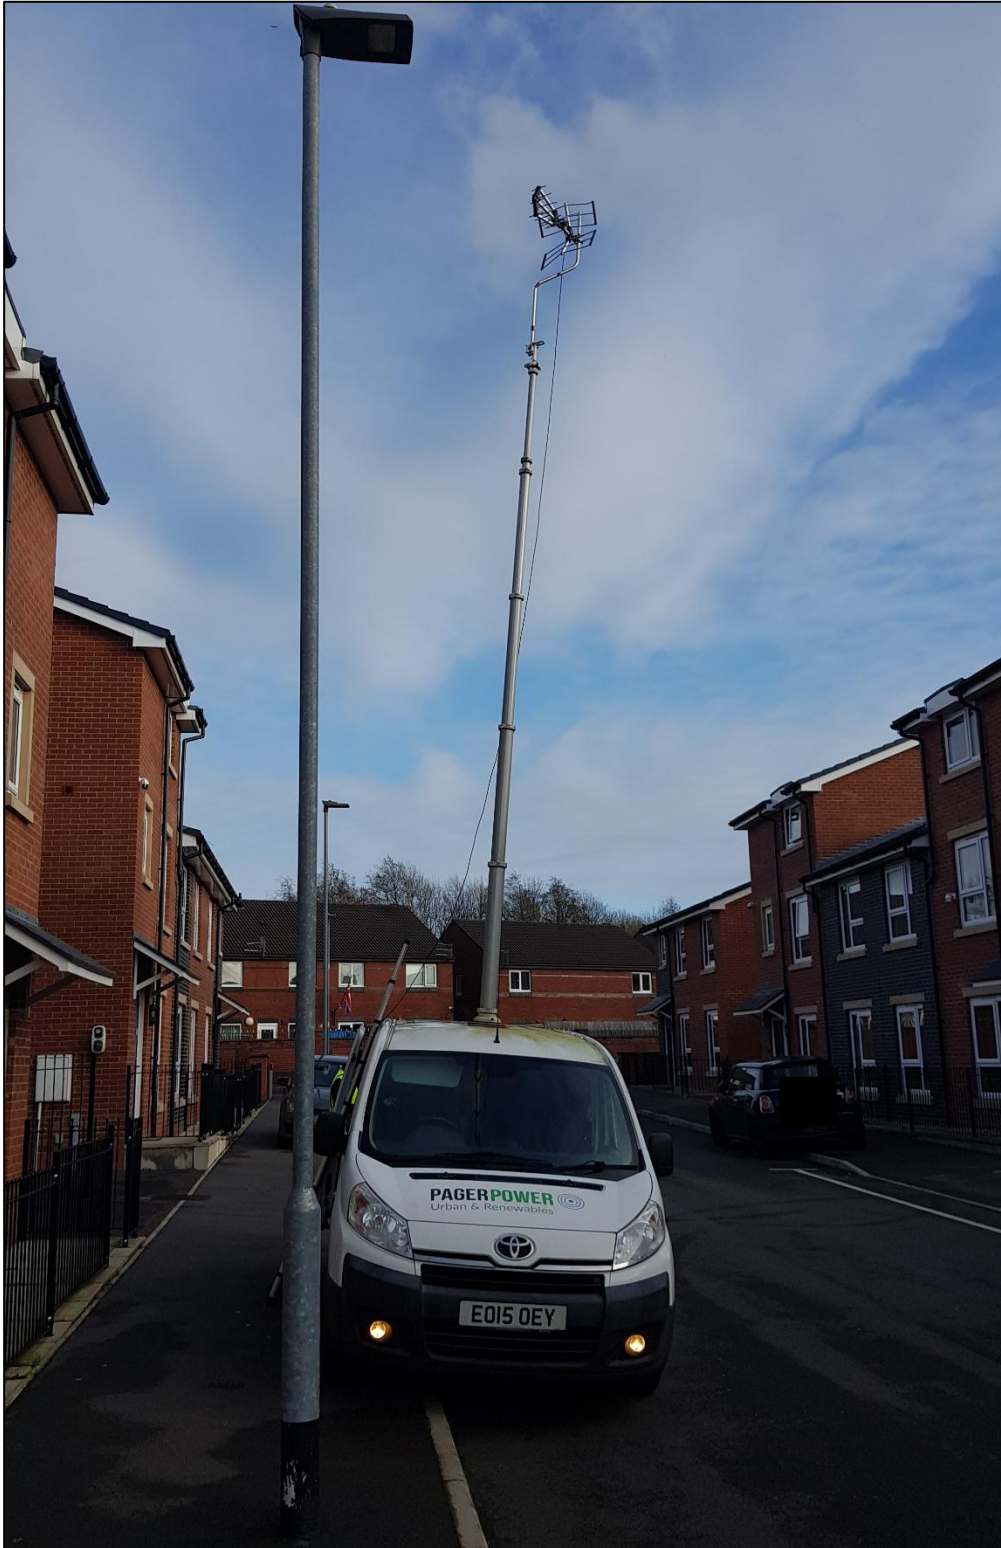
Location 4

| Location | Average Measured Signal Strength (dB) | Remarks | High Level Conclusion |
|---|---|---|---|
| 4 | <p>Overall average:<br/><b>71.0 (Very Good)</b></p> <p>Main TV MUX:<br/><b>76.2 (Very Good)</b></p> <p>Local TV MUX:<br/><b>55.4 (Very Good)</b></p> | <p>Multiple horizontally polarised aerials and satellite dishes were observed at this location.</p> <p>All main multiplexes displayed fine picture and audio quality. An average of moderate signal strength and signal fluctuations of less than or equal to 0.2dB.</p> <p>Both local multiplexes displayed fine picture and audio quality. An average of low signal strength and signal fluctuations of less than or equal to 0.3dB.</p> | <p>The survey location is approximately 1.81km from the development and within its shadow zone.</p> <p>Predominately low-rise residential housing adjacent to this location.</p> <p>Effects at this range are likely to be relatively small based on previous experience. Based on the current signal quality, effects are unlikely to be noticeable for the main multiplexes. Effects upon local multiplexes are considered possible due to current signal strength.</p> |

Notes: Multiple horizontally polarised aerials and satellites dishes observed.

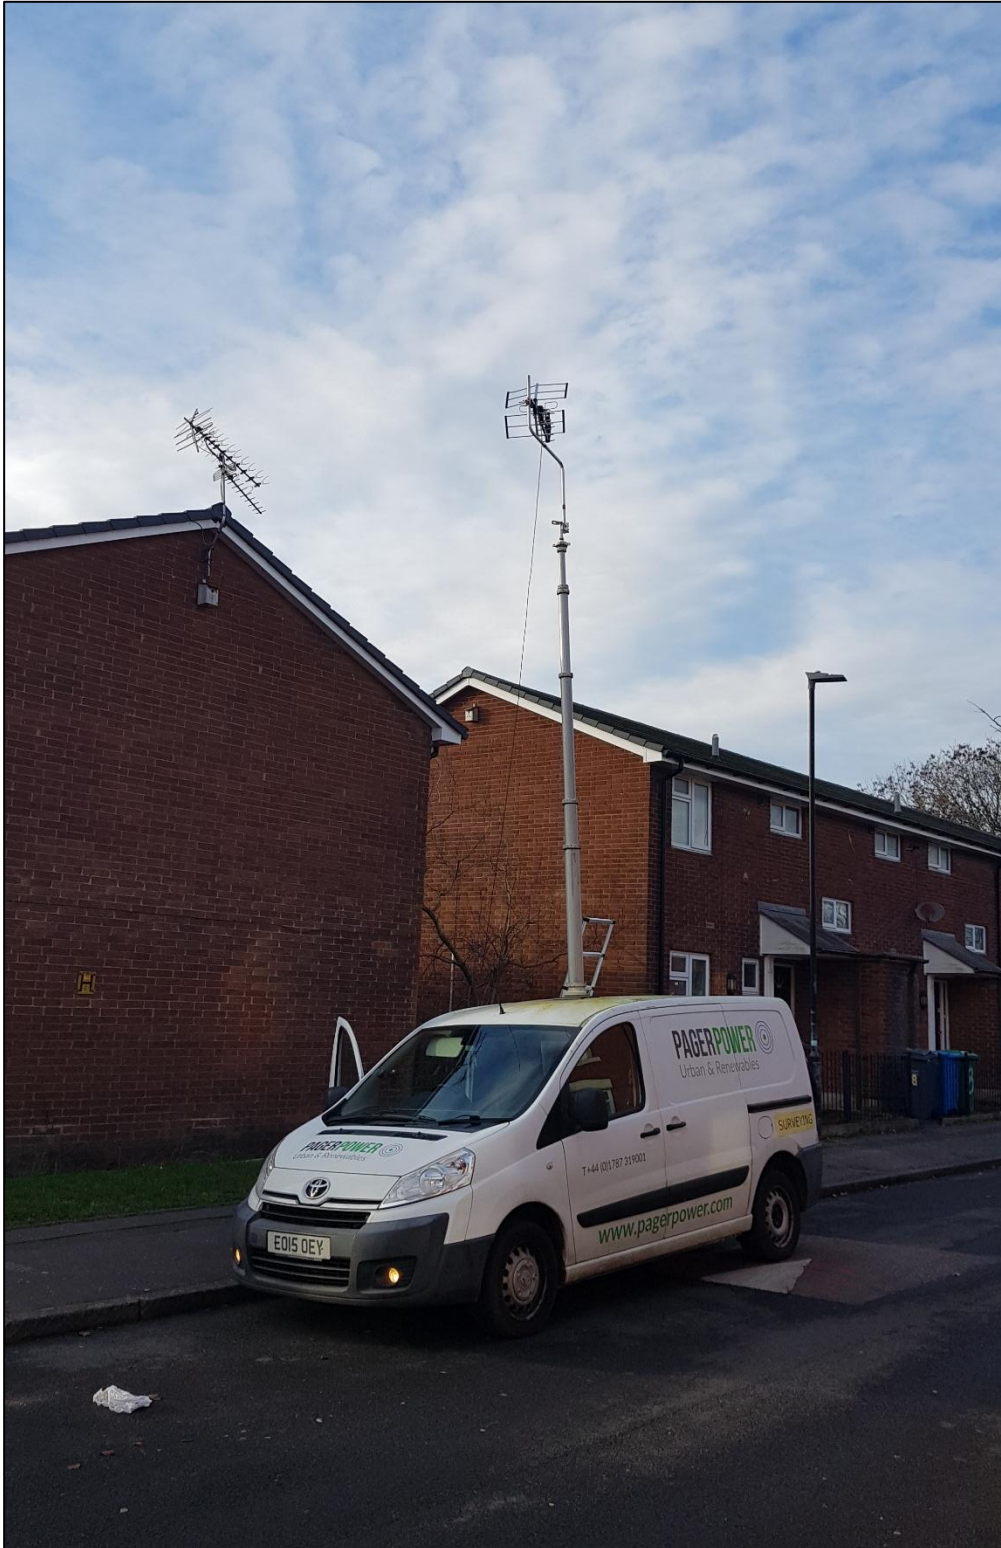
Location 5

| Location | Average Measured Signal Strength (dB) | Remarks | High Level Conclusion |
|---|---|---|---|
| 5 | <p>Overall average:<br/><b>69.6 (Very Good)</b></p> <p>Main TV MUX:<br/><b>74.7 (Very Good)</b></p> <p>Local TV MUX:<br/><b>54.2 (Good)</b></p> | <p>Multiple horizontally polarised aerials and satellite dishes were observed at this location.</p> <p>All main multiplexes displayed fine picture and audio quality. An average of moderate signal strength and signal fluctuations of less than or equal to 0.2dB.</p> <p>Both local multiplexes displayed fine picture and audio quality. An average of low signal strength and signal fluctuations of less than or equal to 0.2dB.</p> | <p>This location is approximately 2.43km from the development.</p> <p>Predominately low-rise residential housing adjacent to this location.</p> <p>Effects at this range are likely to be relatively small based on previous experience. Based on the current signal quality, effects are unlikely to be noticeable for the main multiplexes. Effects upon local multiplexes are considered possible due to current signal strength.</p> |

Notes: Multiple horizontally polarised aerials and satellites dishes observed.

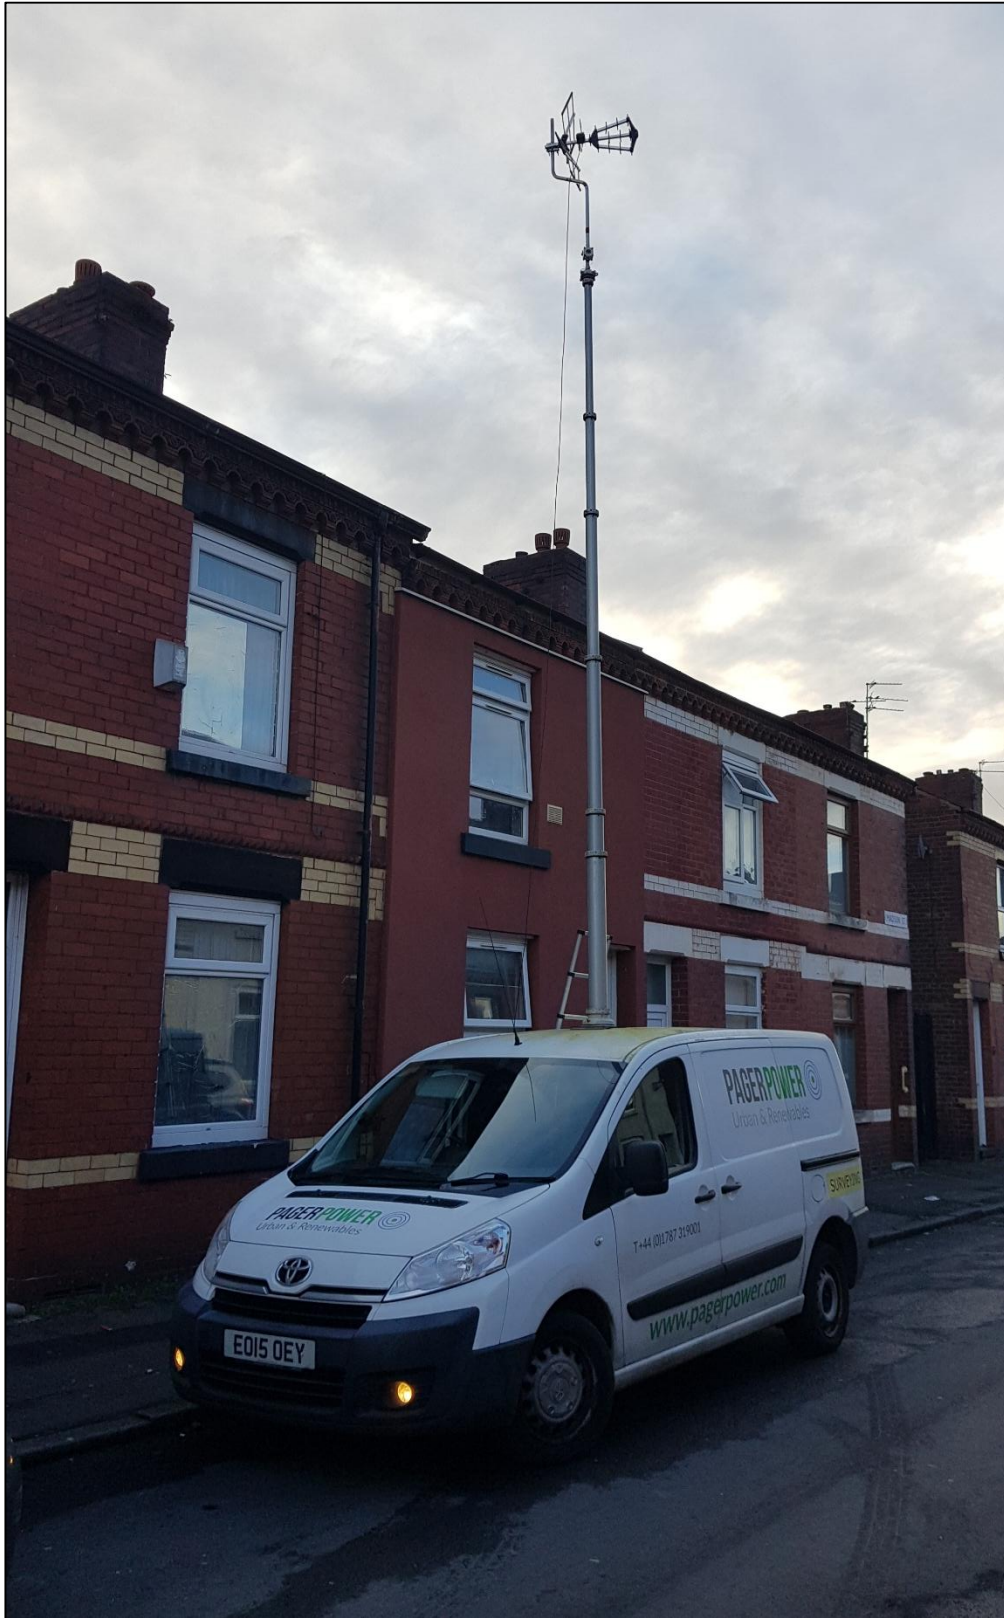
Location 6

| Location | Average Measured Signal Strength (dB) | Remarks | High Level Conclusion |
|---|---|---|---|
| 6 | <p>Overall average:<br/><b>68.8 (Very Good)</b></p> <p>Main TV MUX:<br/><b>73.9 (Very Good)</b></p> <p>Local TV MUX:<br/><b>53.5 (Good)</b></p> | <p>Multiple horizontally polarised aerials and satellite dishes were observed at this location.</p> <p>All main multiplexes displayed fine picture and audio quality. An average of moderate signal strength and signal fluctuations of less than or equal to 0.2dB.</p> <p>Both local multiplexes displayed fine picture and audio quality. An average of low signal strength and signal fluctuations of less than or equal to 0.2dB.</p> | <p>This location is approximately 3.27km from the development.</p> <p>Predominately low-rise residential housing adjacent to this location.</p> <p>Effects at this range are likely to be relatively small based on previous experience. Based on the current signal quality, effects are unlikely to be noticeable for the main multiplexes. Effects upon local multiplexes are considered possible due to current signal strength.</p> |

Notes: Multiple horizontally polarised aerials and satellites dishes observed.

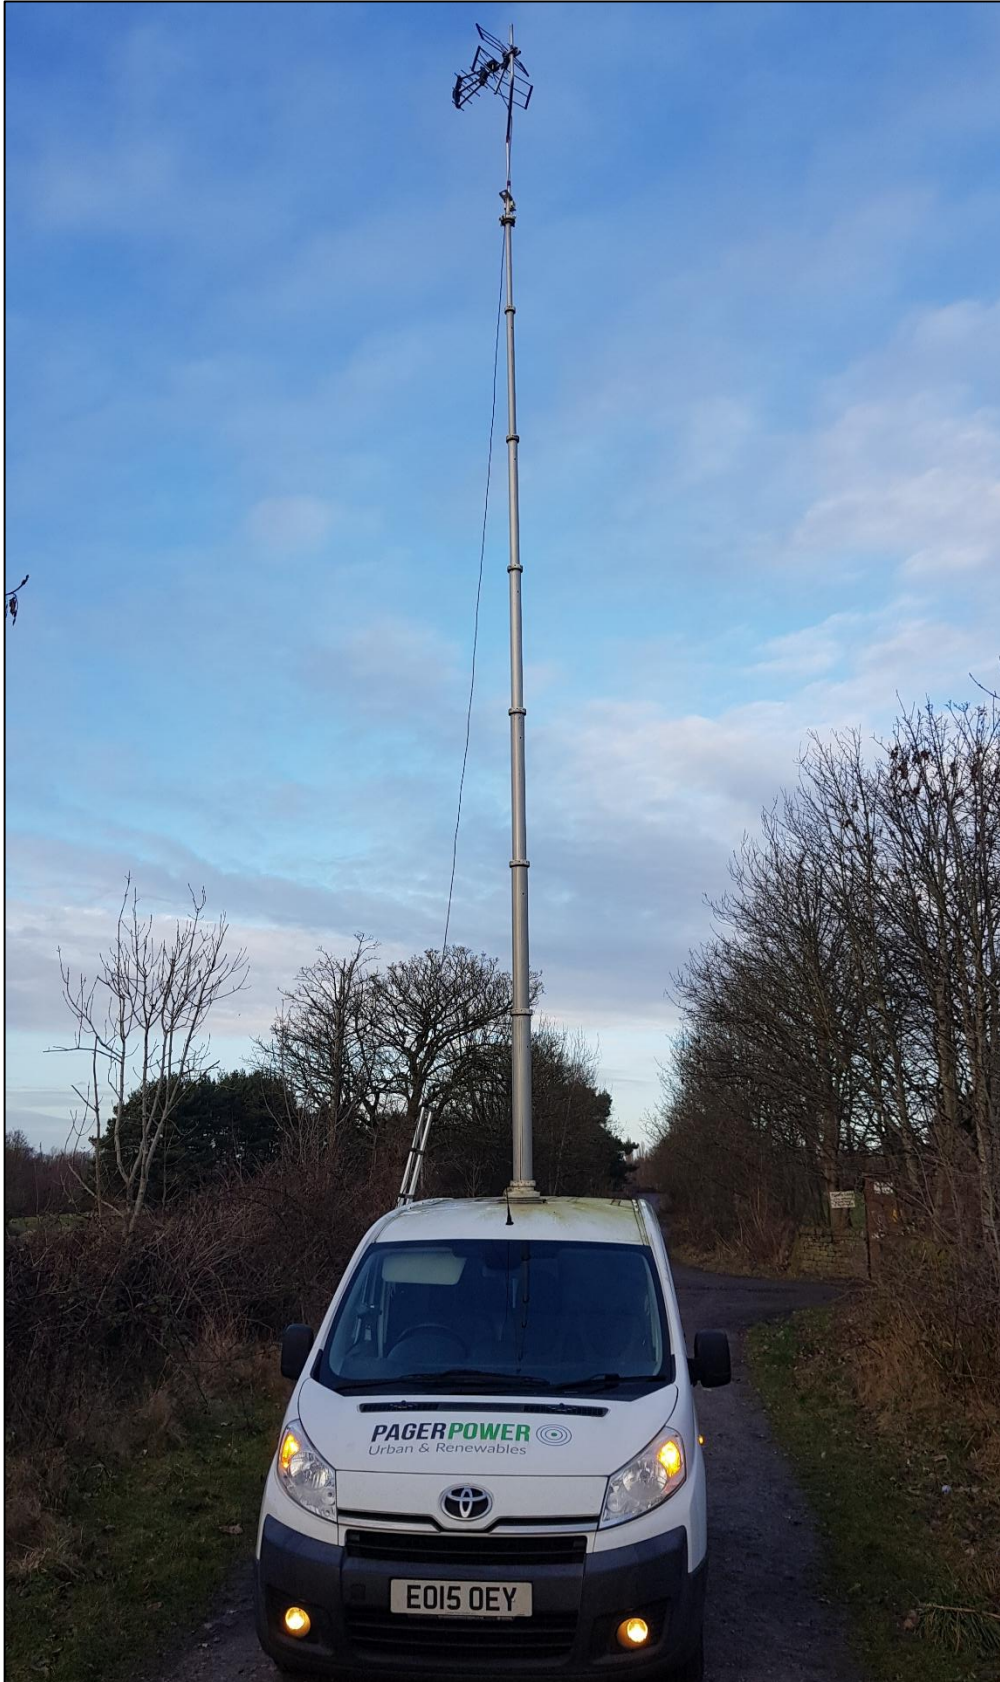
Location 7

| Location | Average Measured Signal Strength (dB) | Remarks | High Level Conclusion |
|---|---|---|---|
| 7 | <p>Overall average:<br/><b>63.0 (Very Good)</b></p> <p>Main TV MUX:<br/><b>67.7 (Very Good)</b></p> <p>Local TV MUX:<br/><b>49.0 (Good)</b></p> | <p>Multiple horizontally polarised aerials were observed at this location.</p> <p>All main multiplexes displayed fine picture and audio quality. An average of moderate signal strength and signal fluctuations of less than or equal to 0.2dB.</p> <p>Both local multiplexes displayed fine picture and audio quality. An average of low signal strength and signal fluctuations of less than or equal to 0.3dB.</p> | <p>This location is approximately 4.18km from the development.</p> <p>Predominately low-rise residential housing adjacent to this location.</p> <p>Effects at this range are likely to be relatively small based on previous experience. Based on the current signal quality, effects are unlikely to be noticeable for the main multiplexes. Effects upon local multiplexes are considered possible due to current signal strength.</p> |

Notes: Multiple horizontally polarised aerials observed.
