# Ecology Report

**All Saints Library  
19th November 2025**

TG Report No. 13126\_R06b\_MF

**MMU, All Saints  
13th February 2023**

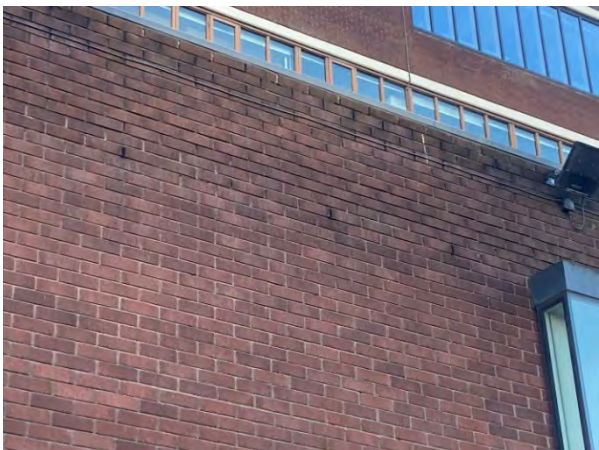
**Photograph 3 : Weep holes present on the exterior of MMU library building (B01)**

- 4.2. It is recommended that pre-construction checks of the low bat roost potential features are required to ensure the protection of bats. It is not recommended that nocturnal surveys are undertaken given the structure of this building (i.e. no roof void), the high temperature of the spaces with crevices and the urbanised location. Additionally, due to the features being positioned on the 6<sup>th</sup> floor and above, nocturnal surveys would be unsuitable due to low visibility. Given the urban setting of the site nocturnal surveys would raise a health and safety risk given the need for surveyors to stand in roads to see the features of interest. Late-night city surveys are also prone to issues with members of the public making nocturnal surveys less viable.
