Remediation and Enabling Works Validation Report  
Belle Vue

Reference:12-123-R5-2  
Date: August 2022

Belle Vue Greyhound Stadium  
Kirkmanshulme Lane  
Manchester  
M18 7BD

Prepared for:  
**Countryside Properties**

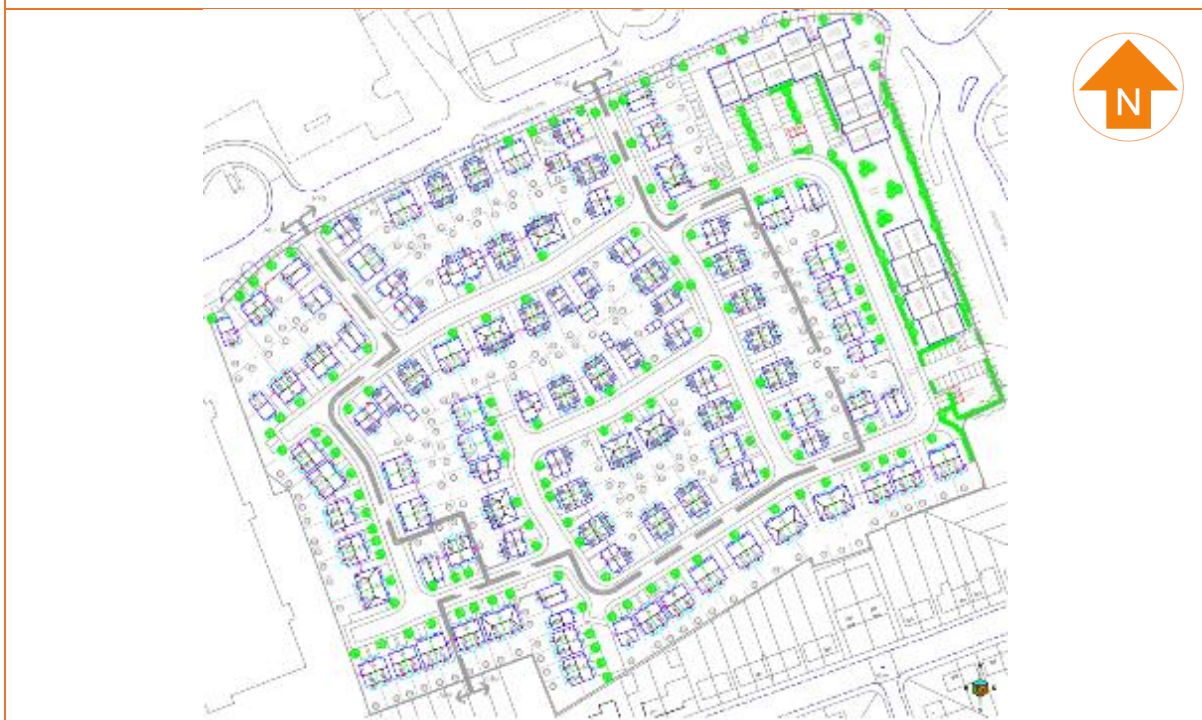
FIGURE 1.1      SNAPSHOT OF PROPOSED DEVELOPMENT

A snapshot of the proposed development layout is indicated in Figure 1.1 below.

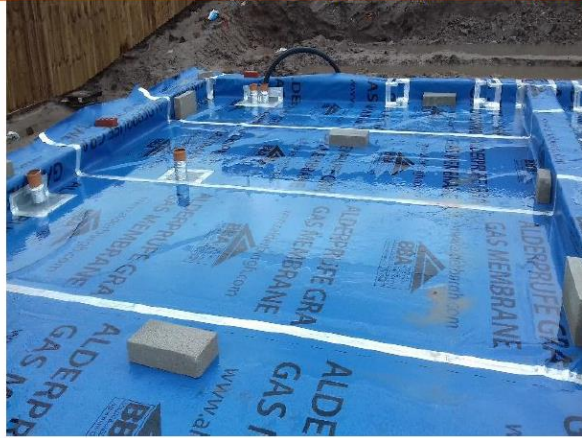
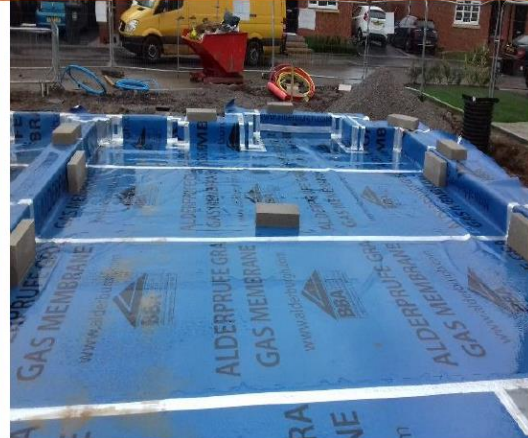
**Plot – 236**

**General Condition of Membrane-Good Condition**

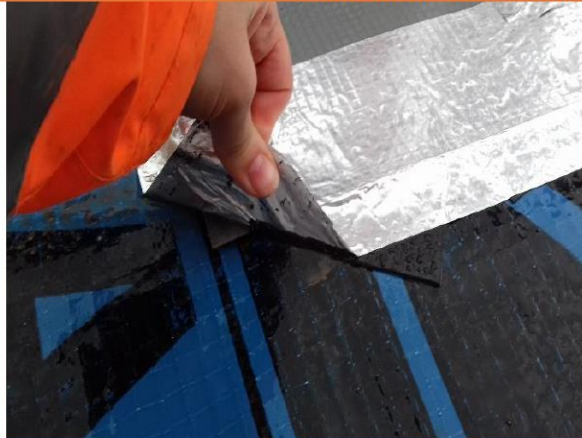
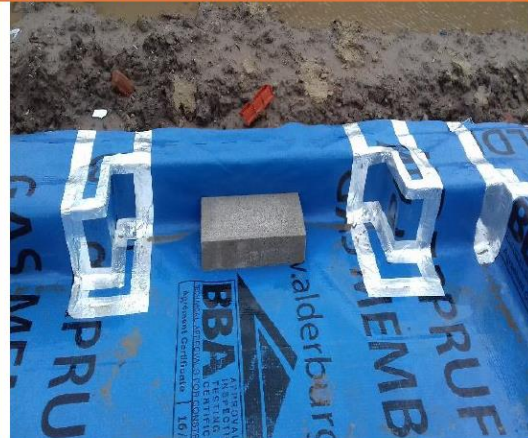
**Verification of Joints and Seals-Good Condition**

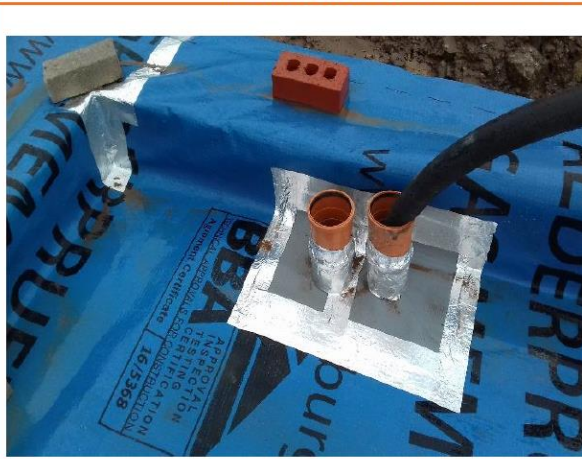
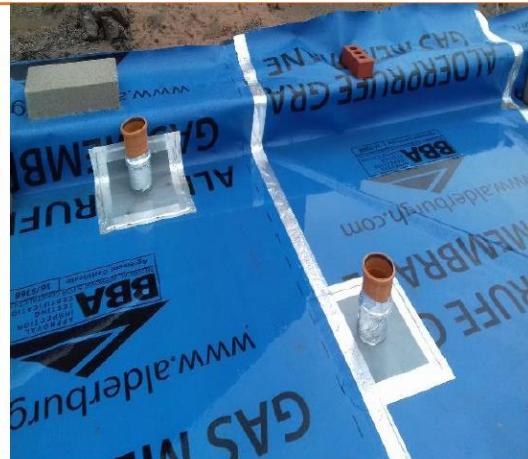
**Verification of Service Penetrations-Good Condition**

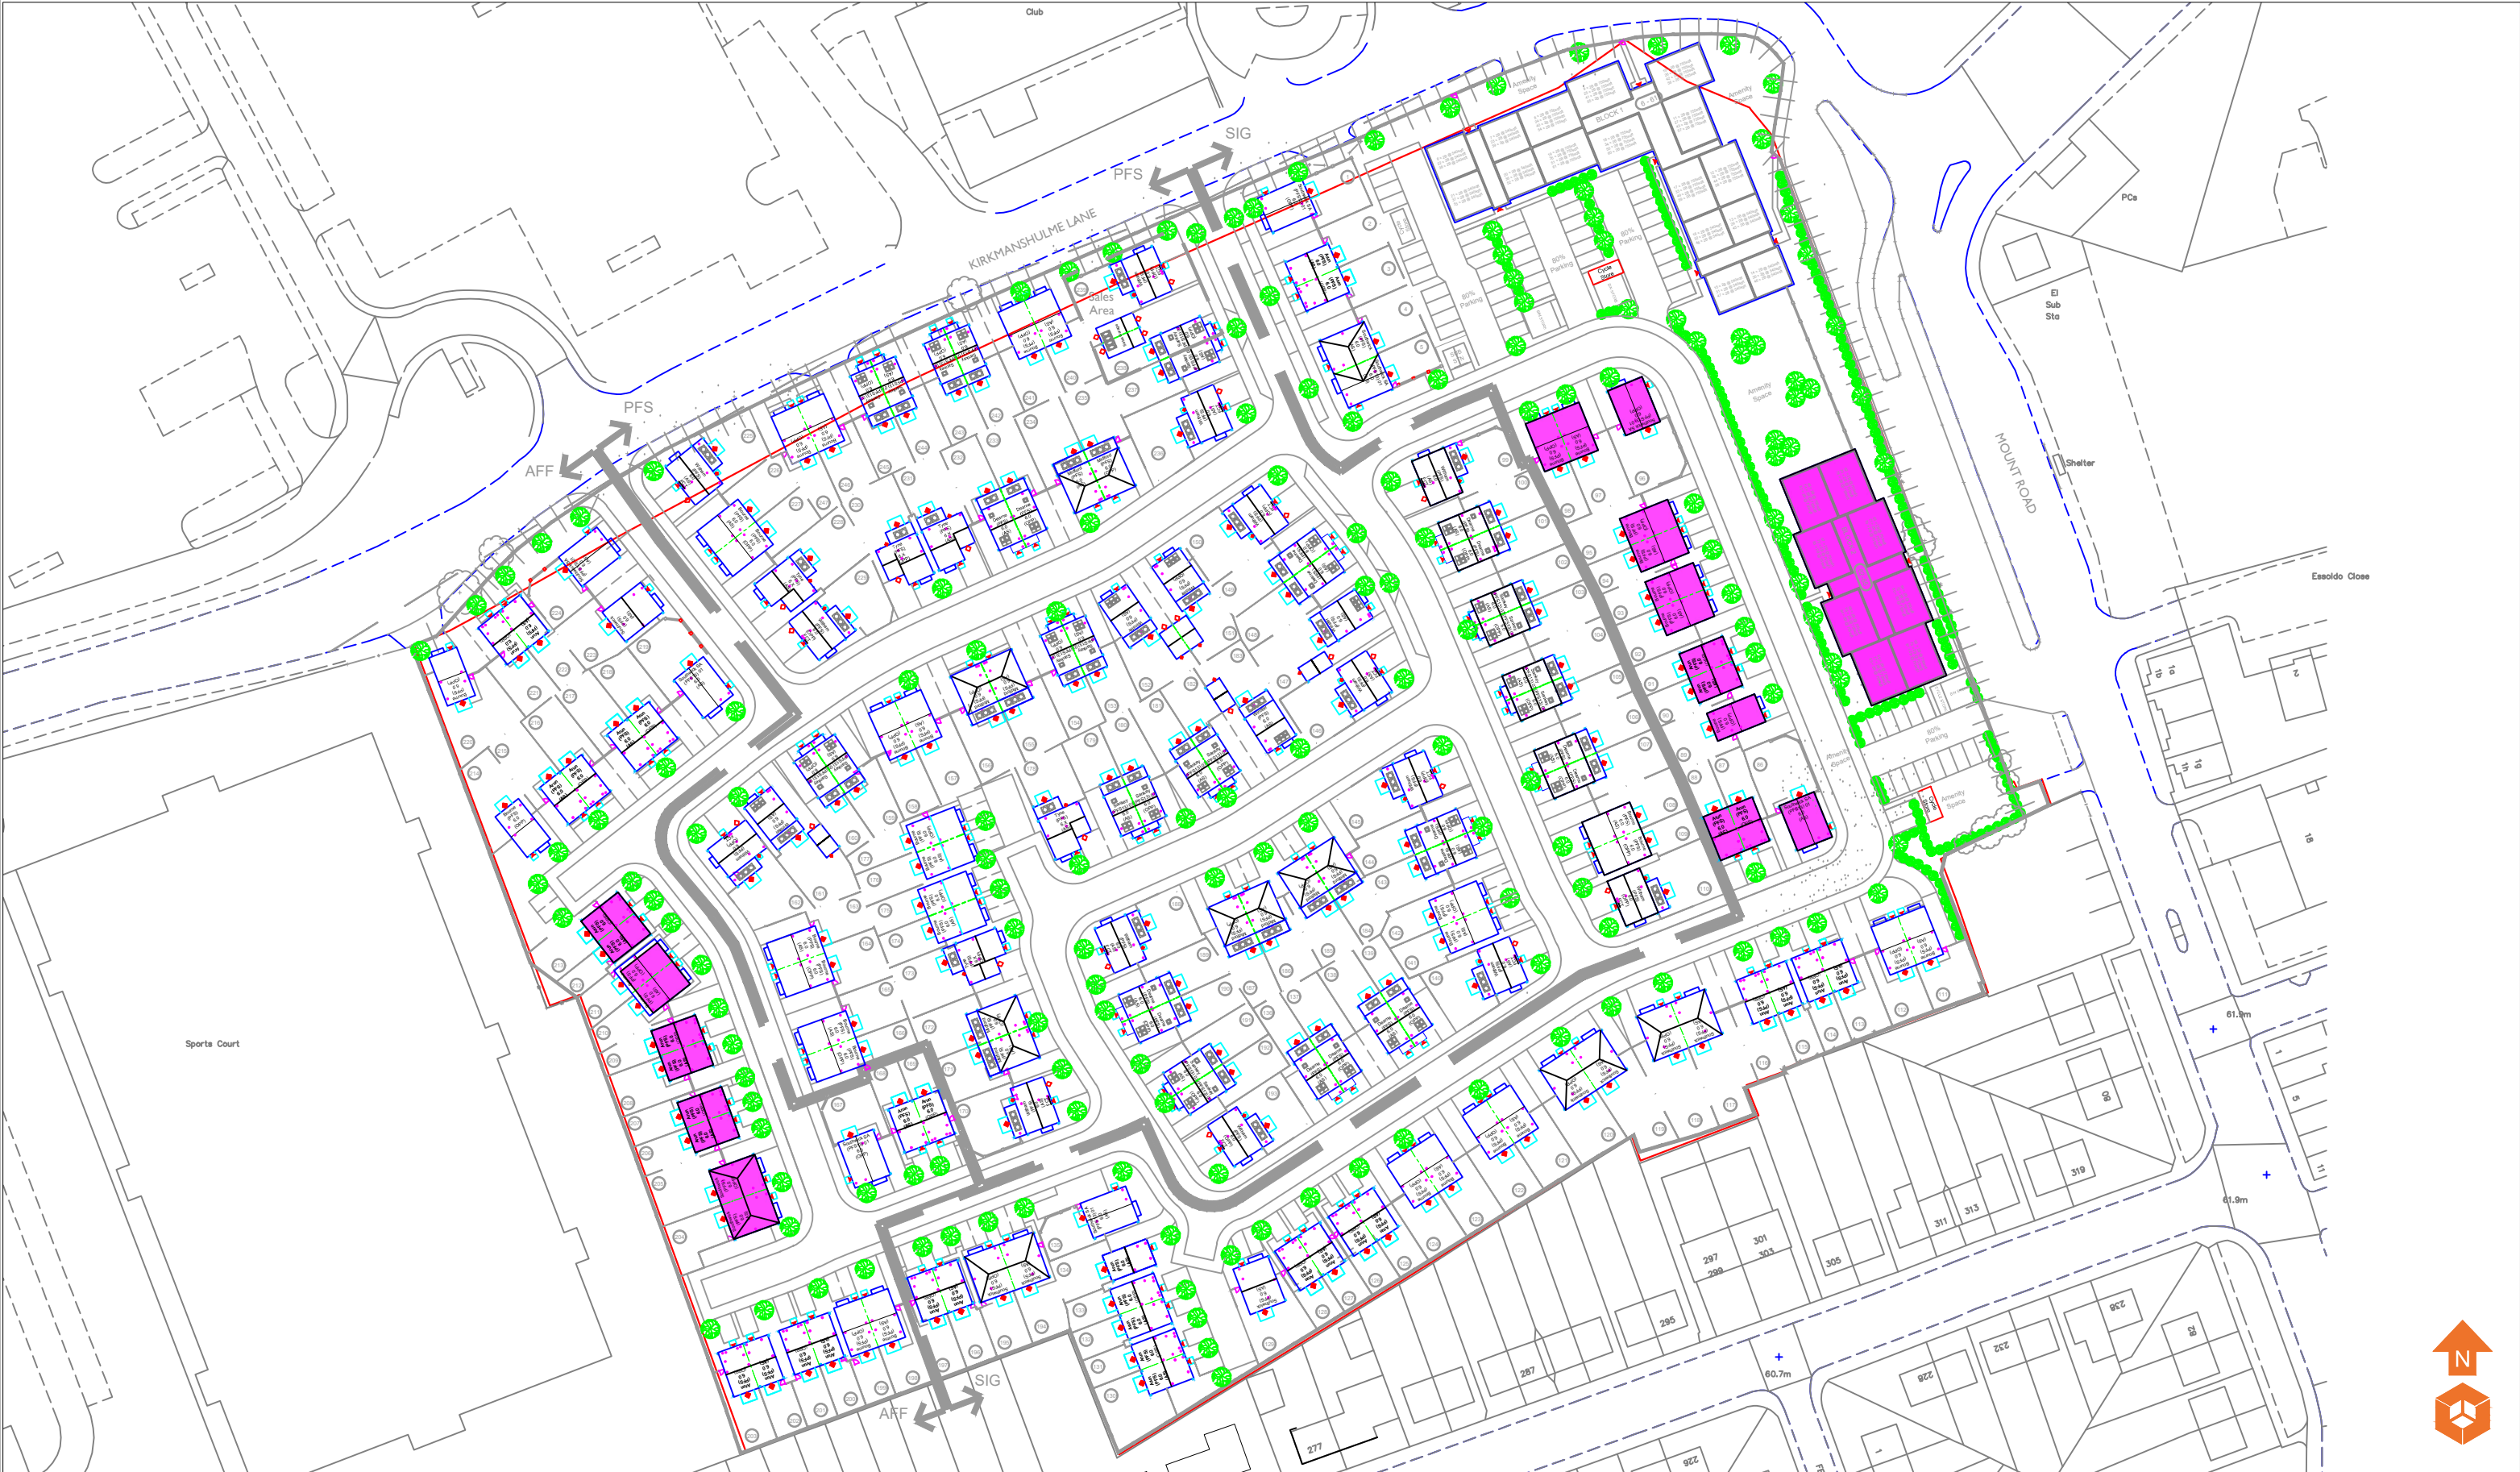
| <div>Vapour Membrane</div> <div><div></div> Vapour Membrane Required</div> | Notes: | | | | | Client: | Countryside Properties | Job No: | 12-123 | Date: | 03.05.2022 | <div><div></div>e3p</div> <div>Environmental Engineering Partnership Ltd<br/>Taylor Road, Trafford Park Urmston, Manchester, M41 7JQ<br/>Tel: 0161 707 9612<br/>E-mail: info@e3p.co.uk<br/>Website: www.e3p.co.uk</div> | |

Due to further testing on site highlighting exceedances of naphthalene and other SVOCs it has been recommended that within Plots 86-98, Apartment Block 2 and 204-214 where SVOCs are identified as critical determinants, specialist vapour resistant membranes are included within the construction of the dwelling in addition to any proposed ground gas membranes, outlined in Drawing 12-123-015.

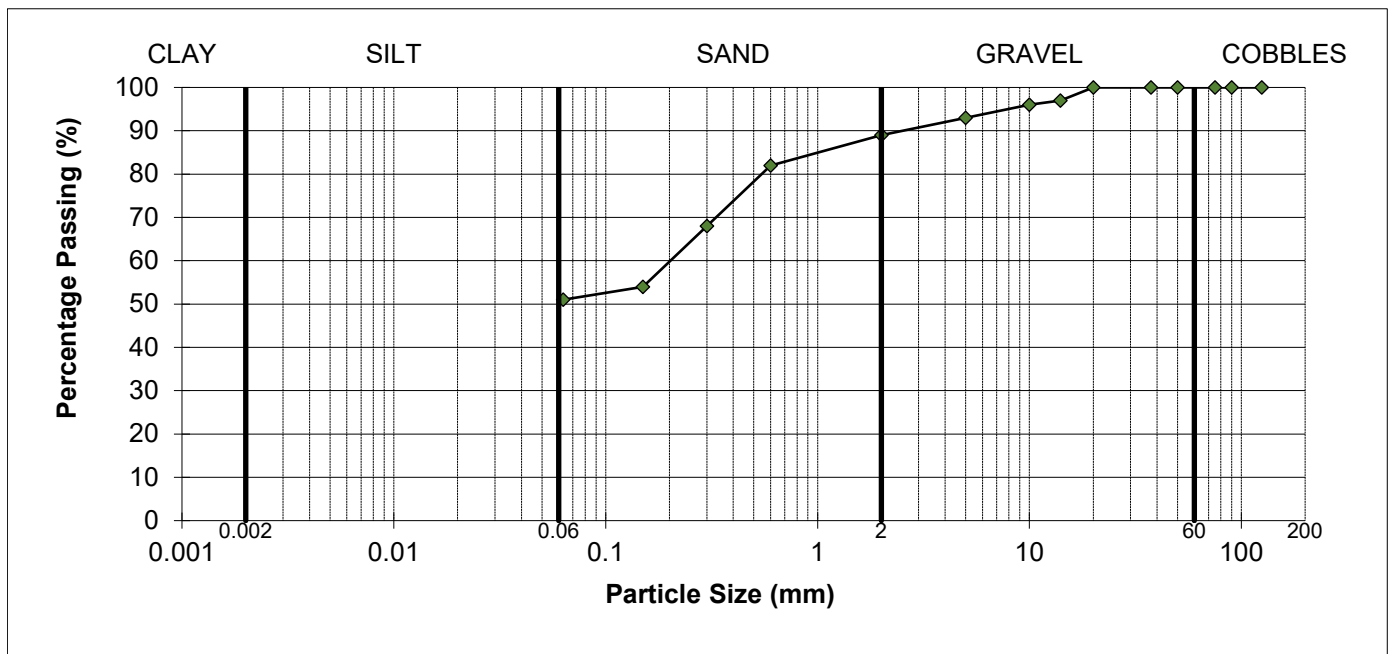
Sample complies with the advised grading specification for a 2A/2B material (SHW 2016)  
 As received moisture content = 14%

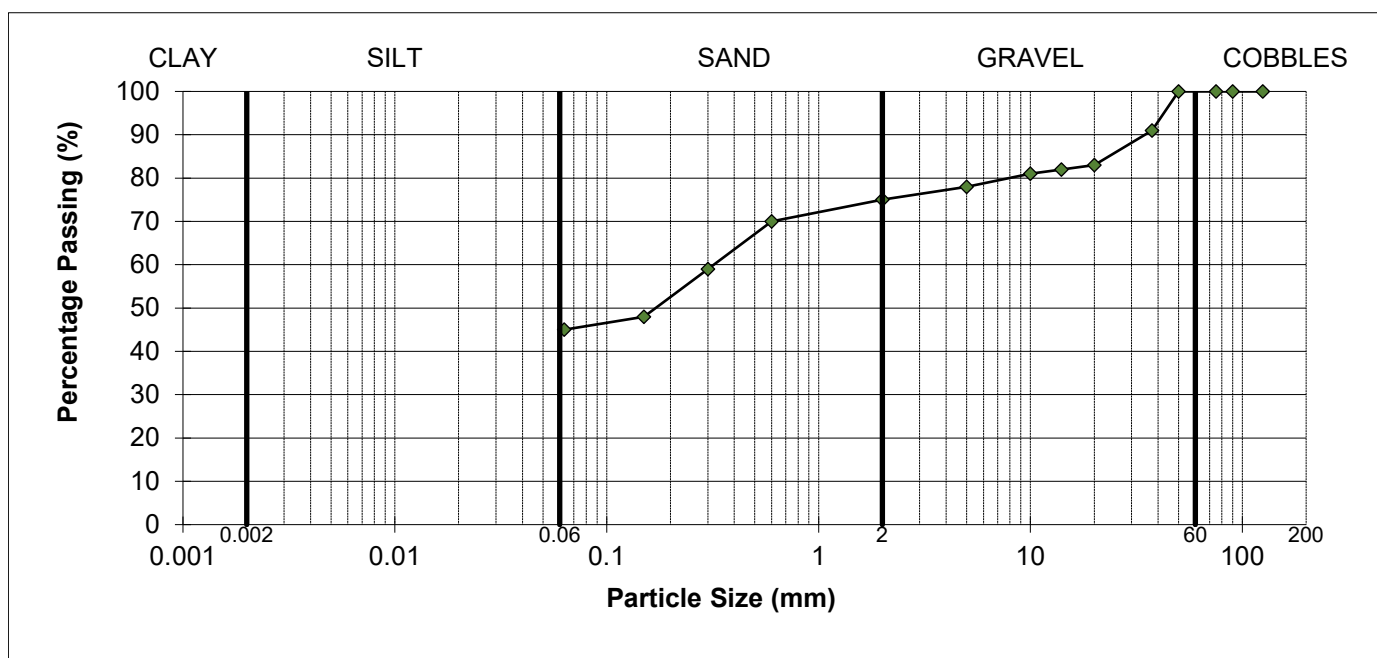
Sample complies with the advised grading specification for a 2C material (SHW 2016)

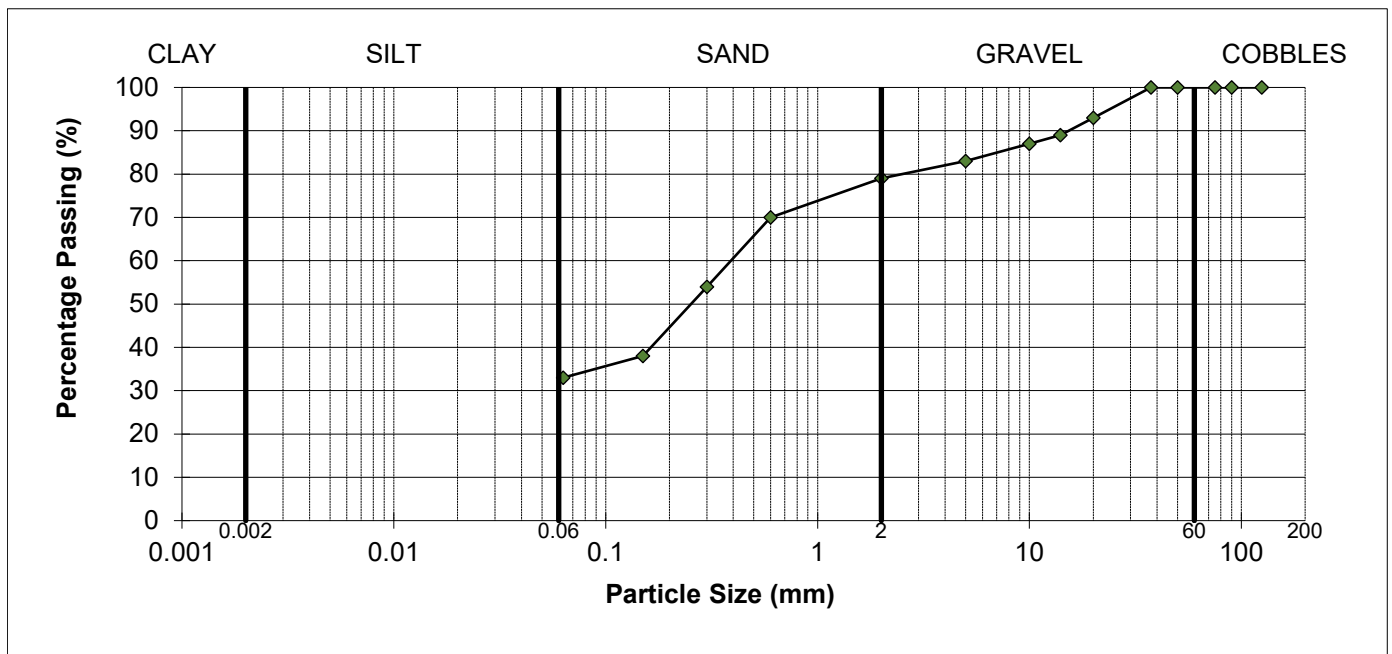
Sample complies with the advised grading specification for a 2C material (SHW 2016)

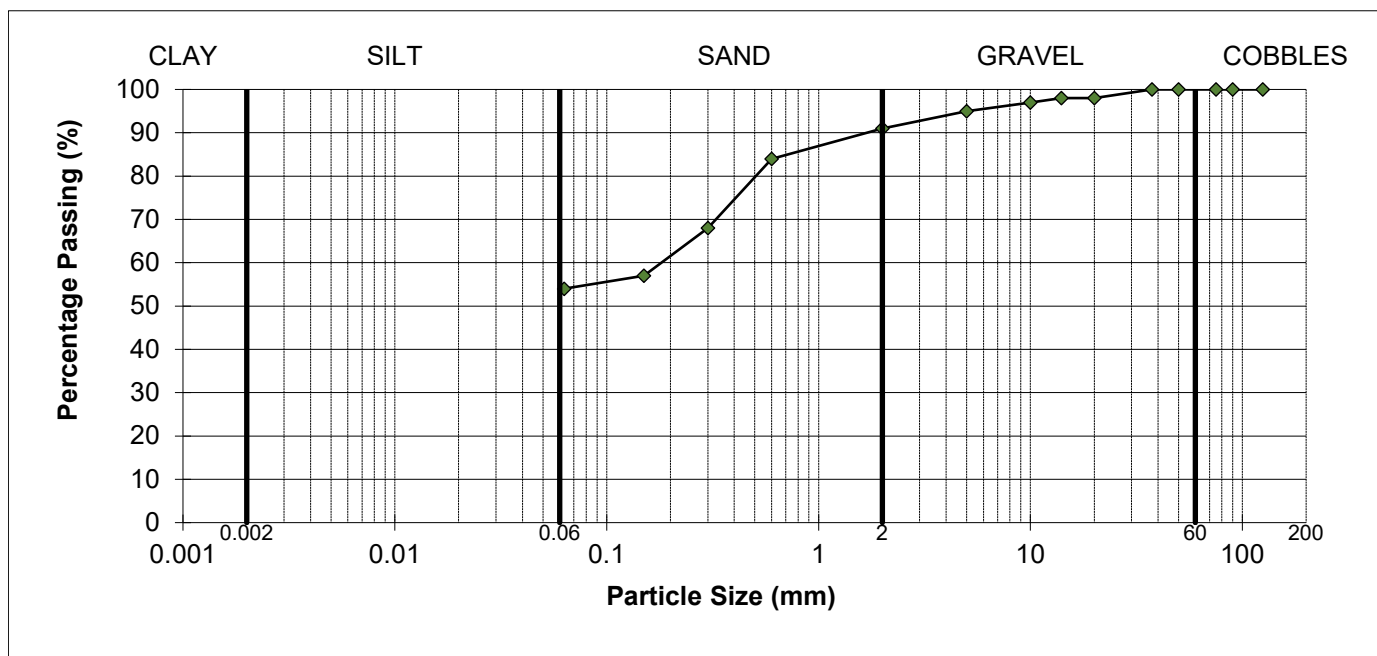
Sample complies with the advised grading specification for a 2A/2B material (SHW 2016)

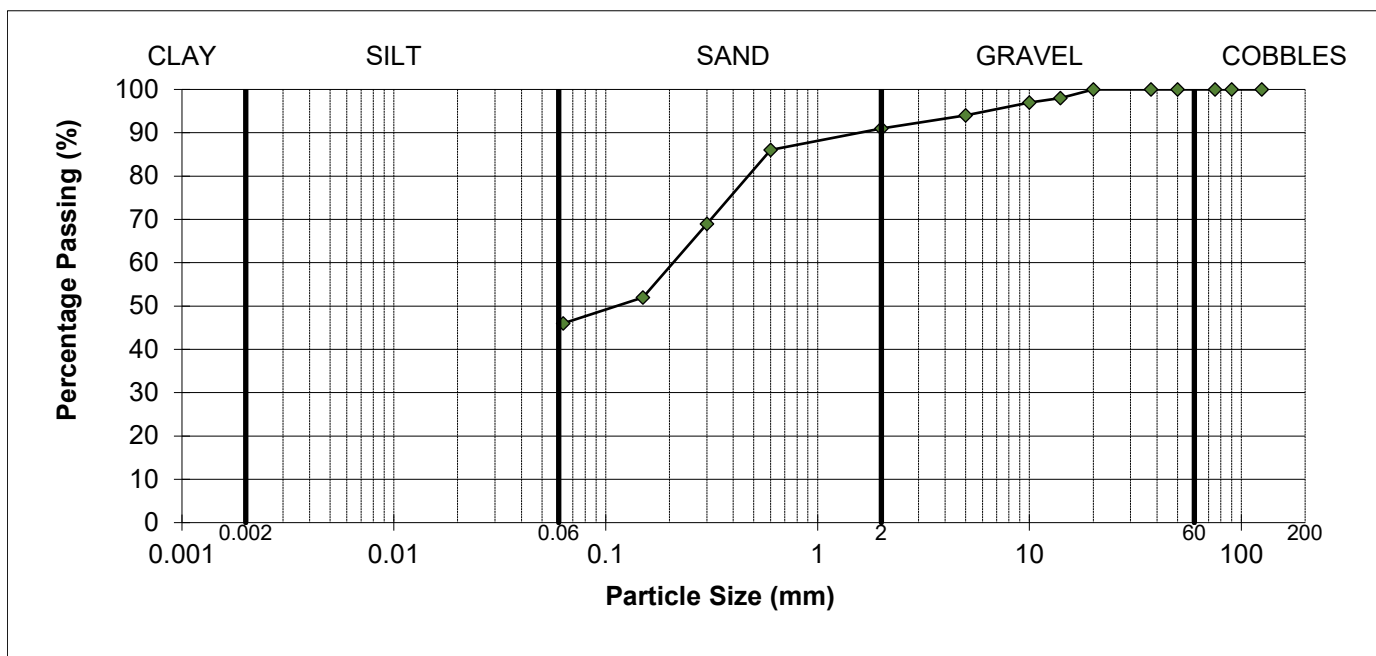
Sample complies with the advised grading specification for a 2A/2B material (SHW 2016)

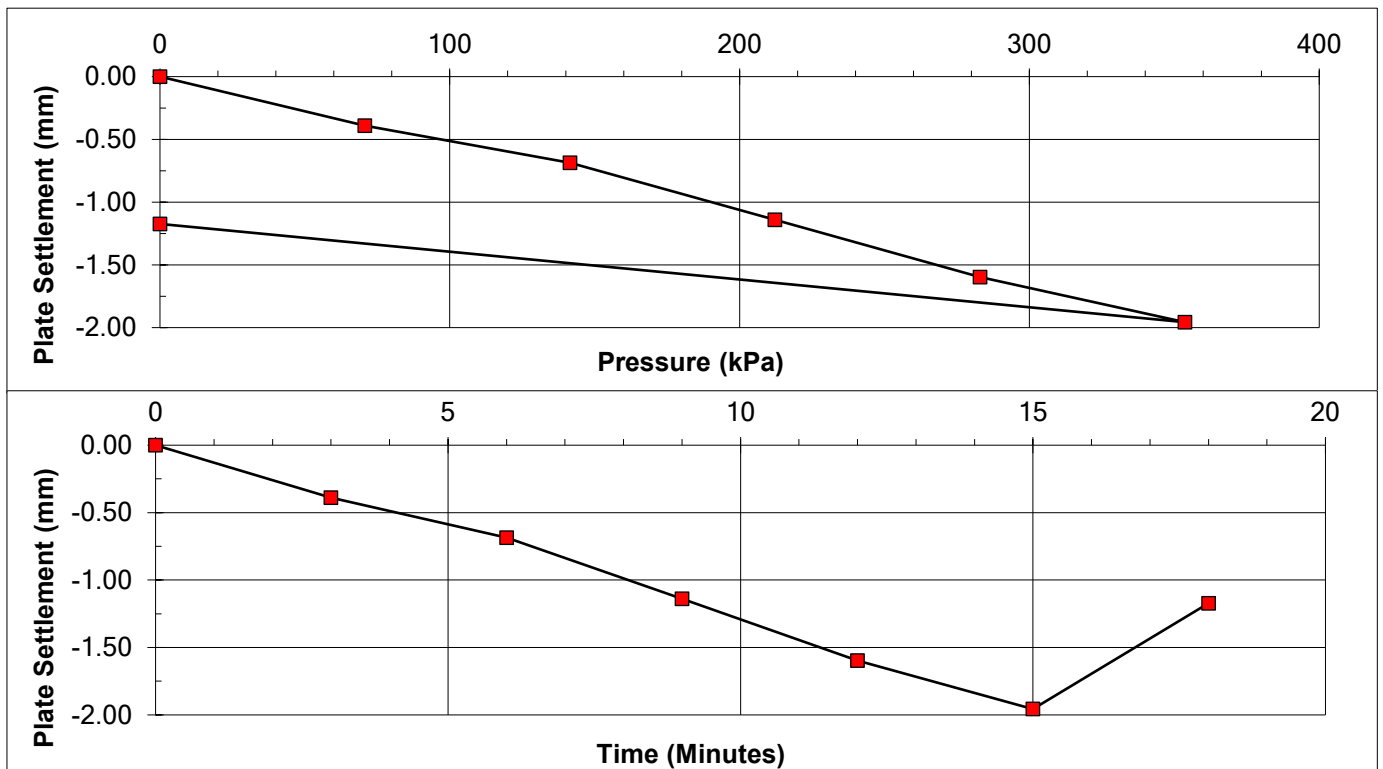
Pressure at 1.25 mm deflexion = 229 kPa  
Modulus of subgrade reaction (k) = 183 MPa/m  
Equivalent 762 mm plate reaction = 81 MPa/m  
Equivalent CBR = 19.6 %

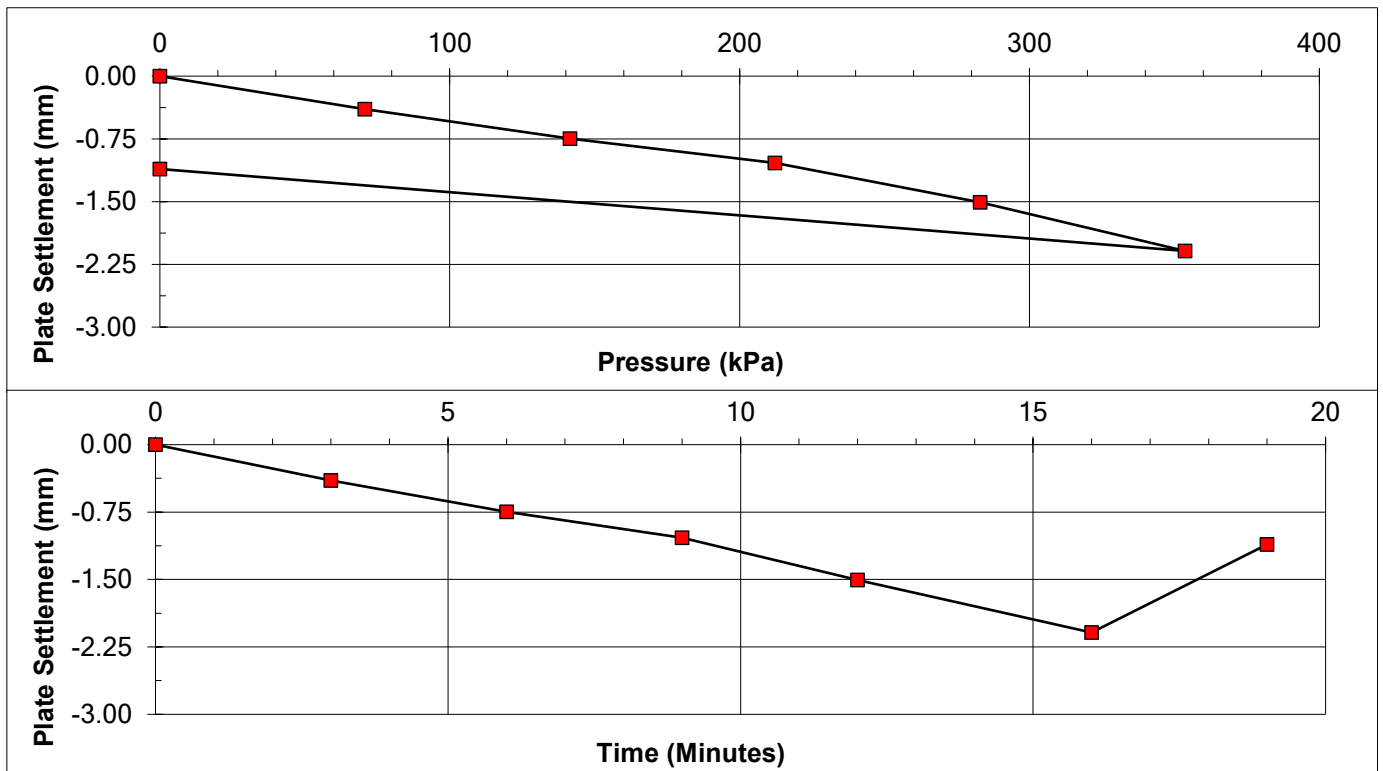
Pressure at 1.25 mm deflexion = 244 kPa  
Modulus of subgrade reaction (k) = 195 MPa/m  
Equivalent 762 mm plate reaction = 86 MPa/m  
Equivalent CBR = 21.9 %
