**CHURCHILL RETIREMENT LIVING**

**FORMER GREENFINCH P.H., LAPWING LANE, WEST DIDSBURY, M20 3ZA**

**SUPPLEMENTARY GROUND INVESTIGATION REPORT**

May 2024  
Report No. CCL03767.CU49

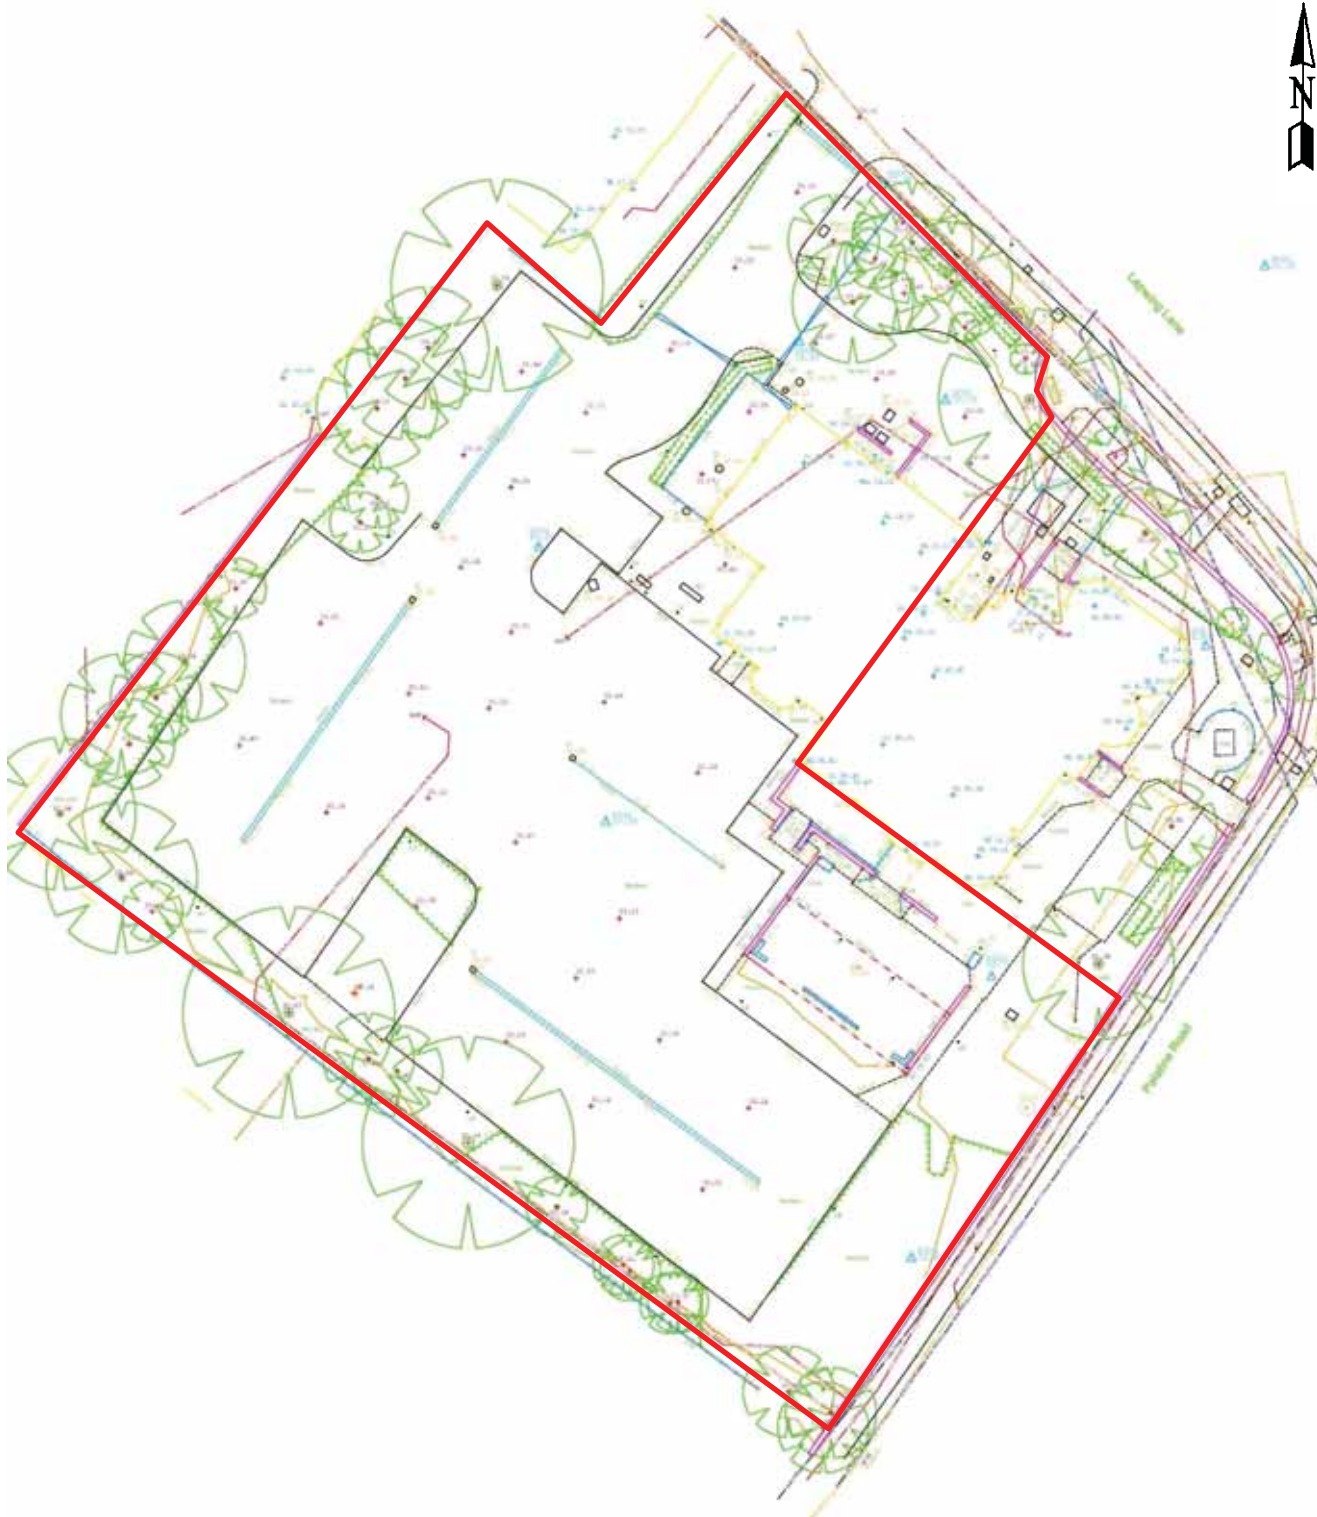
FIGURE 2

**SITE PLAN AND TOPOGRAPHICAL SURVEY**

Reproduced from the topographical survey by Geospatial (undated) provided by the Client

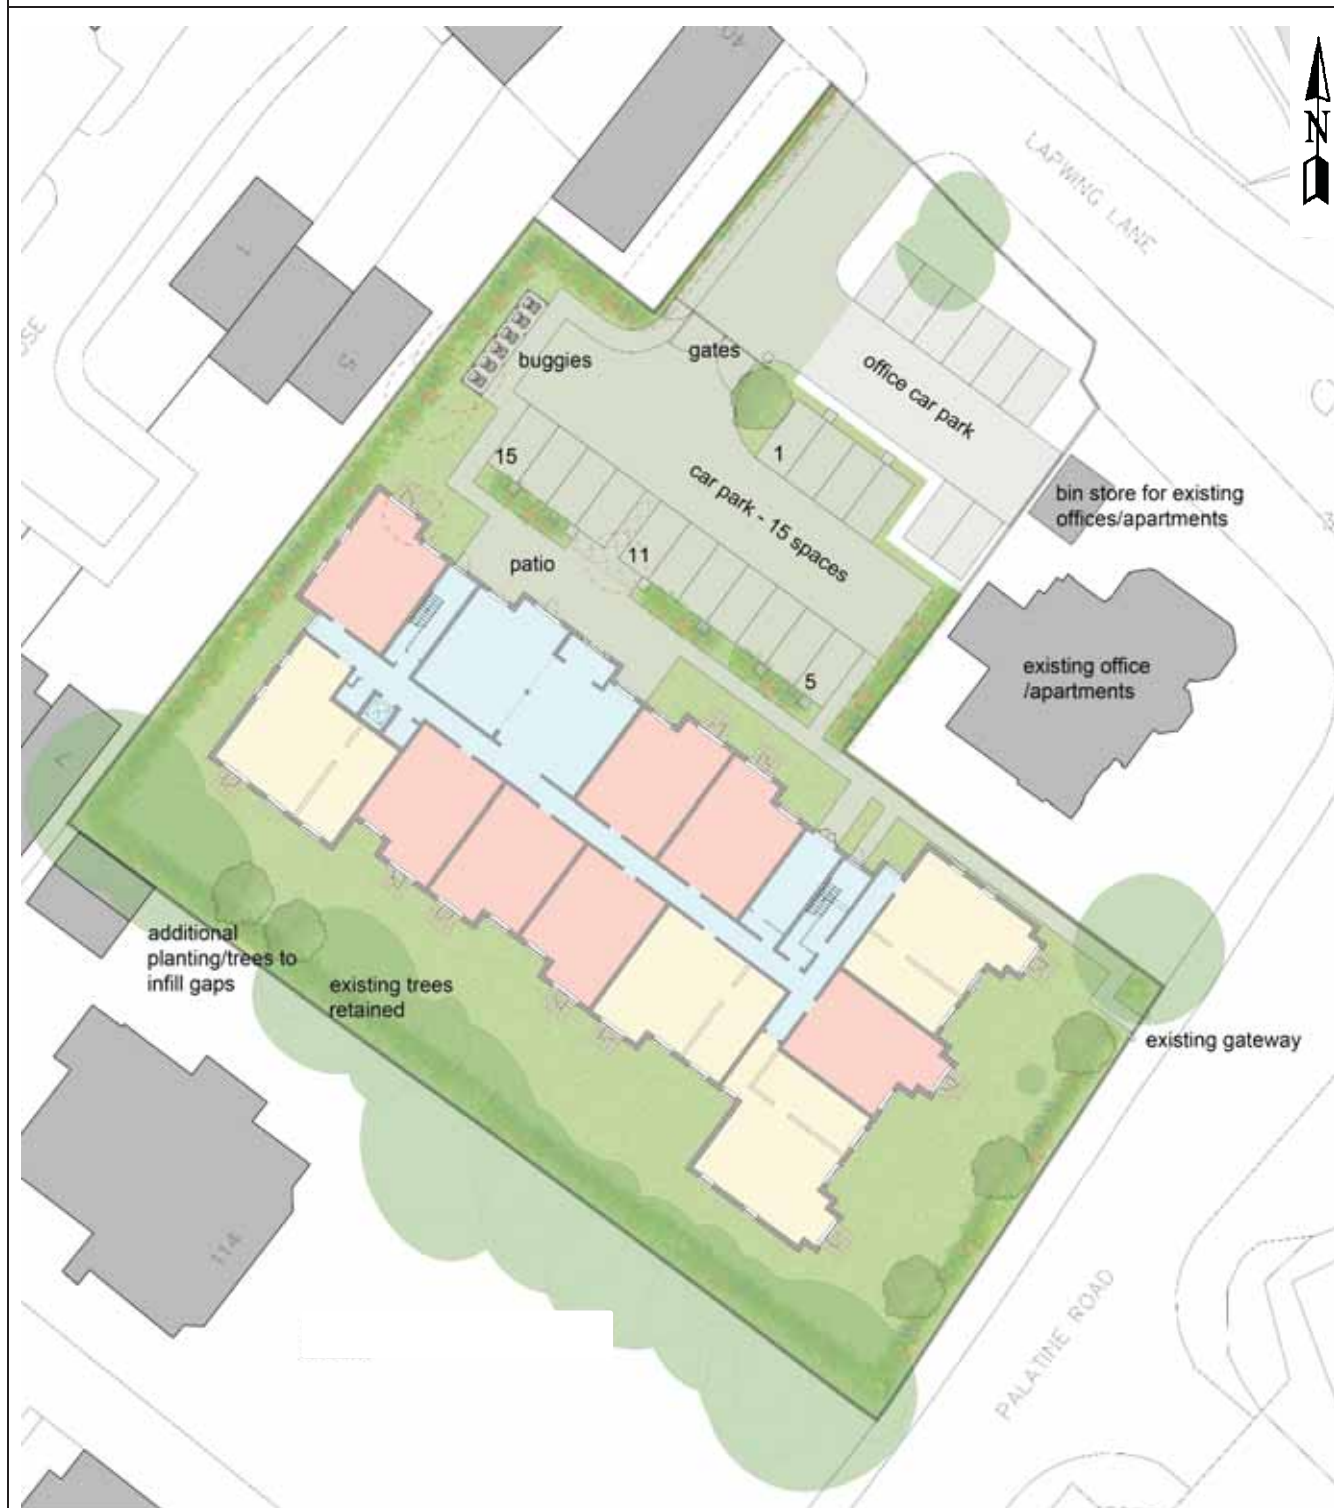
FIGURE 3

**PROPOSED DEVELOPMENT PLAN**

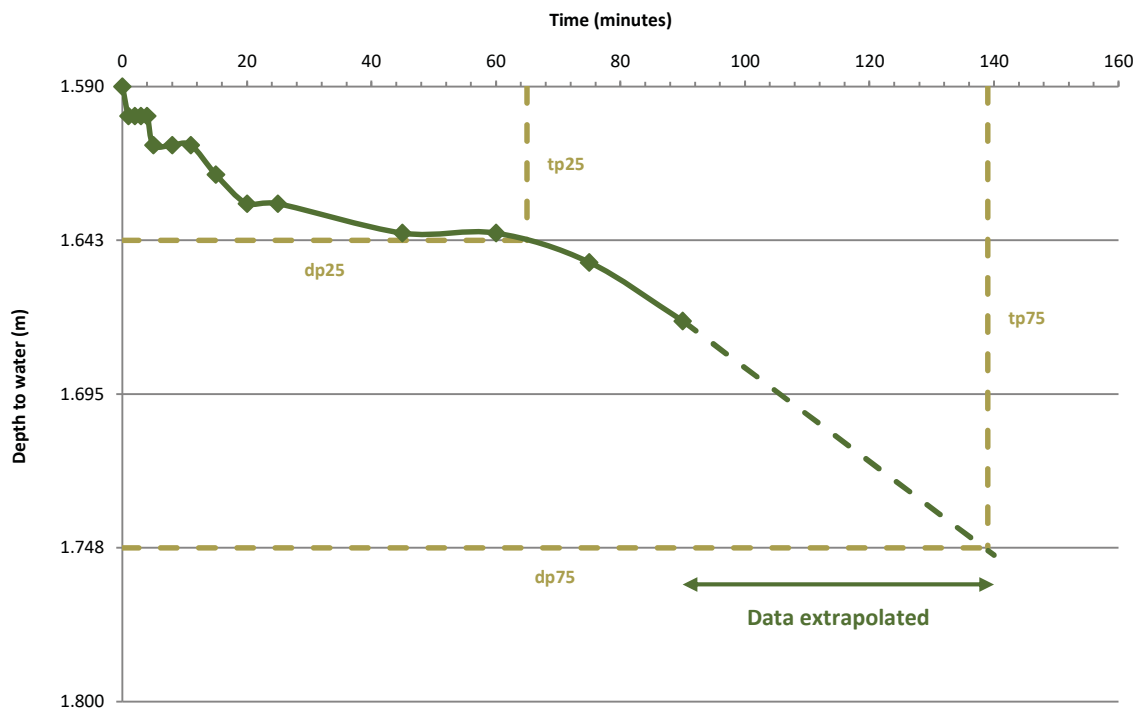
| $a_{p50}$ | Internal surface area up to 50% effective depth and including the base | 1.967m <sup>2</sup> m <sup>2</sup> |
| $t_{p75-25}$ | Time for the water level to fall from 75% to 25% effective depth | 4440 s |

| <b>f</b> | <b>Soil infiltration rate</b> | <b>1.68E-05 m/s</b> |

Infiltration testing was undertaken within six of the trial pits. Testing was repeated once within two of the pits (TP04 and TP104), twice in two of the pits (TP02 and TP101), and thrice in two of the pits (TP102 and TP103). Two of the tests (with TP02 and TP103) recorded insufficient infiltration over the course of 90 minutes and were terminated. Completed tests recorded infiltration rates between  $6.4 \times 10^{-6}$  m/s and  $1.8 \times 10^{-5}$  m/s with an average of  $9.5 \times 10^{-6}$  m/s.

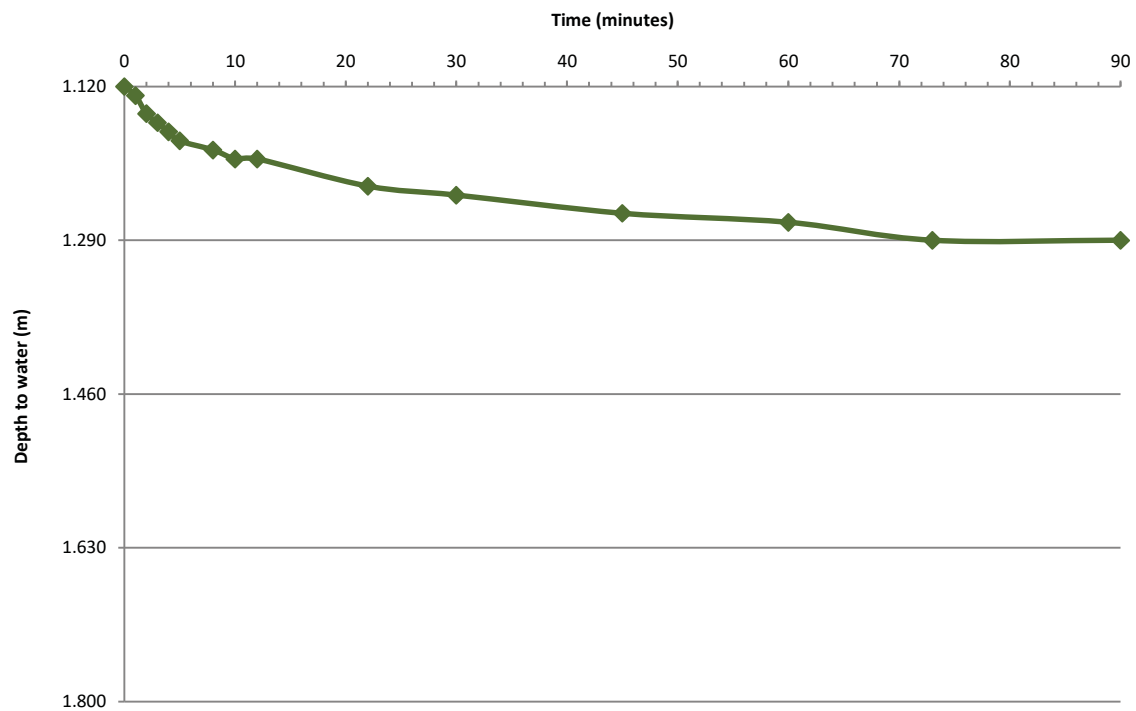
| Location | Cycle | Test date | Dimensions (m) |
|---|---|---|---|
| 1.8 | No groundwater encountered. | | |

Insufficient infiltration over 90 minutes of monitoring therefore unable to calculate soil infiltration rate.

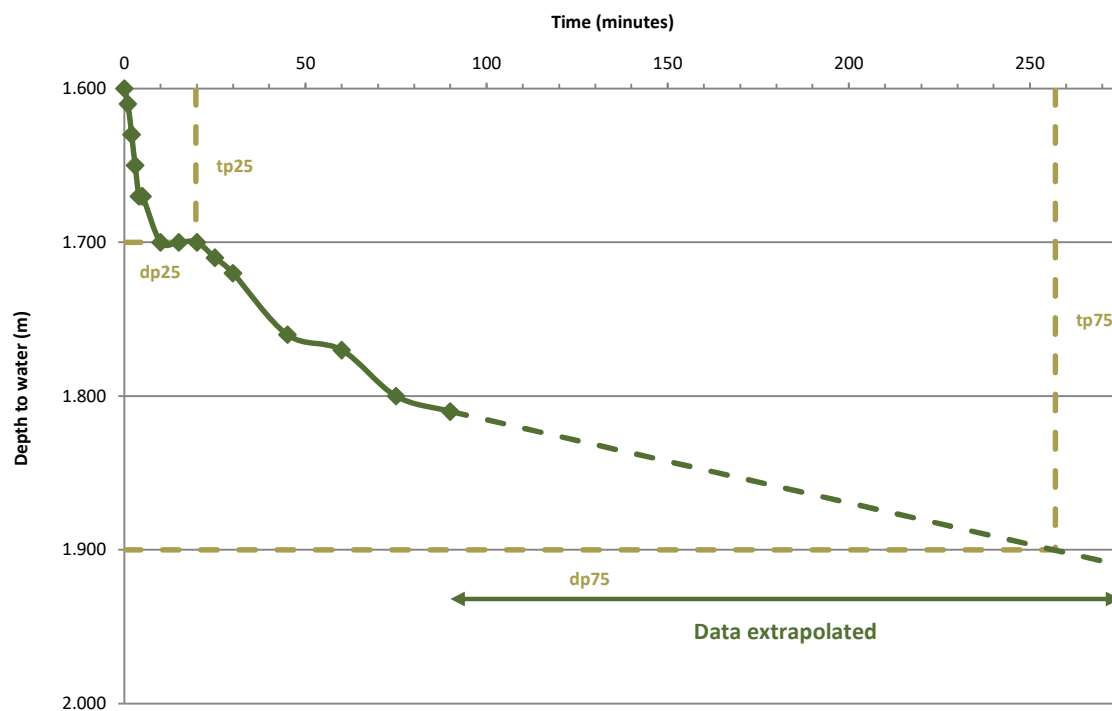
| $a_{p50}$ | Internal surface area up to 50% effective depth and including the base | 3.03m <sup>2</sup> m <sup>2</sup> |
| $t_{p75-25}$ | Time for the water level to fall from 75% to 25% effective depth | 14235 s |

| f | Soil infiltration rate | 8.11E-06 m/s |

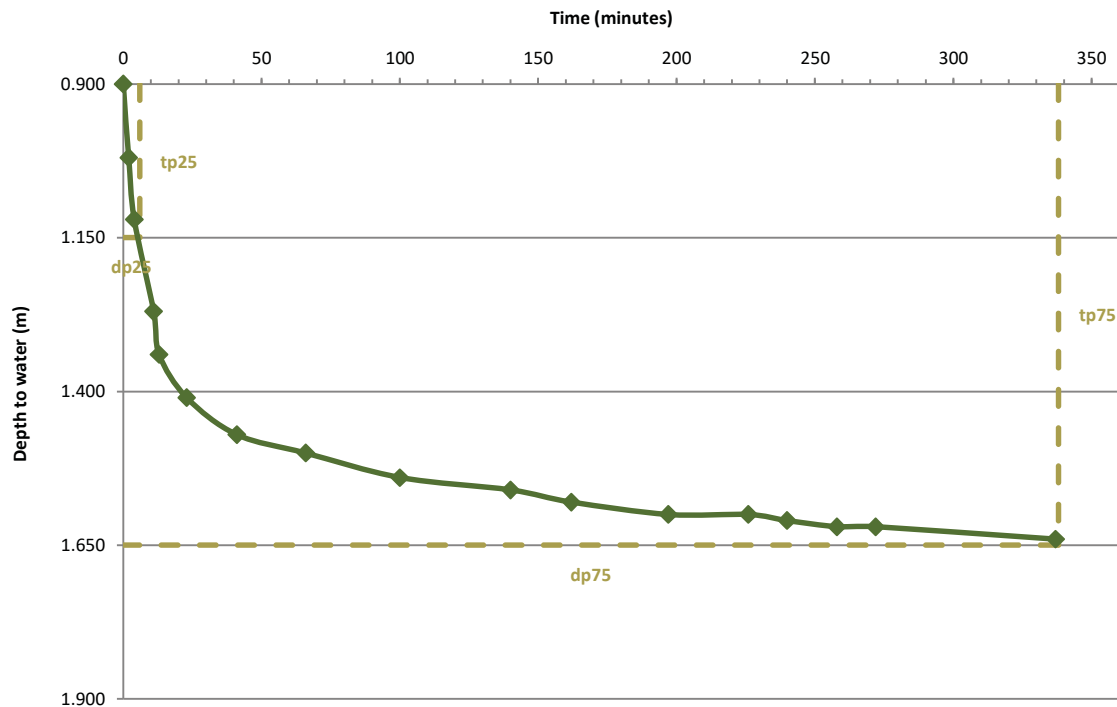
| Depth at start of test (m) | Groundwater observations (at time of excavation) |
|---|---|
| 0.9 | No groundwater encountered. Pit silted to 1.9m depth |

$$f = \frac{V_{p75-25}}{a_{p50} \times t_{p75-25}}$$

| f<br>Soil infiltration rate | 8.64E-06 | m/s |

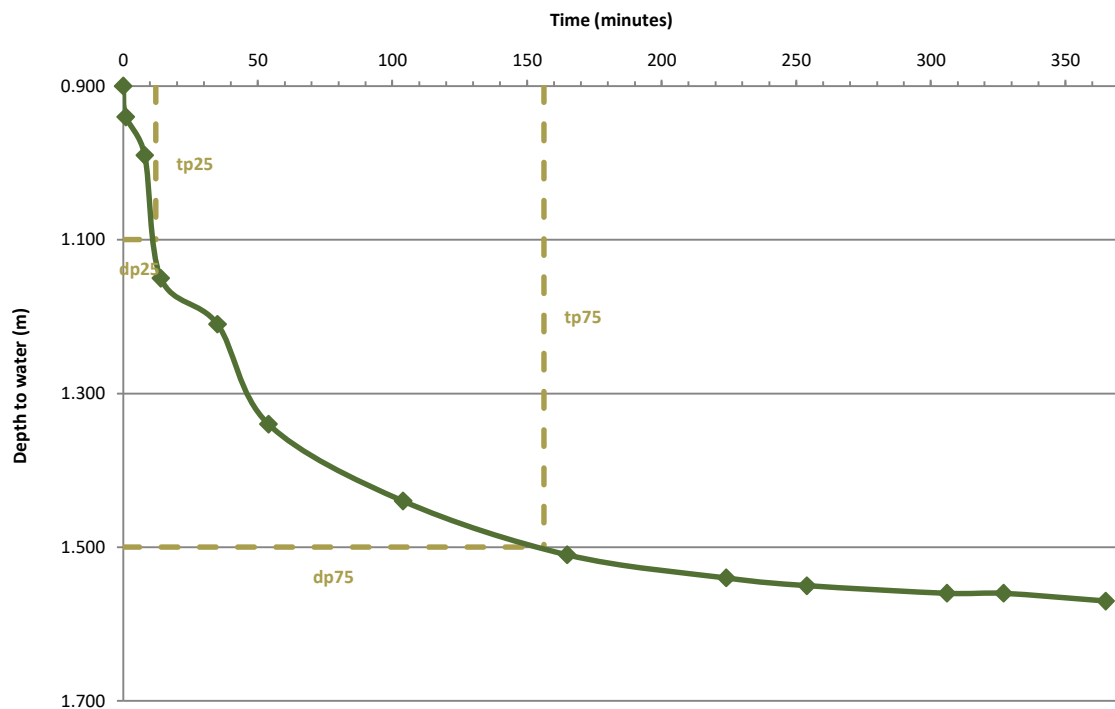
| Depth at start of test (m) | Groundwater observations (at time of excavation) |
|---|---|
| 0.9 | No groundwater encountered. Pit silted/collapsed to 1.7m prior to 2nd cycle commencing |

| Soil infiltration rate | 1.83E-05 | m/s |

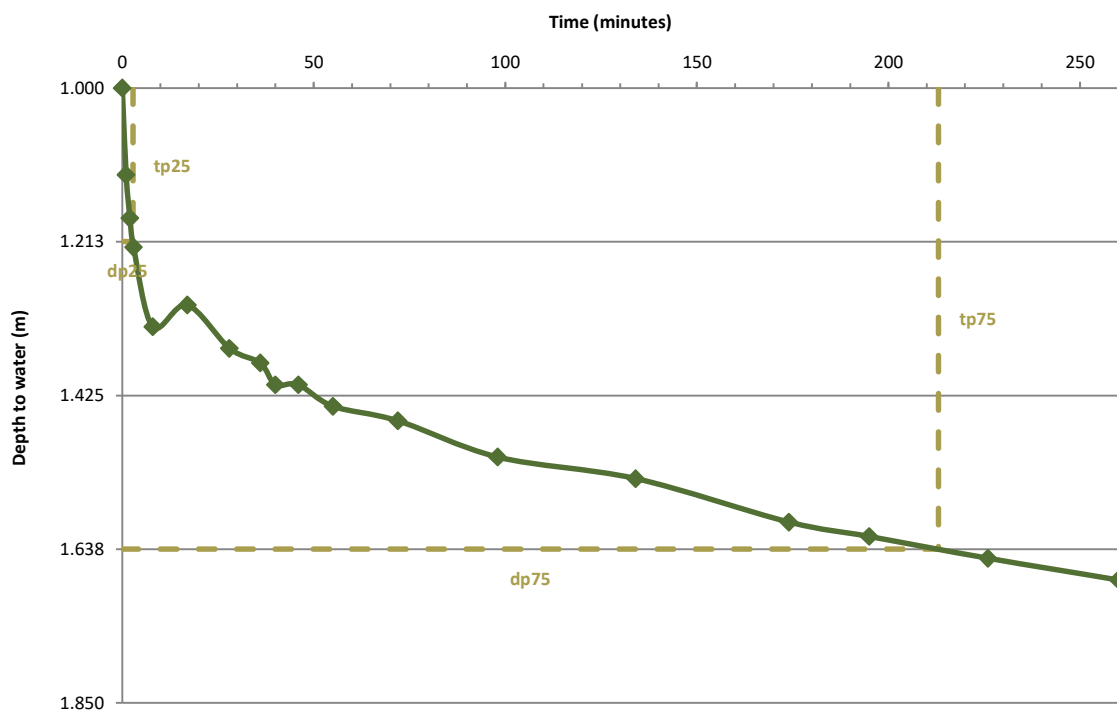
| Depth at start of test (m) | Groundwater observations (at time of excavation) |
|---|---|
| 1 | No groundwater encountered. Pit collapsed slightly at start of test to 1.85m depth |

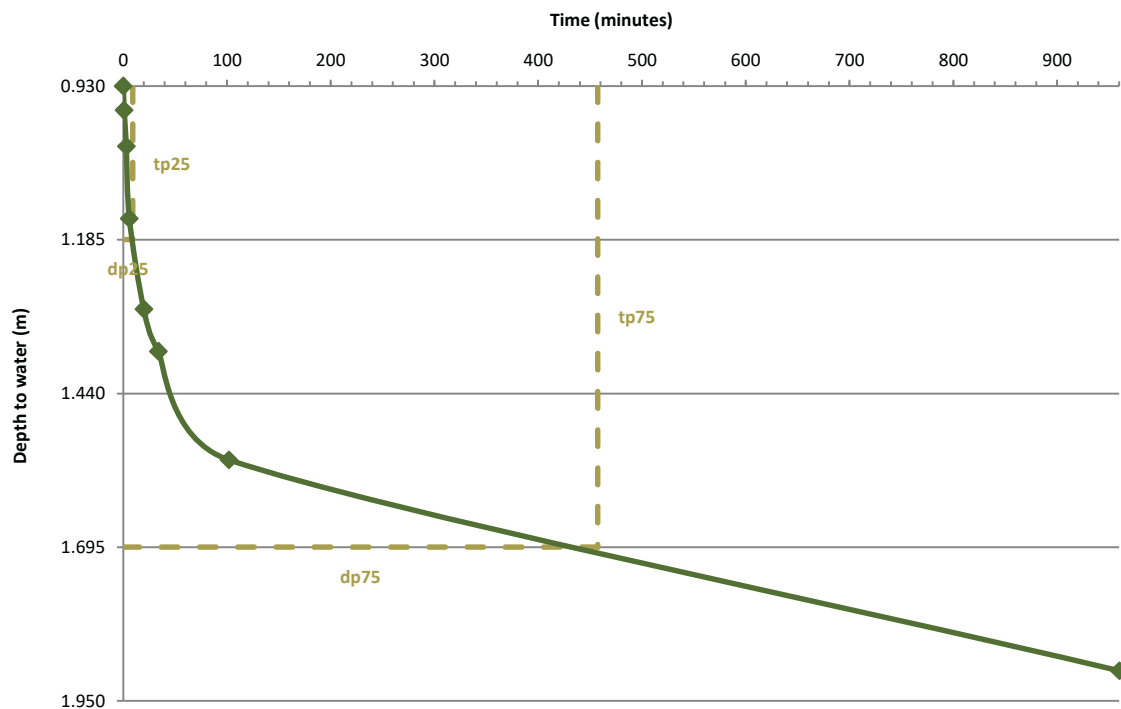
| Depth at start of test (m) | Groundwater observations (at time of excavation) |
|---|---|
| 0.93 | No groundwater encountered. Pit re-excavated to 1.95m depth for 2nd cycle |

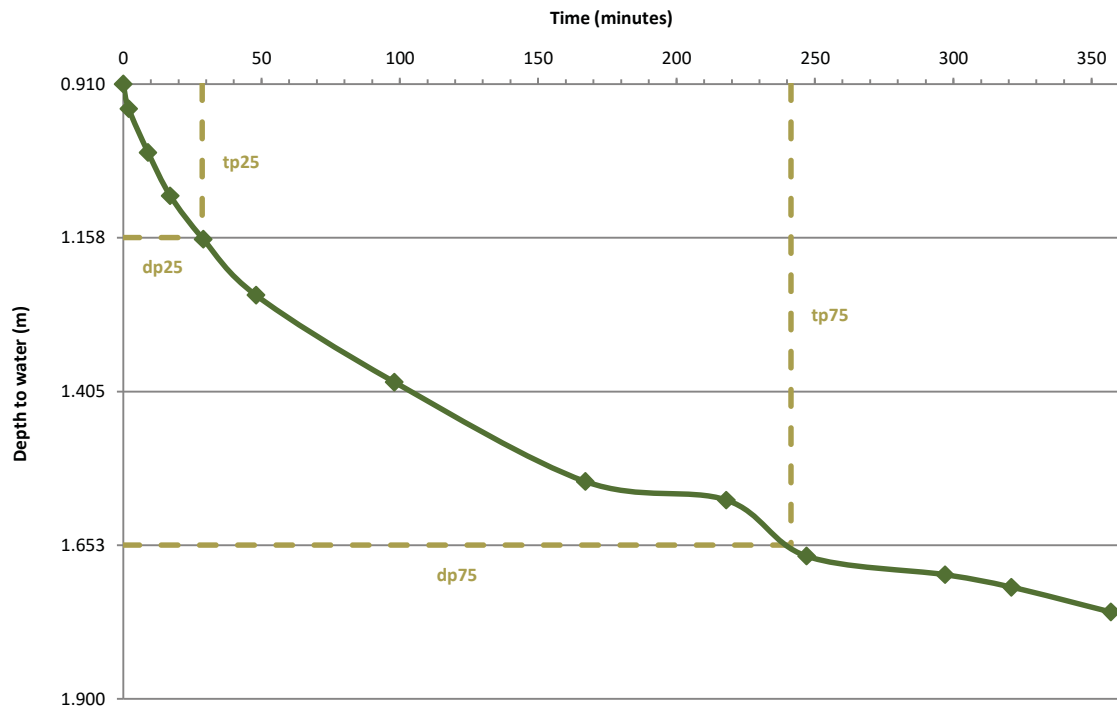
| Depth at start of test (m) | Groundwater observations (at time of excavation) |
|---|---|
| 0.91 | No groundwater encountered. Pit silted to 1.9m at start of 3rd cycle on day 2 |

| Soil infiltration rate | 1.34E-05 | m/s |

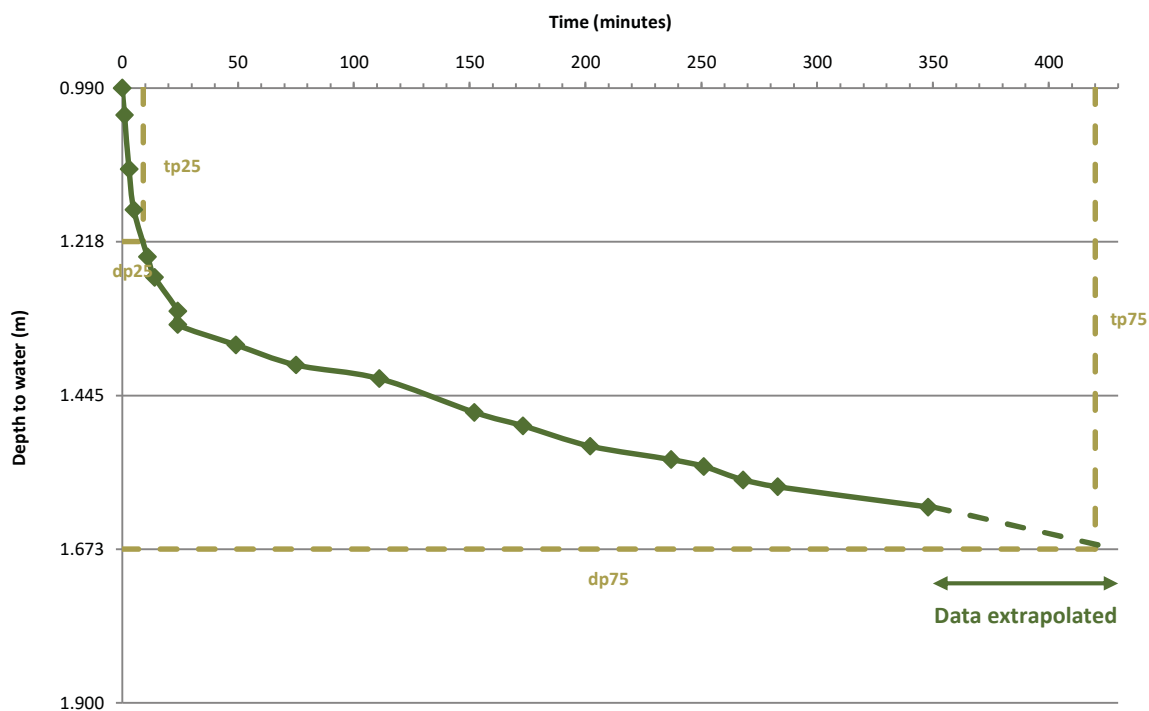
| Depth at start of test (m) | Groundwater observations (at time of excavation) |
|---|---|
| 0.99 | No groundwater encountered. Pit partially collapsed to 1.9m during test |

| f<br>Soil infiltration rate | 6.75E-06 | m/s |

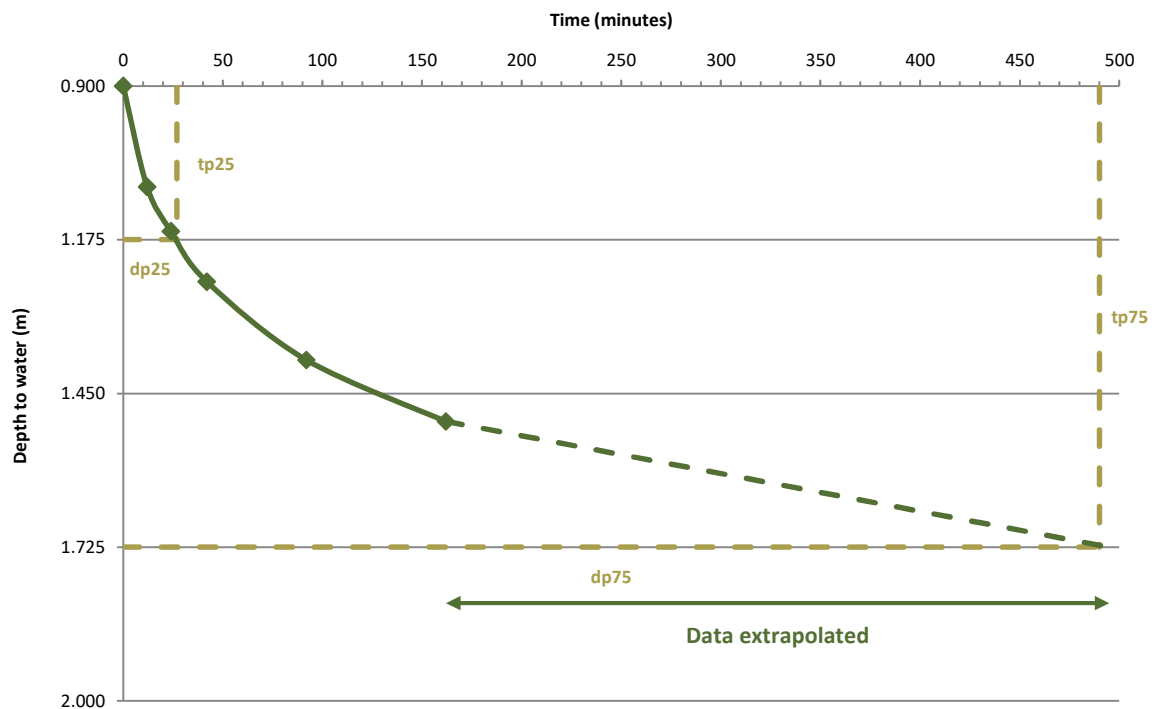
| Depth at start of test (m) | Groundwater observations (at time of excavation) |
|---|---|
| 0.9 | No groundwater encountered. After 200mins the pit sides collapsed, significantly affecting the test. Data extrapolated from last measurement prior to collapse |

| Soil infiltration rate | 6.40E-06 | m/s |

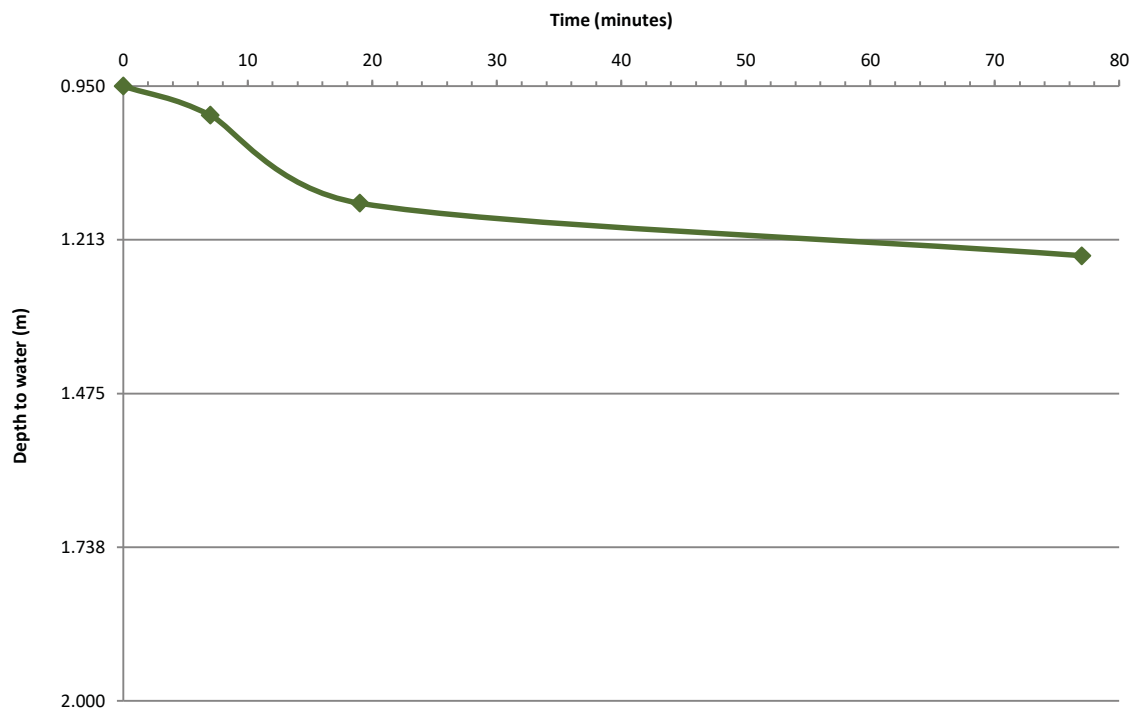
| Depth at start of test (m) | Groundwater observations (at time of excavation) |
|---|---|
| 0.95 | No groundwater encountered. |

Insufficient infiltration over 77 minutes of monitoring therefore unable to calculate soil infiltration rate.

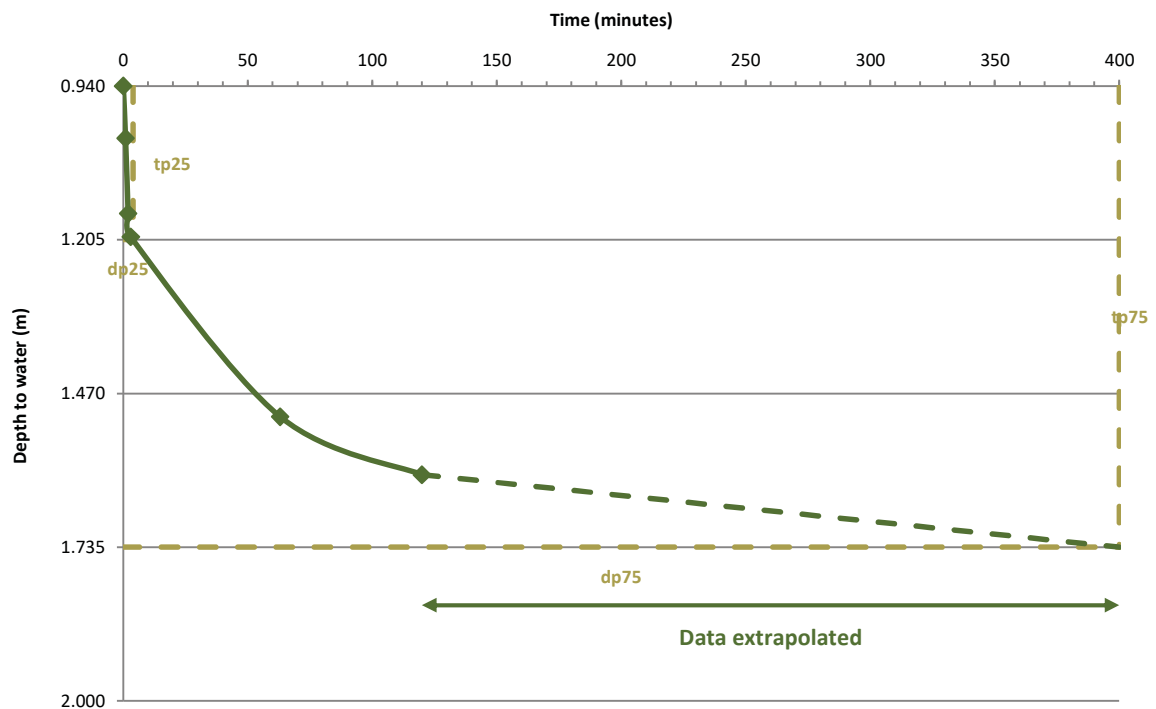
| Depth at start of test (m) | Groundwater observations (at time of excavation) |
|---|---|
| 0.91 | No groundwater encountered. Significant period of inclement weather after 120mins. Test terminated and data extrapolated from last measurement prior to event |

| Soil infiltration rate | 7.39E-06 | m/s |

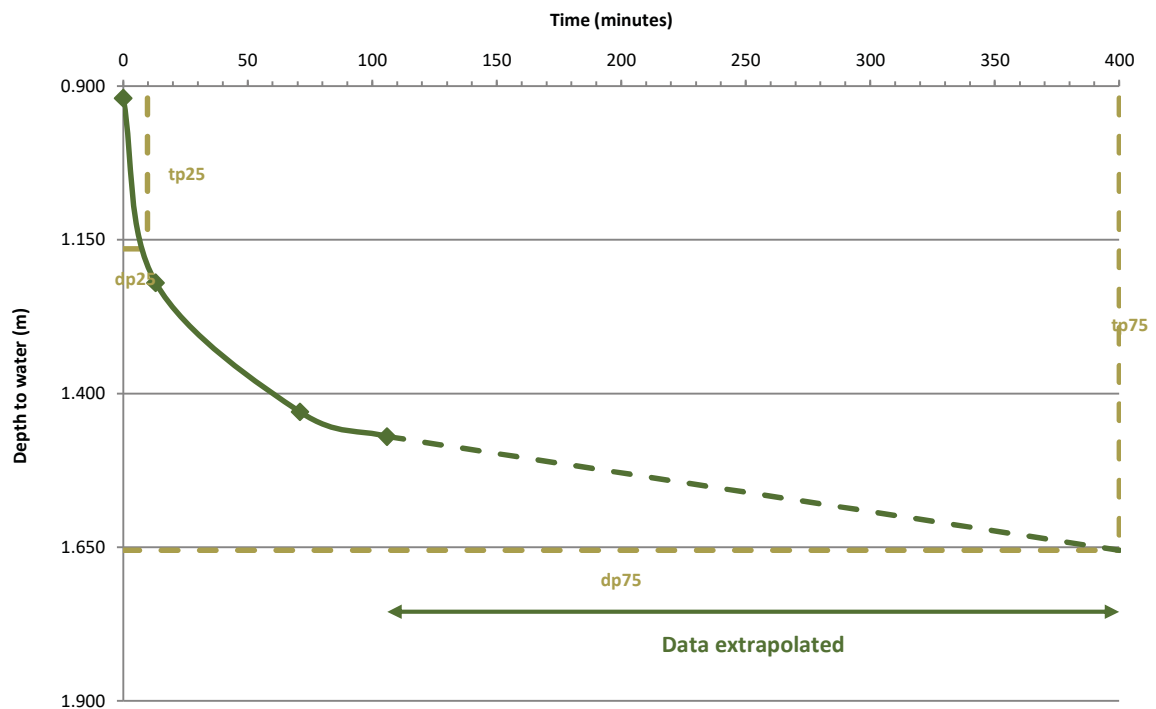
| Depth at start of test (m) | Groundwater observations (at time of excavation) |
|---|---|
| 0.92 | No groundwater encountered. |

| Soil infiltration rate | 7.30E-06 | m/s |

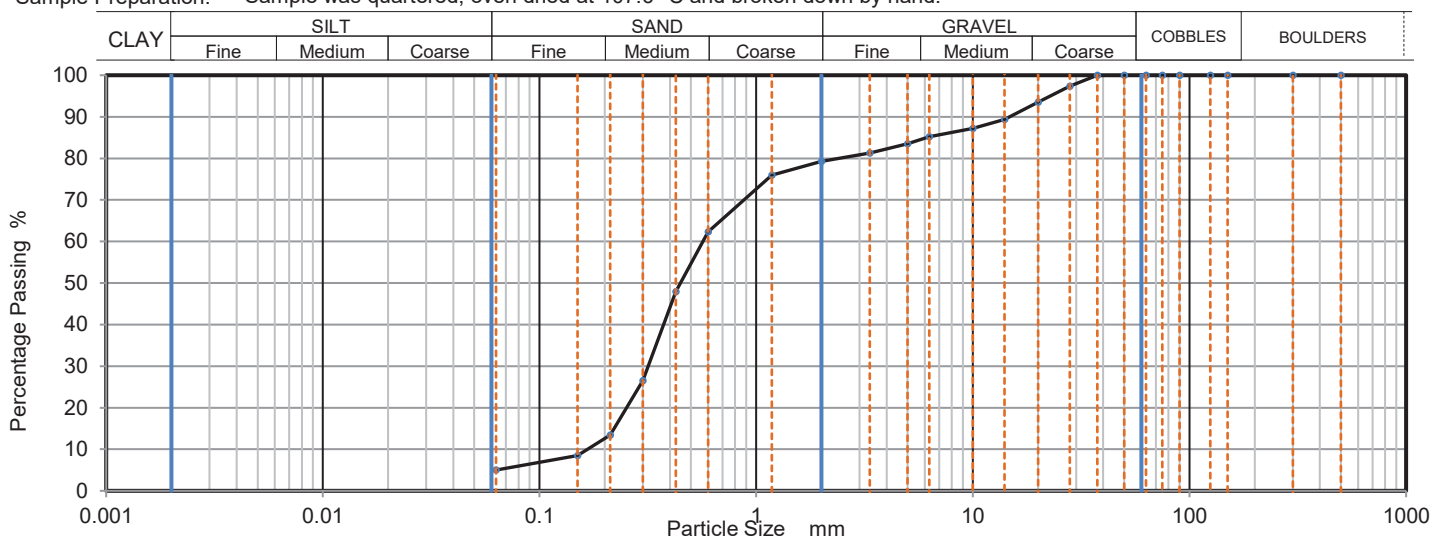
Laboratory Reference: 1843894  
Hole No.: TP01  
Sample Reference: 3  
Sample Description: Brownish grey slightly clayey gravelly SAND  
Sample Preparation: Sample was quartered, oven dried at 107.6 °C and broken down by hand.

Depth Top [m]: 1.00  
Depth Base [m]: Not Given  
Sample Type: B

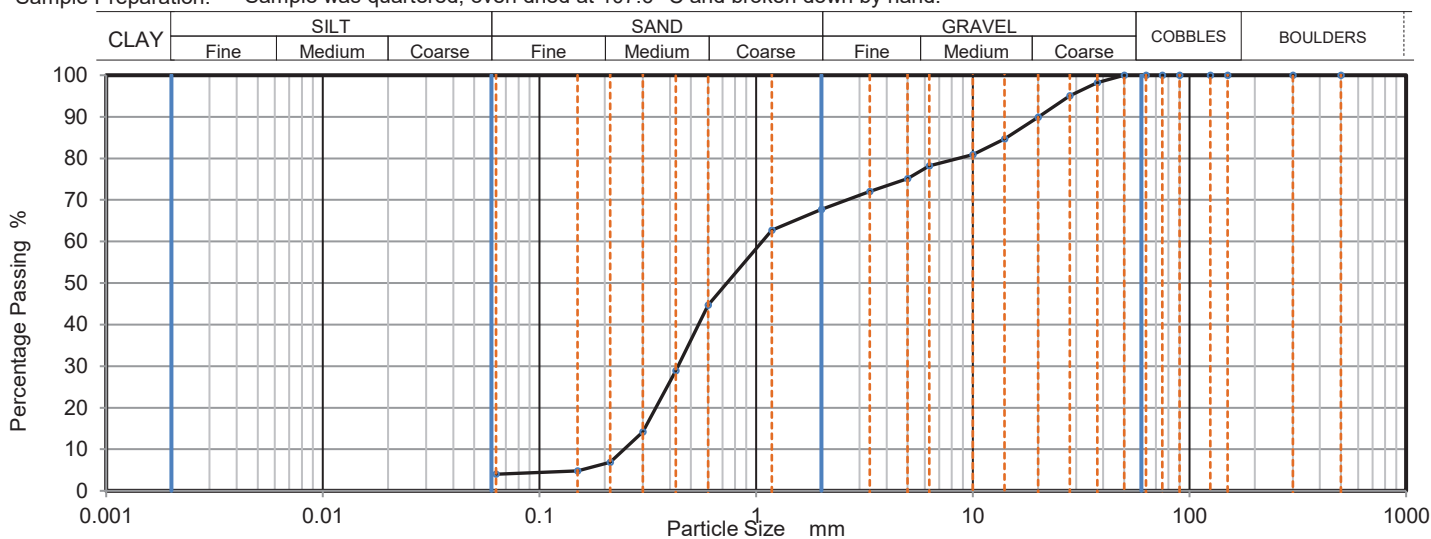
Laboratory Reference: 1843898  
Hole No.: TP04  
Sample Reference: 4  
Sample Description: Brownish grey slightly clayey gravelly SAND  
Sample Preparation: Sample was quartered, oven dried at 107.6 °C and broken down by hand.

Depth Top [m]: 1.30  
Depth Base [m]: Not Given  
Sample Type: B

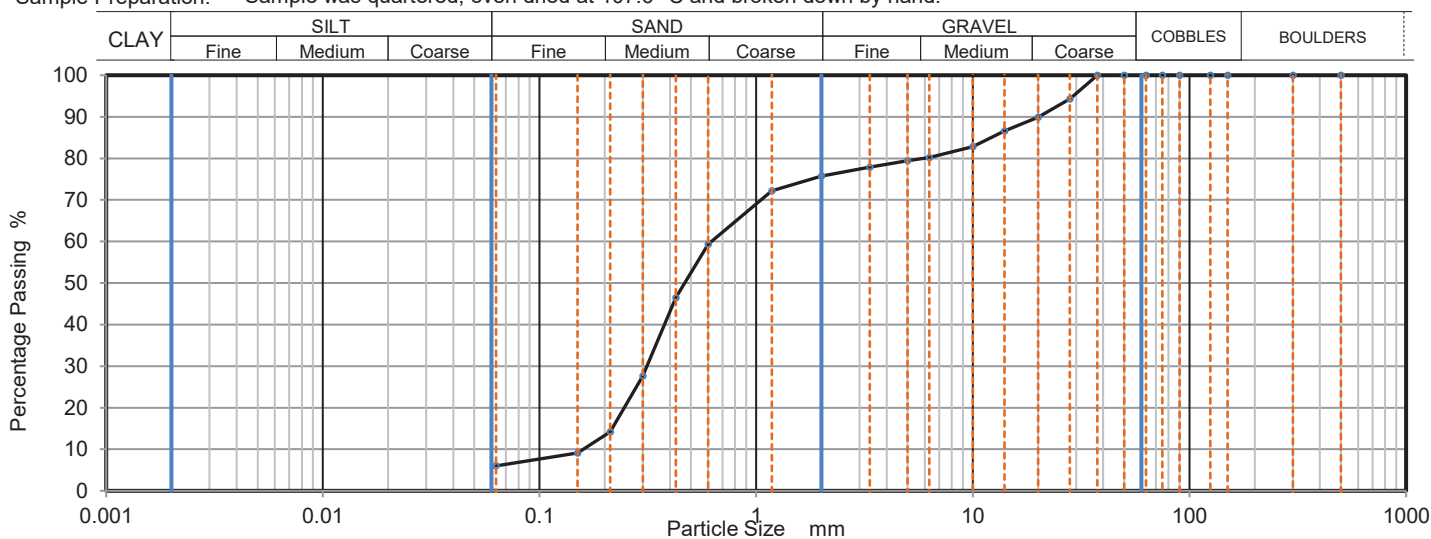
Laboratory Reference: 1843899  
Hole No.: TP05  
Sample Reference: 5  
Sample Description: Brownish grey slightly clayey gravelly SAND  
Sample Preparation: Sample was quartered, oven dried at 107.6 °C and broken down by hand.

Depth Top [m]: 1.80  
Depth Base [m]: Not Given  
Sample Type: B

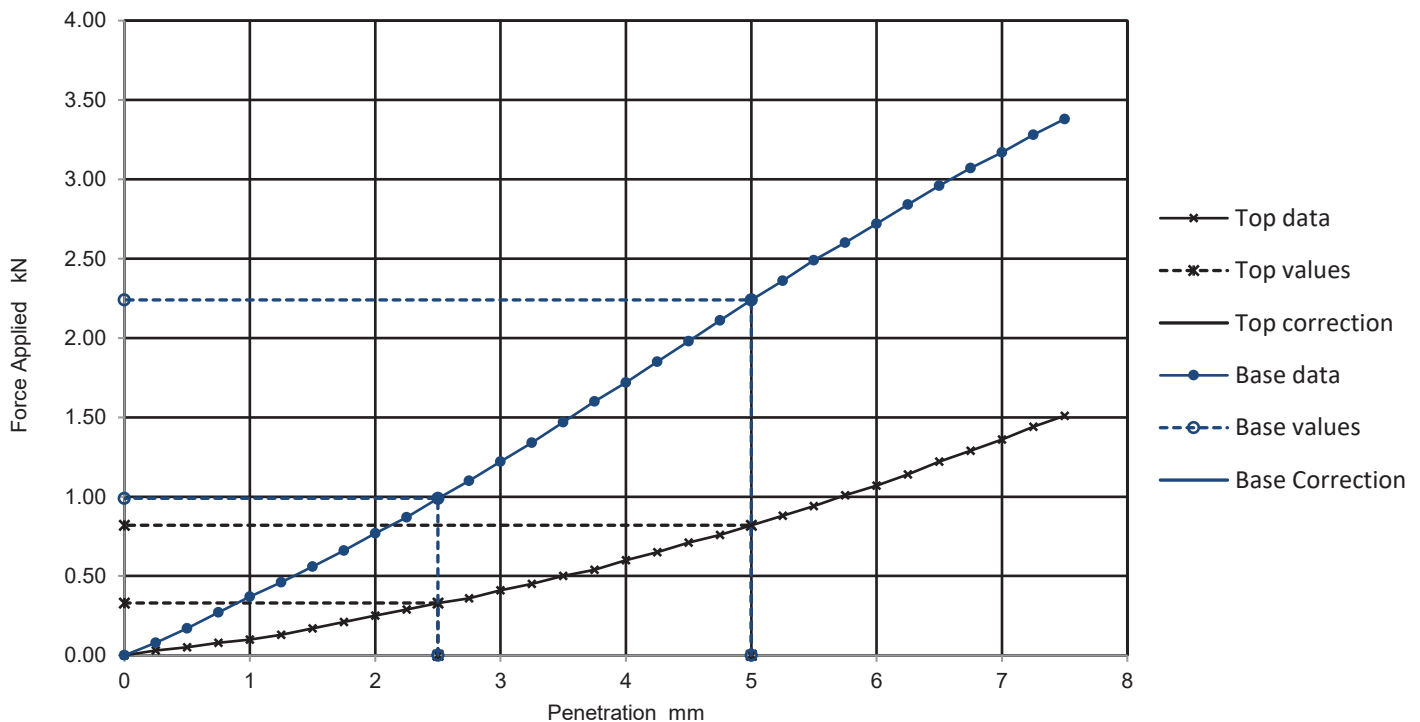
Force v Penetration Plots

| Condition | Remoulded | Soaking details | Not soaked |

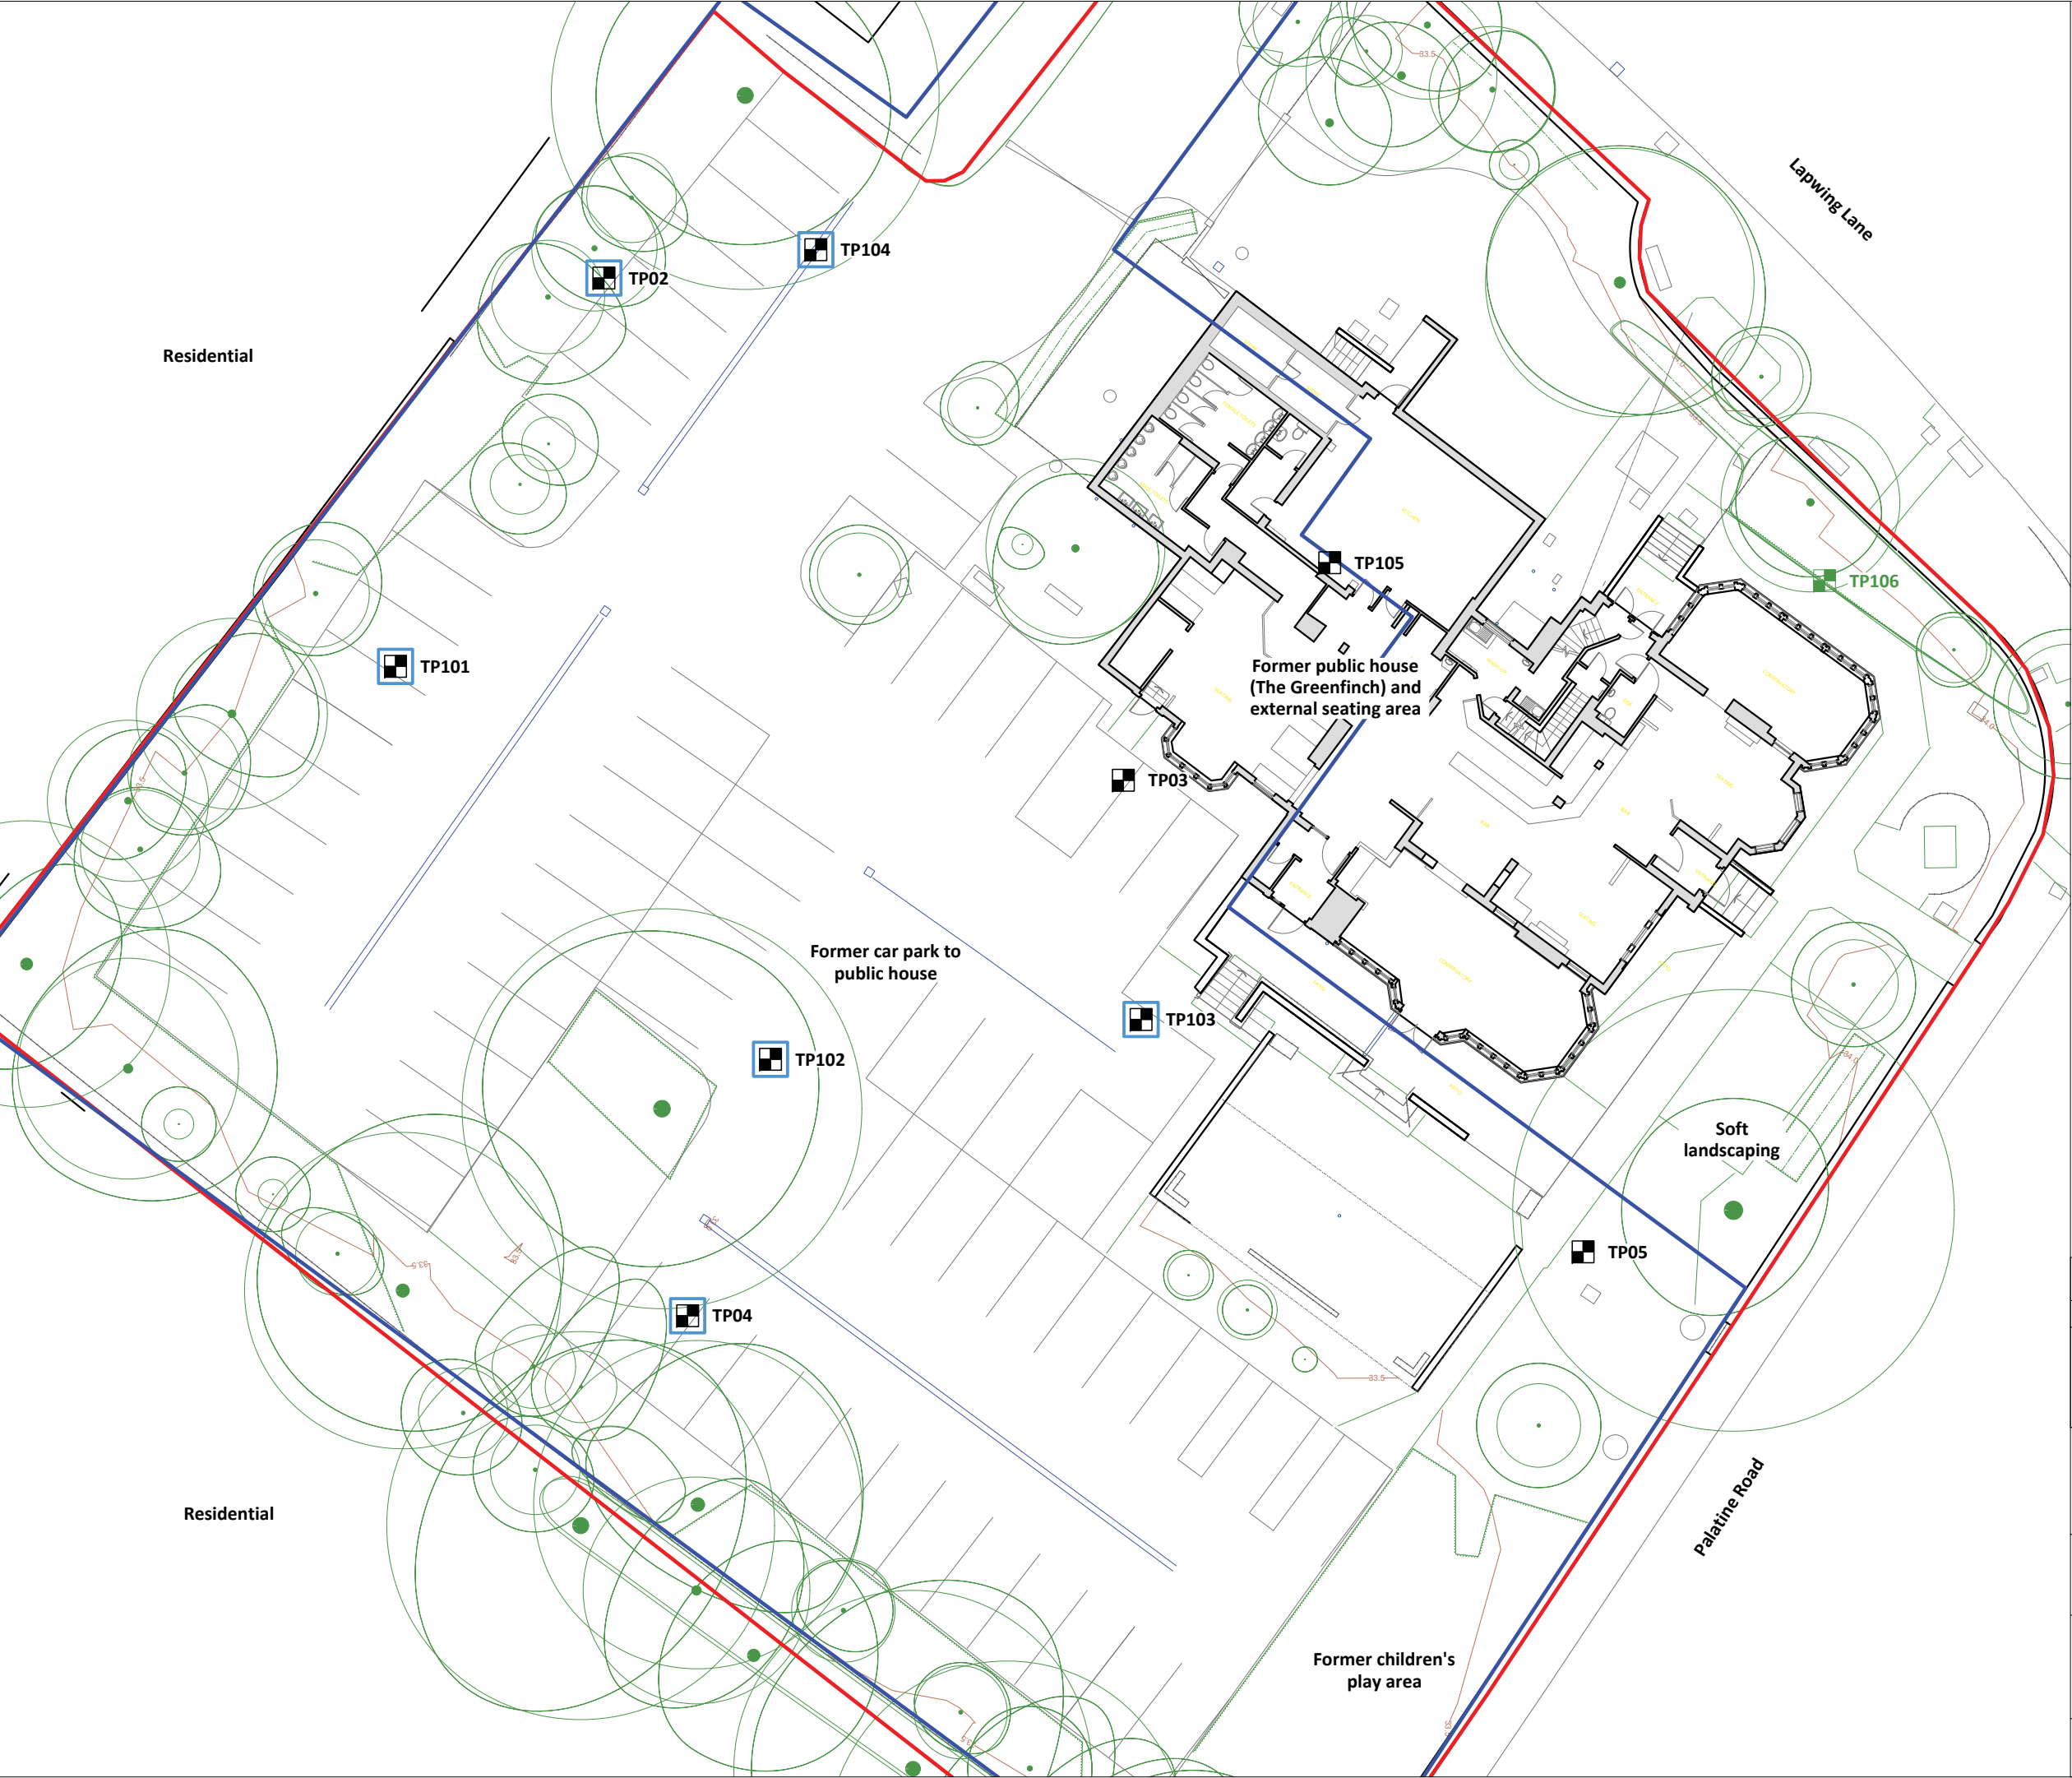
- Key**
- TP Hand excavated trial pit
  - TP Machine excavated trial pit
  - Infiltration testing performed
  - Search area boundary
  - Boundary under consideration
