**CHURCHILL RETIREMENT LIVING**

**FORMER GREENFINCH P.H., LAPWING LANE, WEST DIDSBURY, M20 3ZA**

**SUPPLEMENTARY GROUND INVESTIGATION REPORT**

May 2024  
Report No. CCL03767.CU49

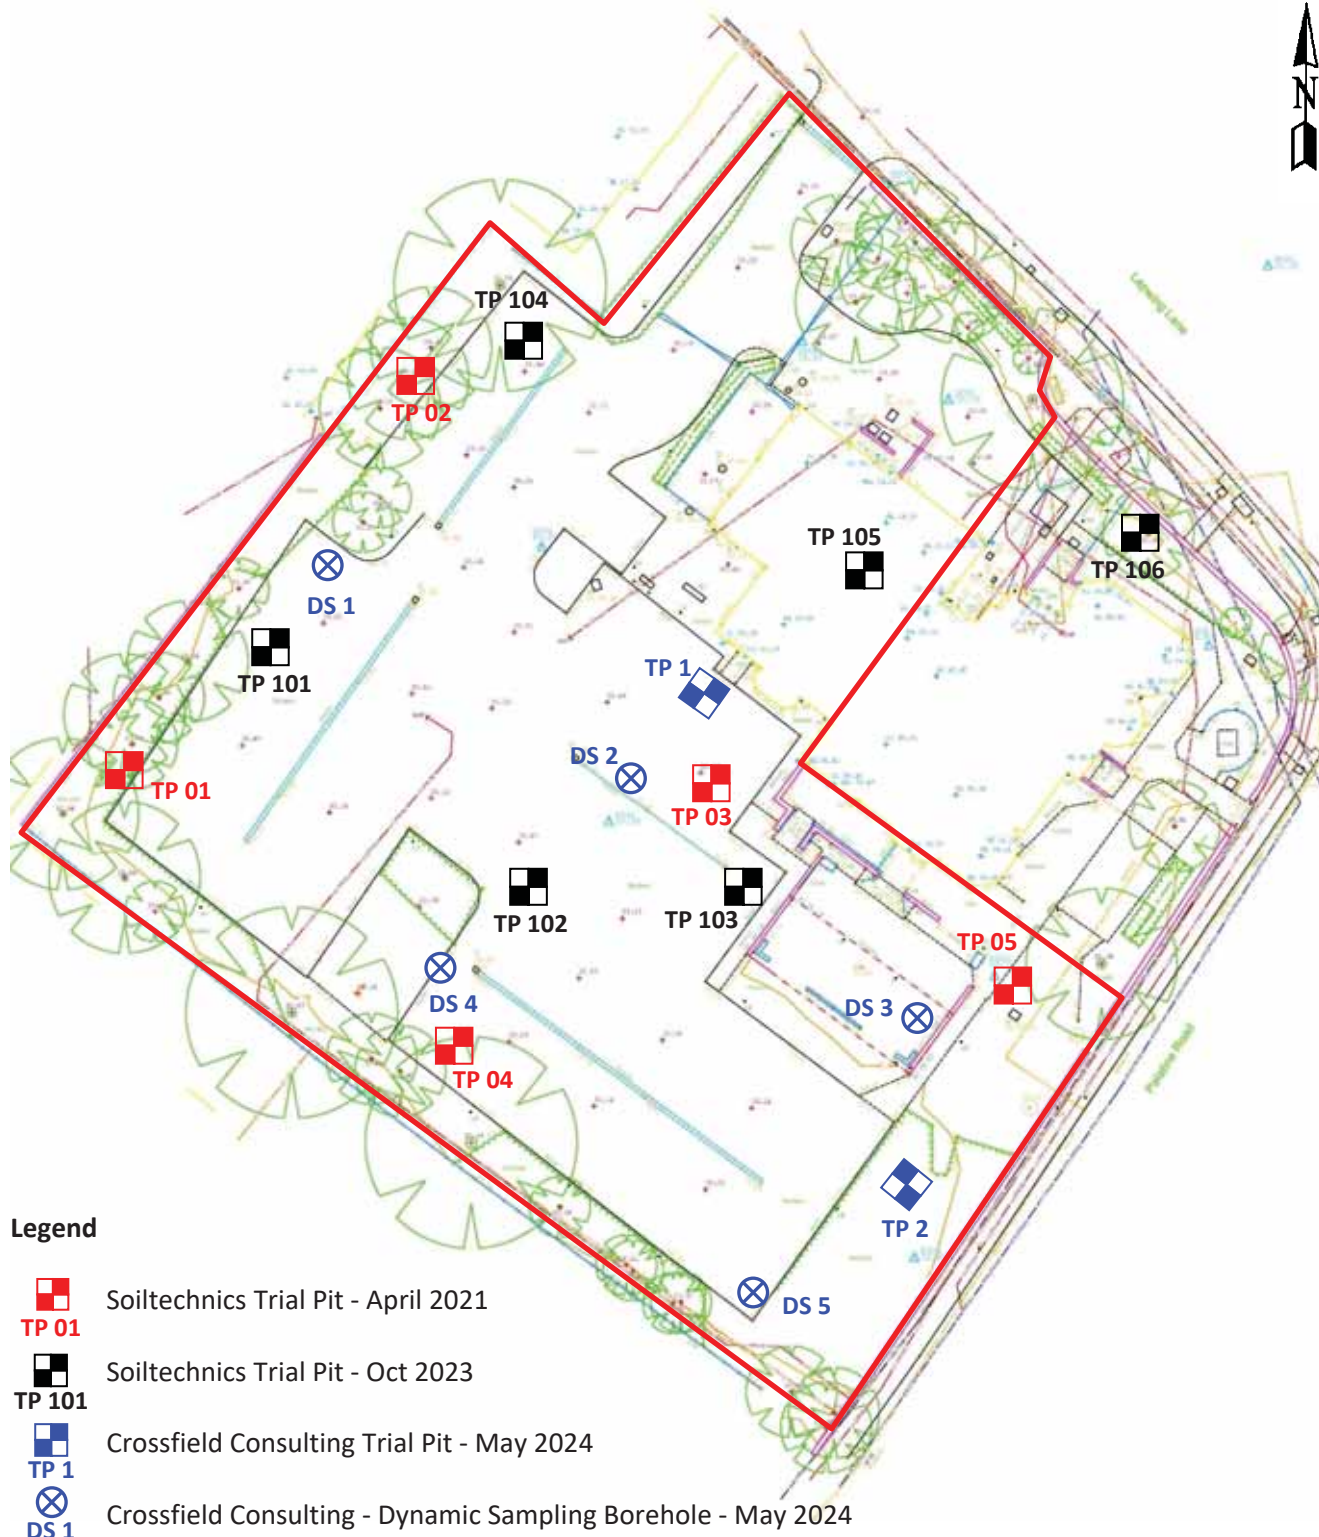
FIGURE II-1

**EXPLORATORY HOLE LOCATION PLAN**
