## File Note: River Condition Assessment

**Site address:** Waterside Hotel & Leisure Club, Wilmslow Road, Didsbury, Manchester, M20 5WZ

**Proposal:** Proposed Flood Defence works

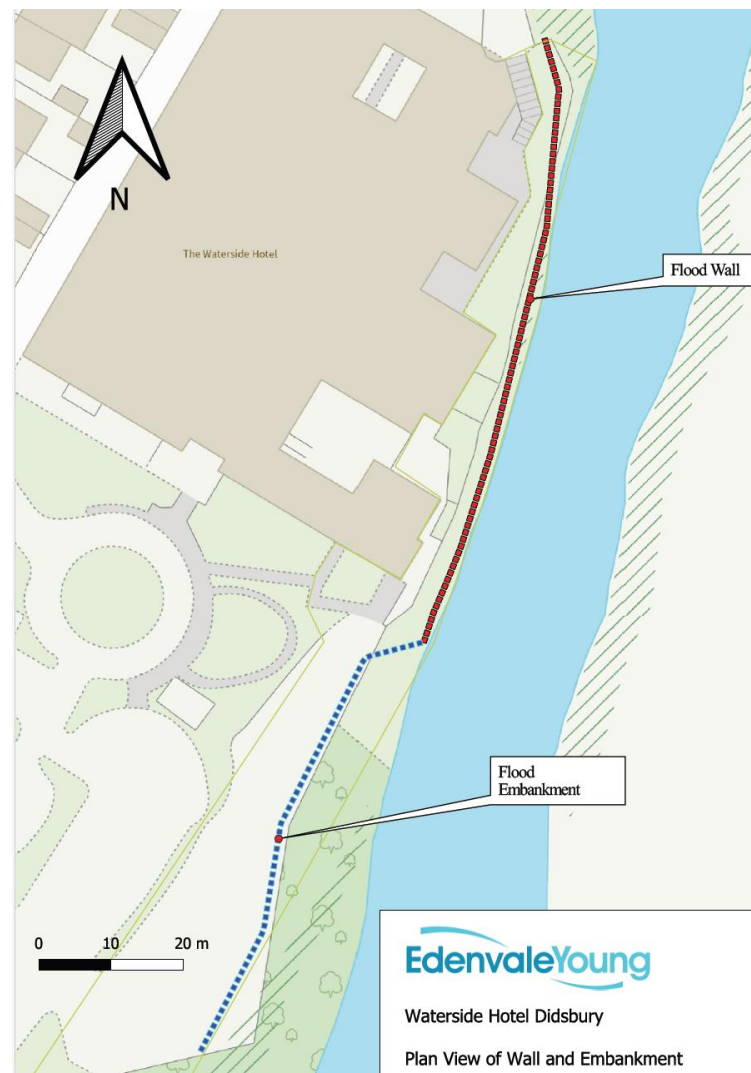
## Appendix 1: Proposed Development

As the proposed works are to install new flood defence infrastructure on the bank top of the right bank only, with the new flood wall being constructed behind the existing sheet piling atop the right bank face, and the proposed embankment constructed within an existing area of hard standing car parking within the southern portion of the site. It is considered that the baseline condition of the river would not change and that positive and negative indexes associated with the bank top and extent of natural and artificial surfaces would not change significantly to that recorded during the baseline.

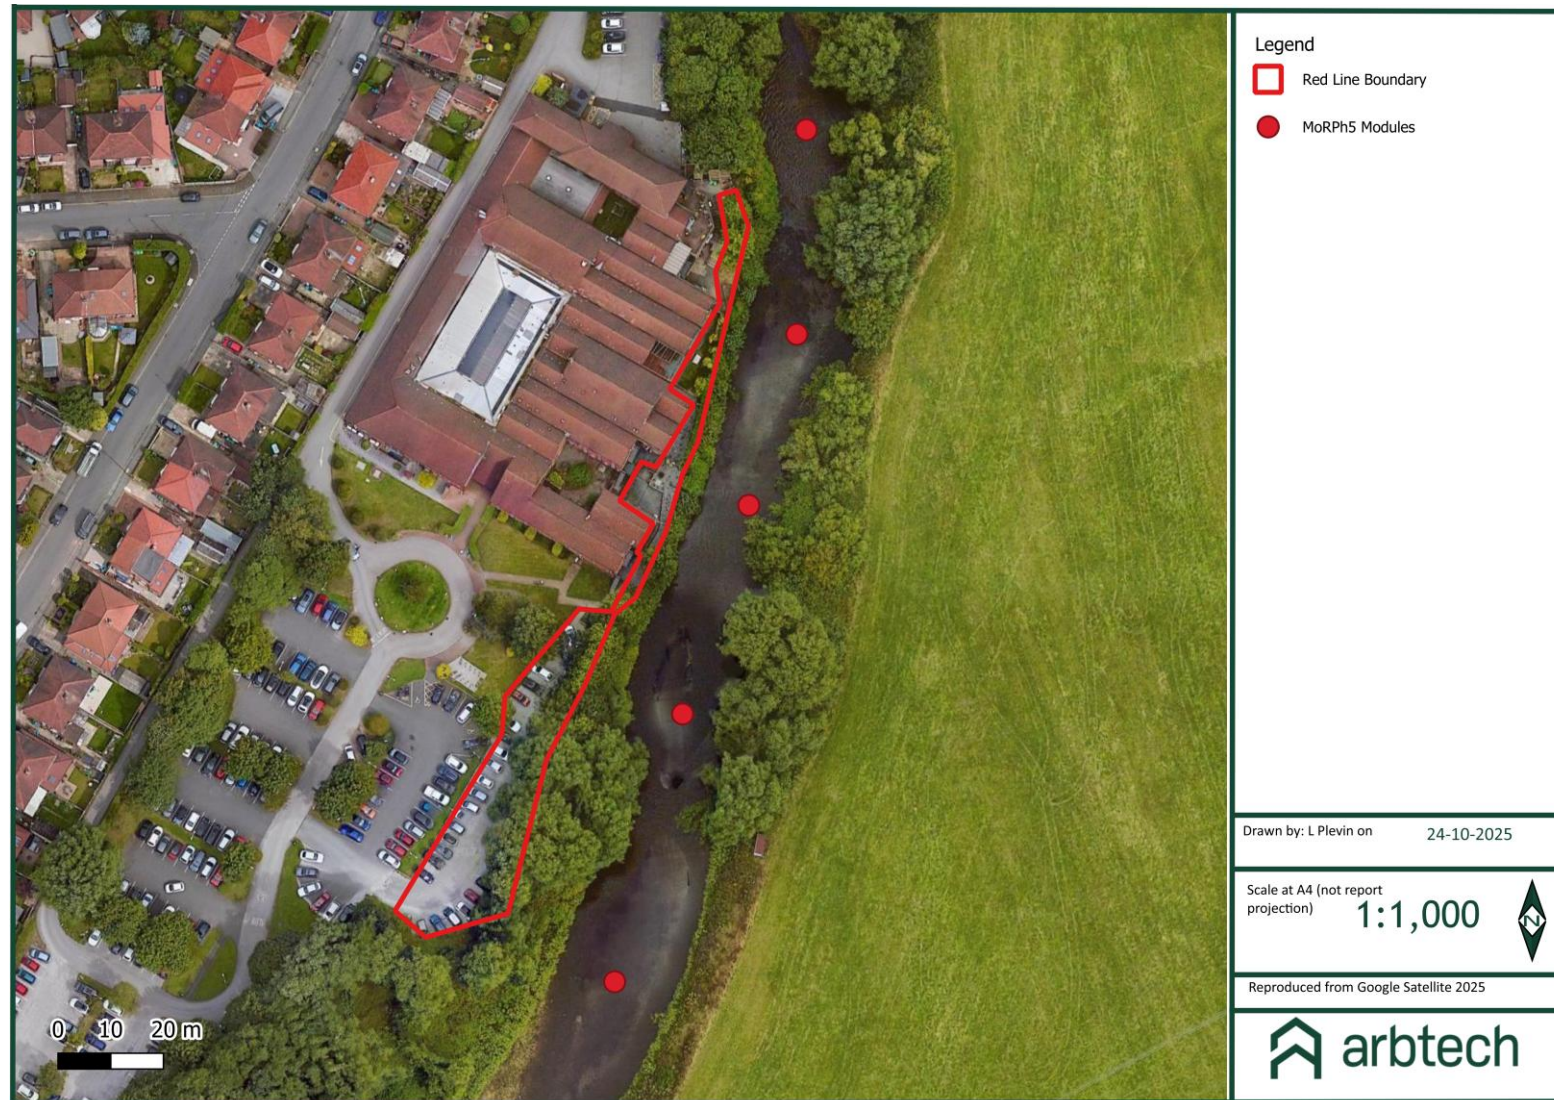
## Appendix 2: MoRPh Survey Locations

The watercourse subject to the RCA was the River Mersey, which lies along the western boundary of the site. Approx. 170m of the River Mersey lies within 10m of the red line boundary. One subreach consists of a total of 5 MoRPh modules equating to 50m or 200m for each length. The average width of the River Mersey was over 20m wide and therefore the modules are comprised of 40m lengths.

A single subreach was surveyed comprising 5 x 40m MoRPh5 surveys. This covers the full length of the River Mersey within 10m of site boundary.

The MoRPh survey locations are shown at **Appendix 2**.
