### GAS MEMBRANE VALIDATION – BELLE VUE

| <b>Project Name:</b> Belle Vue Stadium |
| <b>Project Number:</b> 12-123 |
| <b>Ground Gas Risk Assessment:</b> Amber 1 |

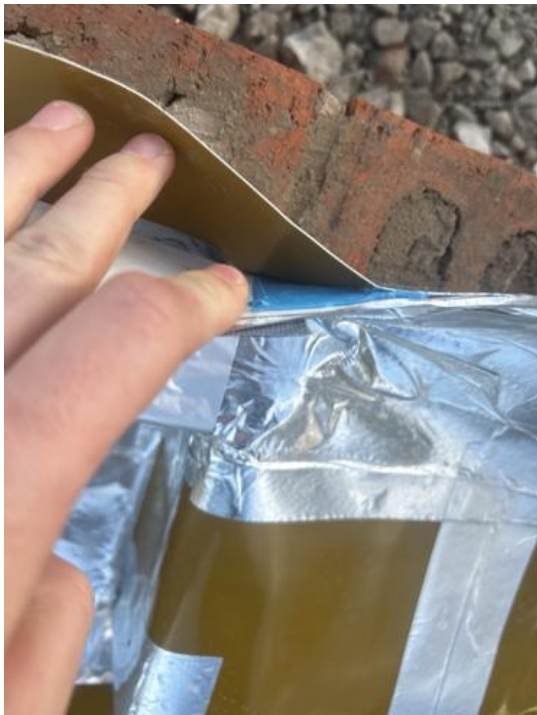
Photo 1

E3P inspected all external joints, and E3P can confirm that the membrane was overlapped and double-taped. The membrane was taped using double-sided jointing tape. All the overlaps were then additionally taped using foil-backed girth tape.

**Laps, welds, and joints seals: Joints lapped and sealed in accordance with manufacturer's requirements/ specification? Minimum overlap insured? Sections taped twice? Are welds complete? Appropriate joining/double-sided tape used, Folds running in line with joints? (no joints cutting across folds)**

Pass

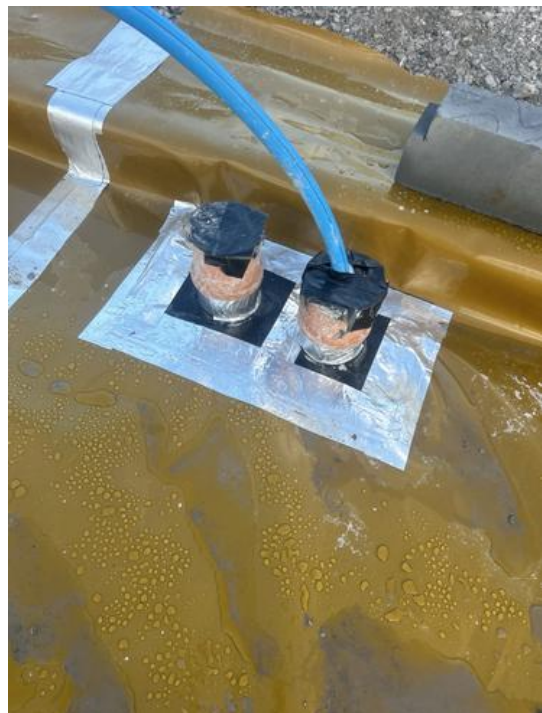
Photo 4

Each unit has a service duct located at the front and outer edge of the property. E3P inspected each one and can confirm that the top hats have been adequately sealed against the membrane.

**Service entries seals: Top hats seal arrangements fixed around service entries? Use of Jubilee clips?**

Yes

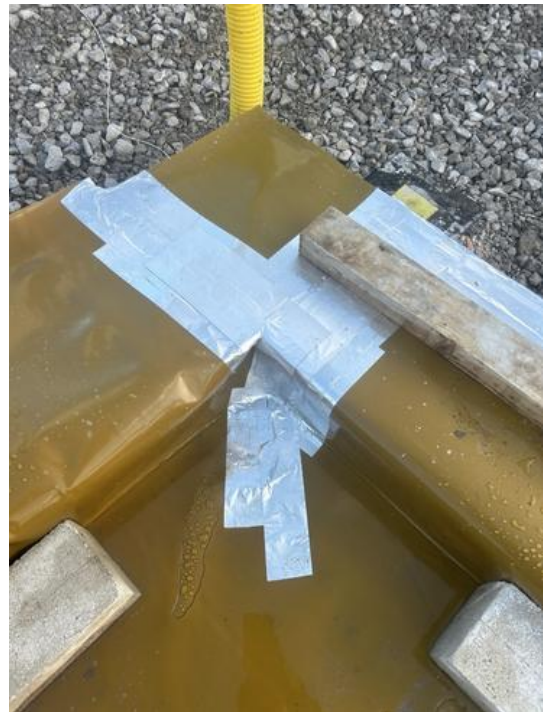
Photo 8

**Corners / Internal joints: Check all corners are correctly formed or contractor has used preformed corners.**

Pass

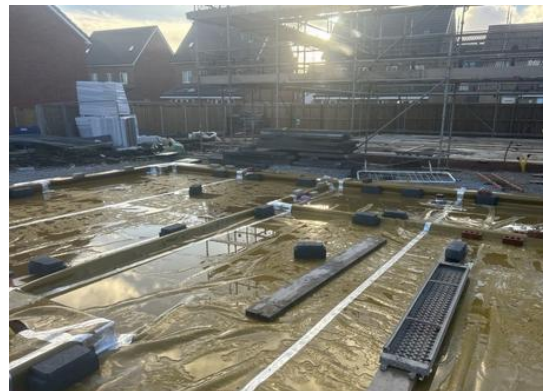
Photo 12

**Extent of Coverage: Is the membrane covering the entire plot? Does membrane span over outside walls?**

Yes

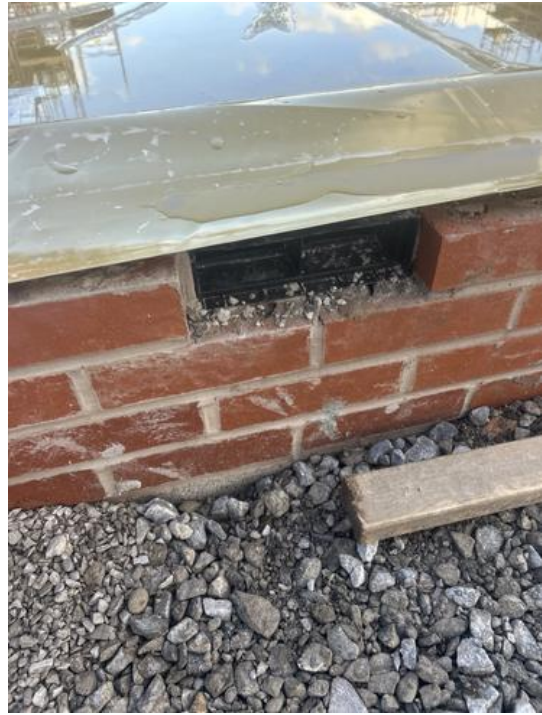
Photo 14

**External Wall Air bricks: Numbers, size. positions as design drawing? (Minimum of 3 walls)**

Pass
