## **Brunswick Mill, Manchester – Engine House Heritage Note**

### **Purpose**

The purpose of this Heritage Note is to provide a brief assessment of the historic development and significance of the original engine house at the Grade II Listed Brunswick Mill, Bradford Street, Manchester (Figure 1).

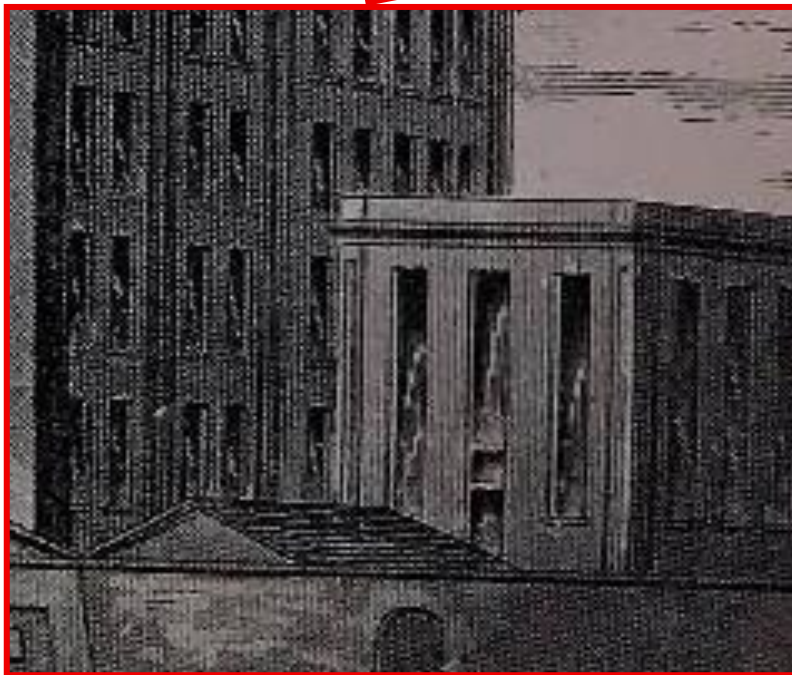
**Figure 2** – An 1893 etching of the principal north front of Brunswick Mill as seen from Bradford Road, showing the original engine house and chimney to the right. Although an indicative drawing, showing flat-headed openings to the engine house instead of round-headed openings as was constructed, it does provide the only known view of the original central doorway into the engine house, shown to the bottom of the central opening.

Note the original form of the projecting stuccoed cornice around the eaves of the buildings.

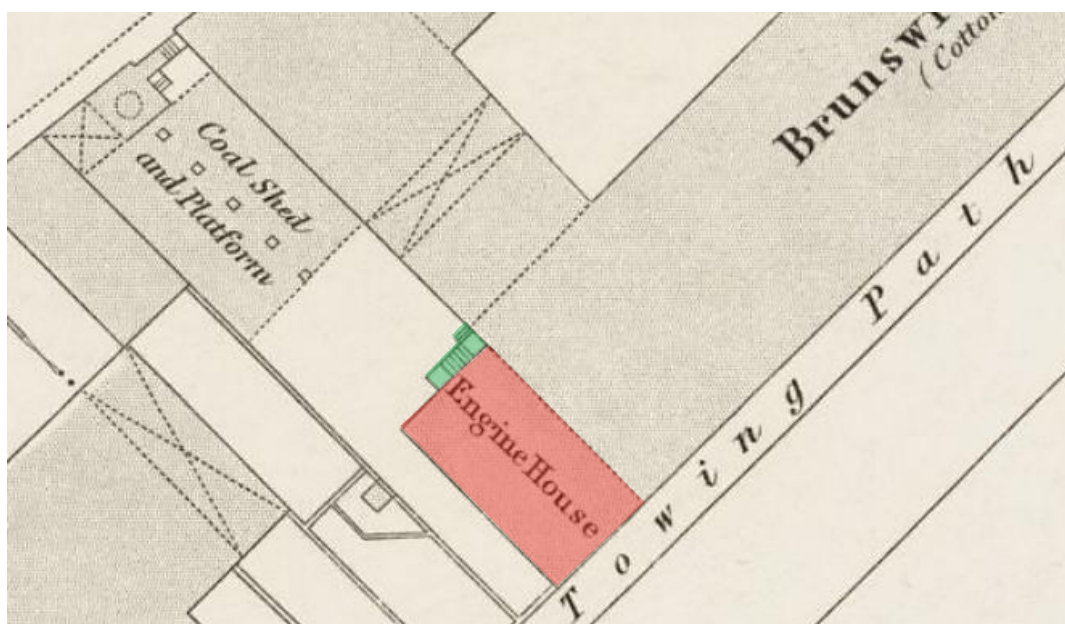
**Figure 3** - The 1851 OS map shows the “Engine House” located within a yard area containing the mill chimney, a coal shed and a platform parallel with Bradford Road next to the original location of the mill’s boilers which were housed within the ground floor of the mill.

Note the original stair arrangement (shaded green) leading to the original central door of the first floor level of the engine house.

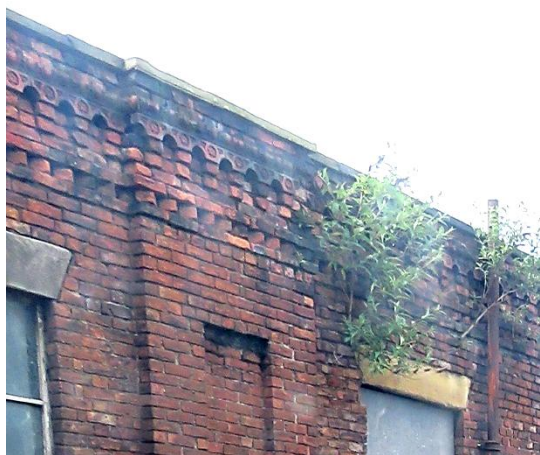
**Figure 5** – An example of the c1880s/90s replacement of the original stuccoed eaves detailing with moulded, decorative redbrick as seen around the perimeter of the main mill.

In 1865 Brunswick Mill was bought by Henry Bannerman & Sons, and at some time during the c1880s/90s, the original stuccoed eaves detailing around the perimeter of the mill buildings (Figure 6) was removed and rebuilt at a slightly lower level used decorative red brick (Figure 5) likely due to the deterioration of the original stucco-covered brickwork.

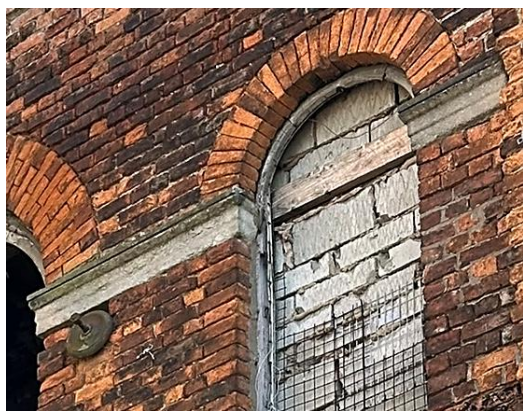
**Figure's 7 & 8** – A view of the principal, northwest elevation, showing one of the three round-headed window openings with carved stone (possibly grit stone) string course between the windows (Figure 7) and a view of the stringcourse from inside the building (Figure 8).

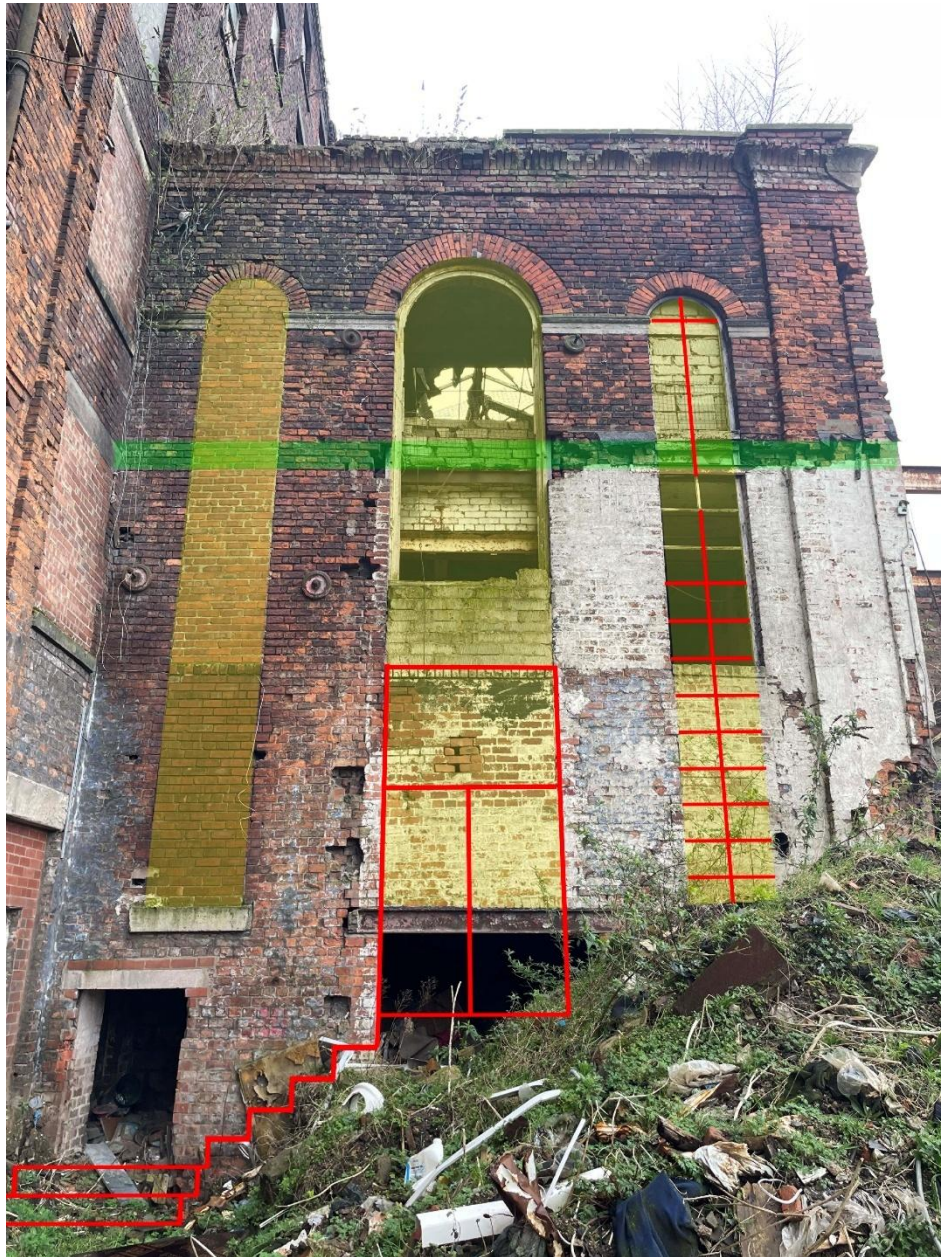
**Figure 10** – A reconstructed view of the principal north-west elevation, showing the original extent of the three openings shaded yellow, the original location of the central doors to the centre, an example of the original glazing pattern to the right, and the original location of the steps to the left.

The fenestration pattern, however, was entirely different to the mill, with the north-east elevation comprised of two very tall, narrow, round-headed window openings with a wider opening to the centre that also incorporated entrance doors/steps. The rear, south-east elevation, comprised three equal, narrow window openings, whilst the side, north-west elevation used three blind openings.

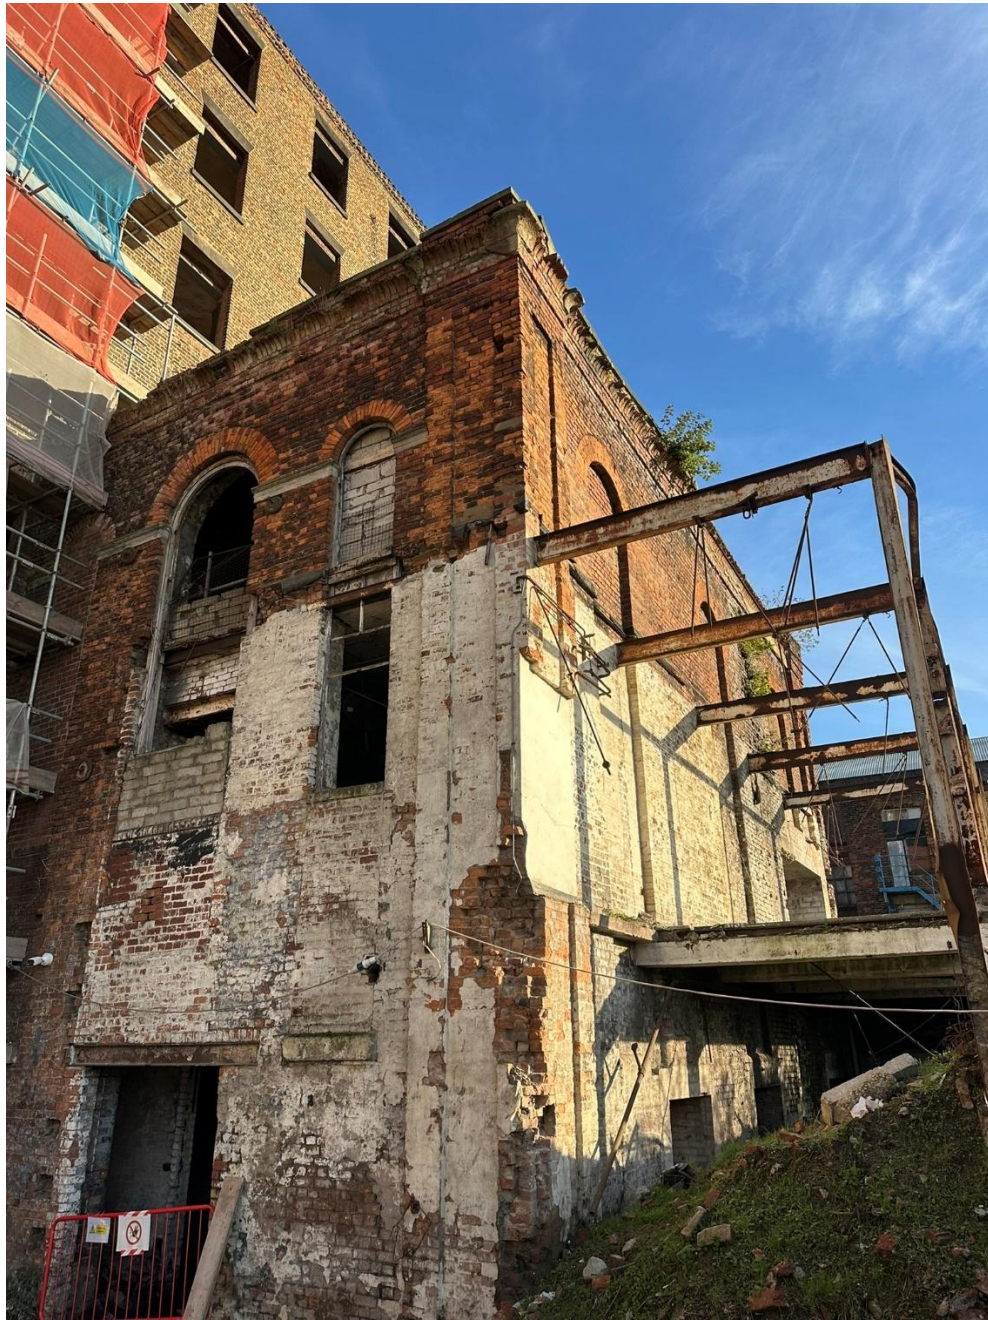
**Figure 11** – A view looking towards the north-west elevation (left) and south-west elevation (right) which illustrates its three original blind openings.

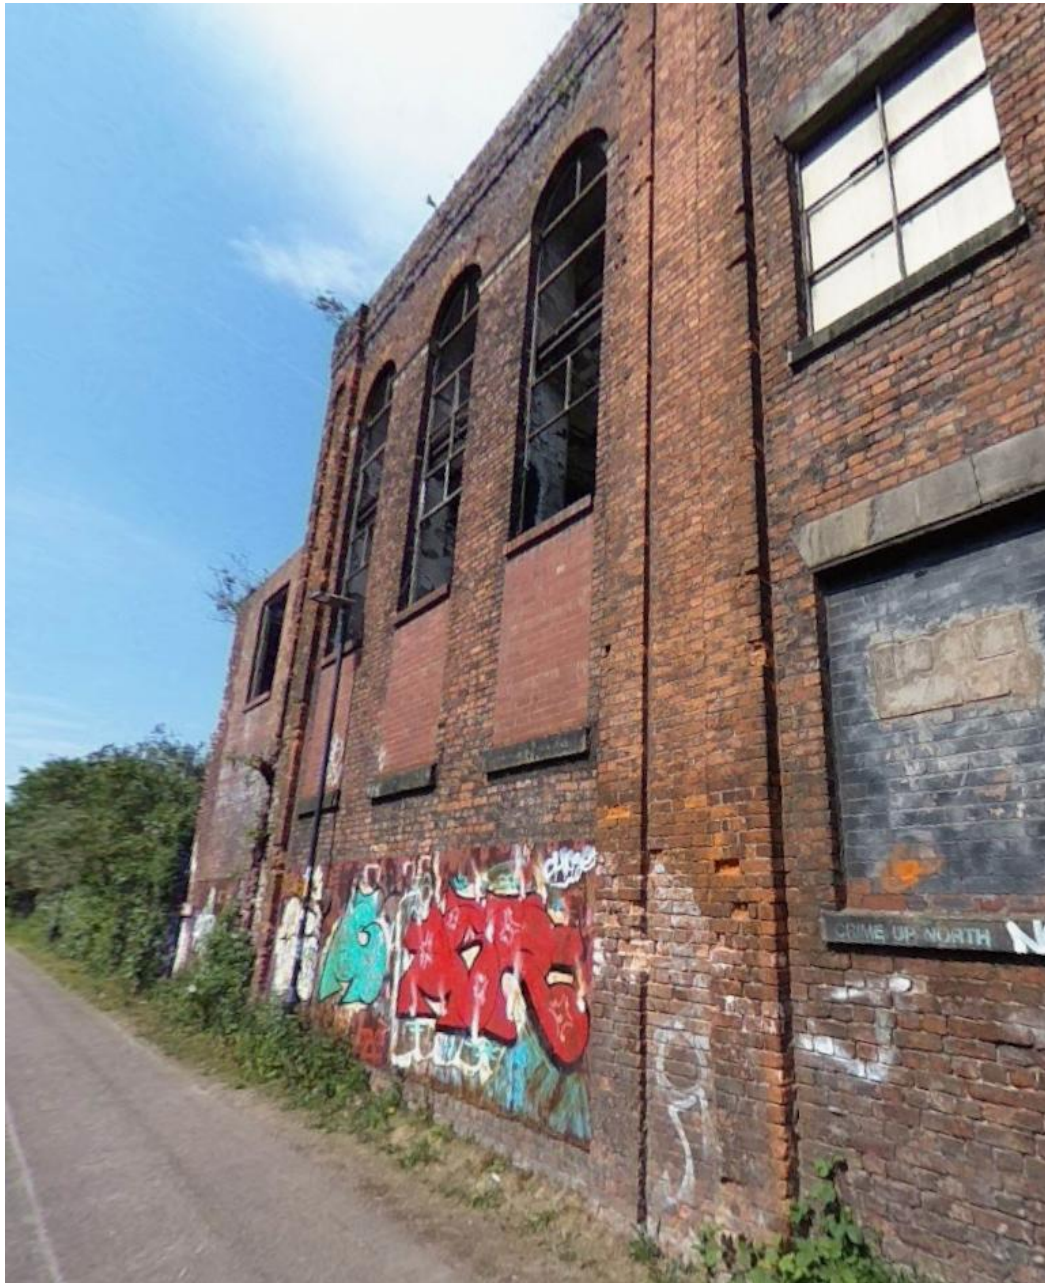
**Figure 12** – A view of the rear, south-east elevation as seen from the canal towpath, showing the three original window openings.

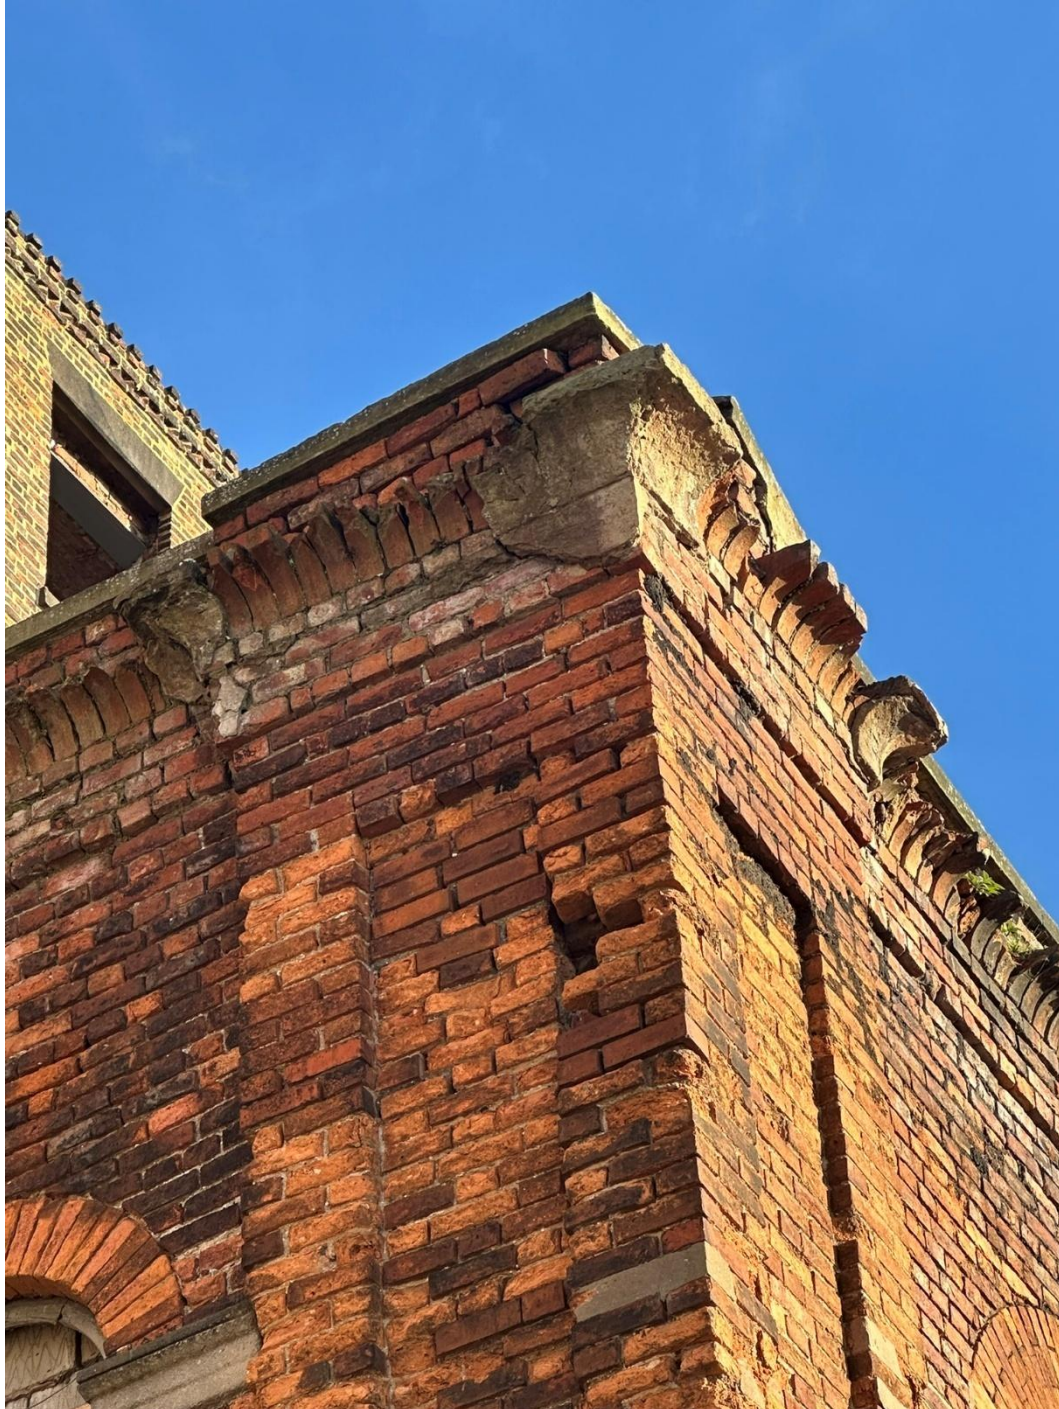
**Figure 13** – Detail of the northern corner of the engine house, illustrating the original brick and stucco arrangement.

The engine house formed a small, two-storey building connected to the south-west corner of the mill. Its design followed that of the mill building with shallow brick pilasters to each corner and projecting eaves detailing, which comprised shaped brickwork that was stuccoed to emulate decorative curved stonework (see Figure ??).

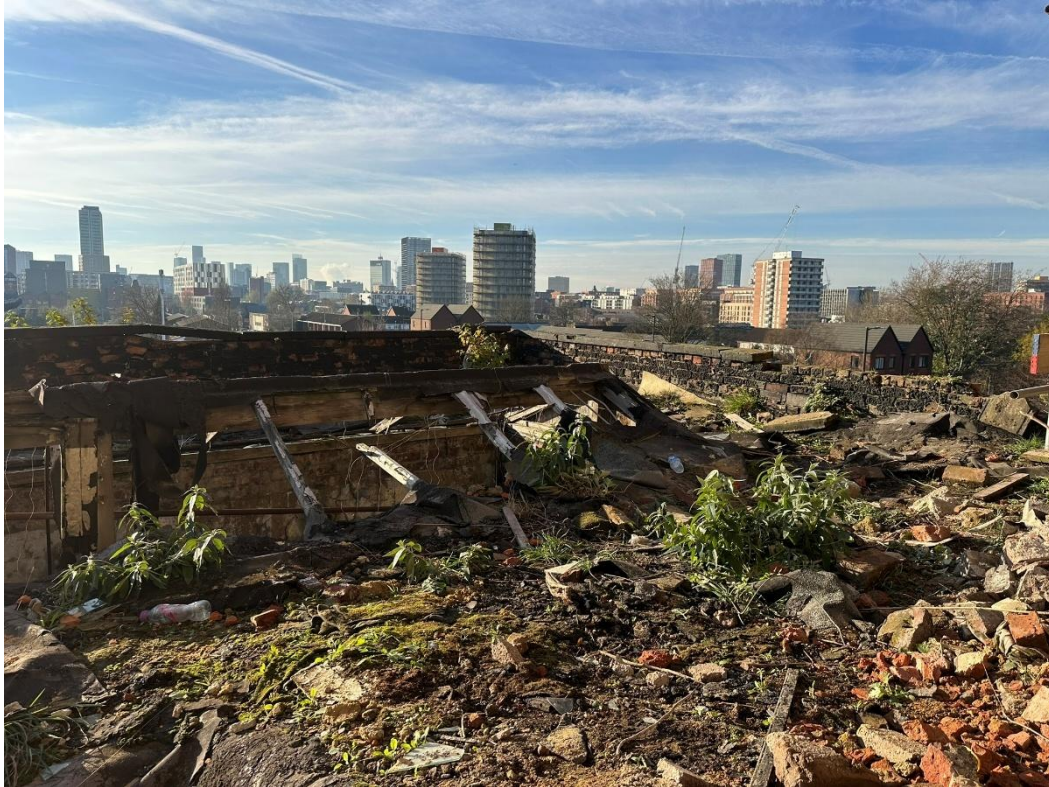
**Figure 14** – A view looking west across the engine house roof, showing the raised timber skylight to the centre of the flat roof.

Internally the building was functional in style, with bare brick walls (later painted) and brick, jack-arched floors to the first floor level and the roof level. The roof level was designed with a large timber skylight, whilst the windows of the building were formed of long, large-paned casement windows.

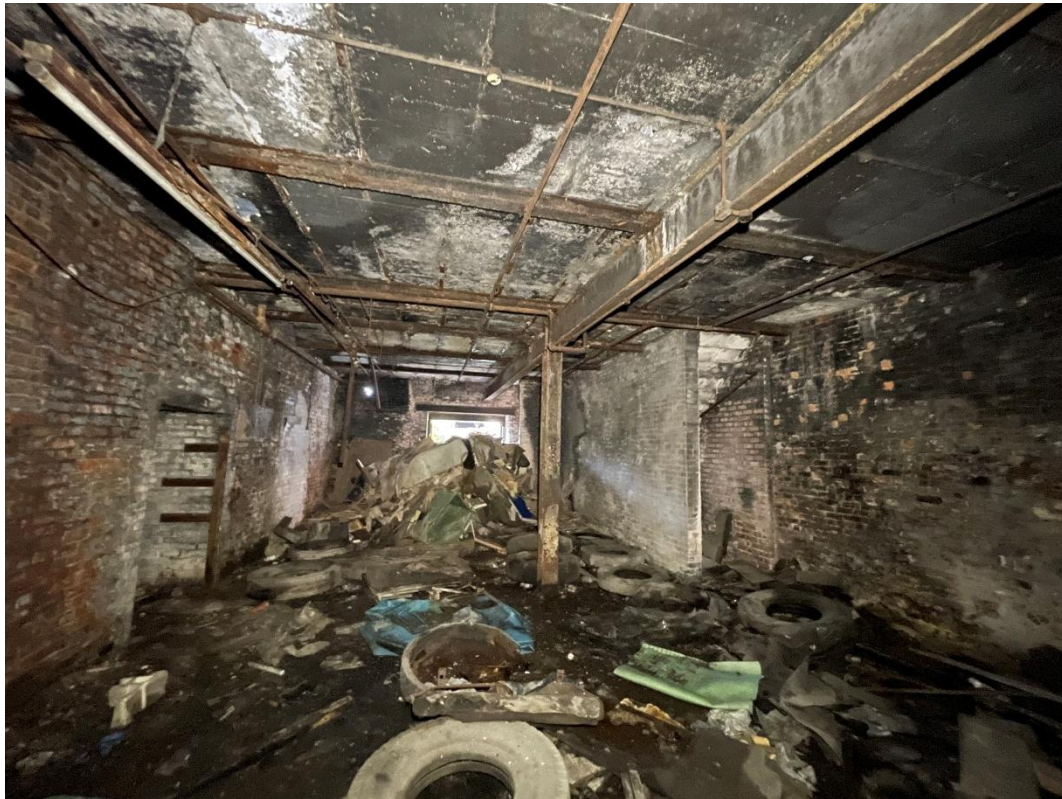
**Figure 15** – A view looking north across the ground floor level, showing the inserted c1950s concrete floor and staircase (left) at a slightly higher level.

At some point after the date of the 1943 Goad map above (presumably in the 1950s) the original jack-arched brick floor dividing the ground floor level from the engine room at first floor level was removed and two reinforced concrete floors were inserted; one at a slightly higher first floor level (see Figure ??) and another to subdivide the engine room into two floor levels, connected with the ground floor level with a new staircase.

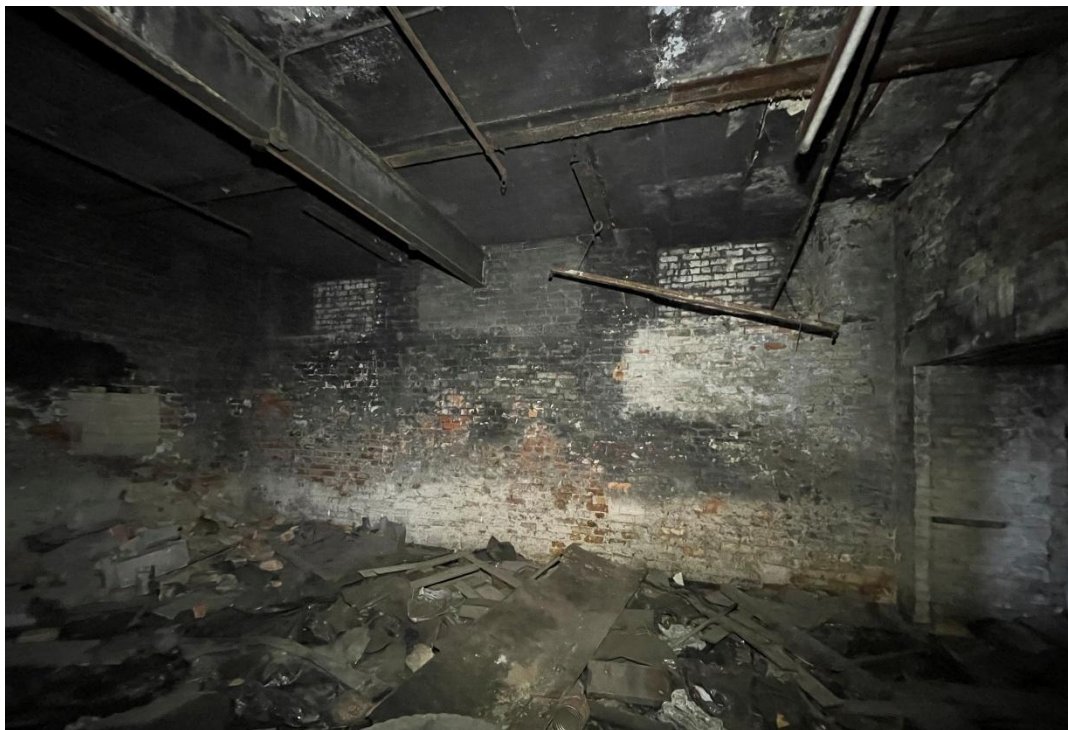
**Figure 16** – A view looking towards the south-east (rear) wall showing the three blocked windows which would have looked onto the canal.

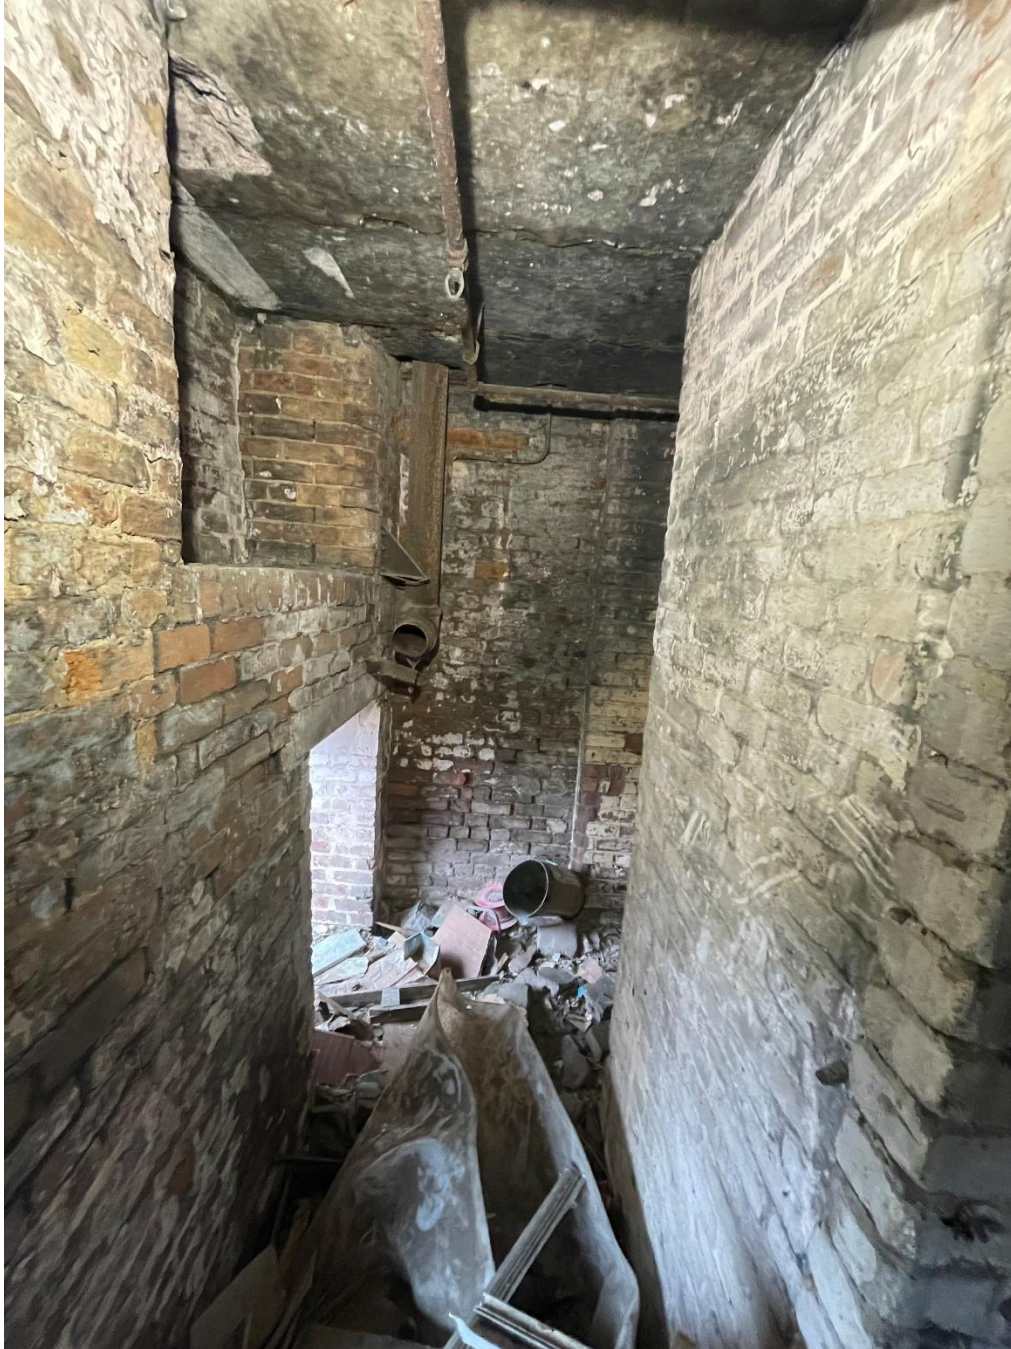
**Figure 17** – A closer view of the principal north-west elevation, showing a blocked window opening top-left which was blocked due to the insertion of the c1950s reinforced floor.

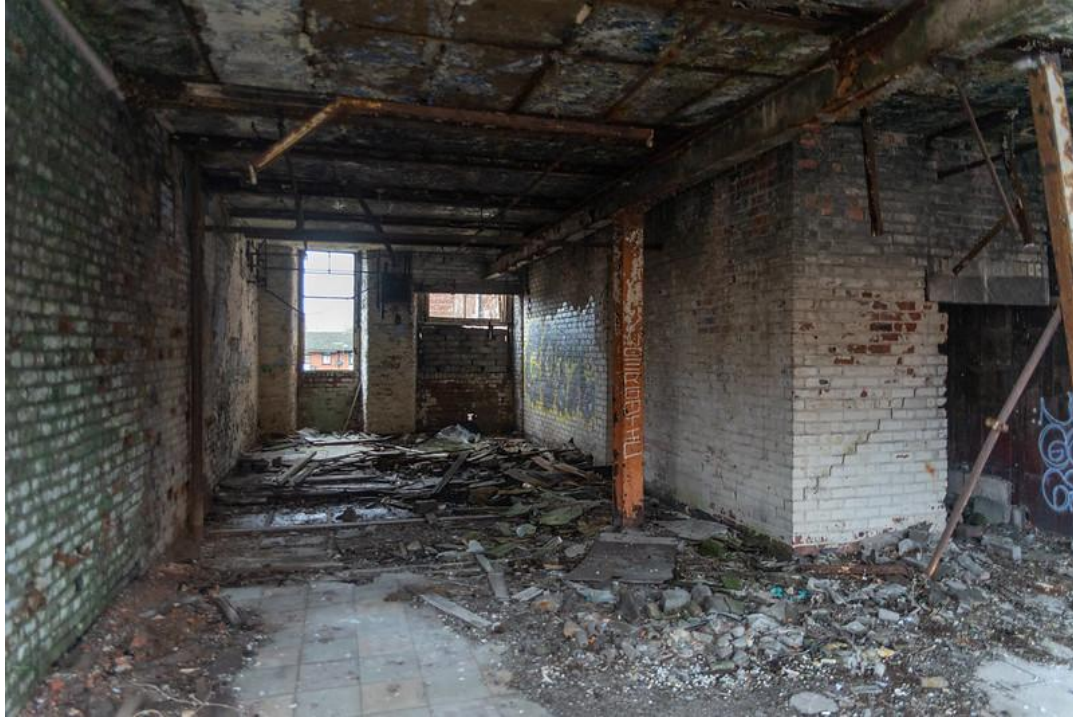
**Figure 18** – A view looking north across the first floor level, which was formed with the c1950s reinforced concrete floor and ceiling.

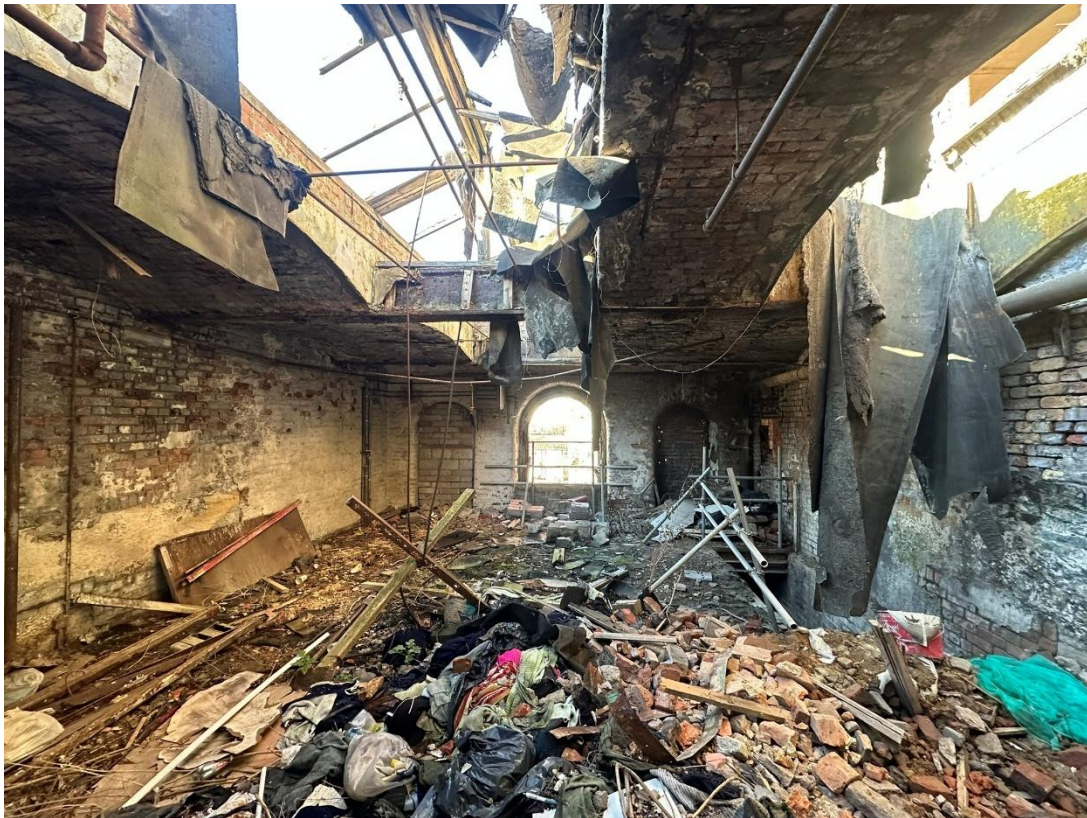
**Figure 19** – Looking north across the top, second floor level, formed in the c1950s with the insertion of its concrete floor, which runs across all window openings.

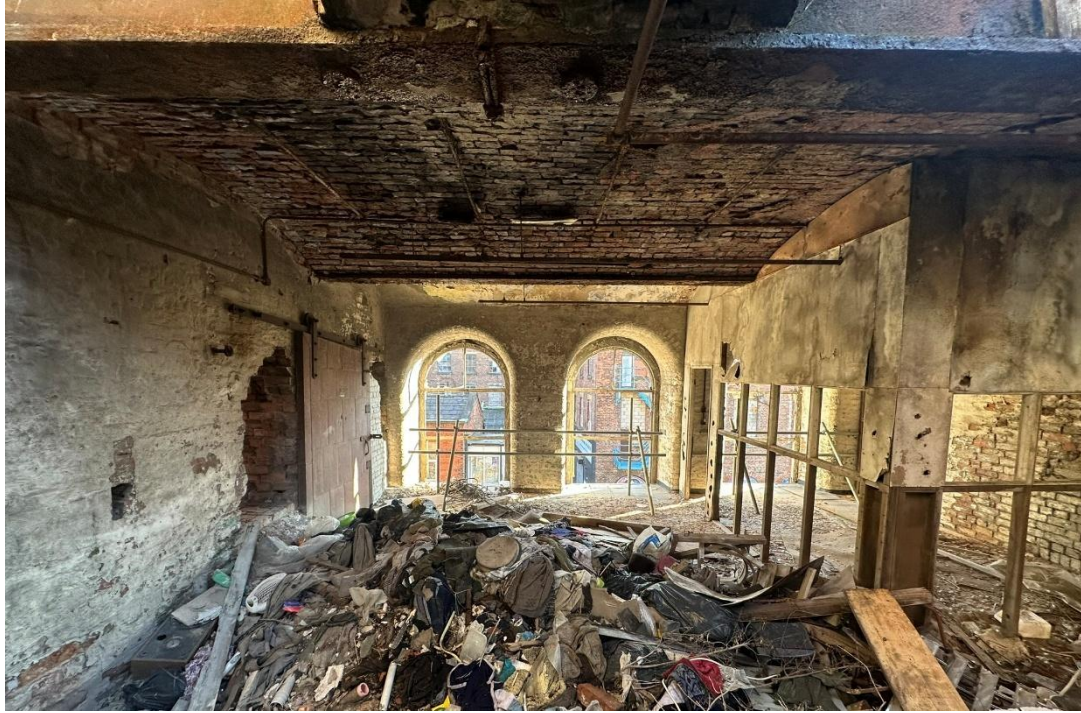
**Figure 20** – Looking south towards the rear elevation, showing the three original round-headed window openings onto the canal.

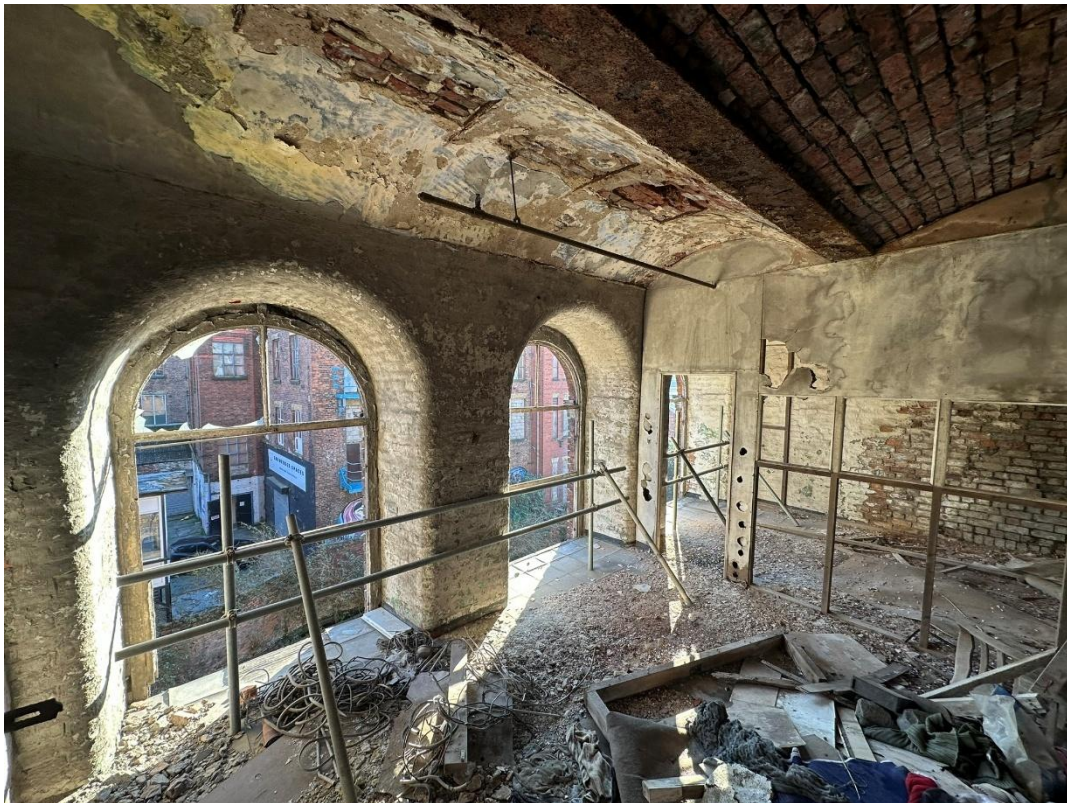
**Figure 21** – A closer view of the southern three windows, showing their deep reveals and bullnose edges. Note the original brick, jack-arched ceiling/roof.

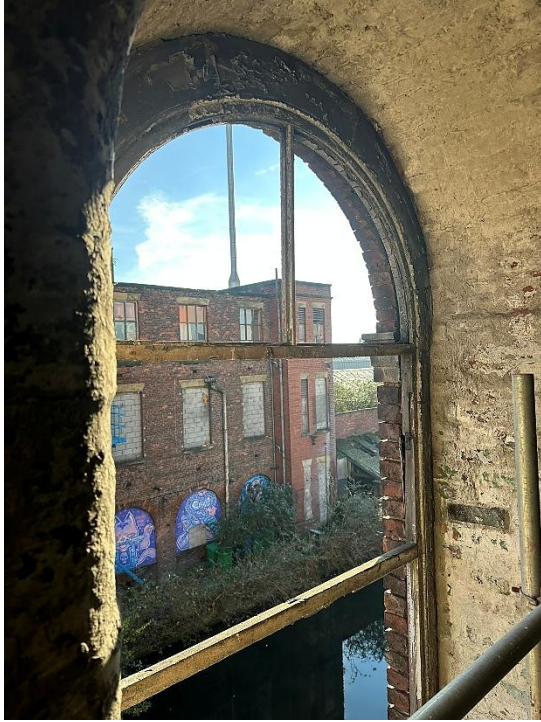
**Figure 22** – One of the three southern windows, showing the remains of its original timber casement windows.

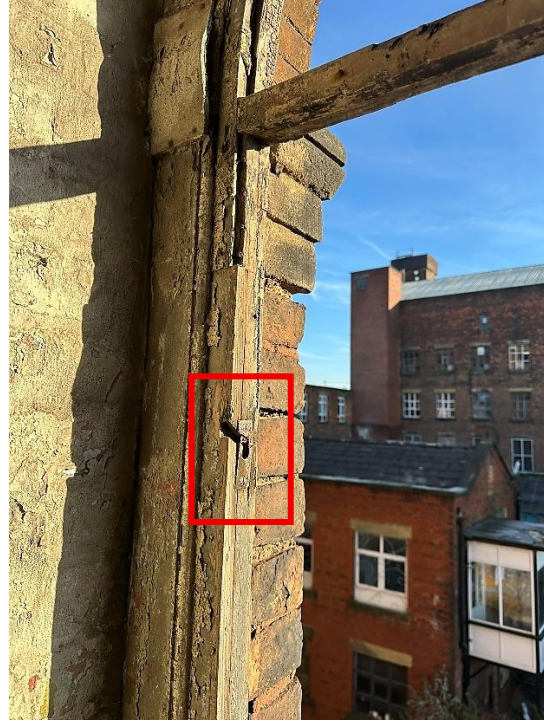
**Figure 23** – A detailed view of one of the southern windows showing evidence of original opening fixings to the frame.

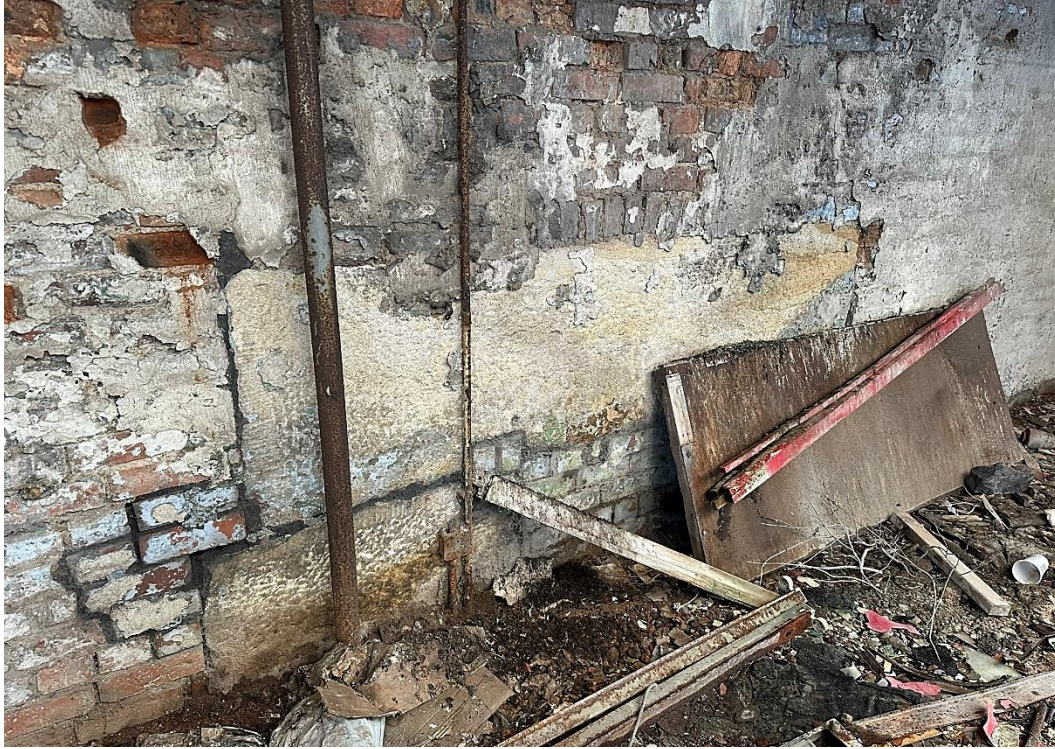
**Figure 25** – A view of the original stone bearing blocks to the north-west wall from which would have supported the original flywheel of the steam engine.

The mill originally ran on 2 steam engines housed within the first floor of the engine house; a two-crank beam engine, which was attached via large stone blocks against the south-west wall (see Figure 25), and a single-crank horizontal engine, which would have been positioned elsewhere on the floor. Together, both engines provided power to the 100,000 mule and ring spindles in the mill via a series of line shafting which ran from the engines, through openings within the western mill wall (see Figure 26 and along the ceiling of each mill floor to the looms.

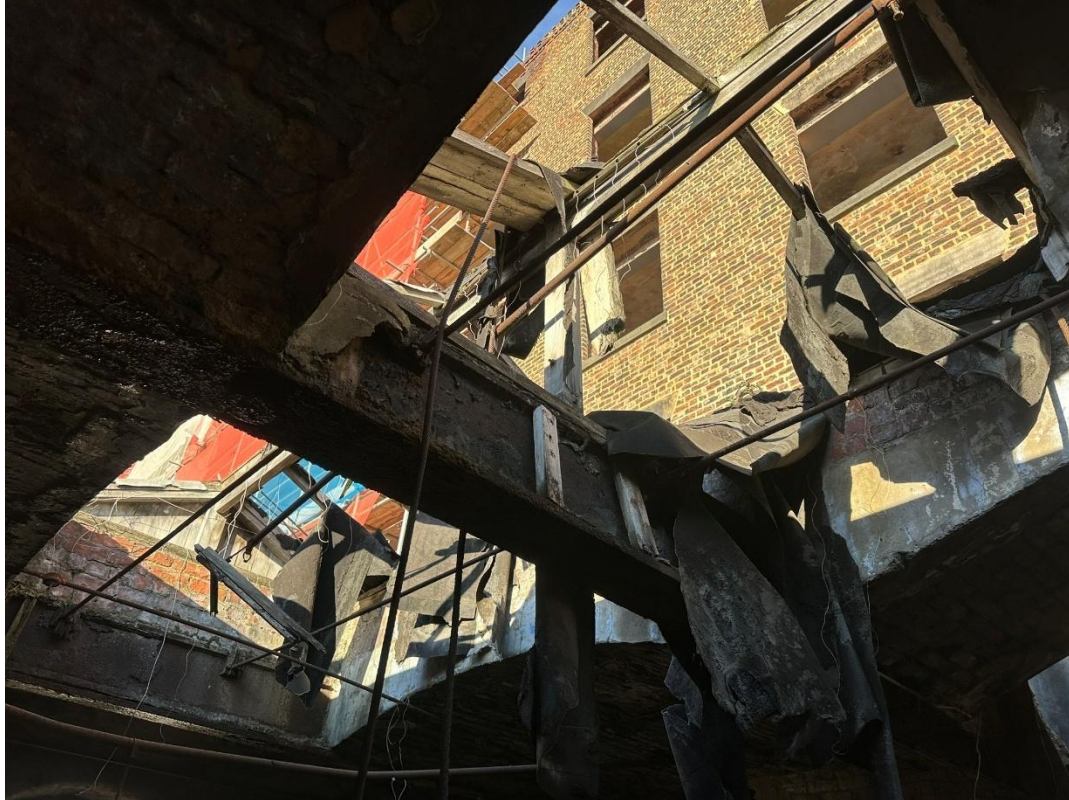
**Figure 27** – Looking up at the original central skylight and the remains of its timber skylight structure.

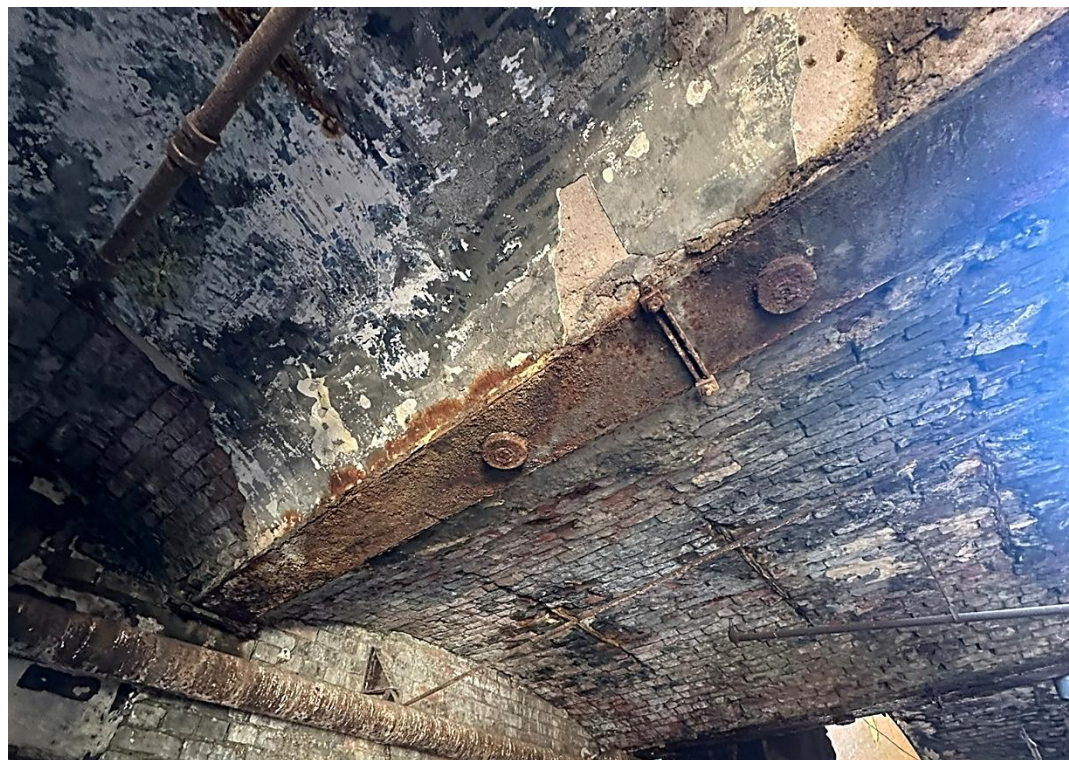
**Figure 28** – Detailed view of the original jack-arched ceiling.
