Leigh Ecology Ltd

85 Rochdale Road,  
Manchester.

*On behalf of McGoff Group Projects Ltd.*

## Preliminary Ecological Appraisal and Bat Roost Assessment

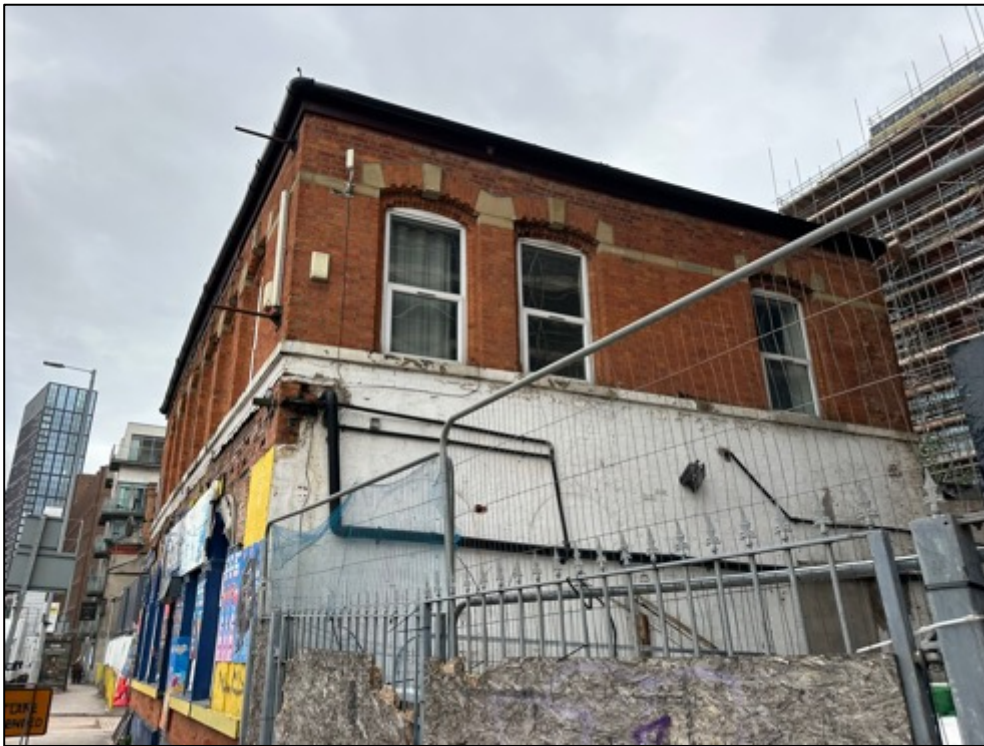
**Photograph 1,** A view of the eastern face of the building on site to be retained. The building is traditional brick, with a single storey mixed painted face. Some slight displacement was noted across some brick decal points above windows.

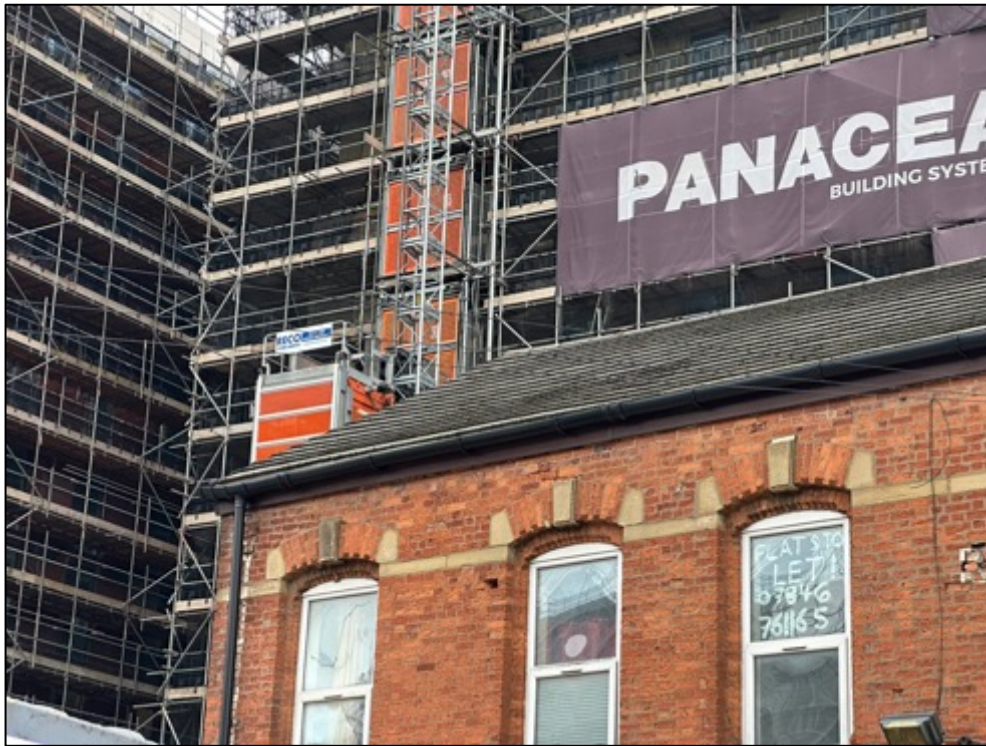
**Photograph 3,** A front view of the building on site. The external roof is in good condition, fascia boarding was in fair condition along the upper front. Small openings were noted across the upper front face among the brickwork but were seemingly hollow, created by previous fittings.

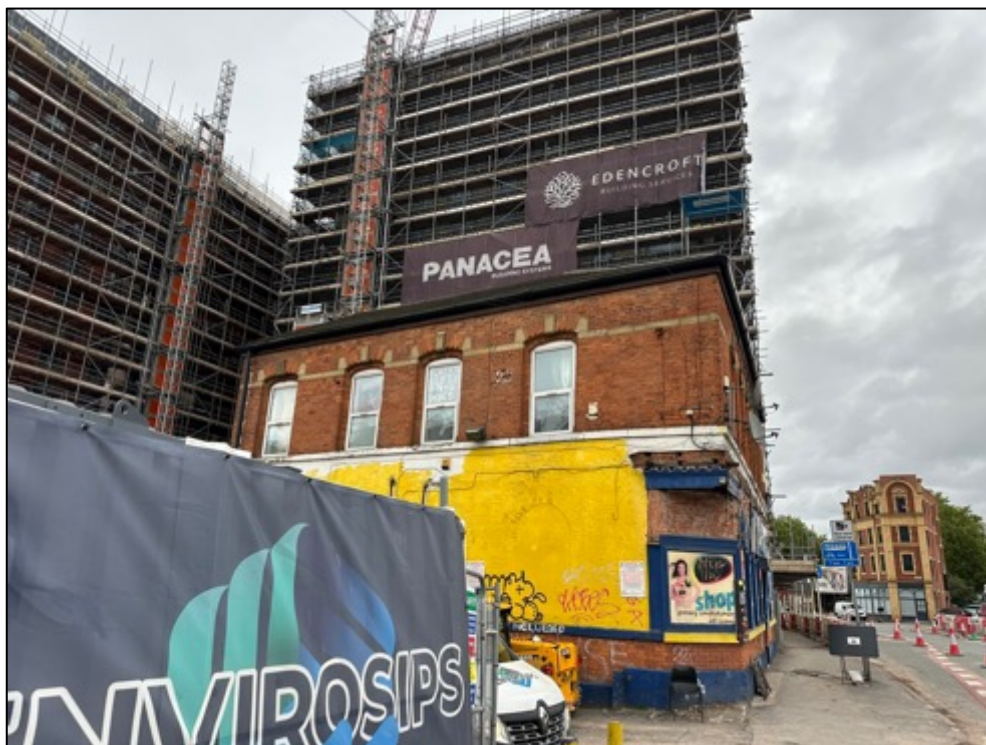
**Photograph 4,** A view of the western face of the building. The western side is to face the proposed apartment block. Again, small openings on the first storey exterior were hollow when assessed with binoculars.

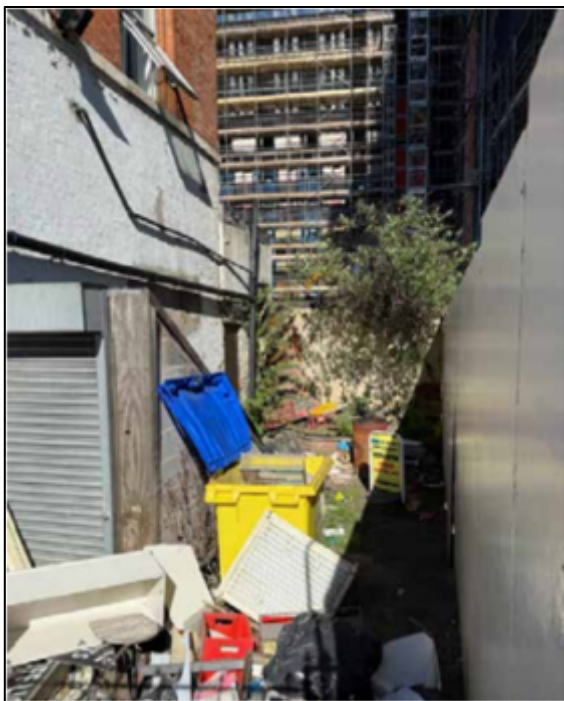
**Photograph 8;** A view from previous visit, showing very small cluster of invasive Buddleia growth along the eastern boundary.

Buddleia was observed around the building and hardstanding areas. A comprehensive INNS management plan should be implemented to ensure effective removal.

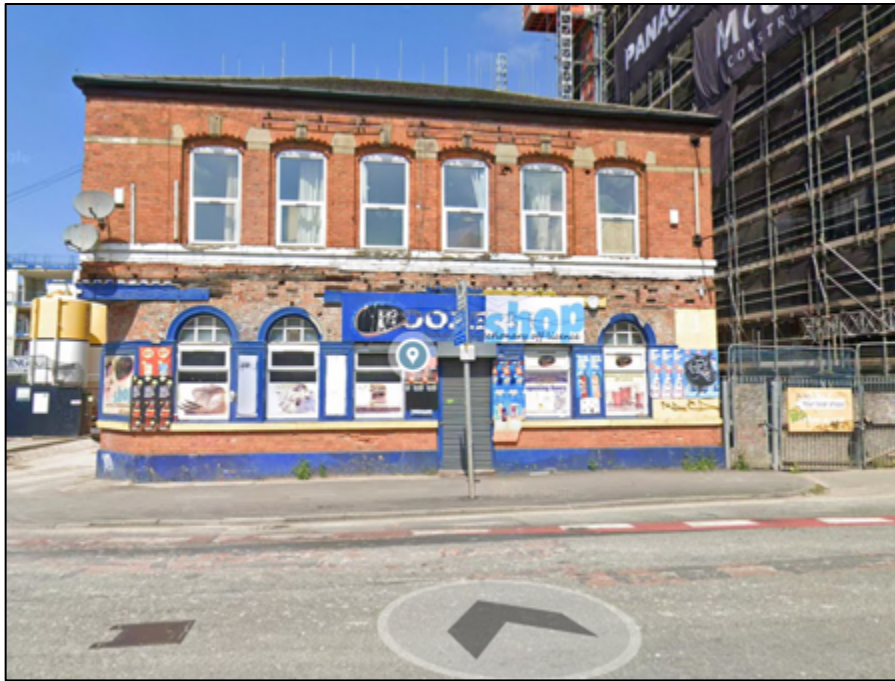
**Photograph 9;** As much of Rochdale Road was blocked off, a photograph of the lower level from a distance was impossible and a snippet from Google maps has been used to annotate. Gaps along the first storey, front face of the building was noted, these were hollow due to previous exterior fittings.

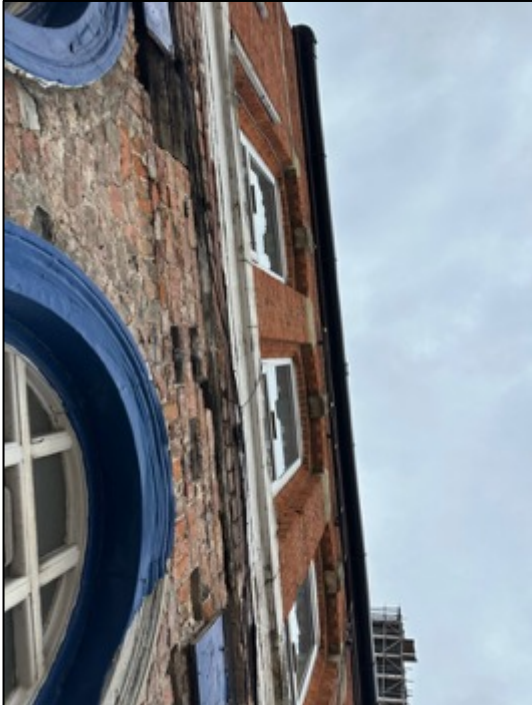
**Photograph 10;** A view of the front of building, showing the various entry points across the first storey face. Again, these openings were hollow and mostly 1 brick/half-brick deep and likely created by alterations and previous exterior fittings.

The building on site will be demolished entirely. The building's external walls show instances of damage across the front, eastern and western face, due to previously fitted exterior panelling and decals that have created large opening across the

external brickwork. The external roof is in very good condition, with supporting fascia boarding again in fair condition. **The building has been classified as offering low bat roost potential, due to the various entry points across the external walls.** The building is removed from ideal bat foraging habitat and flight lines, and any lighting changes are noted as unimportant due to the existing intensive artificial lighting surrounding the site.

Given the building has been classified as offering low bat roost potential, a further bat activity survey should be undertaken to determine the presence of bats within the building. This single further survey will be undertaken in May 2026, with the results of this survey to follow in a separate report.

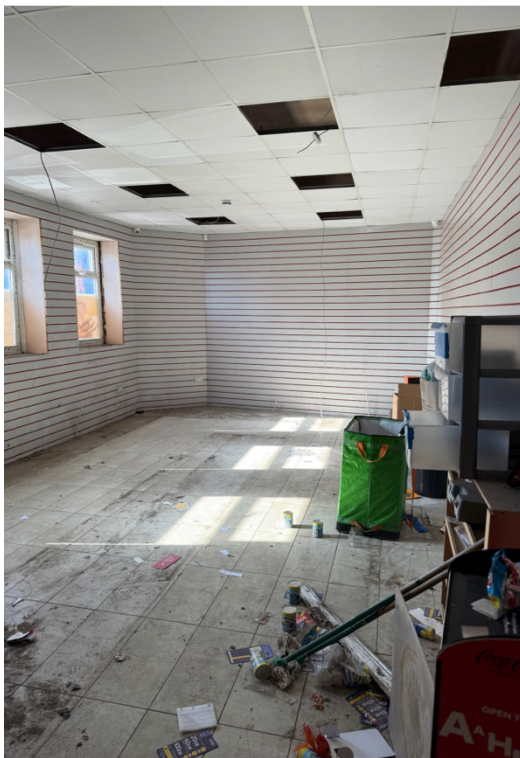
**Photograph 12;** Another photograph of previous internal survey. Some sections of the upper floor feature suspended ceiling.
