# NORTH MANCHESTER GENERAL HOSPITAL

## Bat Survey Report: Preliminary Roost Assessment

2489216-D01 (00)

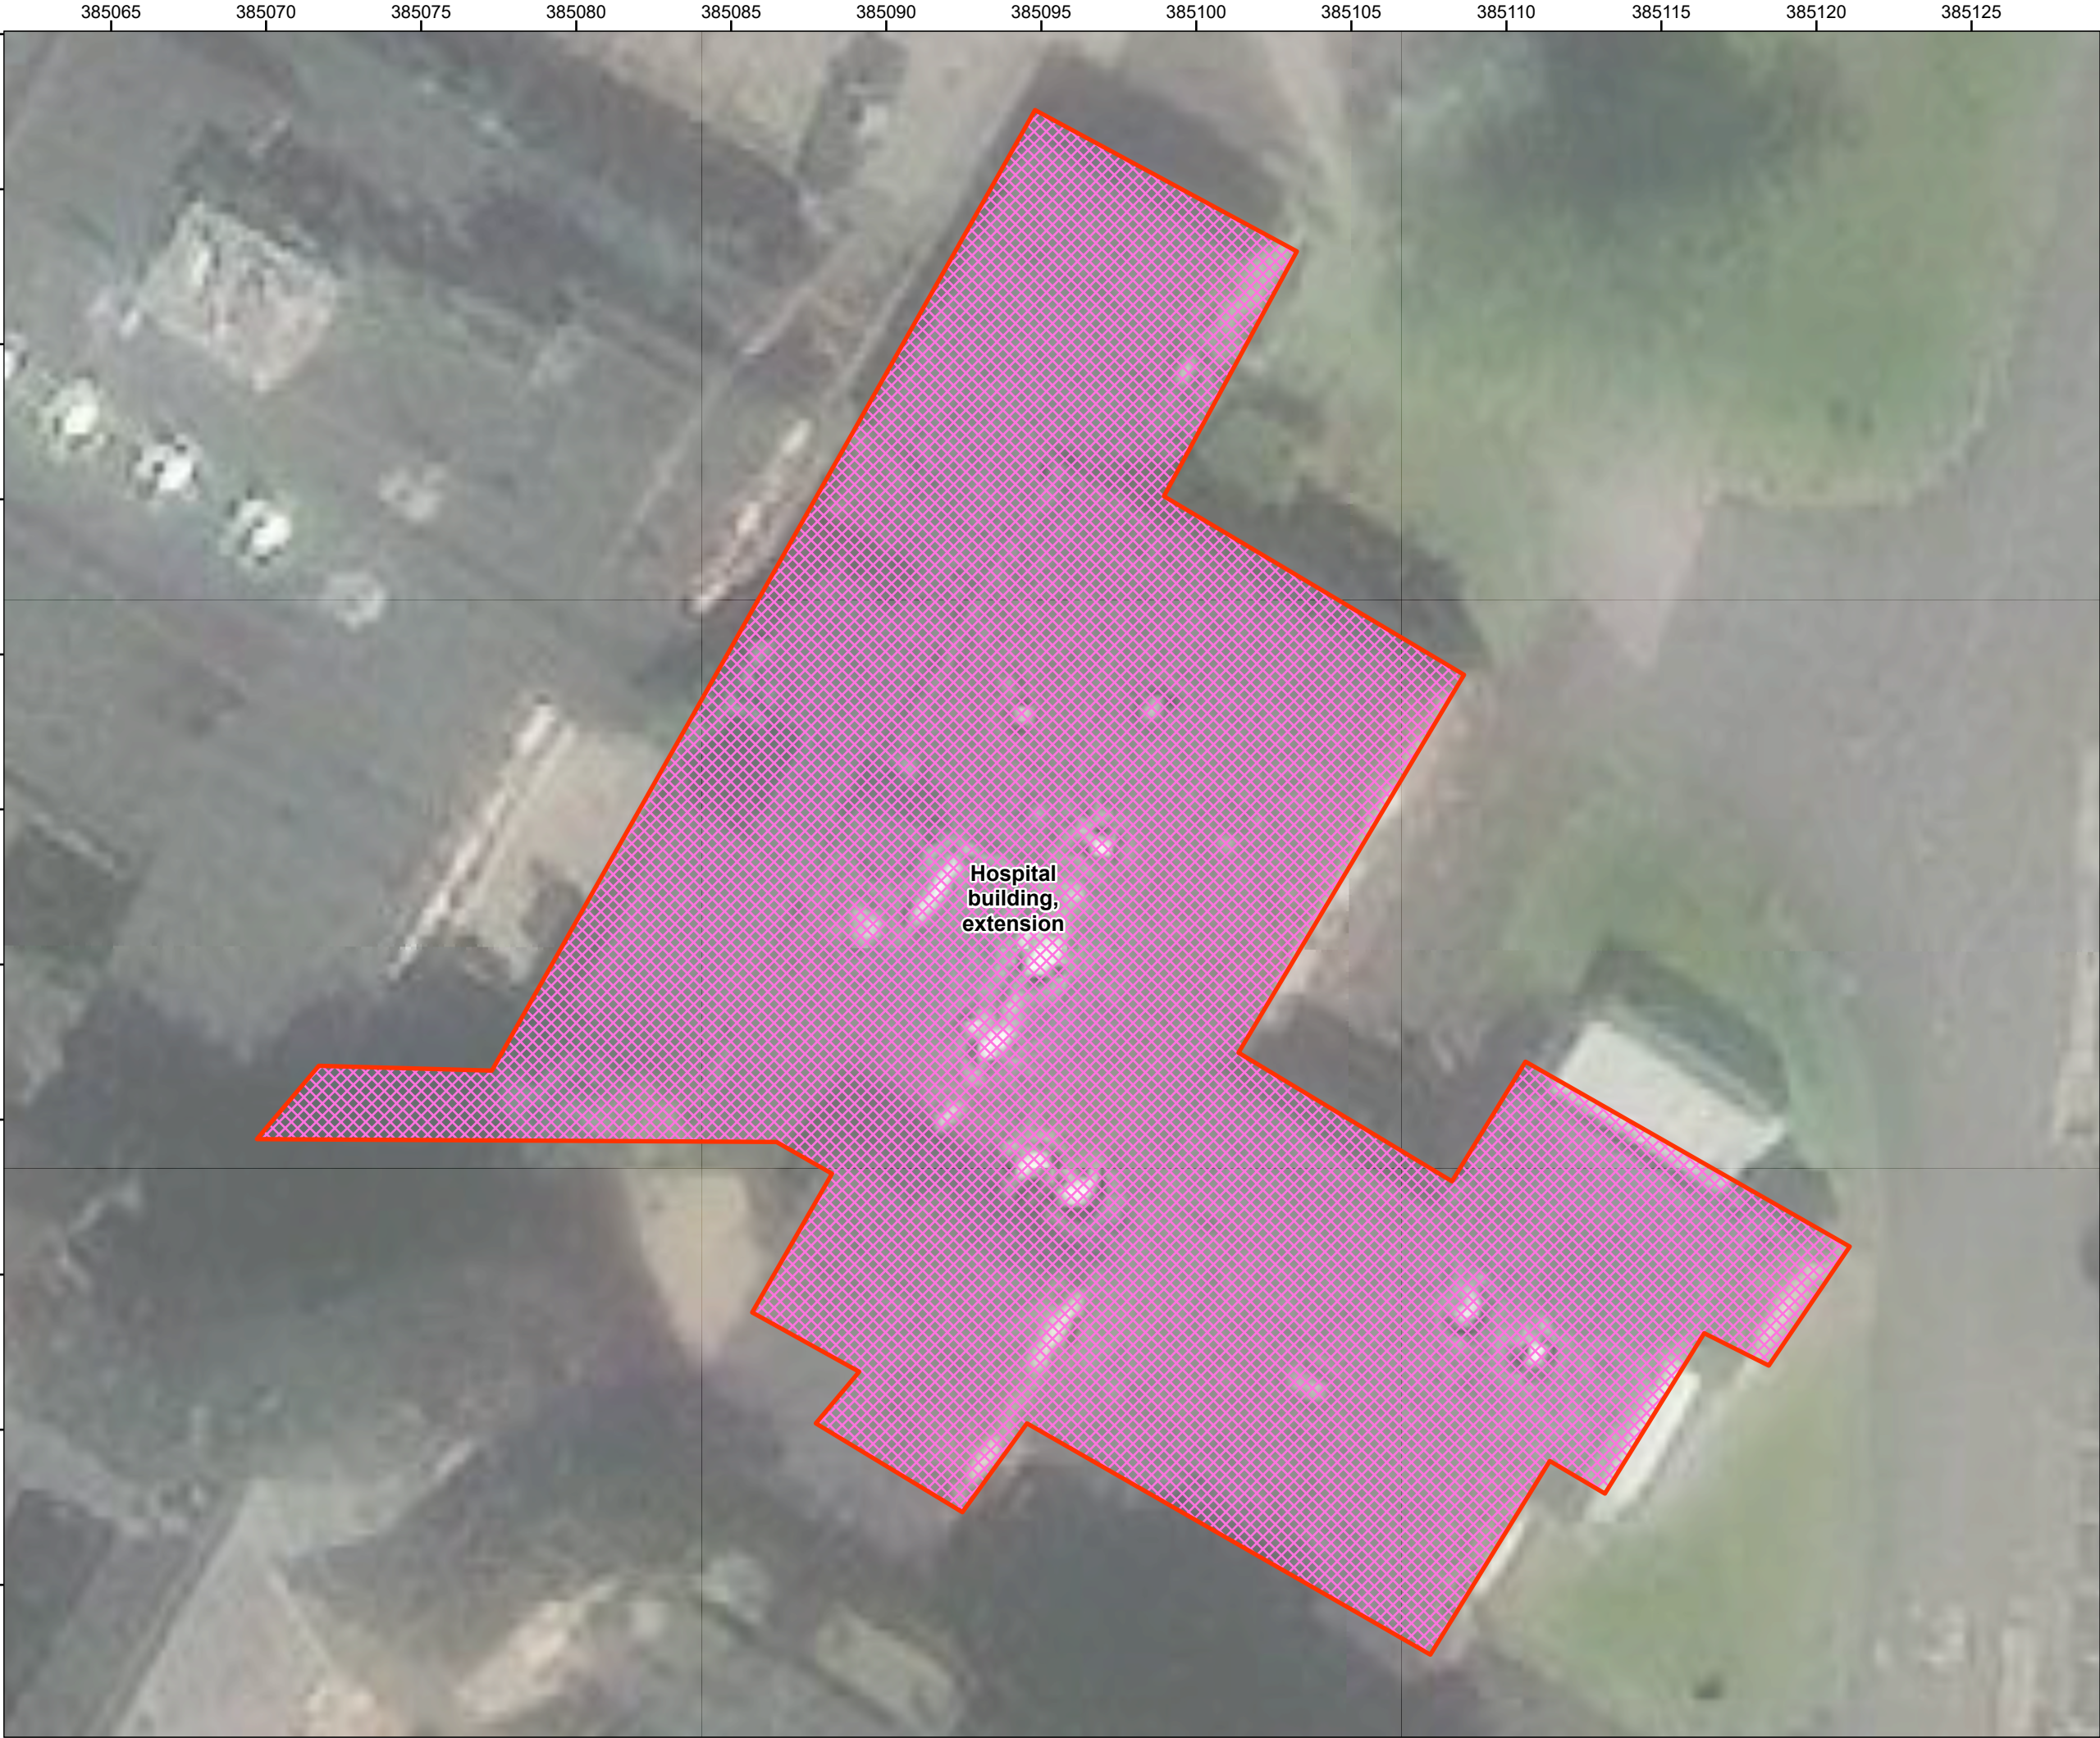
TITLE: Figure 2:  
Survey Results

**Bat Roost Suitability**

Negligible

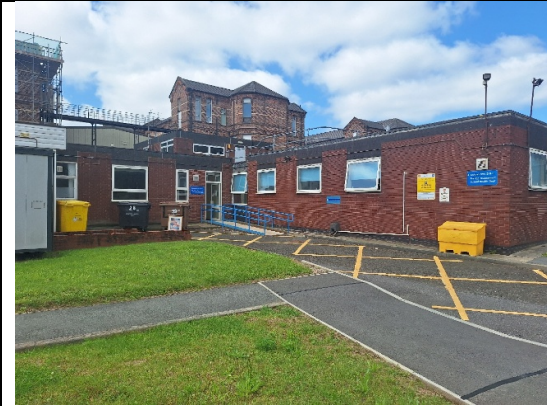
Photo 1 (08/07/2025): Northern and eastern aspects of the building.

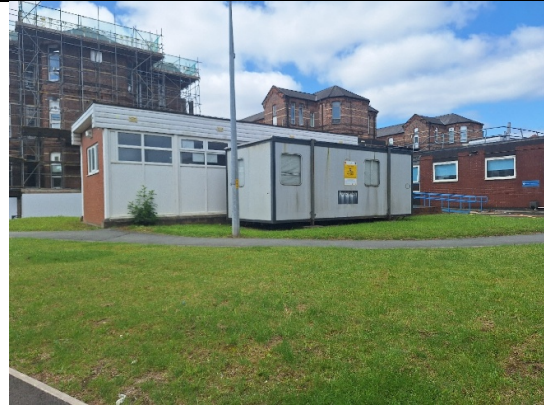
- 3.1.3 The northern sections of EMBE Block 6 are modular, portakabin-type units constructed with wooden soffits, bitumen flat roofs, and walls made of wood and pebble dash render. A small gap was noted in one section of wooden cladding, although on close inspection with a high-powered torch, it was considered to be shallow and offer limited opportunities for roosting bats. Furthermore, no evidence of roosting bats was recorded.

Photo 2 (08/07/2025): Northern aspect of the building.

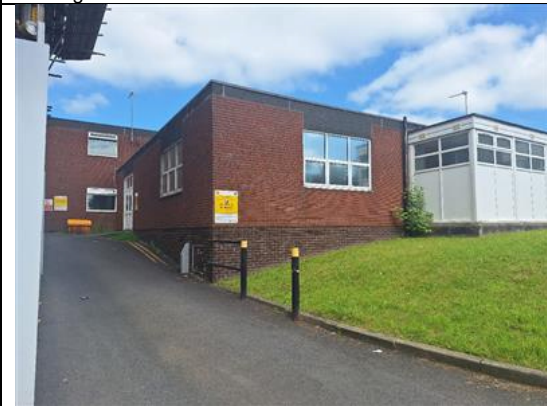
Photo 3 (08/07/2025): Southern and eastern aspects of the building.

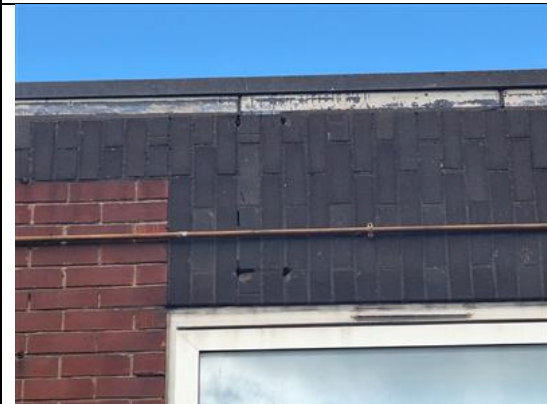
- 3.1.2 Externally, the brick-built sections of the building feature wooden soffits and fascias, and metal/plastic cladding is present across multiple elevations, the majority of these were tightly sealed offering no opportunities for roosting bats. A small section was lifted on the western aspect of the building, but this was fully inspected using a torch and no evidence of roosting bats was recorded. There are several small weep holes on the northern and eastern aspects of the building and a small number of gaps in the brickwork are present on the eastern aspect of the building. However, these gaps were inspected using a high powered torch and the majority of these gaps were found to be superficial, and no evidence of roosting bats was recorded.

Photo 5 (08/07/2025): Gaps in the brickwork identified on the eastern aspect of the building, found to be superficial on closer inspection with a high-powered torch.

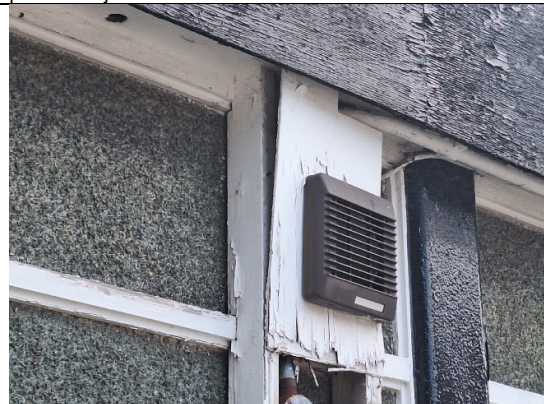
Photo 6 (08/07/2025): Example of a gap in the wooden cladding on the western aspect of the building. Feature fully inspected with a high-powered torch and found to be shallow and limited for roosting bats.

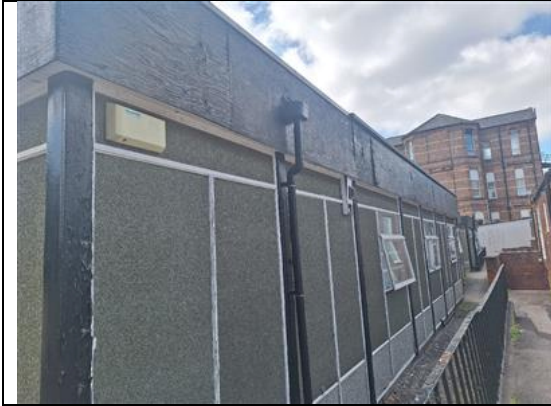
Photo 7 (08/07/2025): Western aspect of the building.

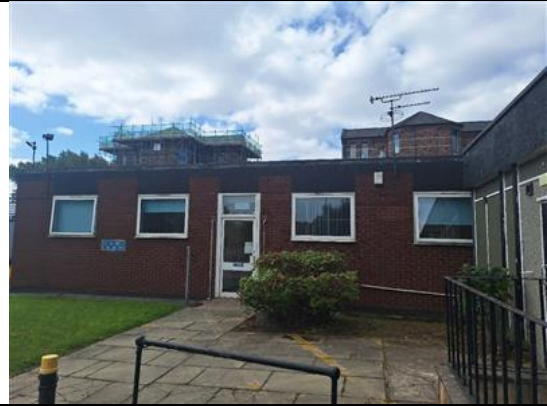
Photo 8 (08/07/2025): Northern and eastern aspect of the building.

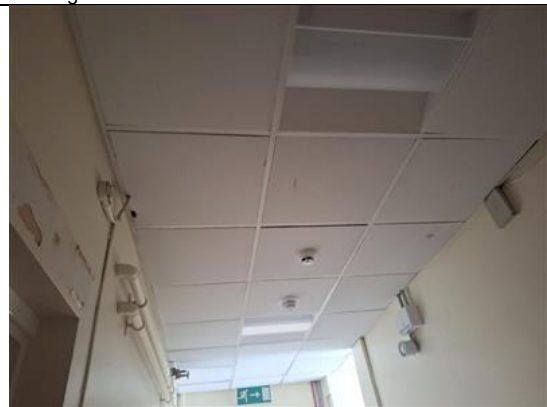
- 3.2.1 Internally, within the inspected sections, the ceiling is constructed from suspended ceiling tiles. No loft voids or accessible roof spaces were present due to the flat-roofed design. Several ceiling tiles were missing and the gap between the tiles and the roof was visible. The voids between the suspended ceiling tiles and roof were not large enough to support roosting bats, and no internal features were found that would offer suitable shelter. No bat droppings were recorded within internal areas. No loft voids are anticipated within the other areas of the building due to the flat roof design.

Photo 10 (08/07/2025): Internal view of room within the south, eastern section of the building.
