## SPARKLE STREET REMEDIATION STRATEGY

**Document Ref:** SPS-CUR-XX-XX-T-G-82-0006

Client Name: Foras (Sparkle Street) Limited

Site Address: Sparkle Street, Manchester, M1 2NA

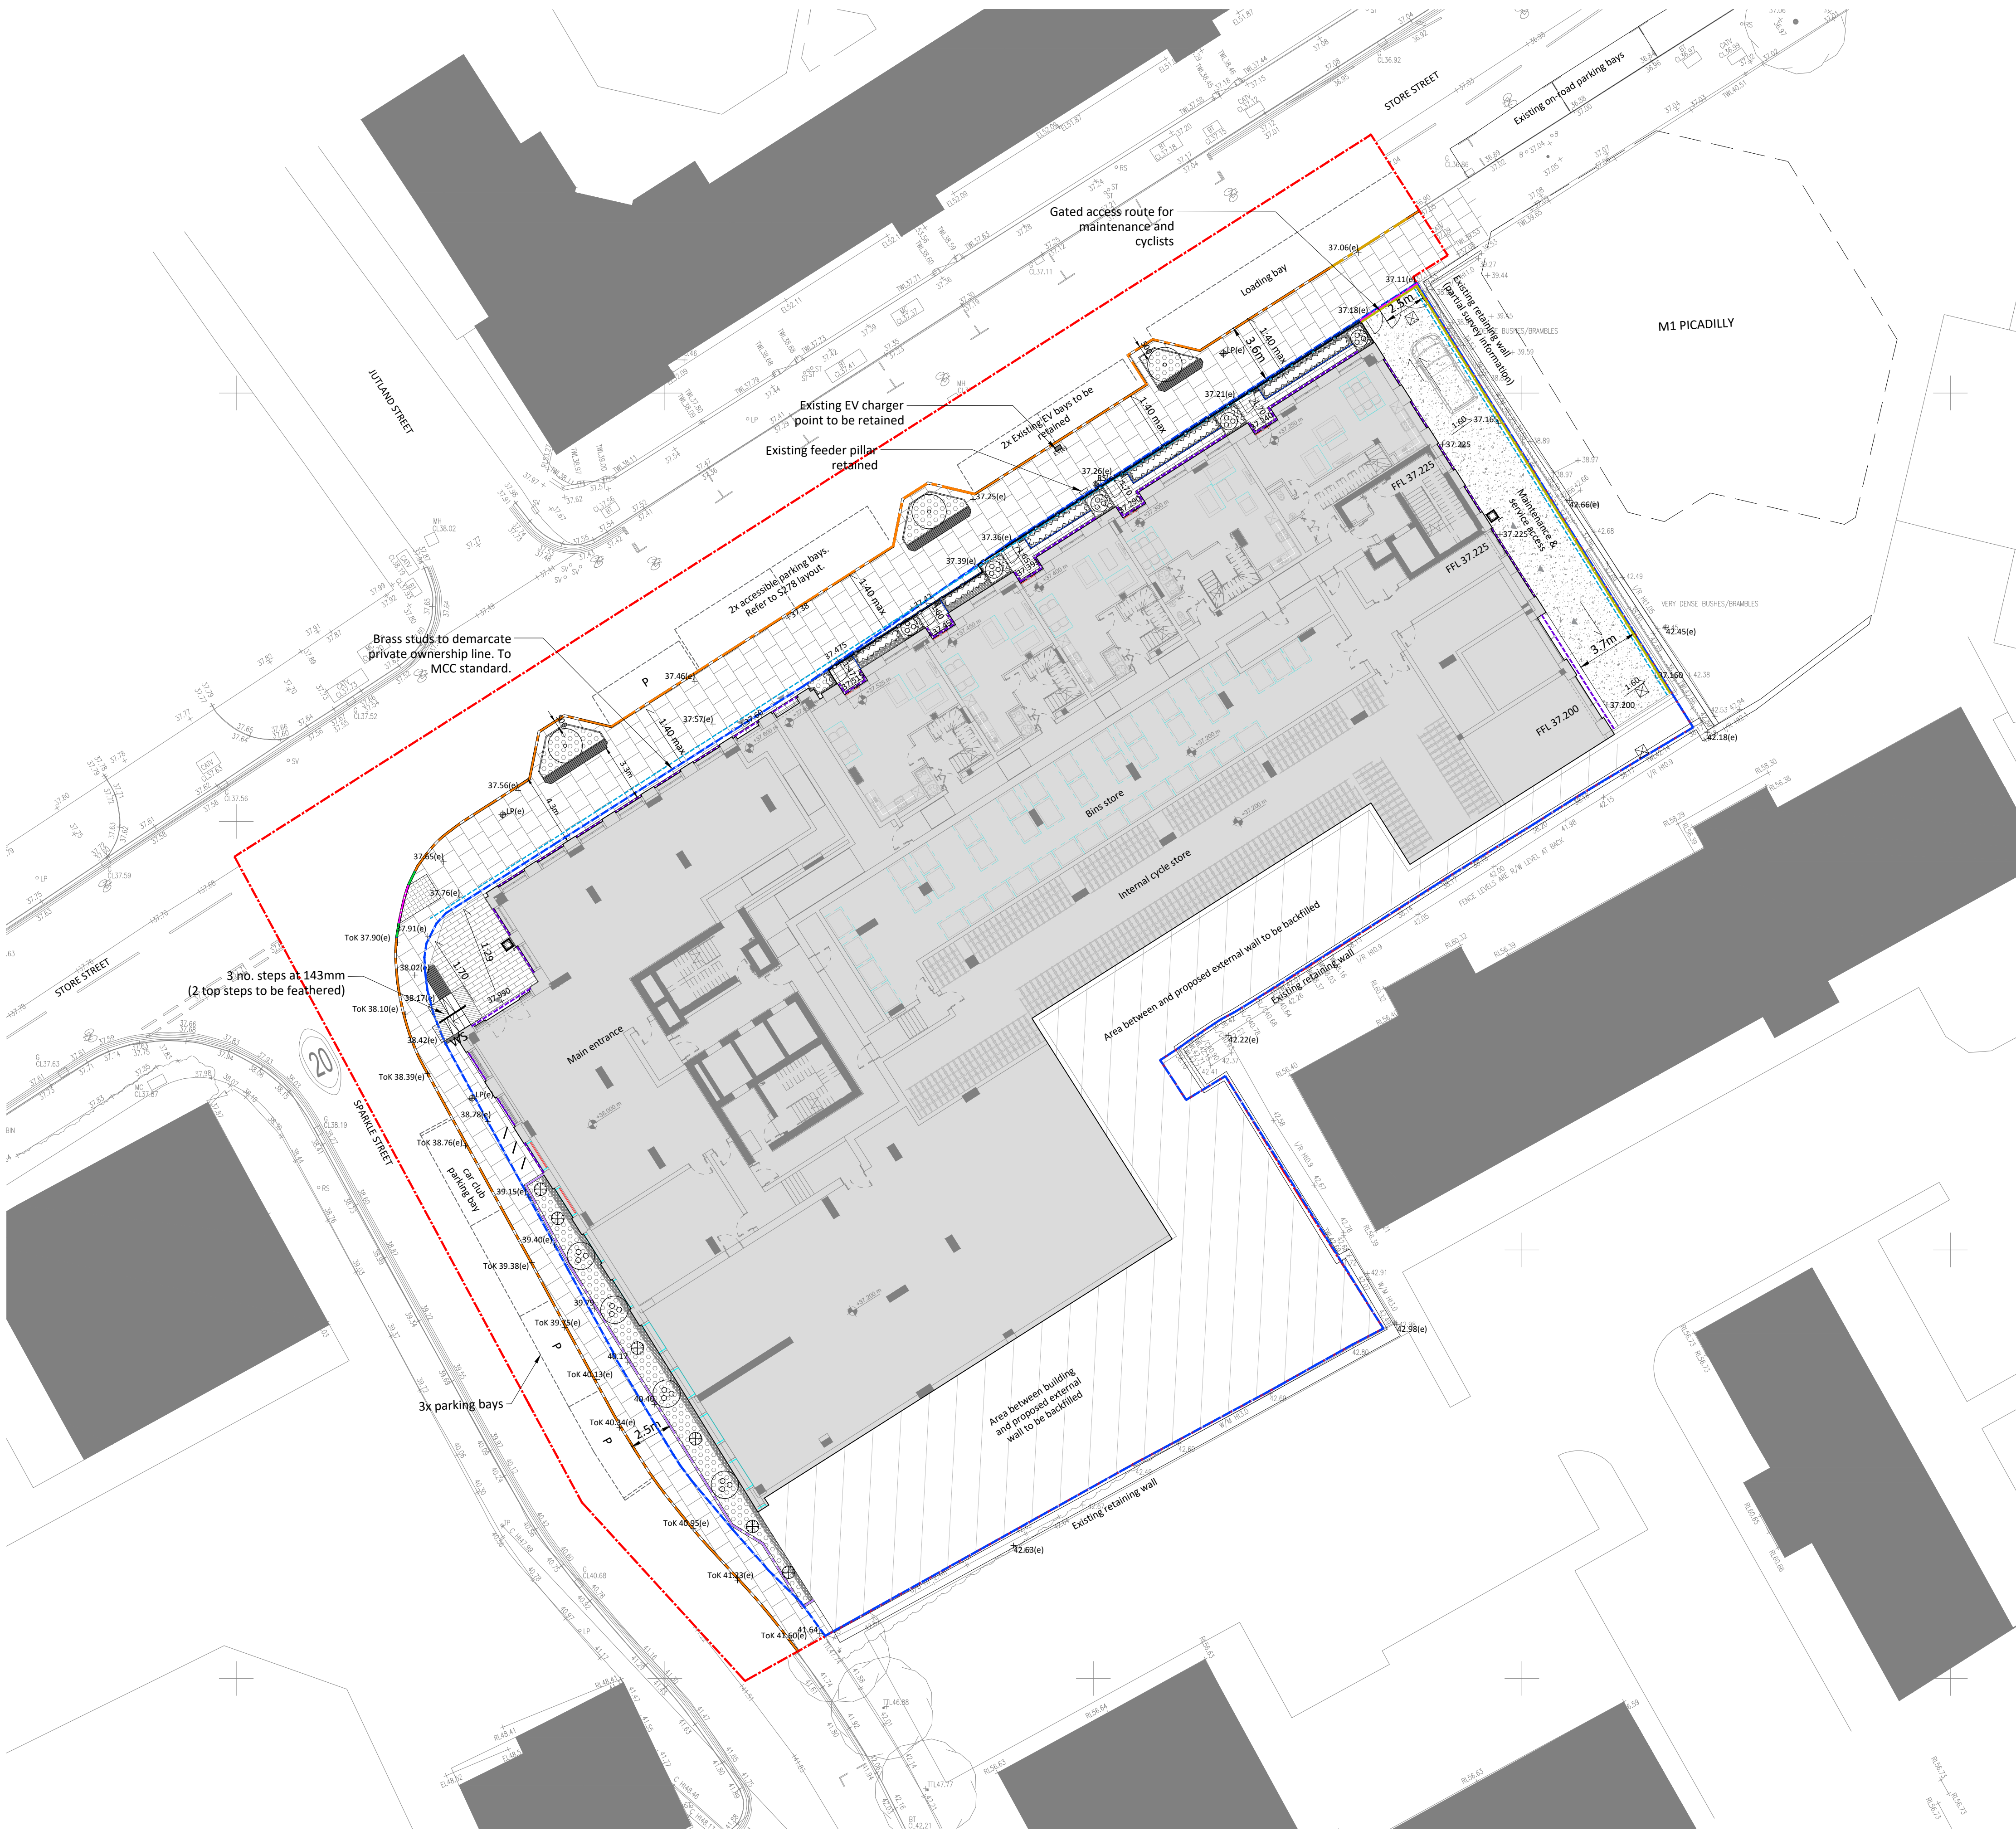
## Appendix A – Drawings

- Key  
For detailed description on below items refer to Outline Landscape Specification & Report SPS-RFM-XX-XX-SP-L-19-0001
- Site works boundary
  - Proposed building

- Existing building
  - PCC Concrete flags to footpath **P1**  
To adoptable standards. To be agreed with MCC.  
Size: 450(W)x450(L)x50(D)mm
  - Small clay paving units **P2**  
To private terraces and main entrance  
Size: 200(W)x65(L)x50(D)mm

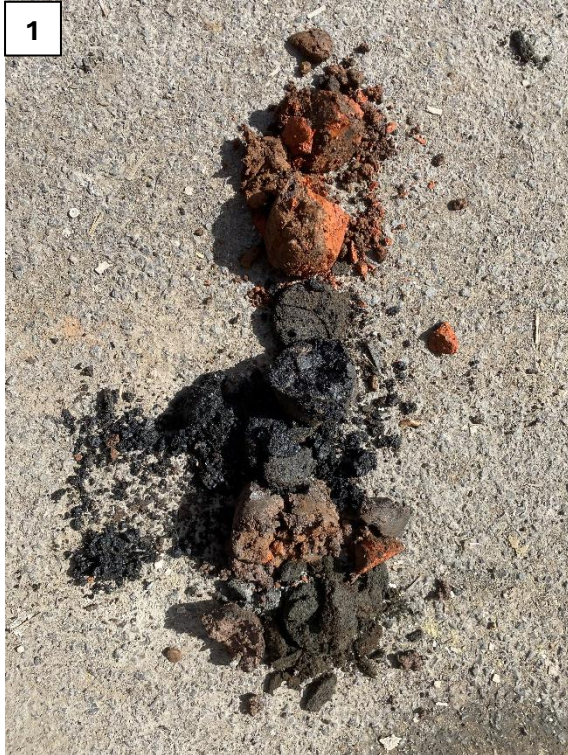
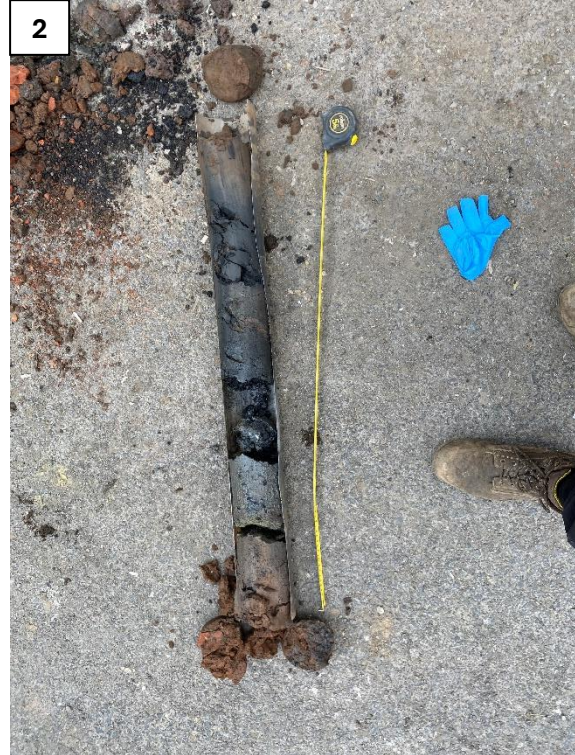
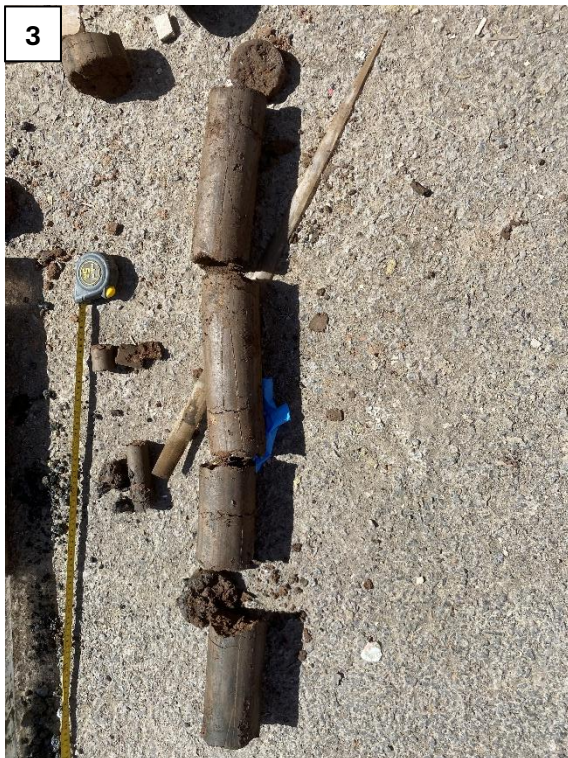
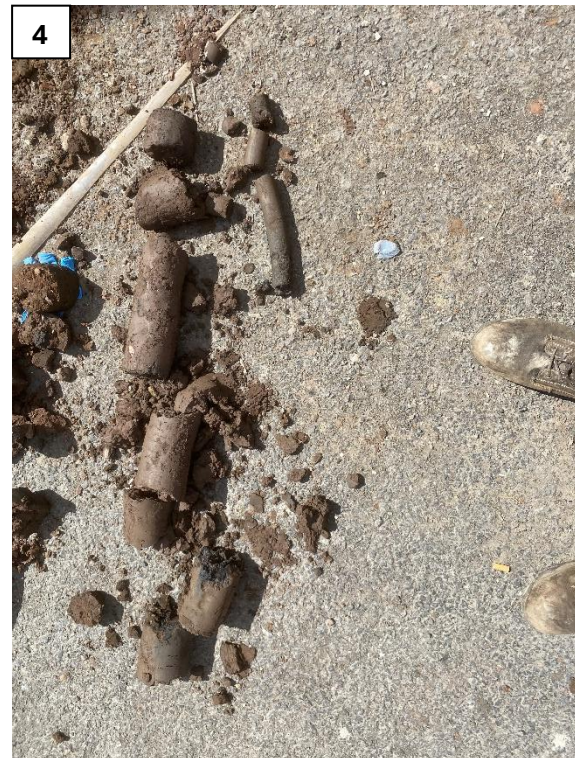
| Location: | BH01 |

| Notes: | Hydrocarbon contamination encountered in BH01 at 1.50m to 2.58m bgl<br>1 – 1.20m to 2.0m bgl<br>2 – 2.0m to 3.0m bgl<br>3 – 3.0m to 4.0m bgl<br>4 – 4.0m to 5.0m bgl |

Visual and olfactory evidence of contamination was observed within BH01, WS106A, and TP105 during the two Curtins ground investigations. These deposits were recorded between a minimum of 1.50m bgl and 2.58m bgl, described as: 'Black or greenish brown very sandy silty gravel of wood chippings with a strong hydrocarbon odour and iridescent sheen', 'Grey slightly gravelly silty sand with a contamination odour and pockets of sandy clay. Gravels comprise brick, wood and ceramic', and/or 'Dark grey clayey fine to coarse sand with a chemical odour'.

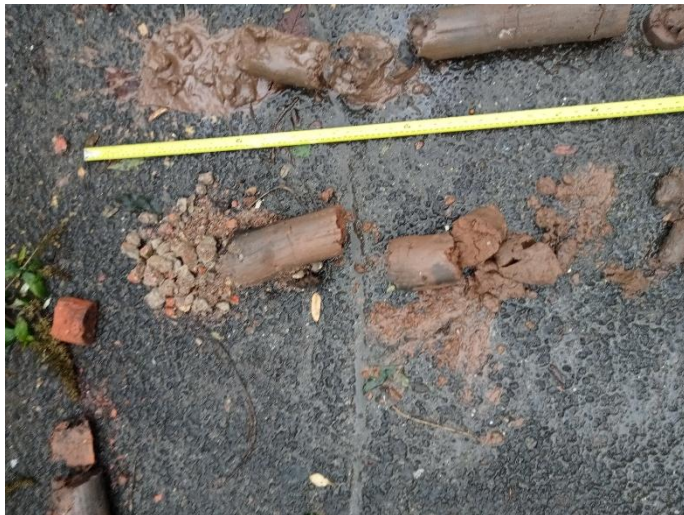
1

| Notes: | Contamination encountered in WS106A at 2.20 to 2.50m bgl<br>1 – 1.20m to 2.00m bgl<br>2 – 2.0 to 2.35m SPT with contamination<br>3 – 2.0 to 2.70m bgl<br>4 – 3.70m to 3.10m bgl SPT |

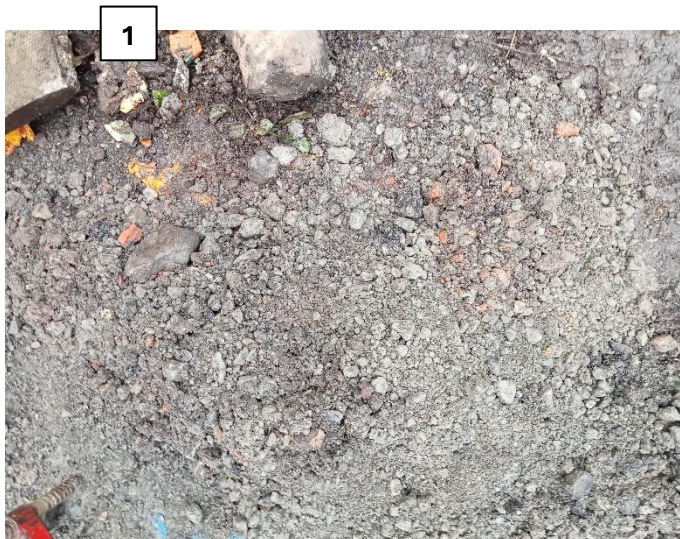
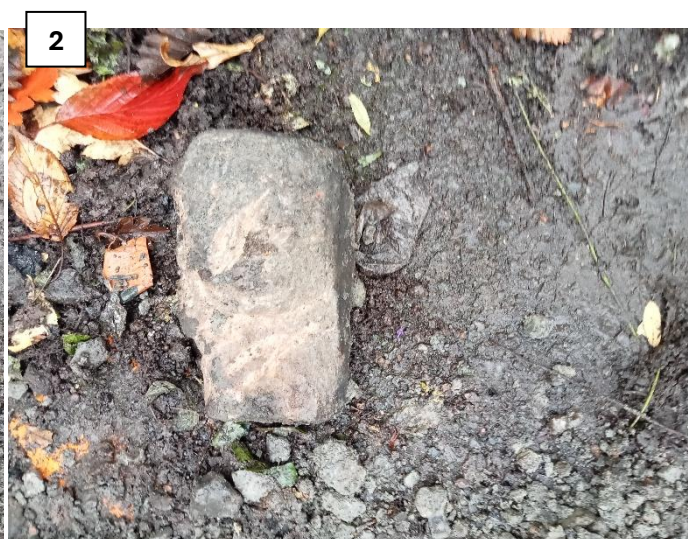
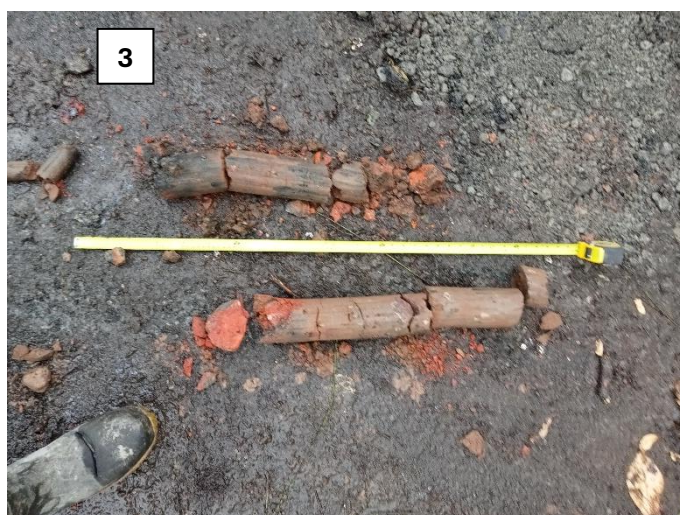
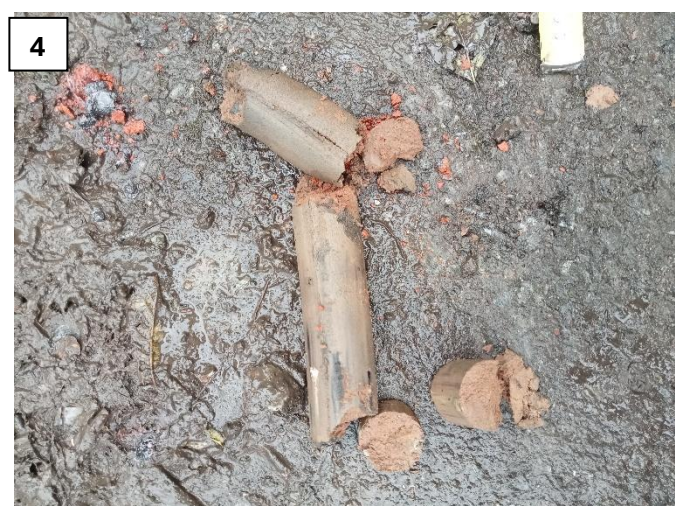
| Location: | WS107 |

| Notes: | Delineation borehole with no observable contamination<br>1 – Hand Pit<br>2 – Cobbles within hand pit<br>3 – Window sample boreholes from from 0.80m to 2.00m bgl<br>4 – Strata from 2.0m to 2.30m bgl |

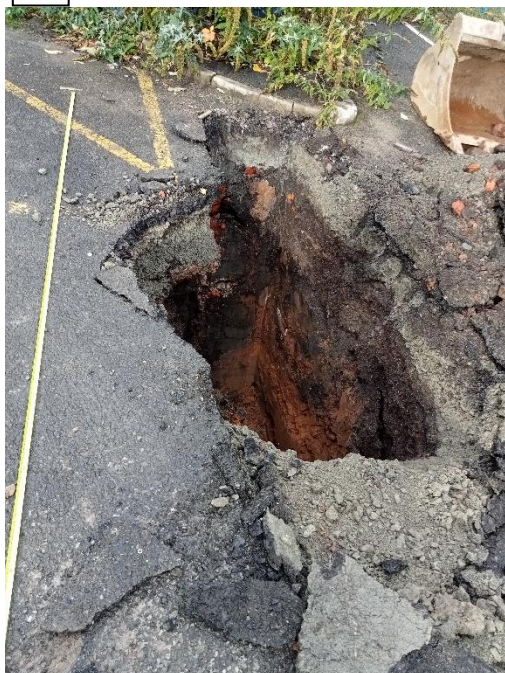
1

| Notes: | Delineation Trial Pit showing no hydrocarbon contamination.#<br>1 – trial pit length<br>2 – trial pit width<br>3 – trial pit depth<br>4 – trial pit with large wood beam within pit |

- Dark greyish brown silty gravelly fine to coarse sand with a medium cobble content. Gravel and cobbles comprise pottery, brick, and wood.
- TP104 observed Made Ground strata comprising, dark grey and brown sandy gravel with a medium cobble content and a low boulder content. Gravel comprised of brick, sandstone, ash, clinker, wood, pottery and limestone. Cobbles and boulders comprised of brick and wood. Large beams of timber were noted during excavation.

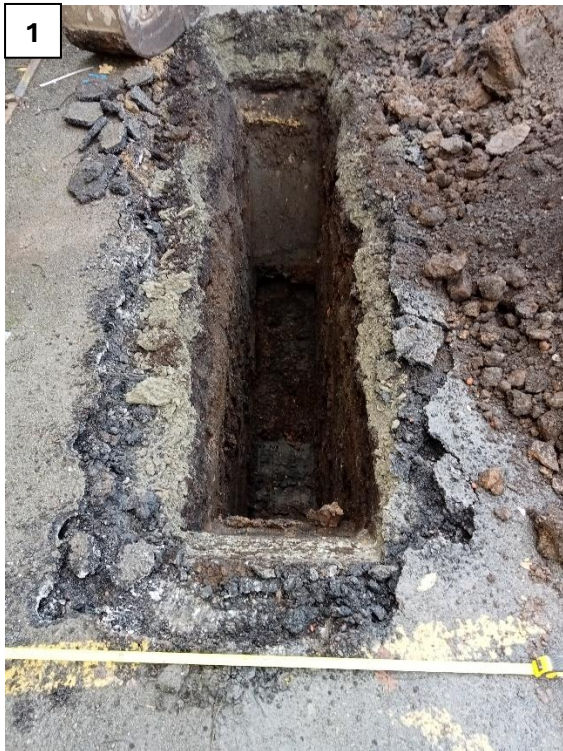
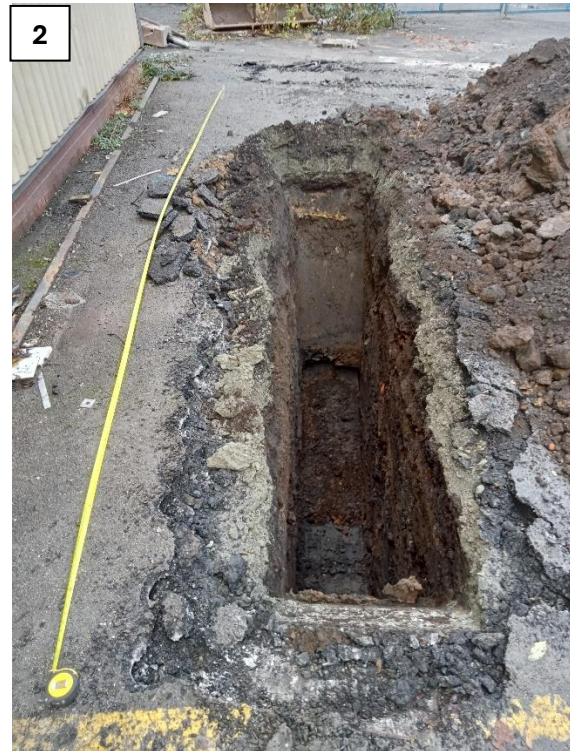
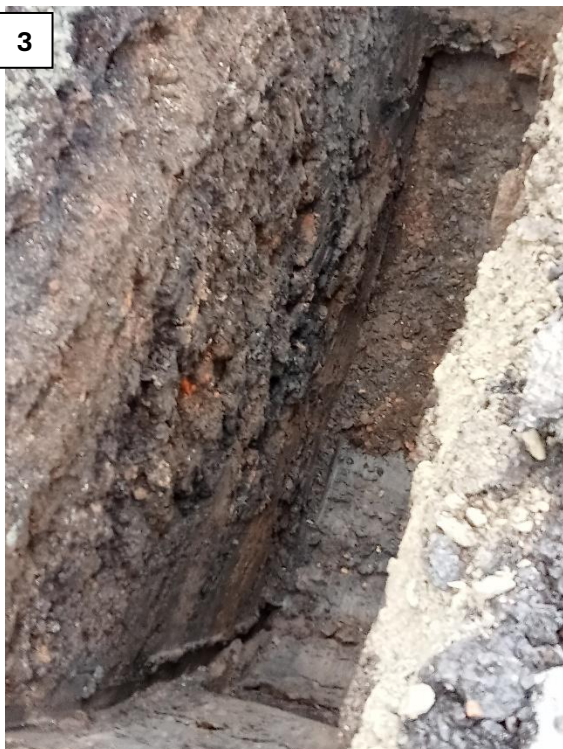
| Notes: | <p>Delineation Trial pit with contamination observed between 1.80m and 2.10m bgl. Contamination was no longer observed 5.2m from the original BH01 position, shown in pictures 2 and 3.</p> <p>1 – Trial Pit Width<br/> 2 – Distance of contamination from BH01<br/> 3 – Trial Pit depth<br/> 4 – Contamination found within trial pit</p> |

Visual and olfactory evidence of contamination was observed within WS106A and TP105 only, at depths of 2.20m to 2.50m and 1.80 to 2.10m bgl respectively (Section 2.4). The contamination within TP105 was no longer observed 5.2m from the original BH01 position.
