### GAS MEMBRANE VALIDATION – SITE NAME

| <b>Project Name: Belle Bue Stadium</b> |
| <b>Project Number: 12-123</b> |
| <b>Plots: Block 1 x 2 Stairwell</b> |

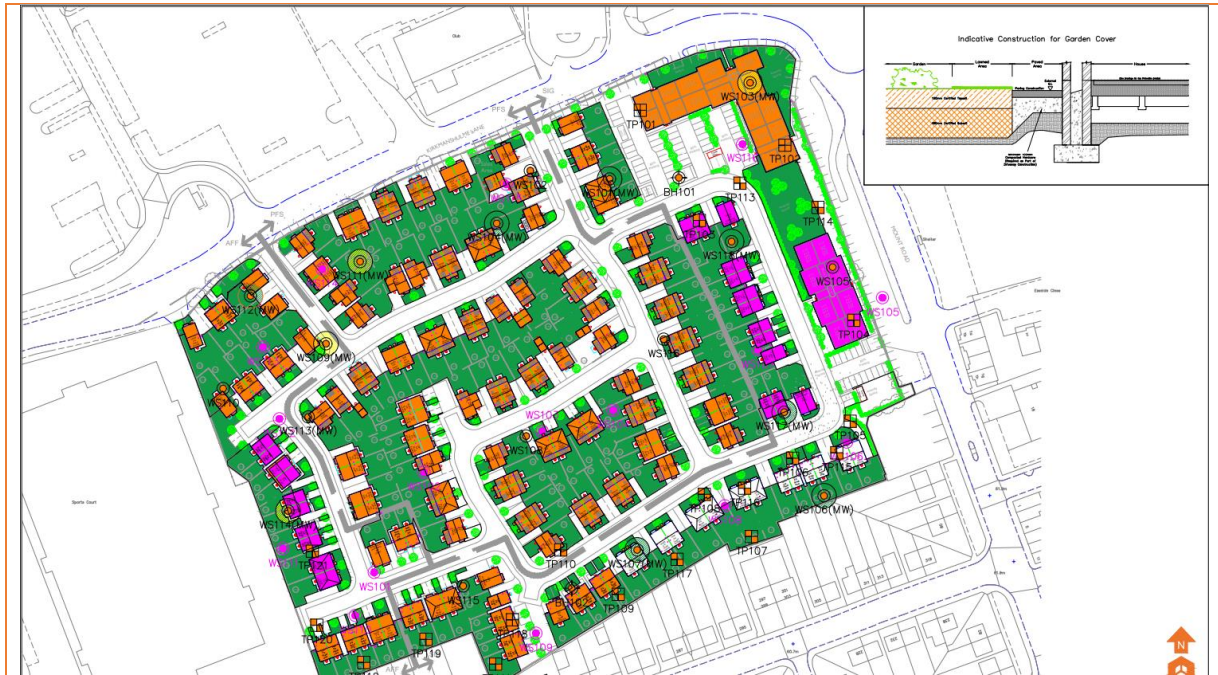
## GAS MITIGATION MEASURES PLAN

The snapshot below is based on rev C of the proposed development layout dated 6<sup>th</sup> May 2022

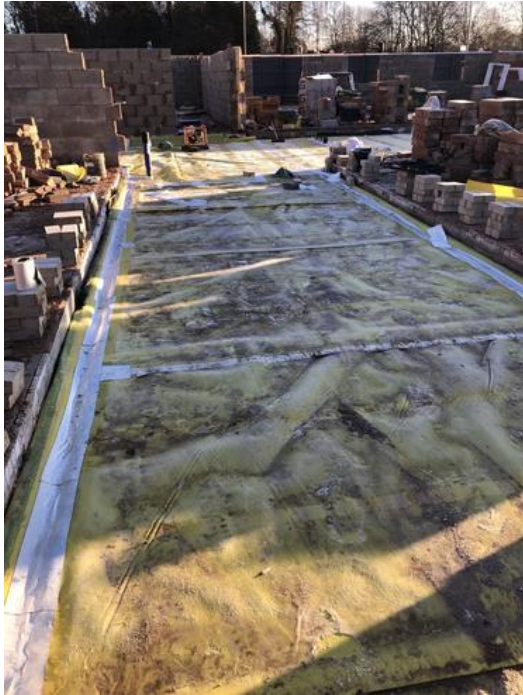
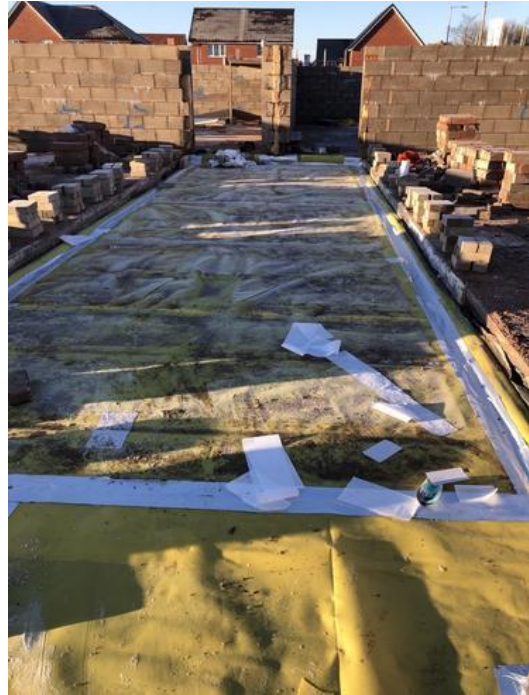
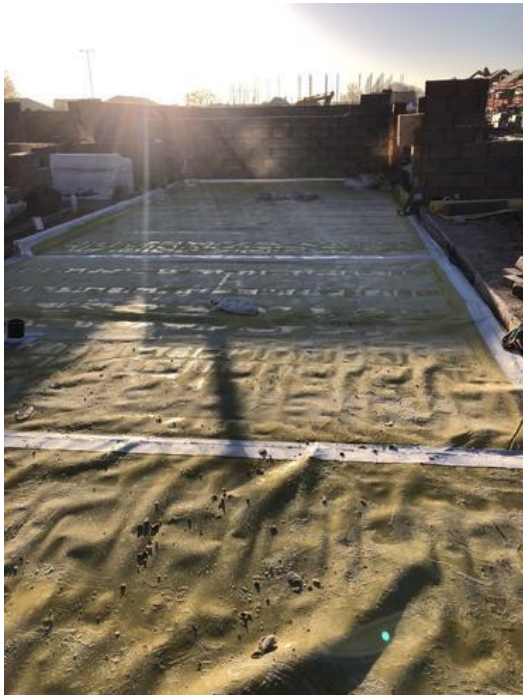
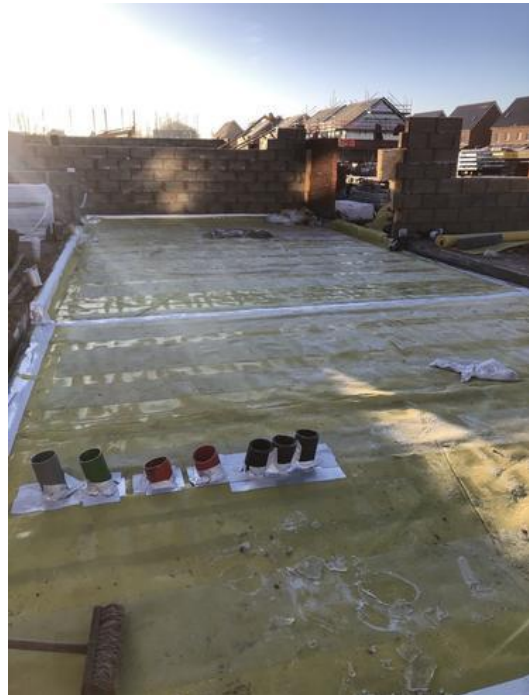
**Gas Membrane Condition: Open punctures, tears, rips, stretching, Presence of debris, Repairs, Signs of weakness such as raised or sunken indentations, Protection plan in place to restrict access to lain gas membrane? IF FAIL DESCRIPTION IN ACTIONS AND PHOTOS REQUIRED**

Pass

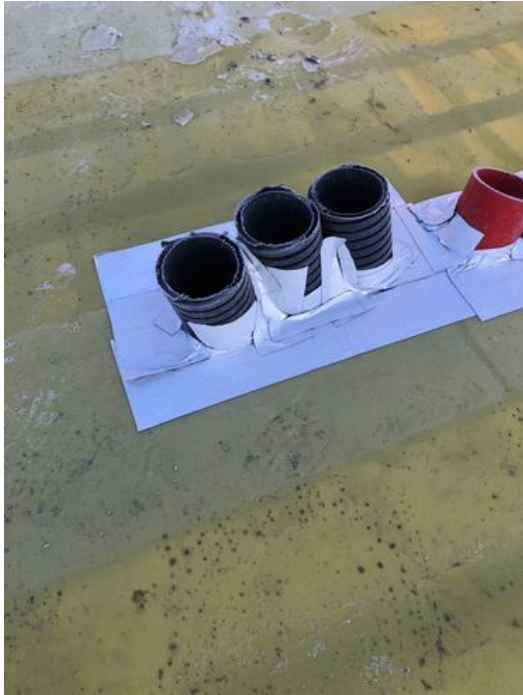
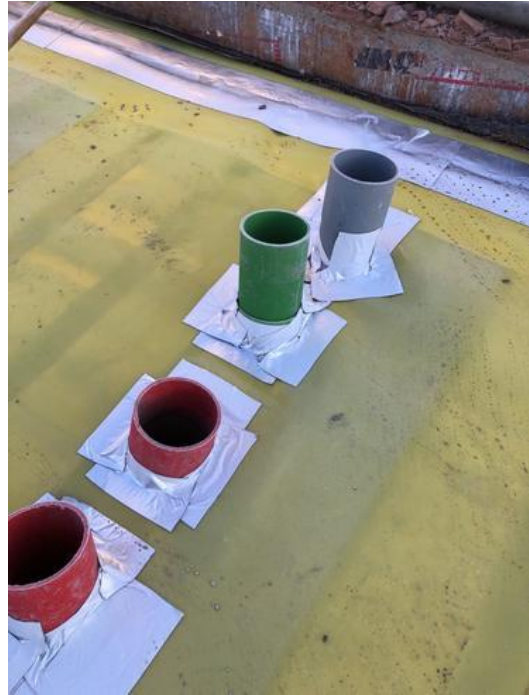
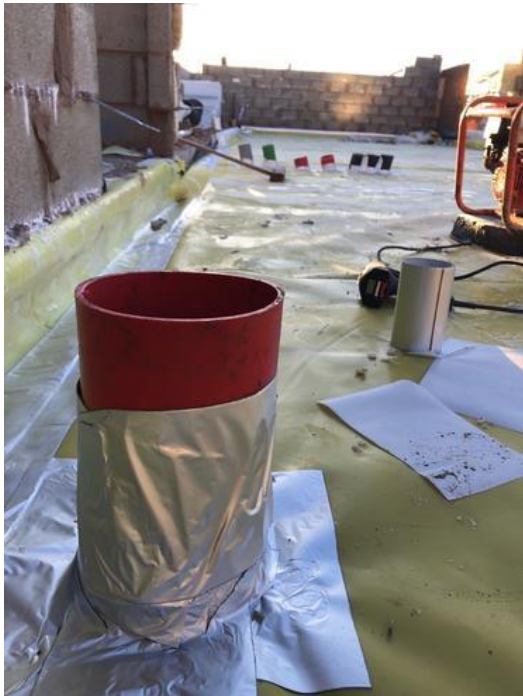
Each unit has a service duct located at the front and outer edge of the property. E3P inspected each one and can confirm that the top hats have been adequately sealed against the membrane.

**Service entries seals: Top hats seal arrangements fixed around service entries? Use of Jubilee clips?**

Yes

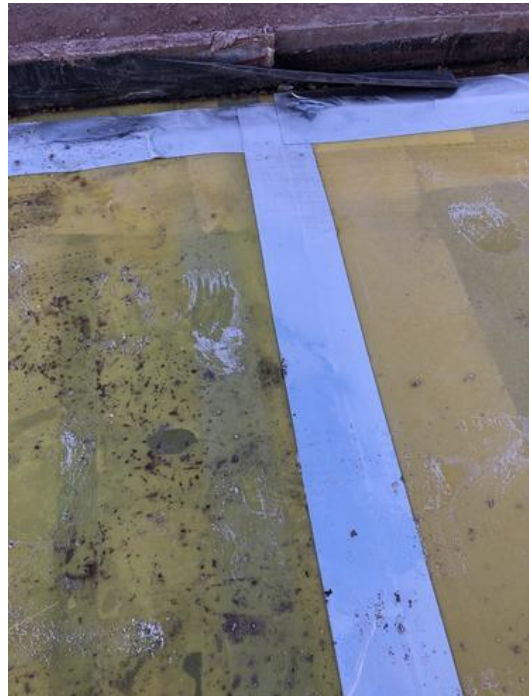
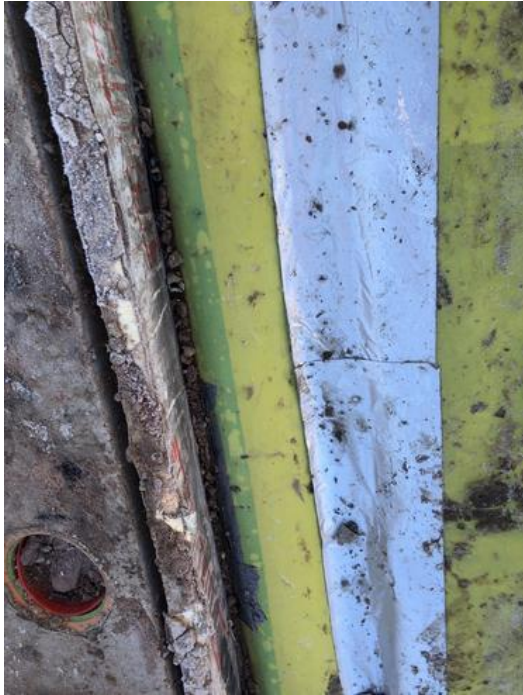
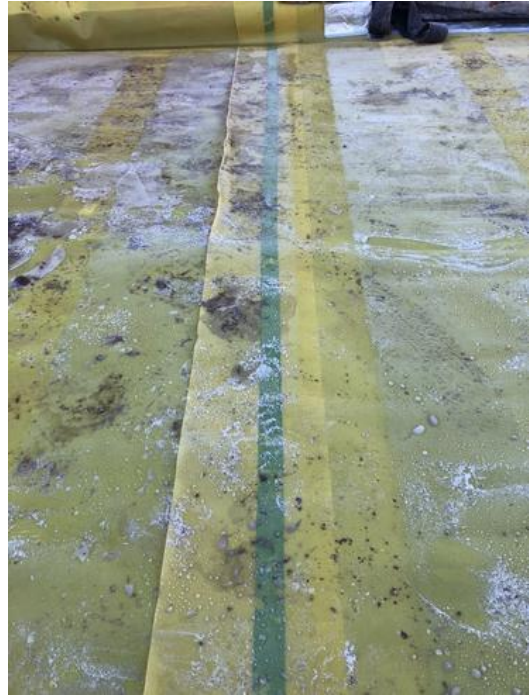
E3P inspected all external joints, and E3P can confirm that the membrane was overlapped and double-taped. The membrane was taped using double-sided jointing tape. All the overlaps were then additionally taped using foil-backed girth tape.

**Type of joints/ Lapping** Welded

Both

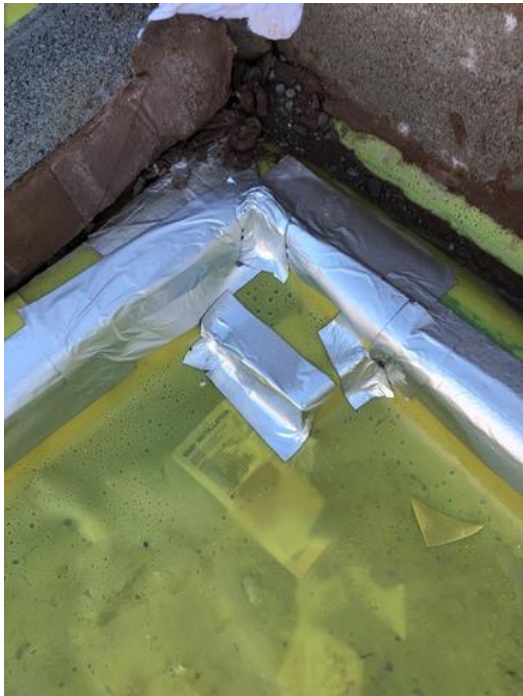
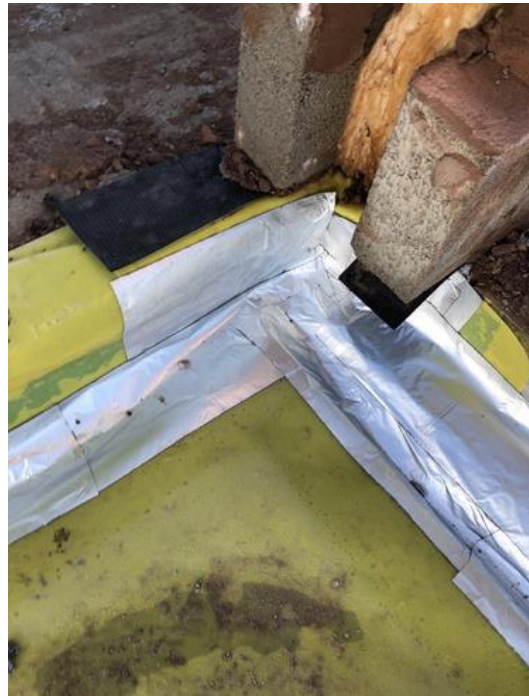
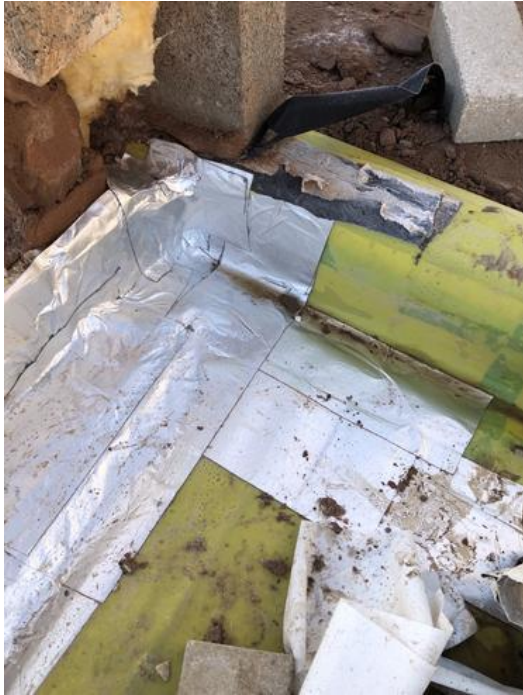
**Corners / Internal joints: Check all corners are correctly formed or contractor has used performed corners.**

Pass

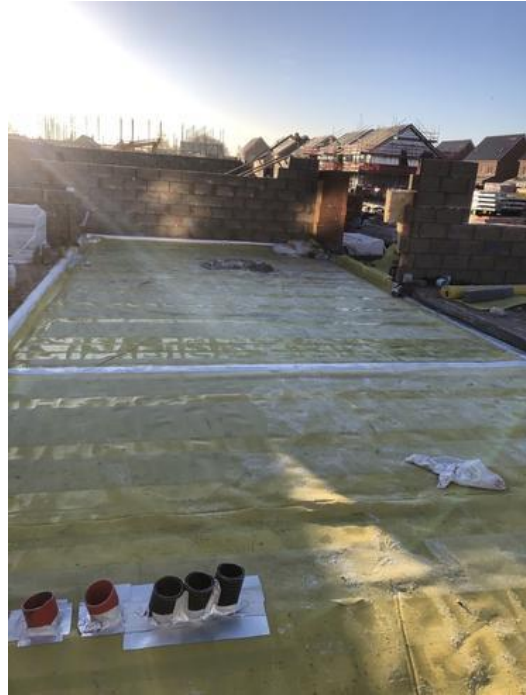
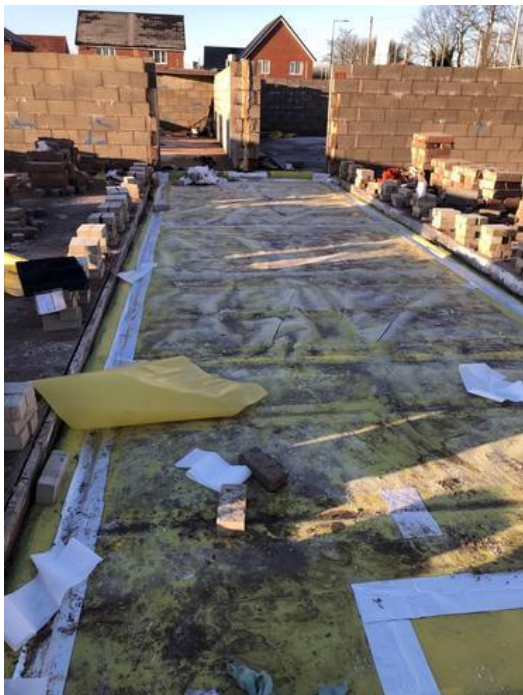
**Extent of Coverage: Is the membrane covering the entire plot? Does membrane span over outside walls?**

Yes
