# **The Christie Advanced Scanning and Imagine Centre Development (CASICD)**

Ground Investigation Report

February 2025

**Document reference:** CASICD-MMD-XX-XX-RP-C-00002

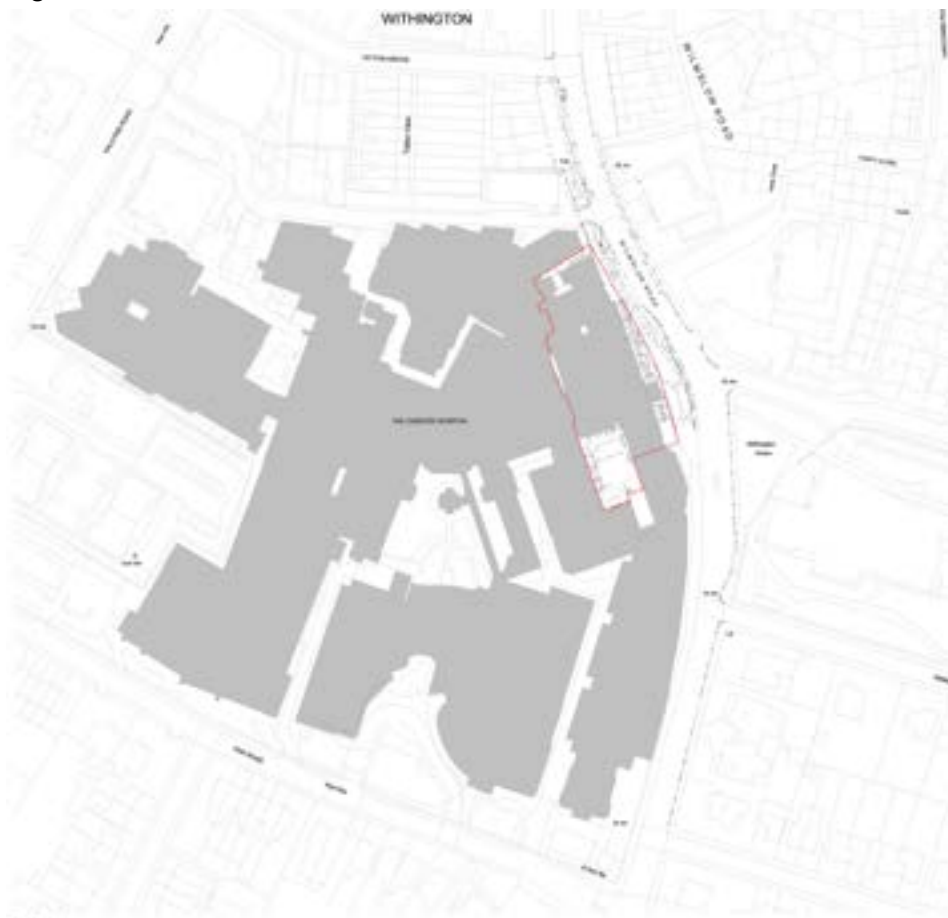
**Figure 1.1: Site Location Plan**

The Christie Hospital campus is in Withington, Greater Manchester and is bordered by Wilmslow Road (including a cycle lane) to the East. The development site consists of existing Blocks 19 and 20 which are to be demolished along with the partial demolition of Block 21 and are to be replaced with a new CT department. The site is surrounded on three sides by existing hospital buildings. An access road is present adjacent to the northern boundary of the site, connecting Wilmslow Road with Palatine Road, to the west of the site. The site plan is shown below in Figure 1.1 and Figure 1.2.

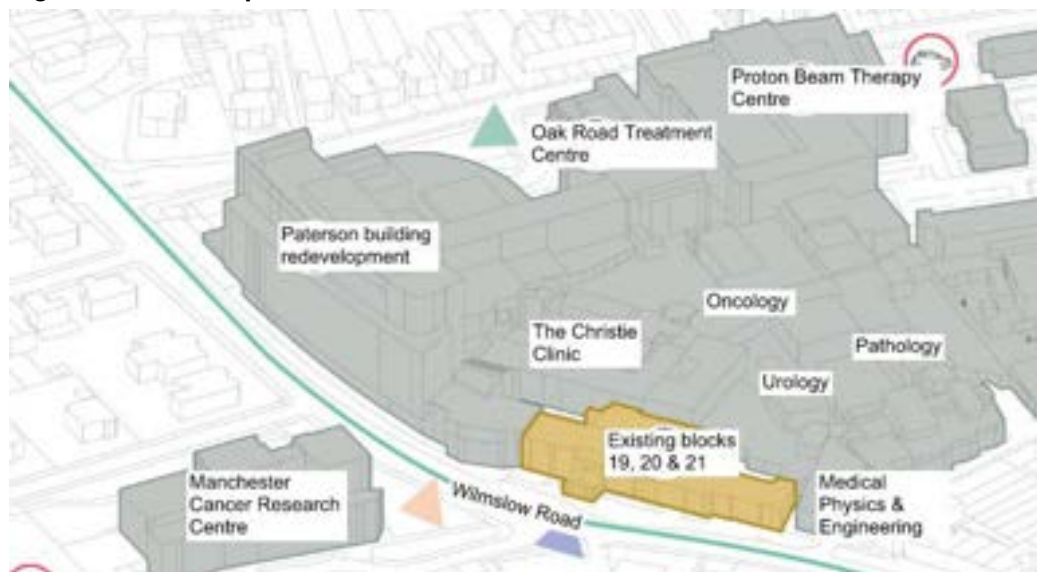
**Figure 1.2: Site Map**

Source: Adapted from Day Architectural Ltd Briefing Presentation. The site footprint is highlighted in yellow.

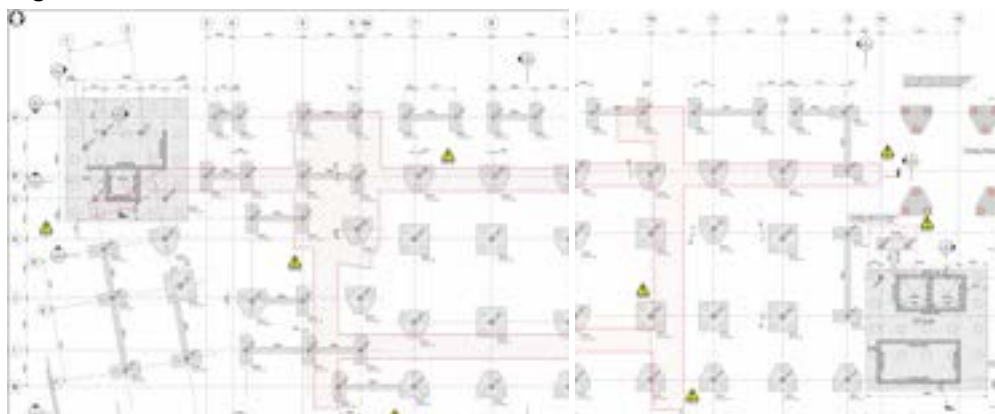
**Figure 1.3: Basement extents to be demolished**

Lateral stability is to be provided through reinforced concrete cores at the north and south ends of the building. There is an existing basement that is used as a conduit for services to feed the wider site. The basement will be demolished, and services rerouted as part of the proposed development (see demolition extents below in Figure 1.3).

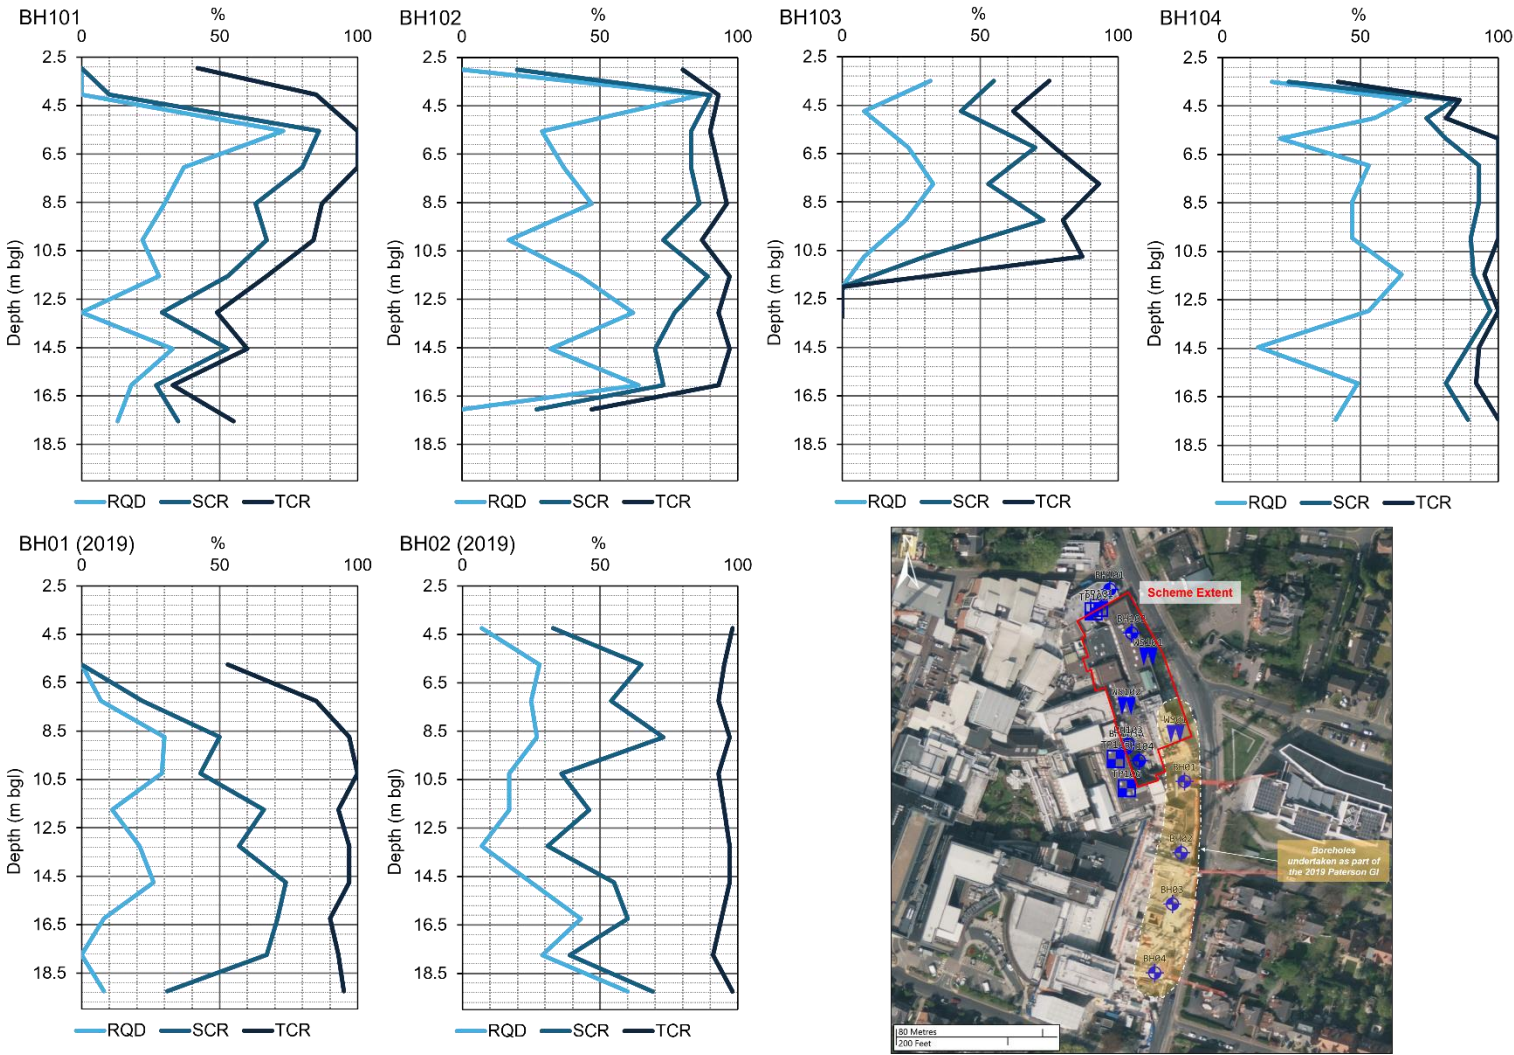
Figure C.5: Core Recovery Parameters with Depth

Core recovery parameters, recorded as part of the 2024 ground investigation works and presented in Figure C.5, showed no evidence of a fault zone beneath the site. A notable drop in core recovery parameters would be anticipated should faulted bedrock be present. No such relationship was observed in the plots presented in Figure C.5.
