**Land at Agnes Court, Fallowfield**  
**Preliminary Bat Roost Assessment Report**  
**Feltham Group**

**29 October 2025**

| <b>Report Title:</b> | Land at Agnes Court, Fallowfield Preliminary Bat Roost Assessment Report |

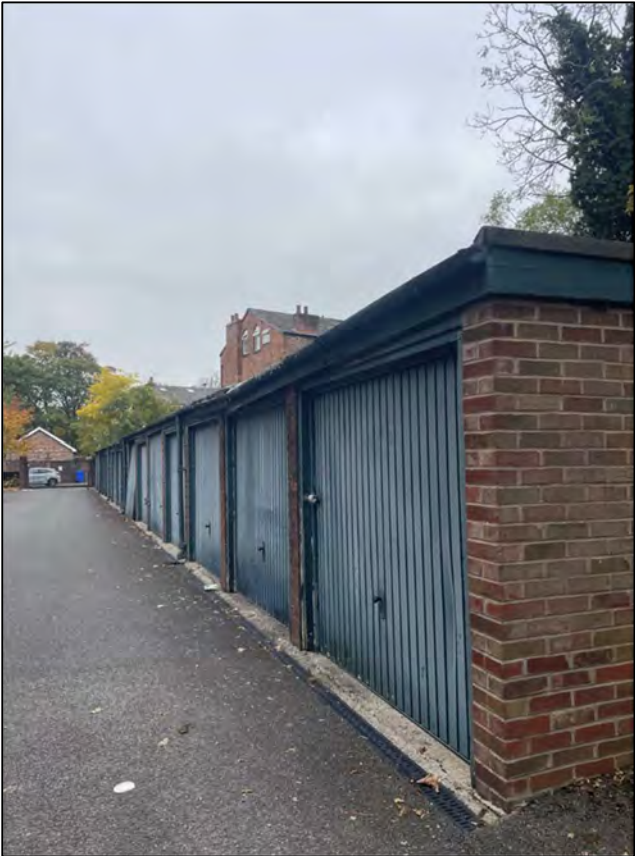
- 4.2.1 Photographs of this building can be seen in Appendix 1: Photographs.
- 4.2.2 Externally this building consisted of brick walls with 16 corrugated metal garage doors running along the eastern side. There is a line of plastic guttering bordered by a fascia above the garage doors, and felt material covers the external areas of roof of the structure. A stand of ivy is present on the rear of the building, around 3 metres wide and in most parts growing from floor to ceiling. This ivy stand was somewhat exposed, but small potential crevices remained.

| <i>The following photographs were all taken by Frankie Tyrrell on the 10th October 2025</i> | | Reference |
|---|--|---|
| | | Building B1 from the north. |

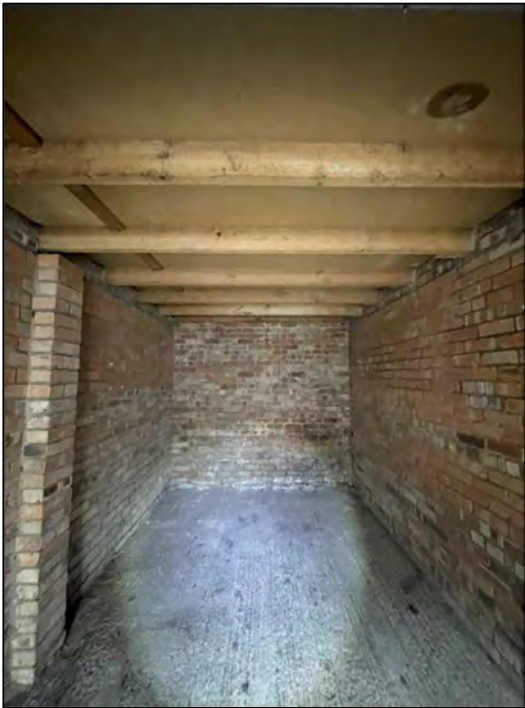
- 4.2.4 The interior of the building comprised 16 individual garages. The roofing of the structure was flat, resulting in a box-like shape of the garages. These interiors were dark and largely uncluttered. The ceiling consisted of flat wooden beams with wooden ply boards laying horizontally above the beams, with a layer of OSB boards topped with wood wool boards placed above for insulation. There is no structural roof void in the building, however, in around half of the garages the ceilings have become

| <i>The following photographs were all taken by Frankie Tyrrell on the 10th October 2025</i> | | Reference |
|---|--|---|
| | | Interior of building B1—garage in good condition. |

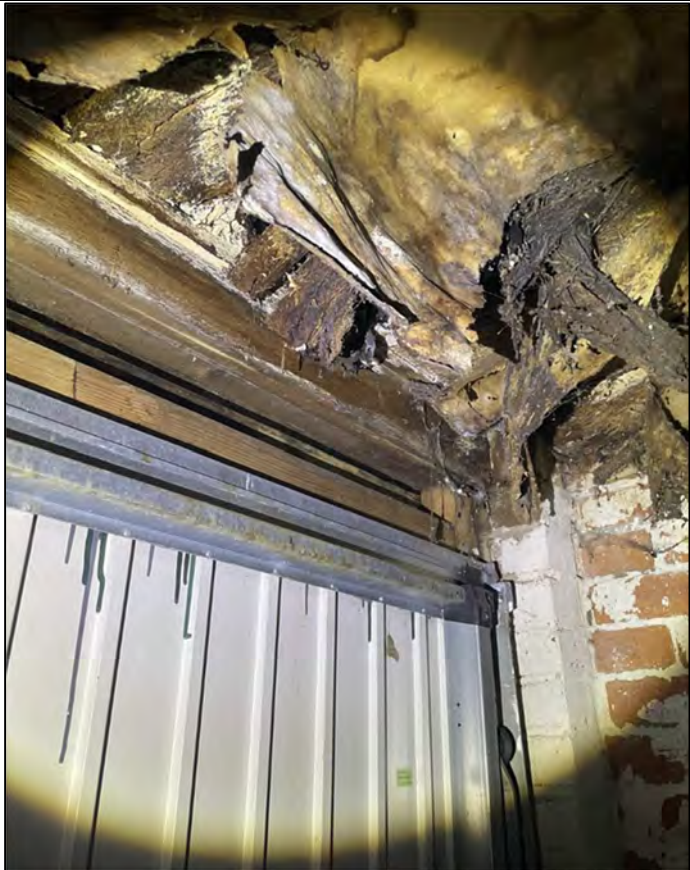
damp and formed ruptures. These ruptures created a small number of crevices albeit with likely normally damp conditions.

| | | <p>Example of ruptures in roofing material.</p> |

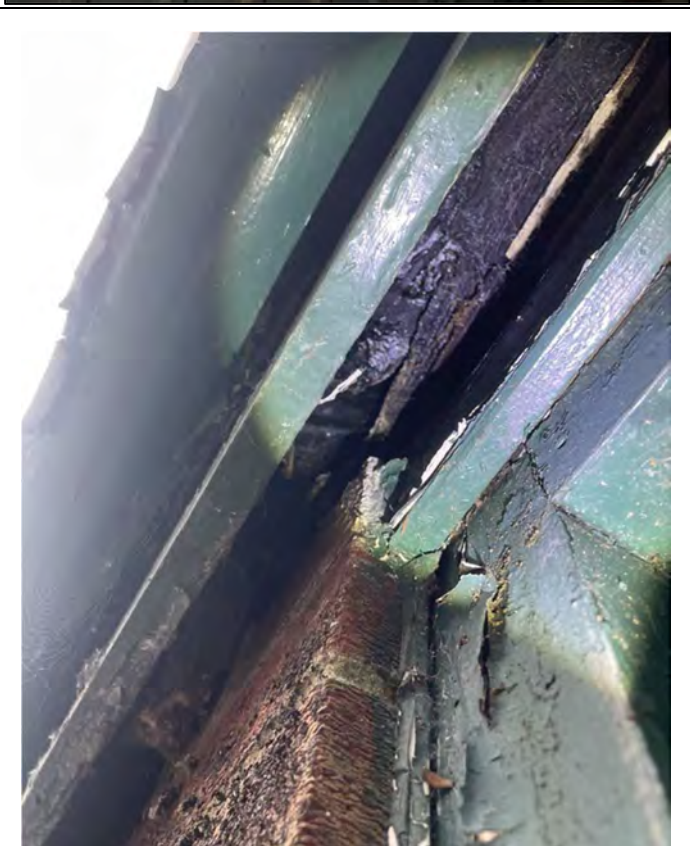
- 4.2.3 There were occasional gaps and holes in the fascia between the top of the garage doors and the roof. These were large enough for bats to traverse through, providing access to the interior spaces, and in some cases small crevices.

| | | <p>Example of potential crevices in gaps between the fascia and garage door.</p> |

- 6.1.2 Due to the small risk to roosting bats in the stand of ivy and fascia boards, a pre-works check or supervised removal by a suitably licensed ecologist is recommended. In the unlikely event any bats or signs of bats are discovered when the ecologist is not present, works are to cease until a licenced ecologist has assessed the situation and advised on how to progress in compliance with wildlife legislation.

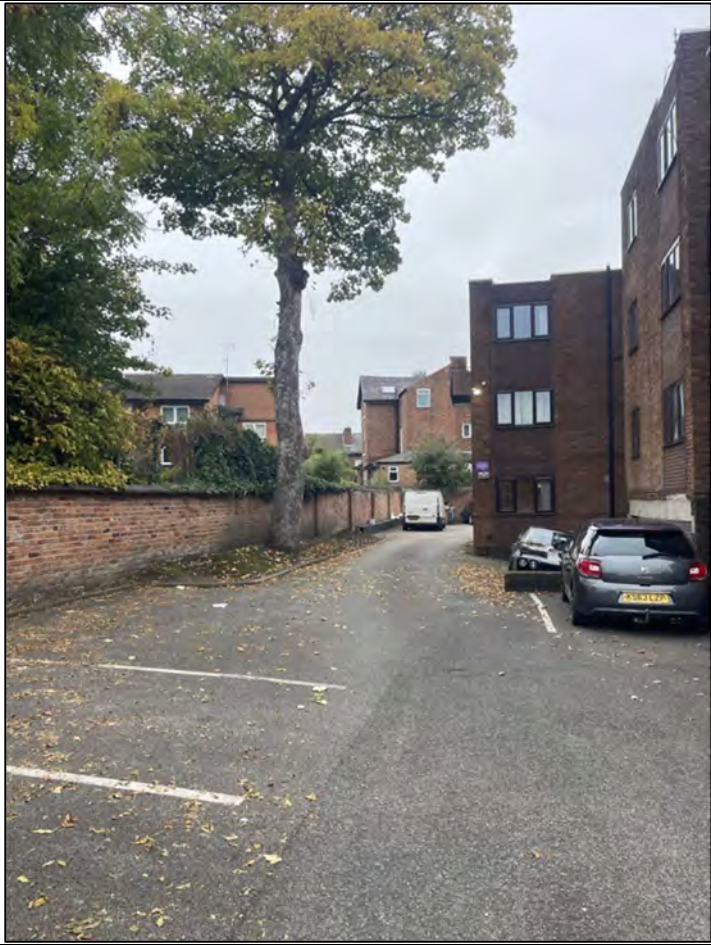
| | | <p>View north of B1, showing urban surroundings.</p> |

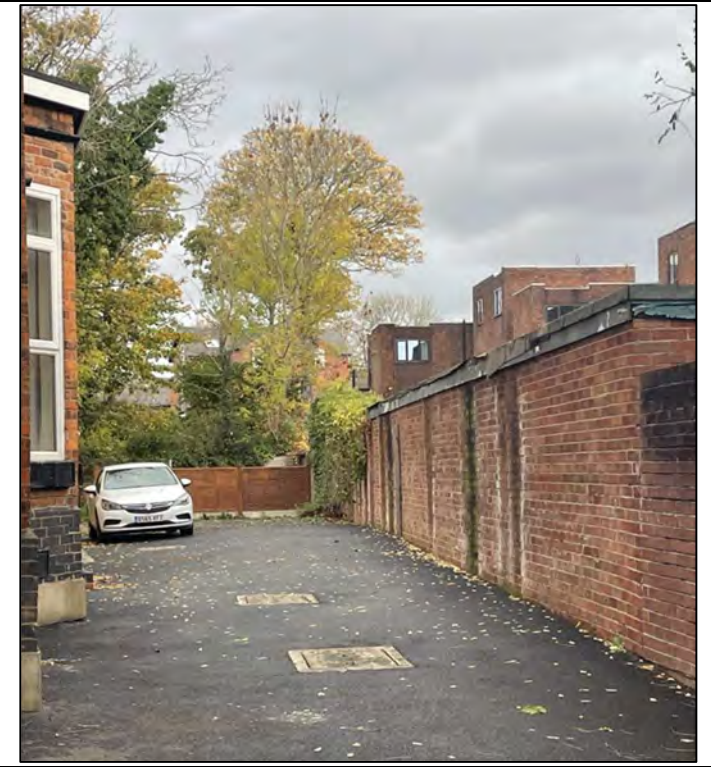
- 4.1.3 The site consisted of a row of garages behind several residential apartment complex buildings, with gravel paths throughout and an area of mown lawn at the front. There is a substantial growth of ivy covering approximately three metres in width along the rear wall of the garages. It appears from aerial imagery this stretches onto the roof, covering a small area. Mushrooms are growing at the base of the ivy stand, indicating damp conditions. Other vegetation on site was limited to the area of grassland and occasional buddleia shrubs and ruderal species growing from cracks.
- 4.1.4 The garages themselves did not appear to be illuminated at night, but it is assumed that surrounding apartments to the east and west would result in partial illumination from light spill. To the south of the garages lies Victoria Road, a small residential road with moderate use, lit by streetlights.

| | | <p>Rear view of the building. The section of ivy is located to the north-east end of the building.</p> |

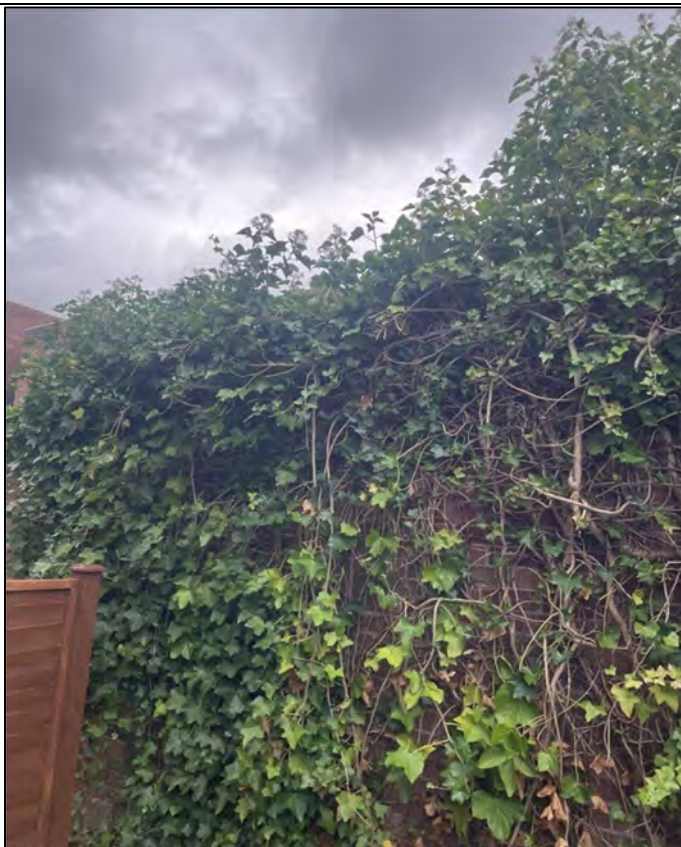
The most dense section of the ivy.
