# Geo-Environmental Investigation & Assessment

Alpha House, Wythenshawe

Wythenshawe Community Housing Group

| <b>Report Reference:</b> | <b>11380G-WML-XX-ZZ RP-G-0002A</b> | |

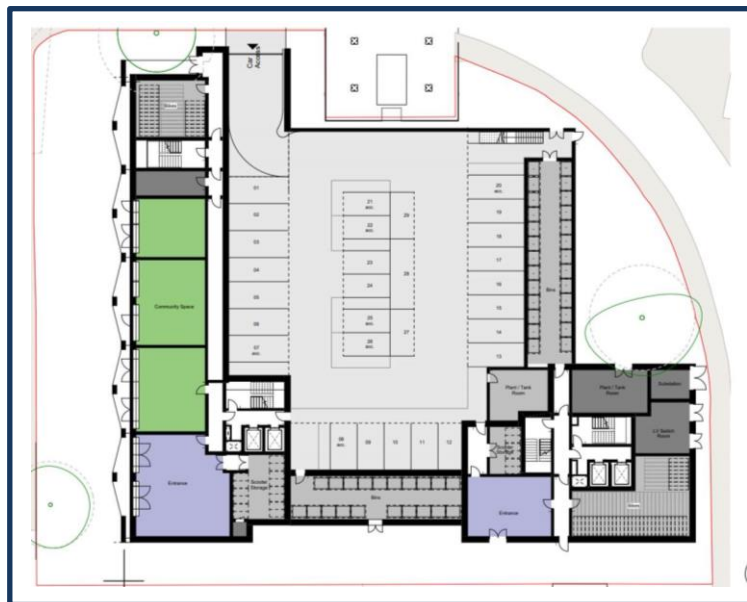
- 1.2 Although the design has not been finalised it is indicated that site development would comprise the demolition of the existing (office) structure and construction of a new ten-storey residential apartment block with potentially one-hundred, one and two-bedroom units.
- 1.3 External areas will likely comprise hardstanding for access and potential parking together with localised areas of soft landscaping.
- 1.4 A copy of the preliminary lower ground/ground floor is provided below for preliminary information only.

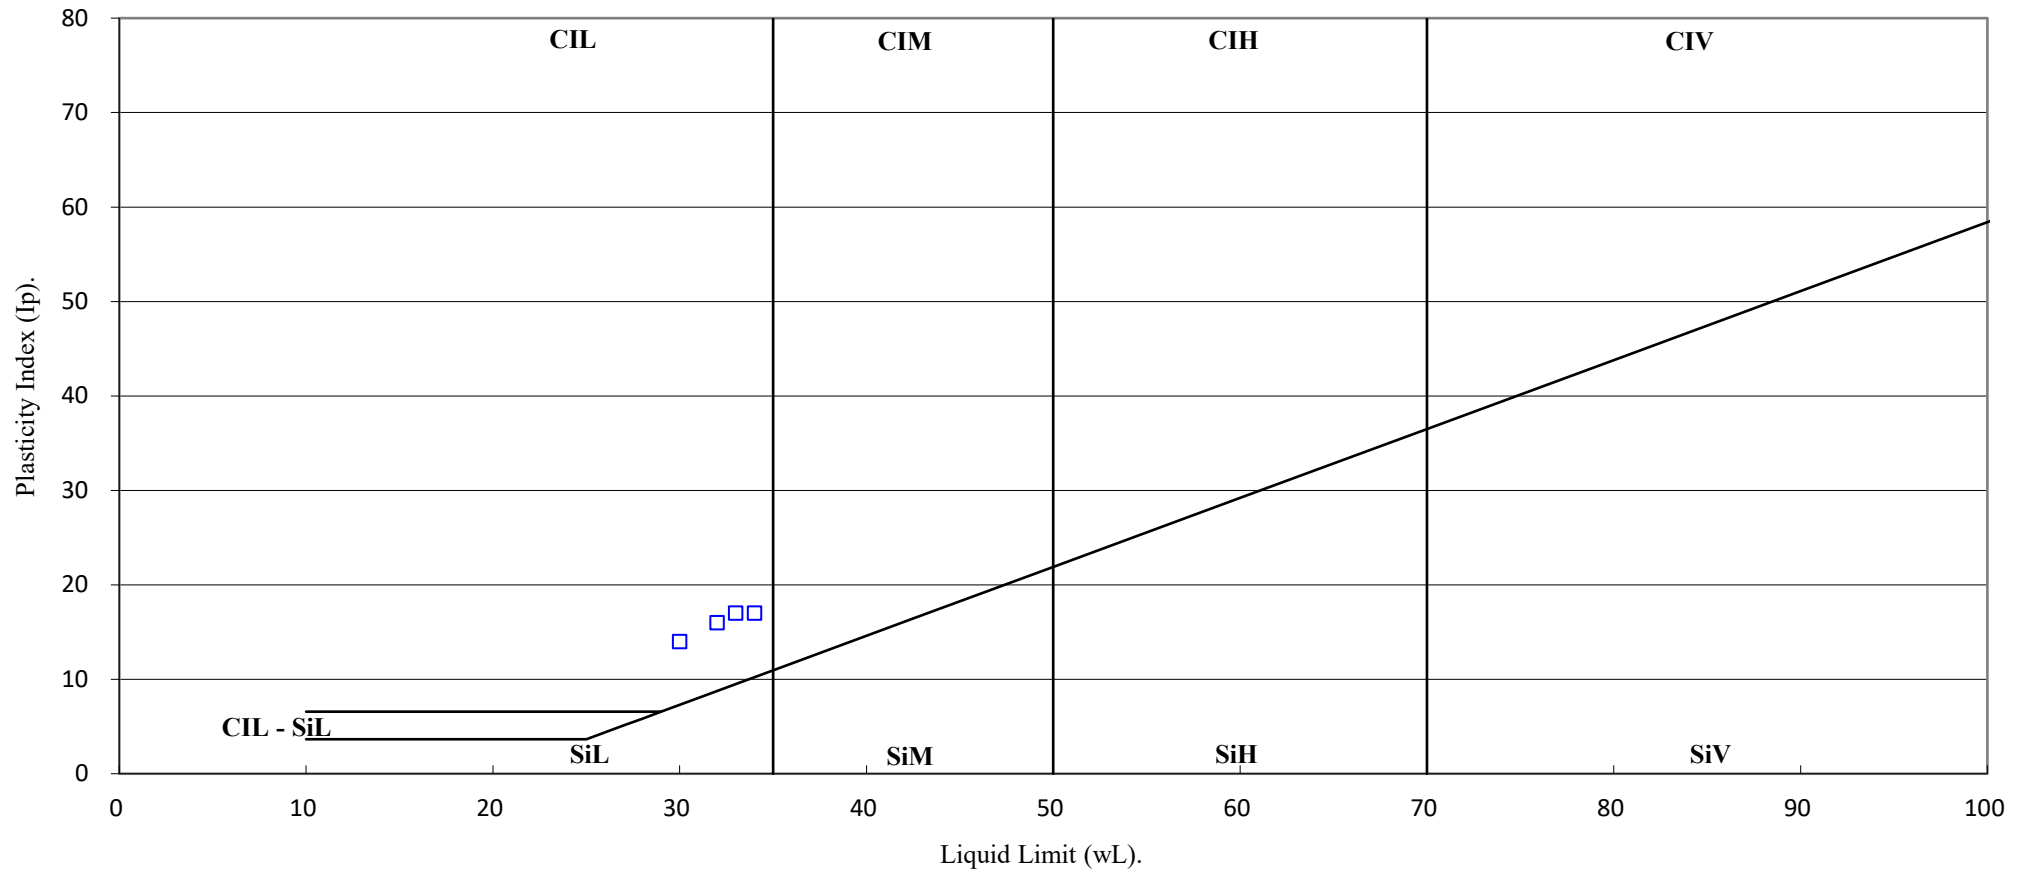
# PLASTICITY CHART

BS EN ISO 14688-2:2017 Clause 4.4

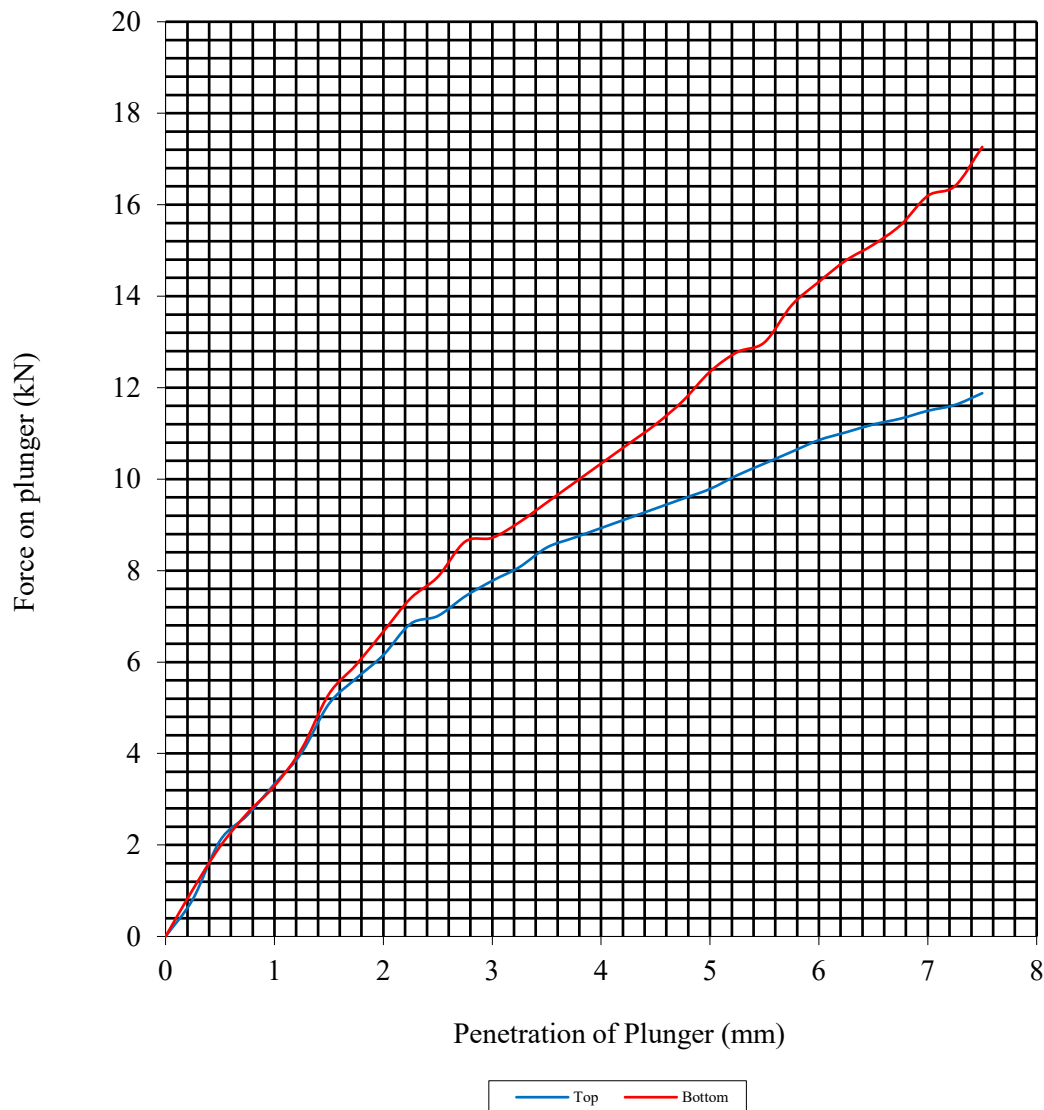
| Initial Sample Conditions | | Sample Preparation | | Final Water Content % | | C.B.R. Value % | |
| Water Content: | 11.8 | Surcharge Kg: | 4.20 | Sample Top | 11.7 | Sample Top | 53.1 |

- 6.21 Laboratory CBR testing has indicated a CBR value of between 6.0 and 53.1% However, it is recommended that new road pavement design should be based on a California Bearing Ratio (CBR) value of no more than 5% in untreated made ground and unsaturated natural granular strata.
- 6.22 The CBR will need to be reviewed and confirmed by site inspection and possibly suitable in-situ testing at formation levels following any earthwork operations and prior to pavement construction.
- 6.23 In any event, all formations should be proof-rolled with any soft, loose or otherwise unsuitable material being removed and replaced with compacted granular fill.

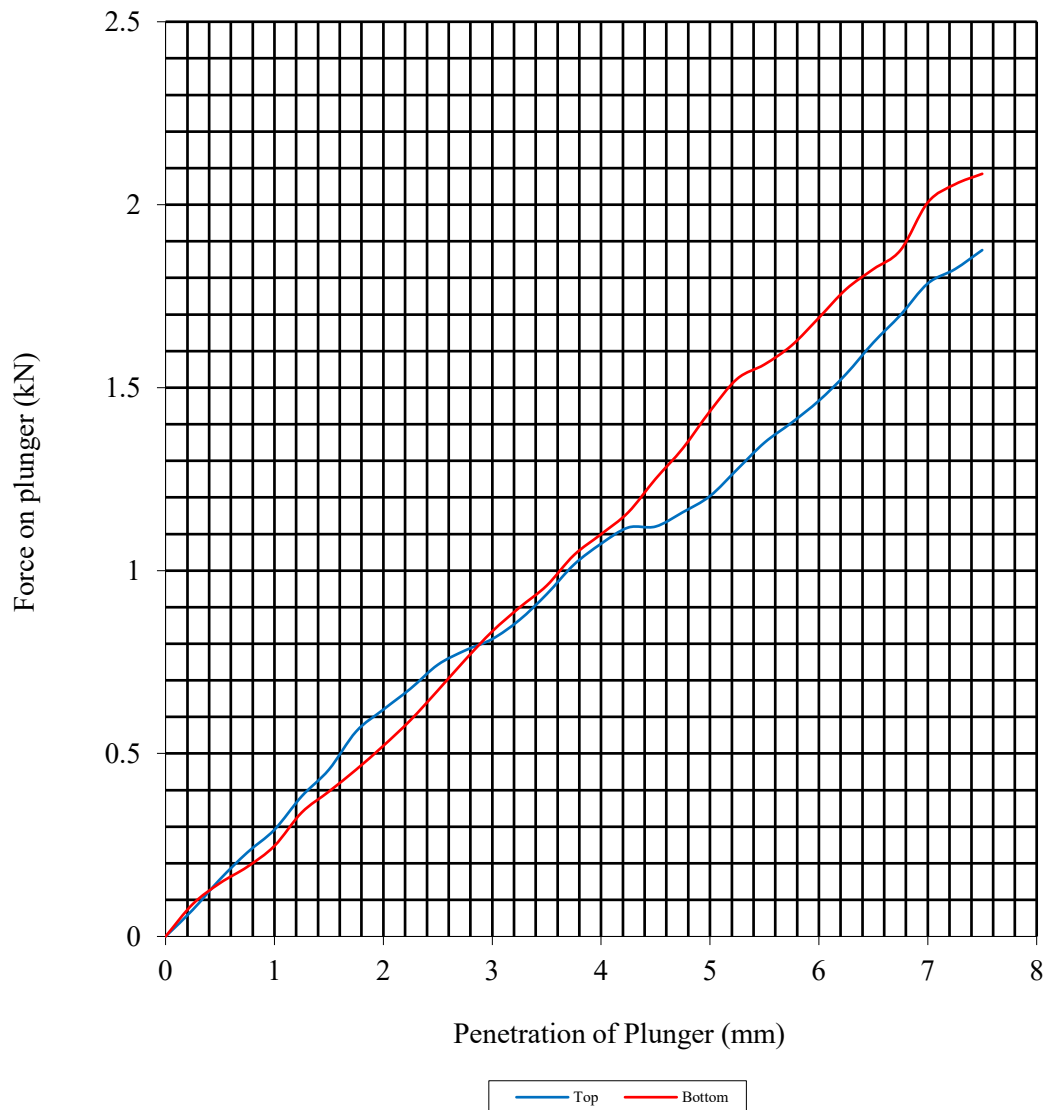
| Initial Sample Conditions | | Sample Preparation | | Final Water Content % | | C.B.R. Value % | |
| Water Content: | 17.5 | Surcharge Kg: | 4.20 | Sample Top | 17.5 | Sample Top | 6.0 |

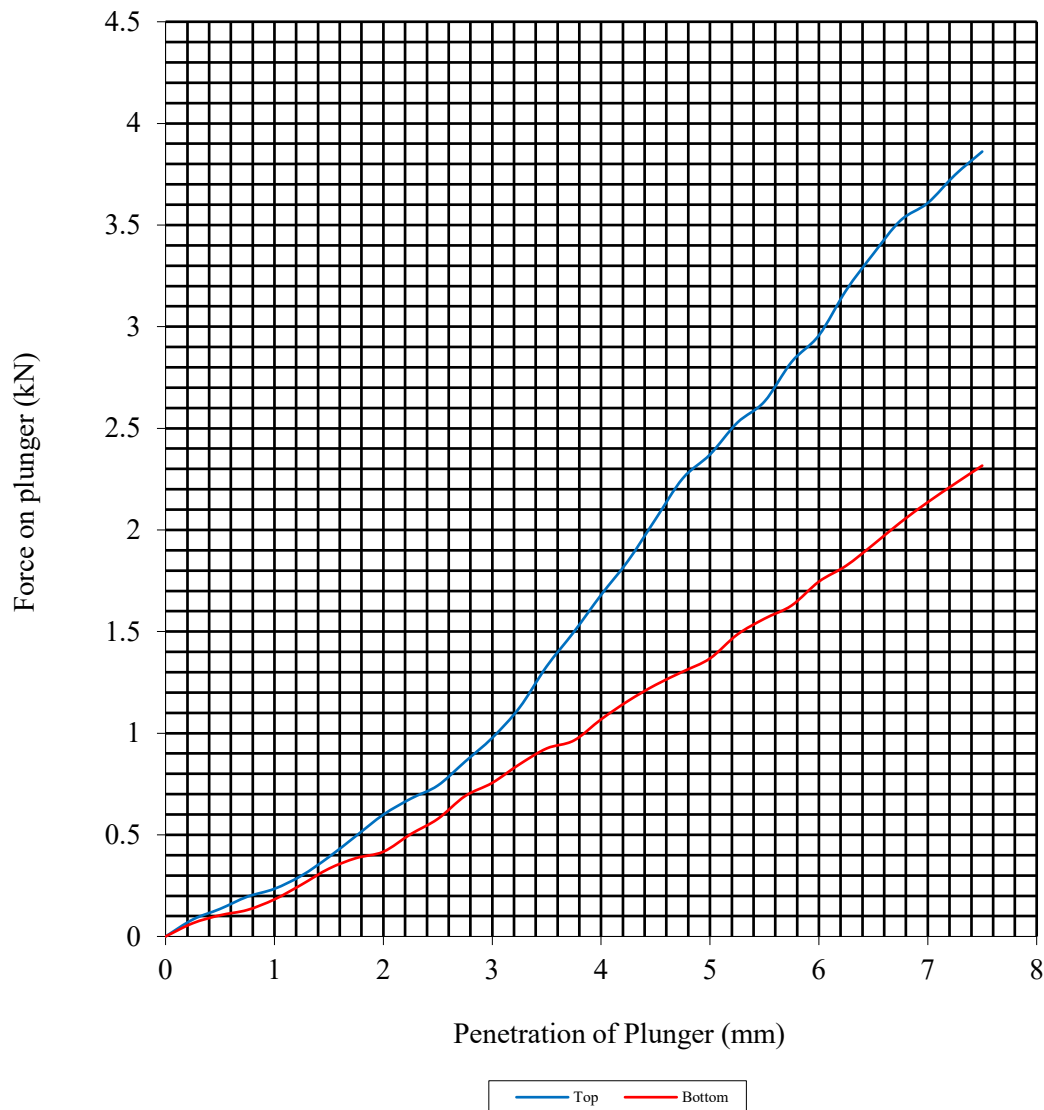
| Initial Sample Conditions | | Sample Preparation | | Final Water Content % | | C.B.R. Value % | |
| Water Content: | 11.1 | Surcharge Kg: | 4.20 | Sample Top | 11.1 | Sample Top | 11.9 |
