RoC Consulting, on behalf of Far East Consortium

# Plots NT02, NT03 and NT04, Northern Gateway, Dantzic Street

Phase 3a Detailed Remediation Strategy Report

11834 R02 (04)

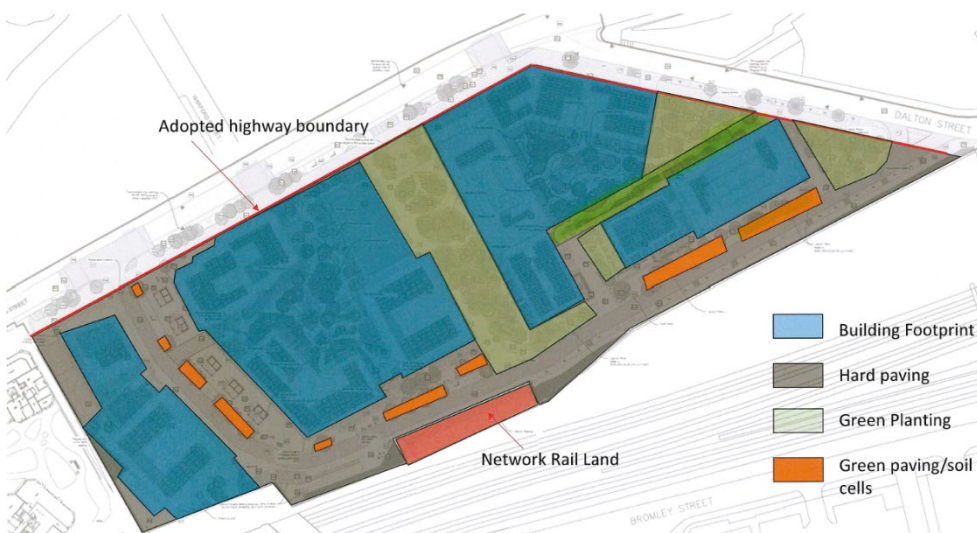
**Image 1: Proposed landscaped areas**

The development is also anticipated to include small areas of soft landscaping comprising green planting and green paving/soil cell areas in communal spaces, as shown in **Image 1** below:
