# FIRE ENGINEERING

## Fire Risk Appraisal for External Walls (FRAEW) According to PAS9980:2022

Agecroft House, Manchester

Ref: OF00178  
Client: Scanlans Property Consultants  
Version: 01  
Status: ISSUE

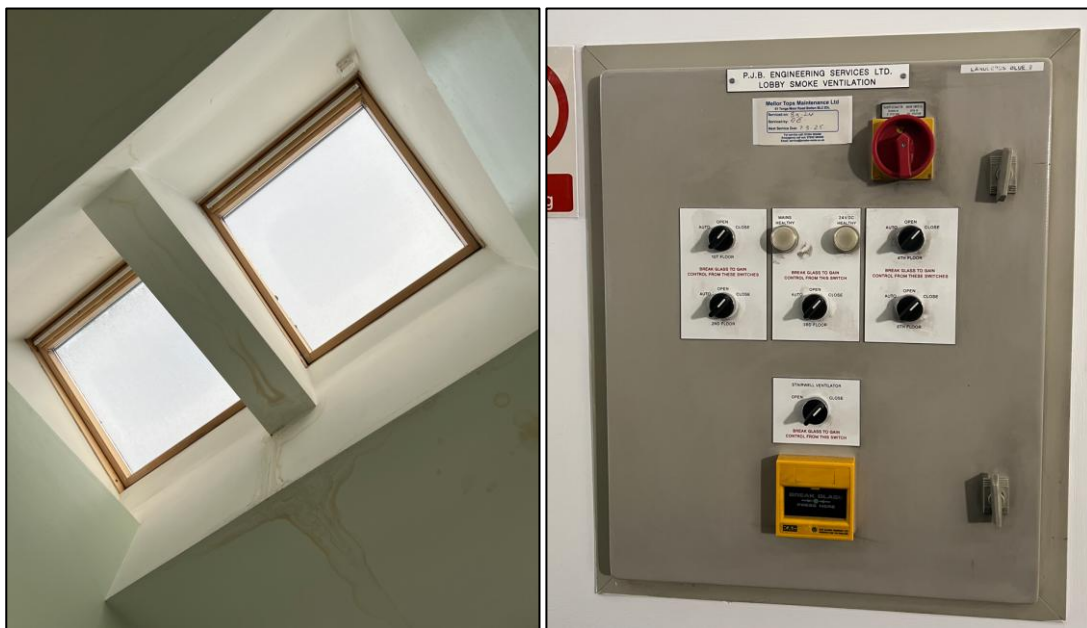
Based on our site visit, 2No. openings were noted at the head of the staircase (which are believed to be AOV's, unless confirmed otherwise); and lobby smoke ventilation panel was also noted at the ground floor, see Fig.7.

**Figure 7** – AOV's at the head of the staircase (left); and lobby smoke ventilation on the ground level (right), image taken by Octa Fire.

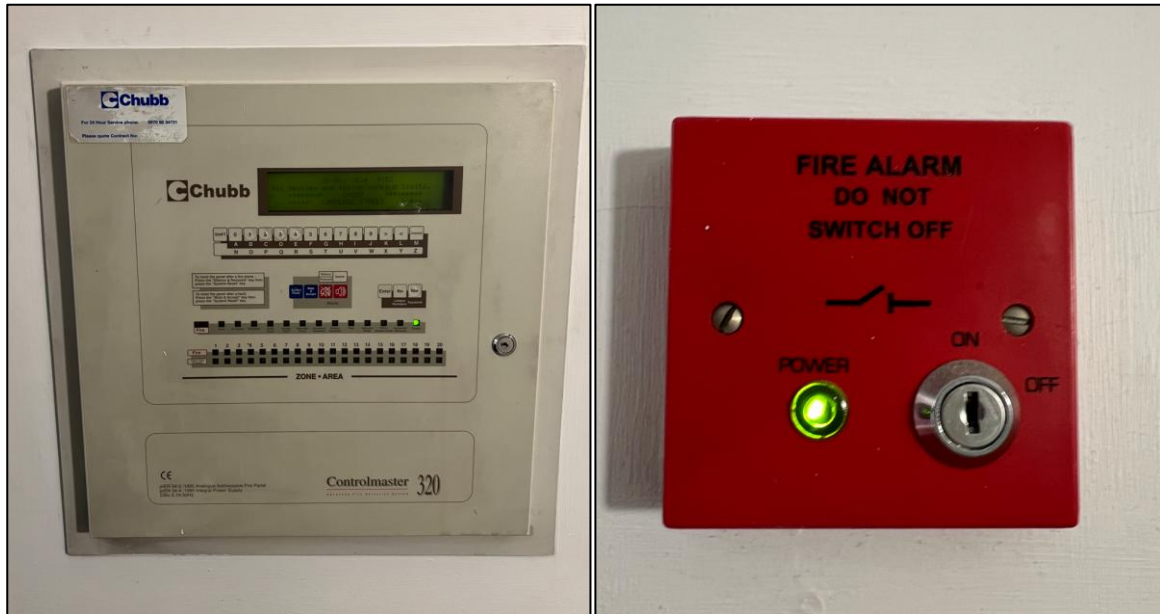
Based on our site visit, Fire alarm control panel was noticed at the ground floor and smoke detectors were noted in the common corridors and the staircase, see Fig.8 & 9.

**Figure 8** – Fire alarm, image taken by Octa Fire.

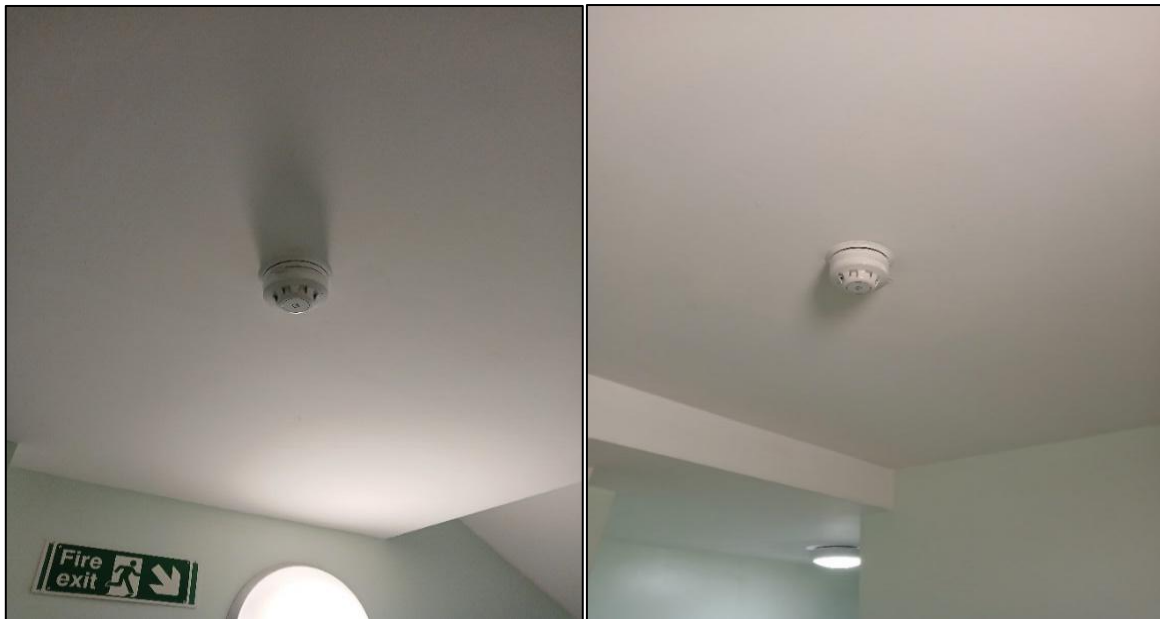
**Figure 9** – Smoke detectors installed in the communal corridors and the staircase.

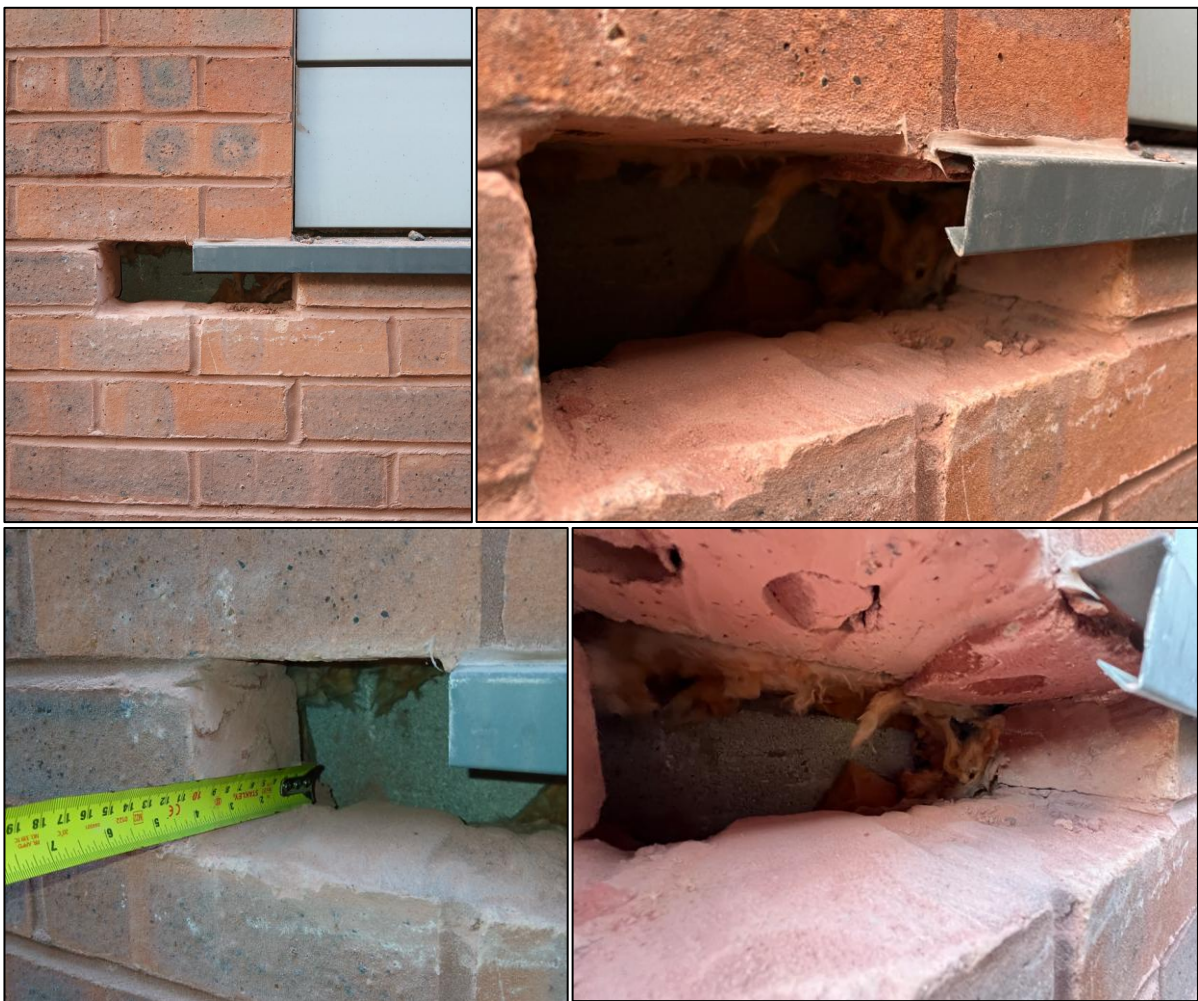
**Figure 19** – Typical inspection images for EWT1 taken by Octa Fire.

Based on the above, it can be concluded that the primary external wall materials within EWT1, with the exception of the thin EPDM membrane (which was only found at the horizontal floor slab level), are of A1 non-combustible nature, which will not add to the fire load or cause rapid fire spread across the facade.

With regards to cavity barrier provisions within EWT1, no proprietary mineral wool-based cavity barrier products were observed at any of the inspected areas (i.e., compartment lines, window openings and vent penetration).

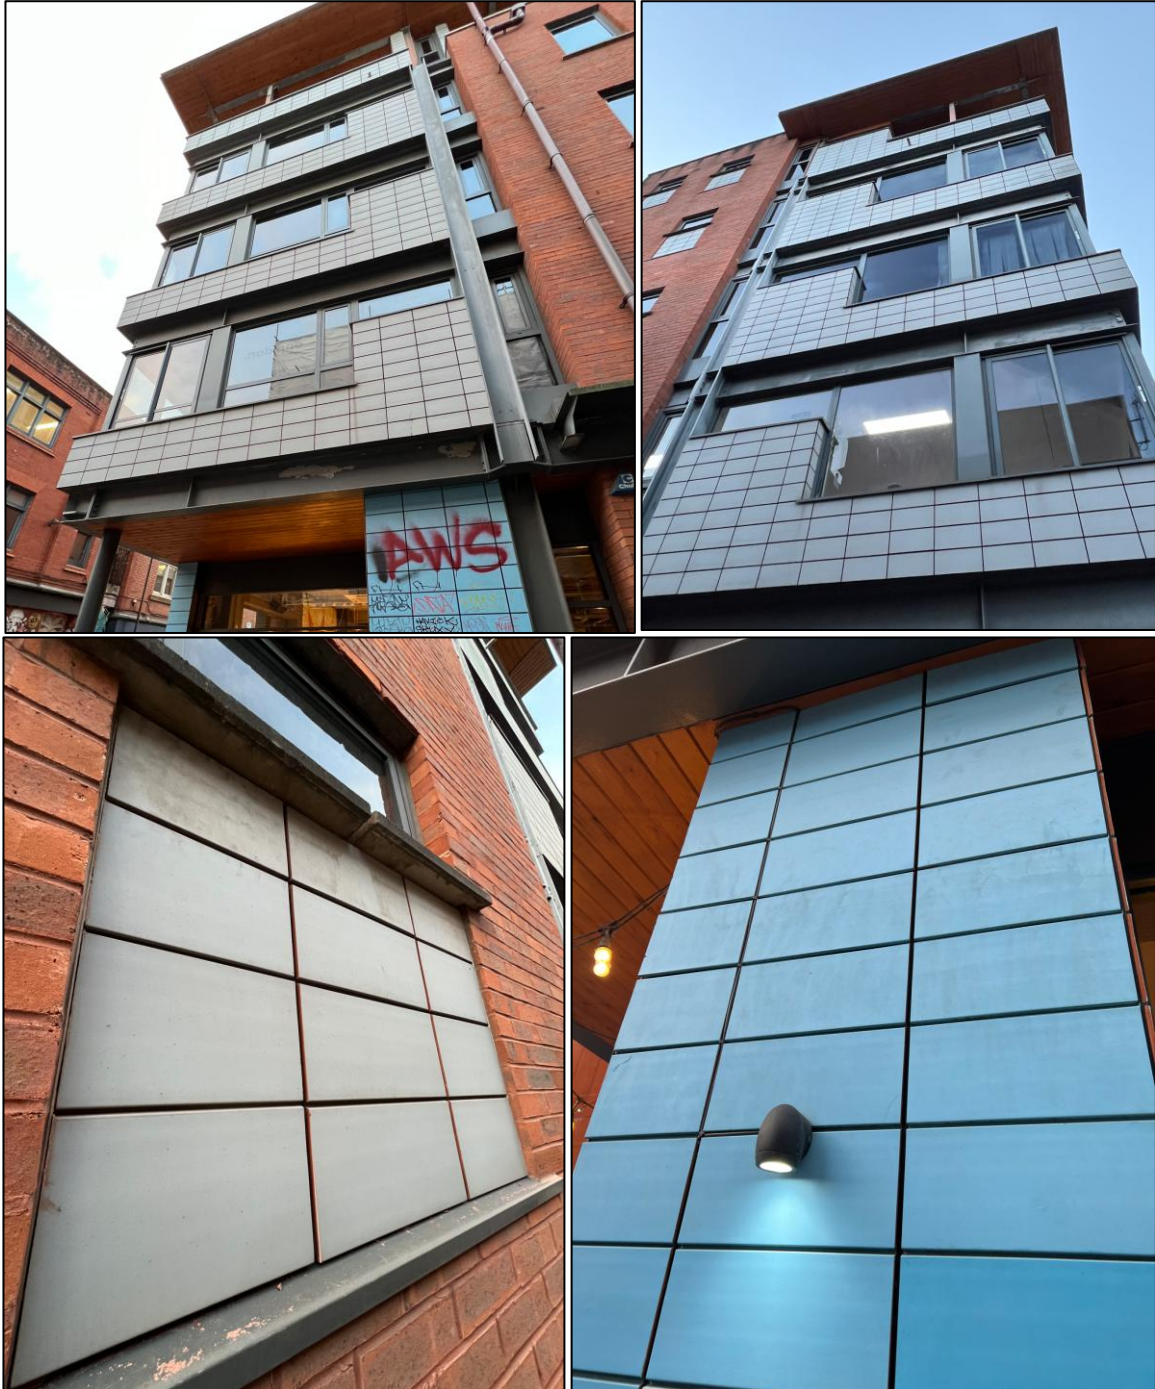
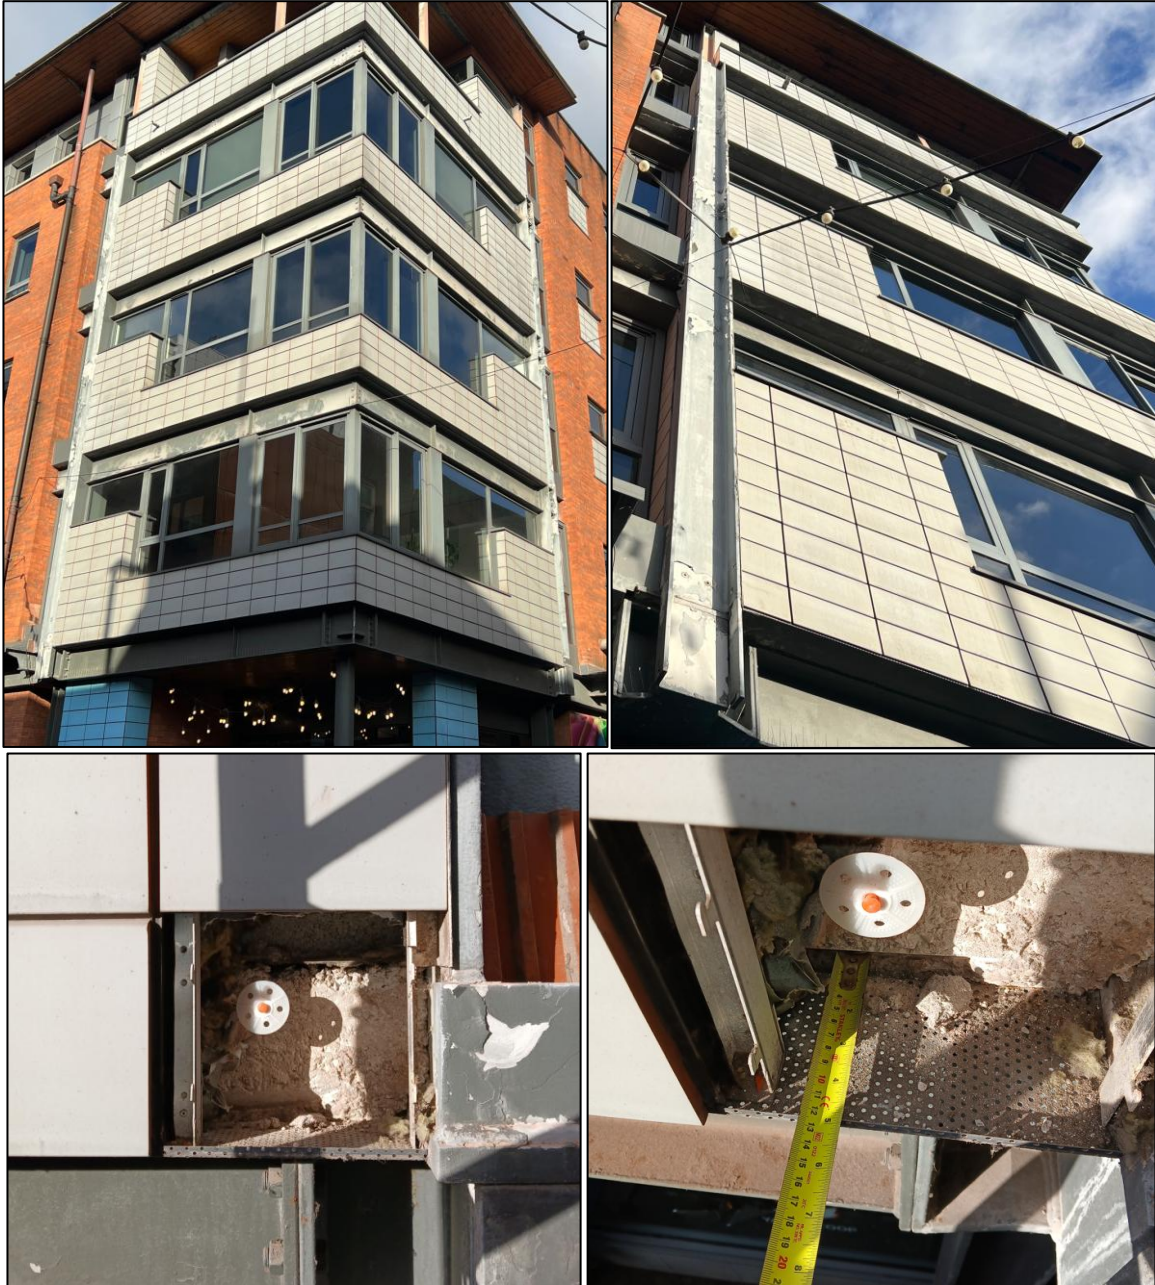
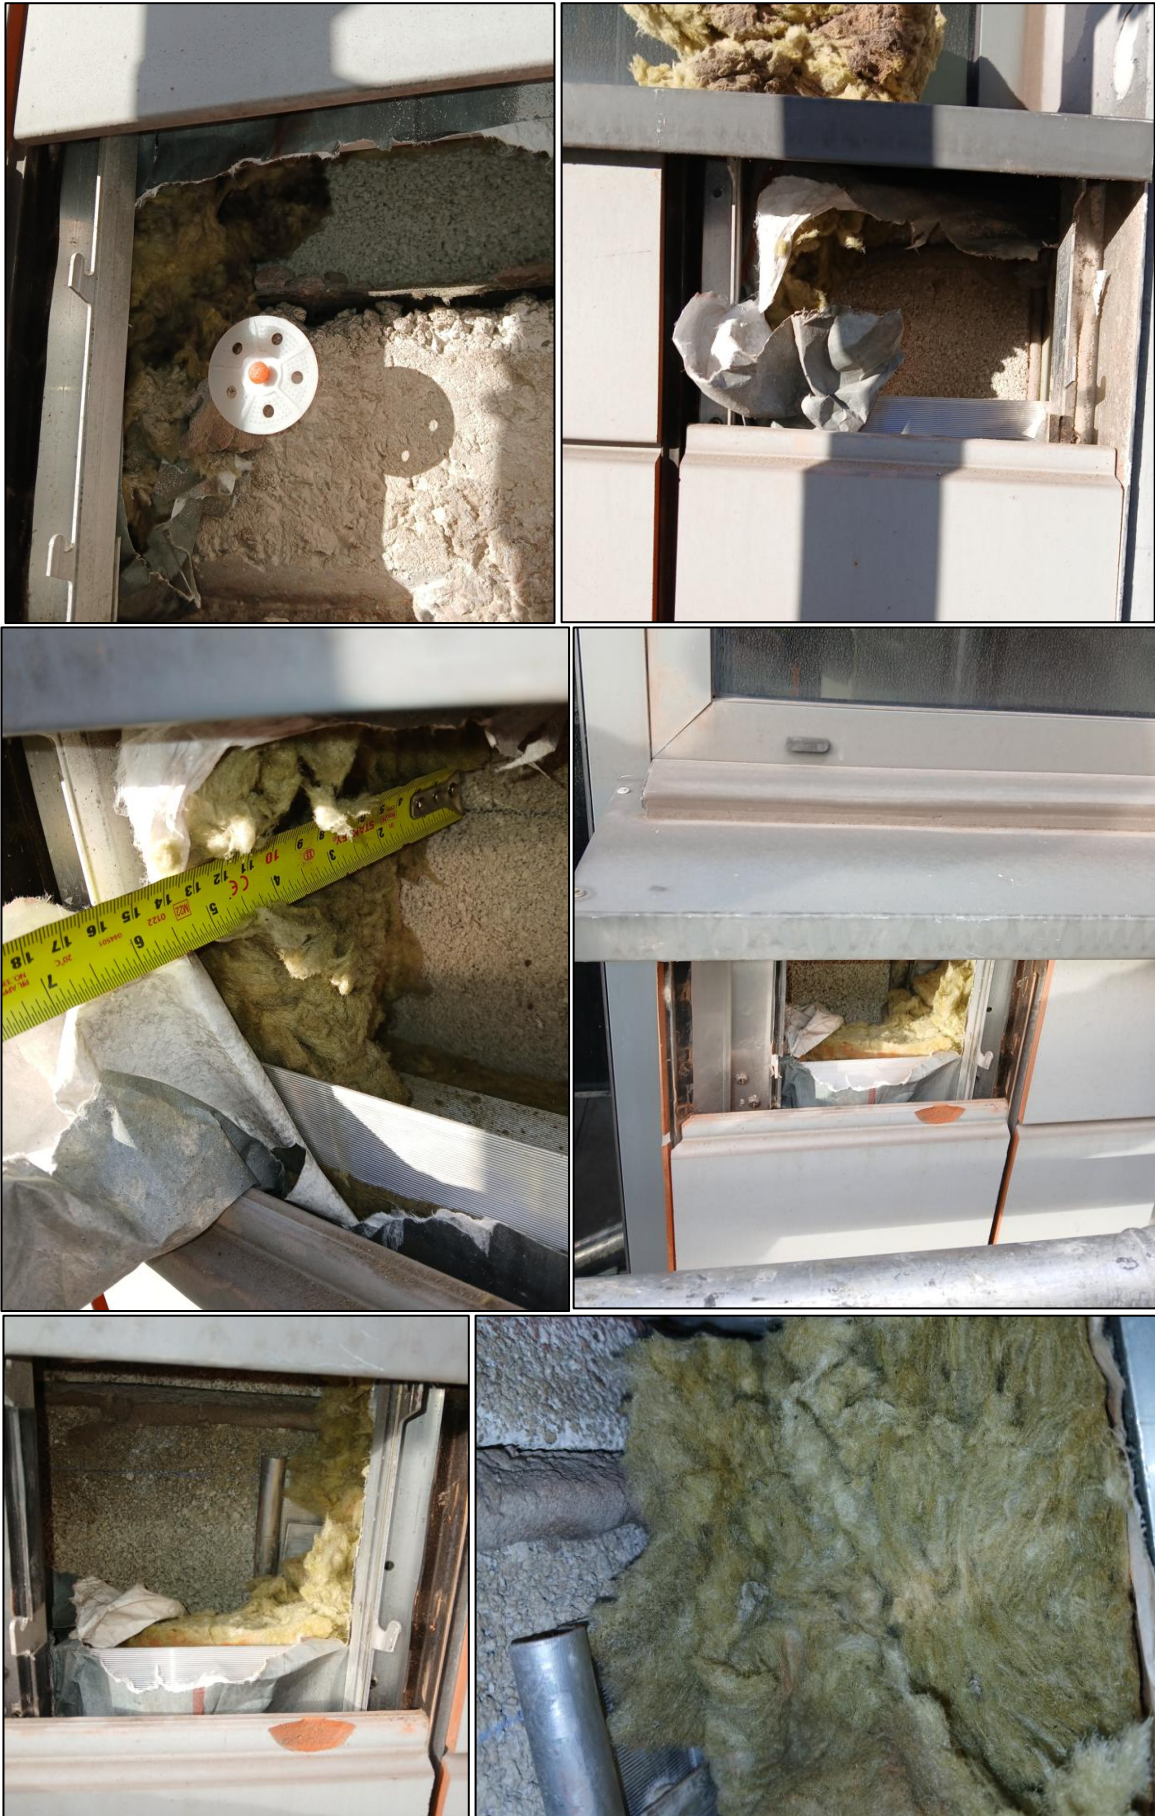
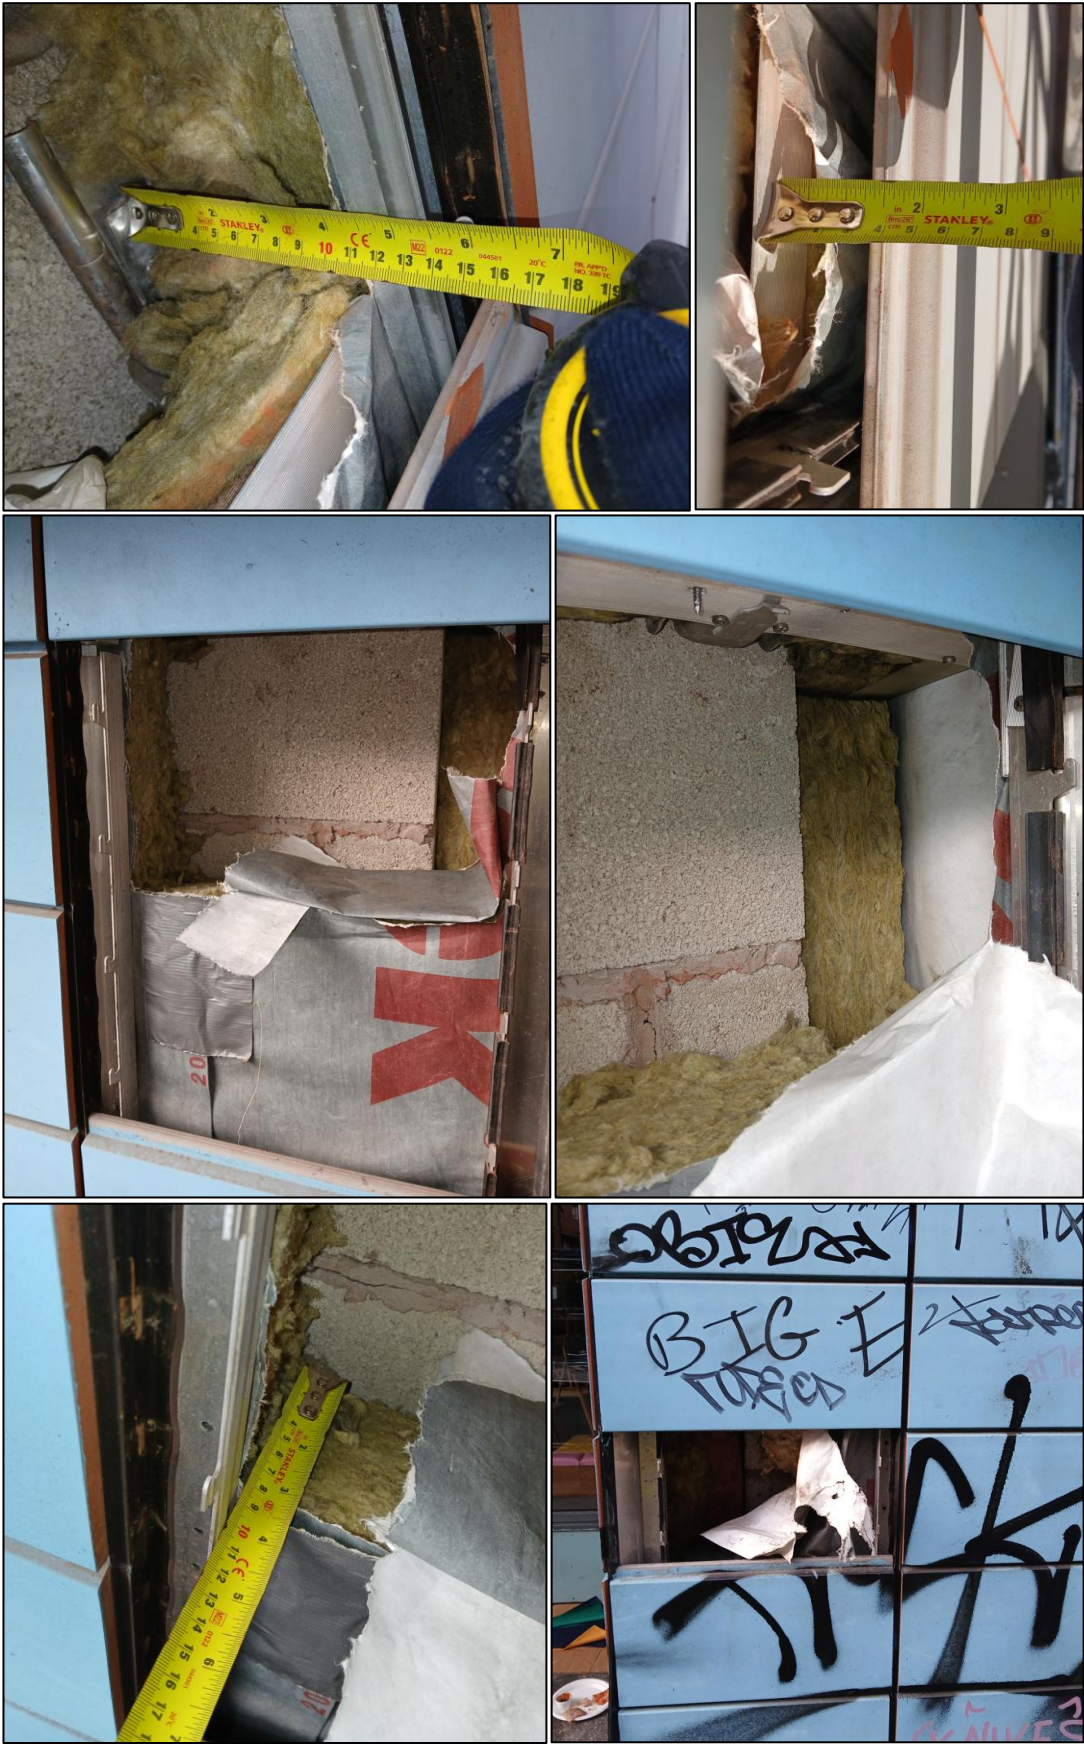
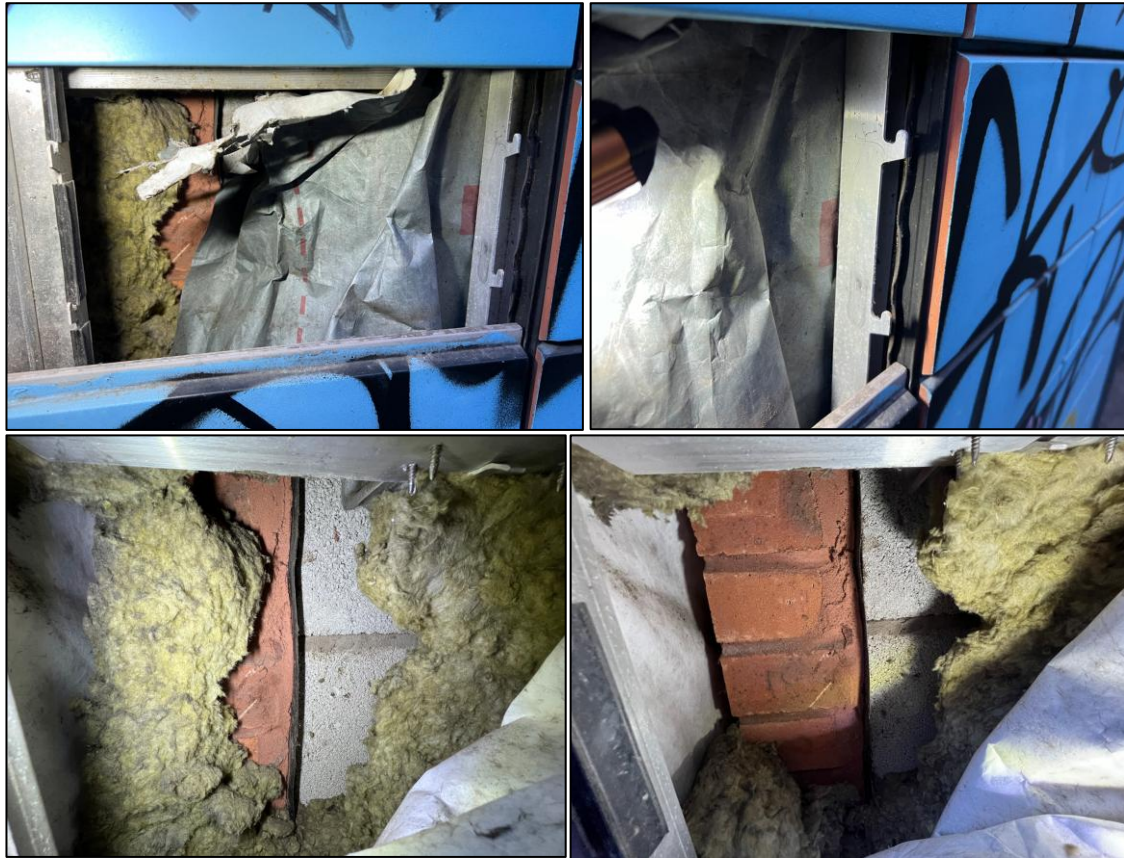
**Figure 20** – Typical inspection images for EWT2 taken by Octa Fire.

Based on the above, it can be concluded that the primary external wall materials within EWT2, with the exception of the thin breather membrane, are of A1 non-combustible nature, which will not add to the fire load or cause rapid fire spread across the facade.

With regards to cavity barrier provisions within EWT2, no proprietary mineral wool-based cavity barriers were observed at any of the inspected locations (i.e., window openings and compartment lines). Nevertheless, it should be noted that the cavity void behind the terracotta tiles comprises of A1 non-combustible insulation material, and as far as we understand it, there are no significant combustible materials within EWT2.

In-addition to above, whilst inspecting EWT2, horizontal steel structures were observed on the building façade at the floor slab levels. The paint applied on the steel structure (unclear if it is intumescent or not) was observed to be peeling off. If the horizontal and vertical steel works (as noted on site) are considered primary structural, loadbearing elements of the building, then they are required to be adequately fire protected to uphold the same level of fire resistance as the element of structure for the building. Review of structural fire performance of the building is currently excluded from our FRAEW scope of works.

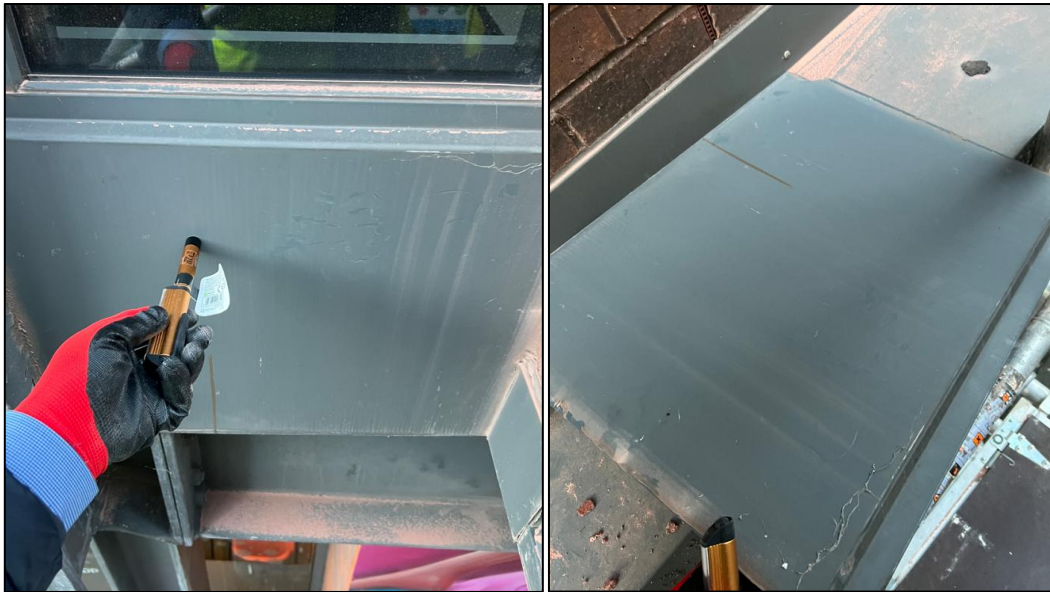
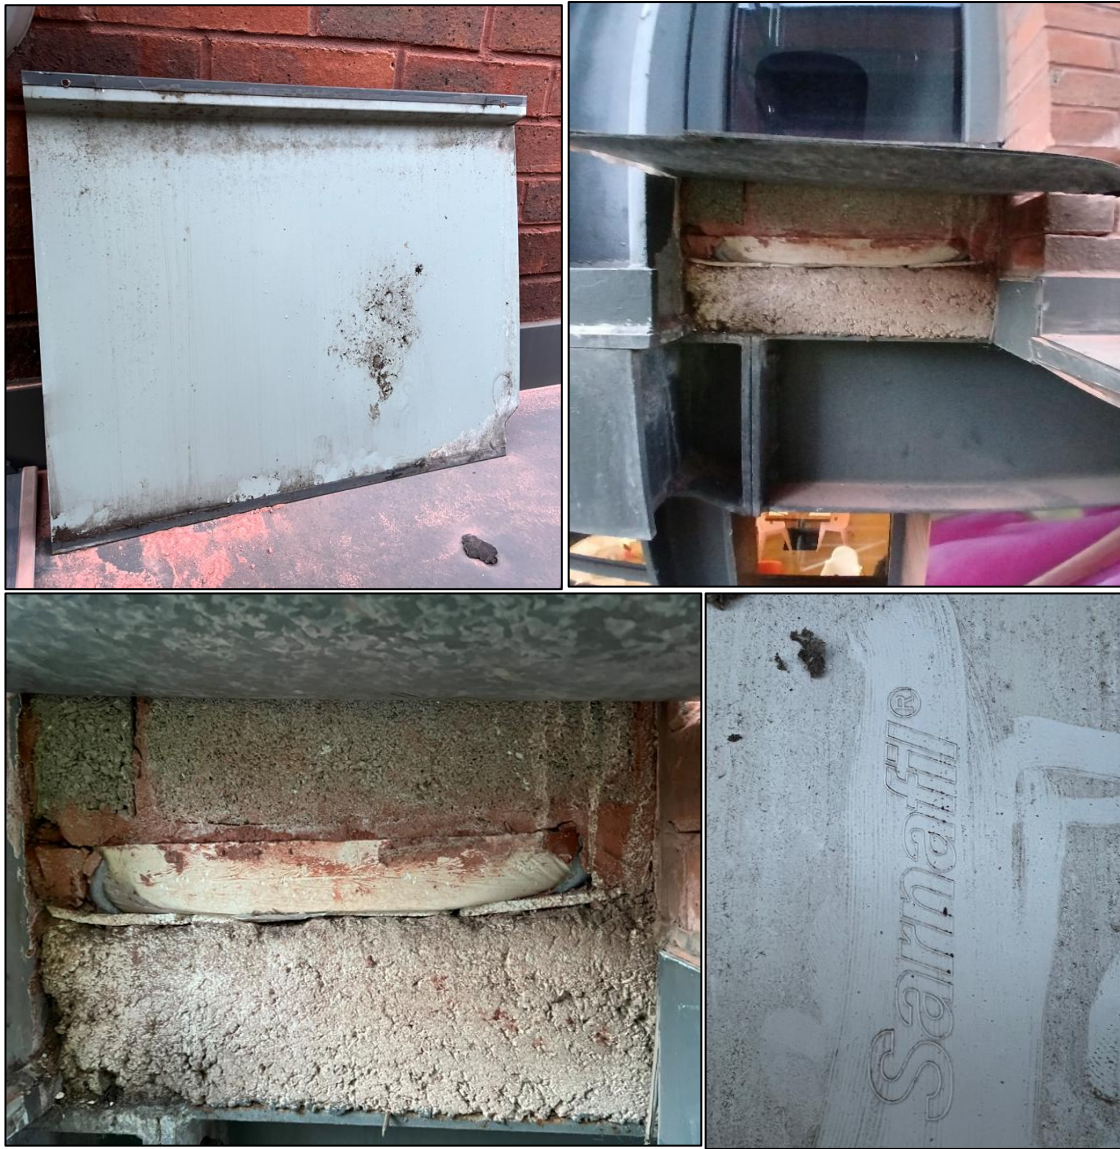
**Figure 22** – Typical inspection images for EWT3 taken by Octa Fire.

In-addition to above, whilst inspecting EWT3, vertical steel structures were observed on the building façade. The paint applied on the steel structure (unclear if it is intumescent or not) was observed to be peeling off, see Fig.23 for more details. If the horizontal and vertical steel works (as noted on site) are considered primary structural, loadbearing elements of the building, then they are required to be adequately fire protected to uphold the same level of fire resistance as the element of structure for the building. Review of structural fire performance of the building is currently excluded from our FRAEW scope of works.

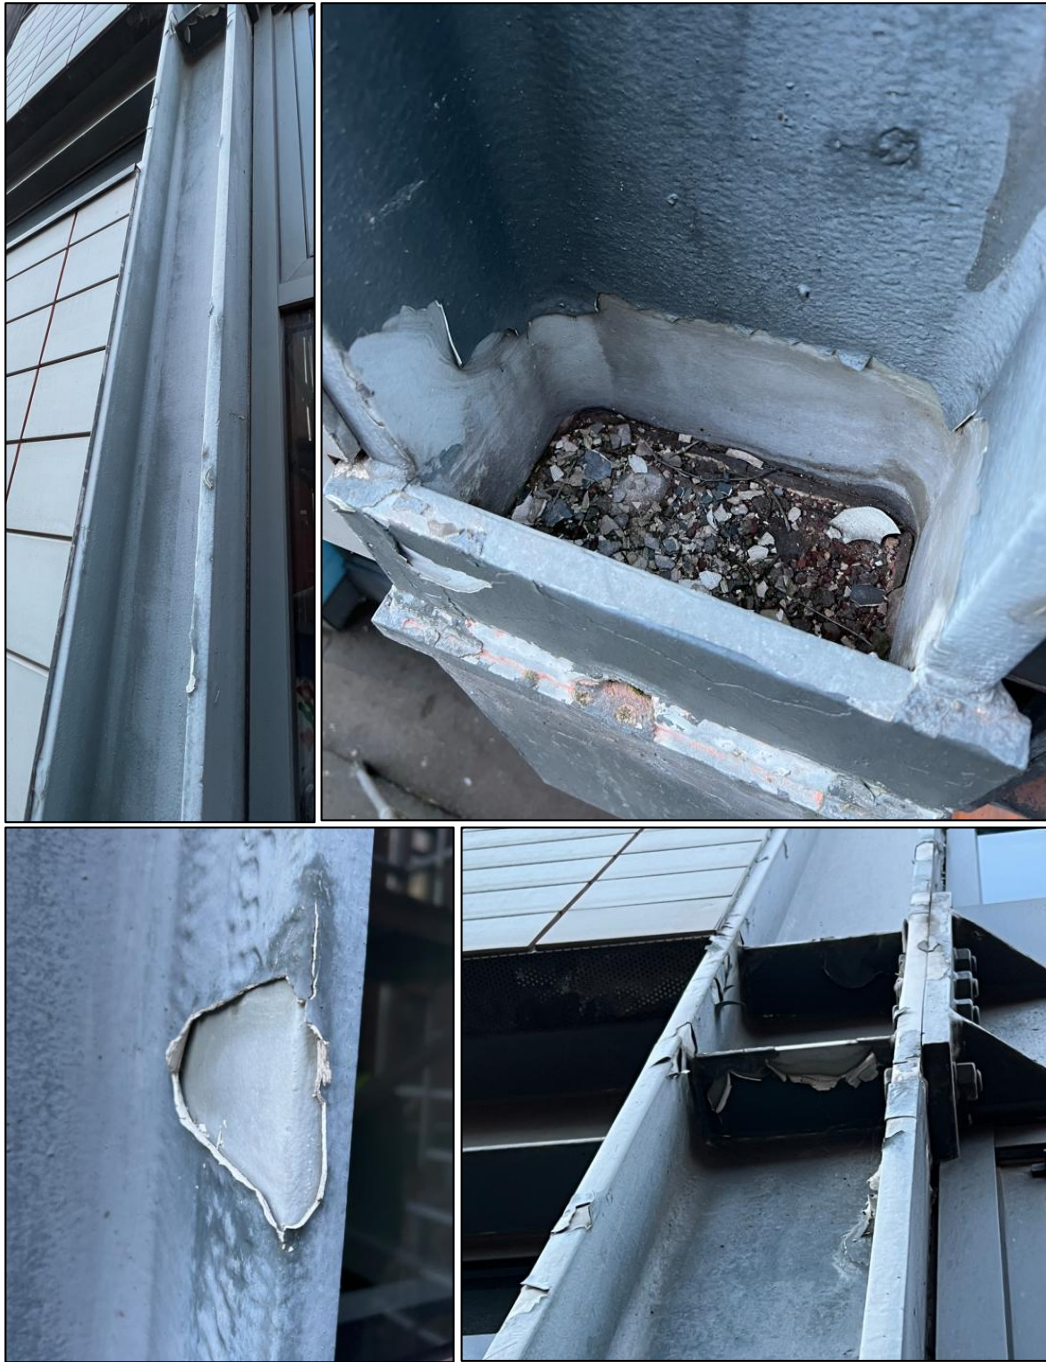
**Figure 23** – Typical inspection images of steel structure taken by Octa Fire.

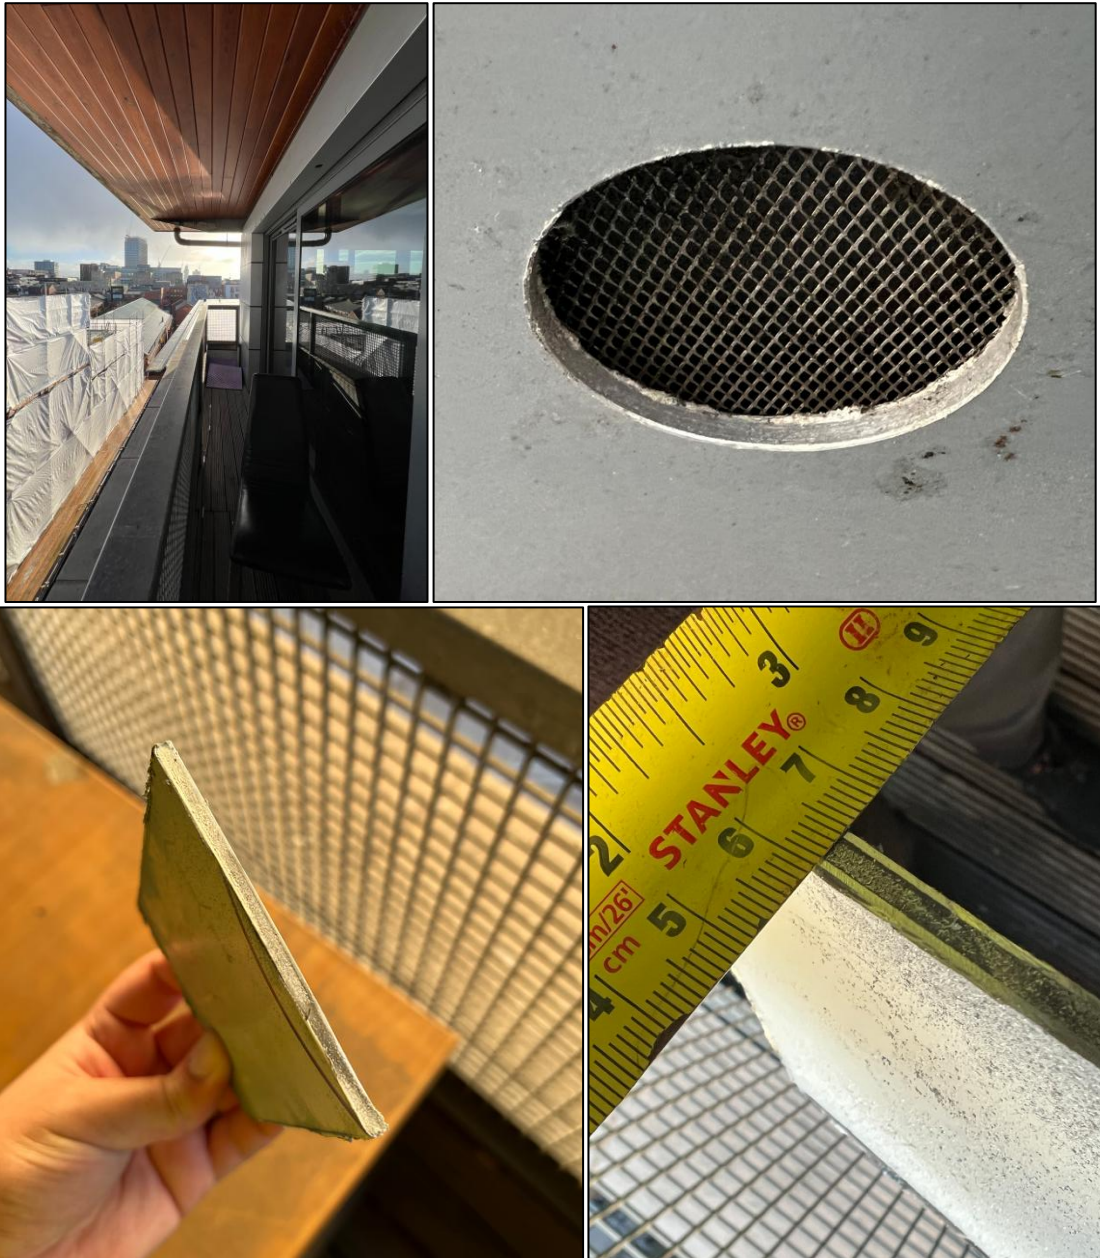
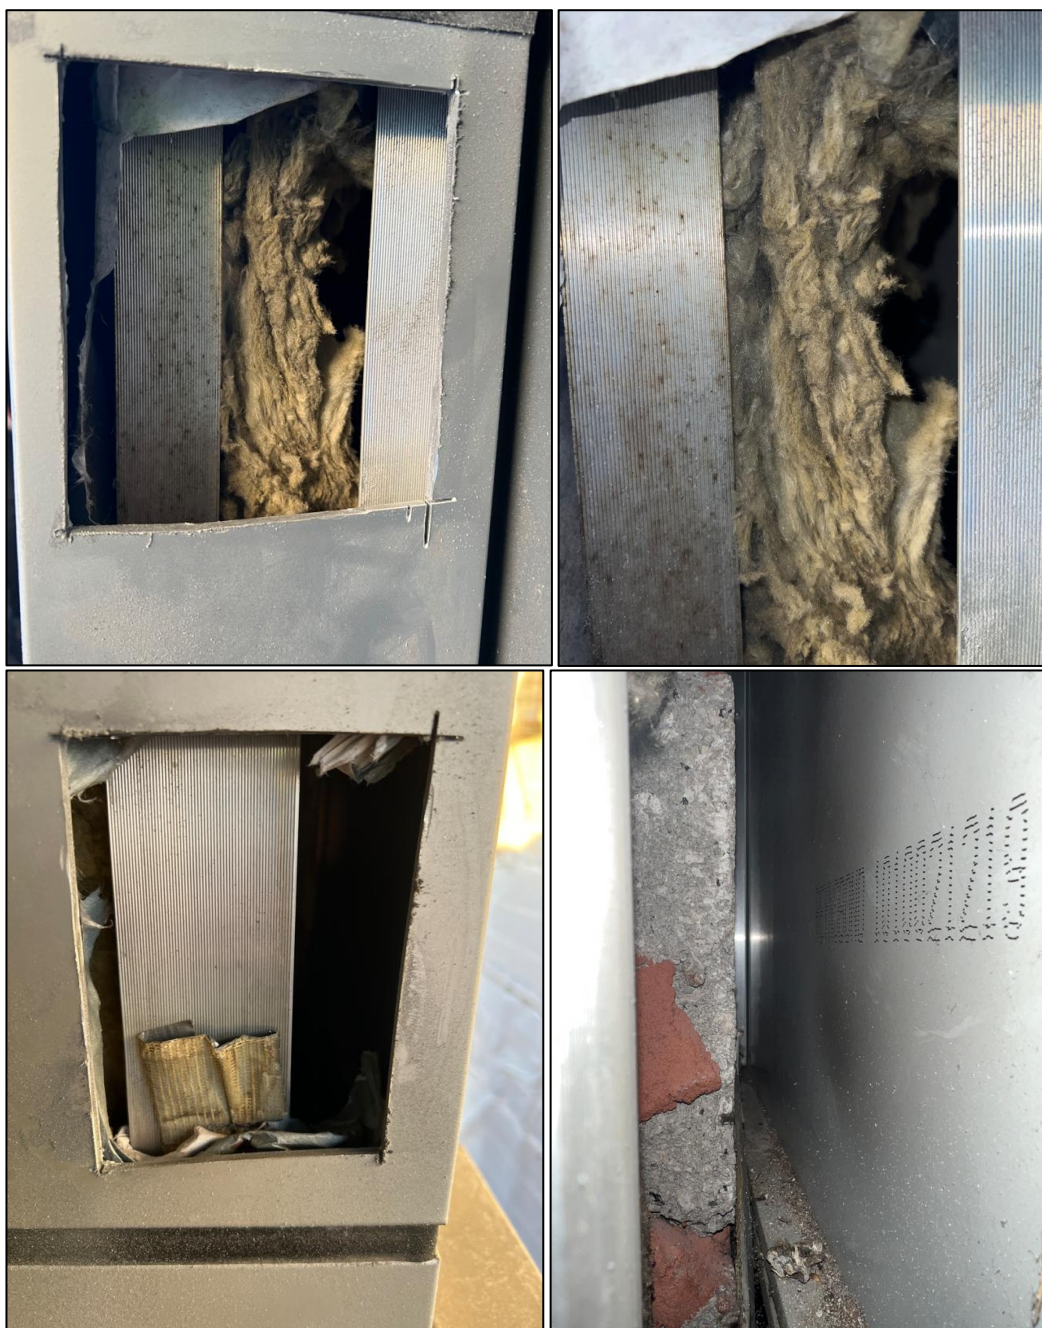
**Figure 25** – Typical inspection images for EWT4 taken by Octa Fire.

With regards to cavity barrier provisions within EWT4, no proprietary mineral wool-based cavity barrier products were observed at any of the inspected locations.

ACM samples extracted from site (level 5 balcony) have been presented in Appendix B. The ACM panels are assumed to be Category 3 (more than 35MJ/kg when tested in a bomb calorimeter apparatus). Considering we have not been provided with any test data at the time of writing this report by the client, a worst case-scenario assumption has been adopted. However, if the ACM's installed on the building are found to be better than Category 3 (i.e., CAT 1 or 2), this report should be reviewed and updated accordingly.
