10 Deerpark Road,  
Whalley Range, Manchester  
Bat Scoping Survey & BNG Assessment

24<sup>th</sup> November 2025

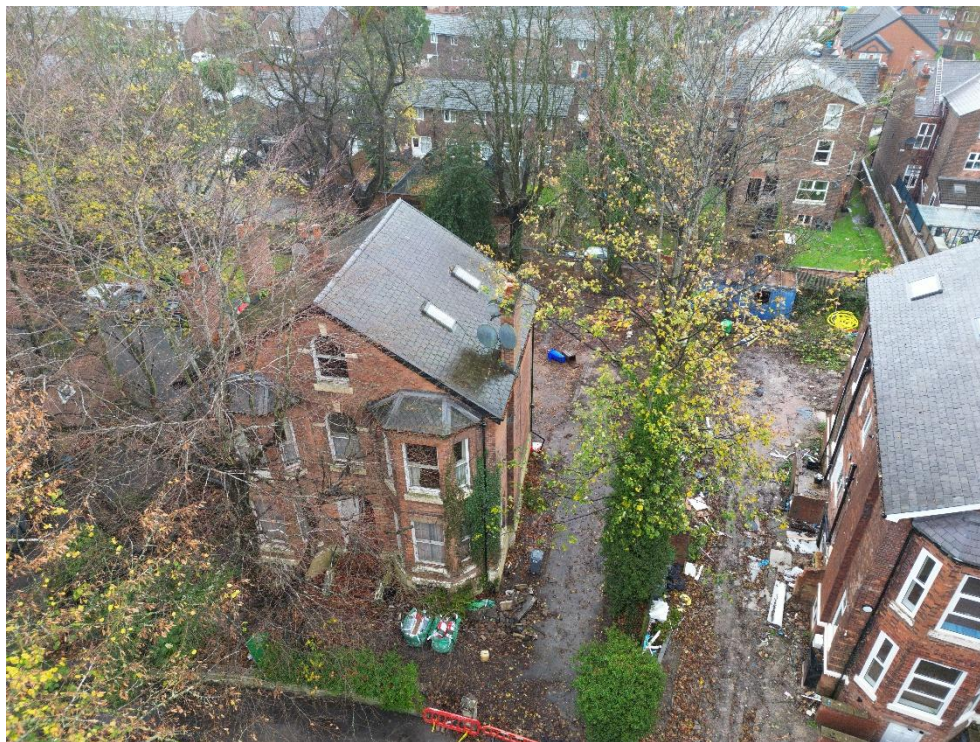
The external masonry was observed to be well-pointed and intact. The fascia was inspected with powerful torch and binoculars. There are no gaps at the eaves or fascia. The roof was inspected using an aerial drone. The roof slates were observed to be intact and in good condition. The building has new ridge tiles which also appeared well sealed. Flashing around the chimney is also tight and intact. No obvious suitable bat roosting features or access to the building's interior was identified during the external inspection.

*Photograph 1- Front face of house*

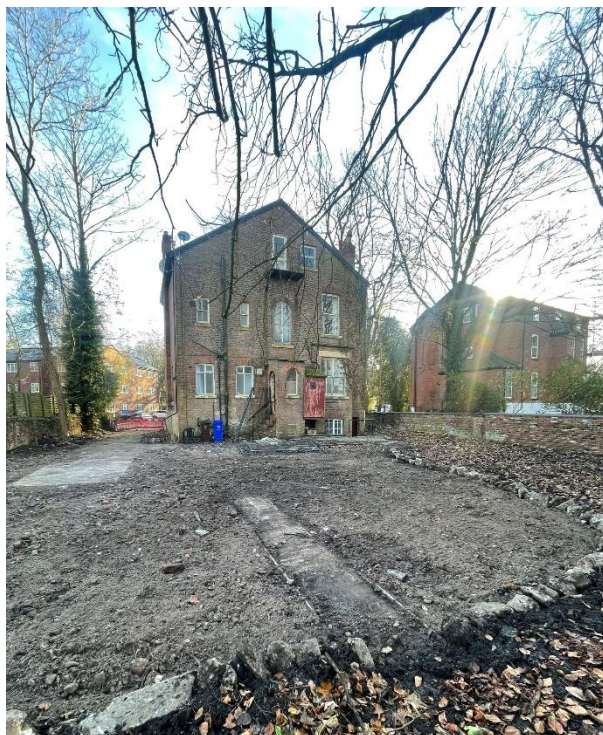
The garden is currently unvegetated, comprising areas of bare ground with scattered soil and patches of brick rubble. Previous habitats likely comprised vegetated garden with areas of developed land/hardstanding. The applicant reports they are carried out some works to tidy up the garden which had become a little overgrown. However, they did not affect any significant trees or habitats of significant biodiversity value. Therefore, all areas outside of sealed surface hardstanding and buildings are recorded as 'vegetated garden'.

*Photograph 2- Rear of House and Gardens*

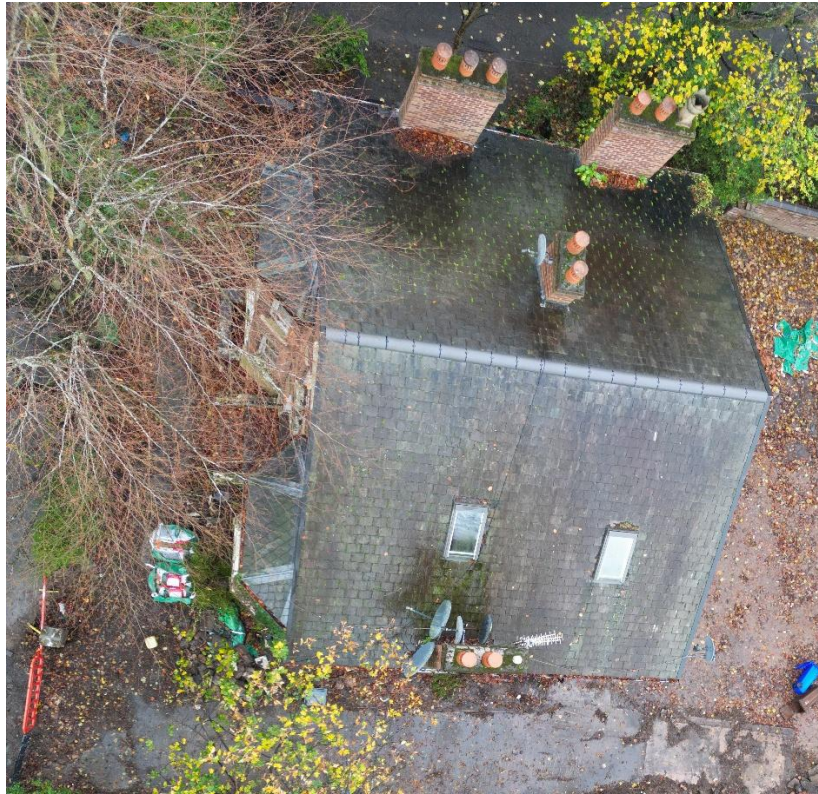
*Photograph 3- View of roof*

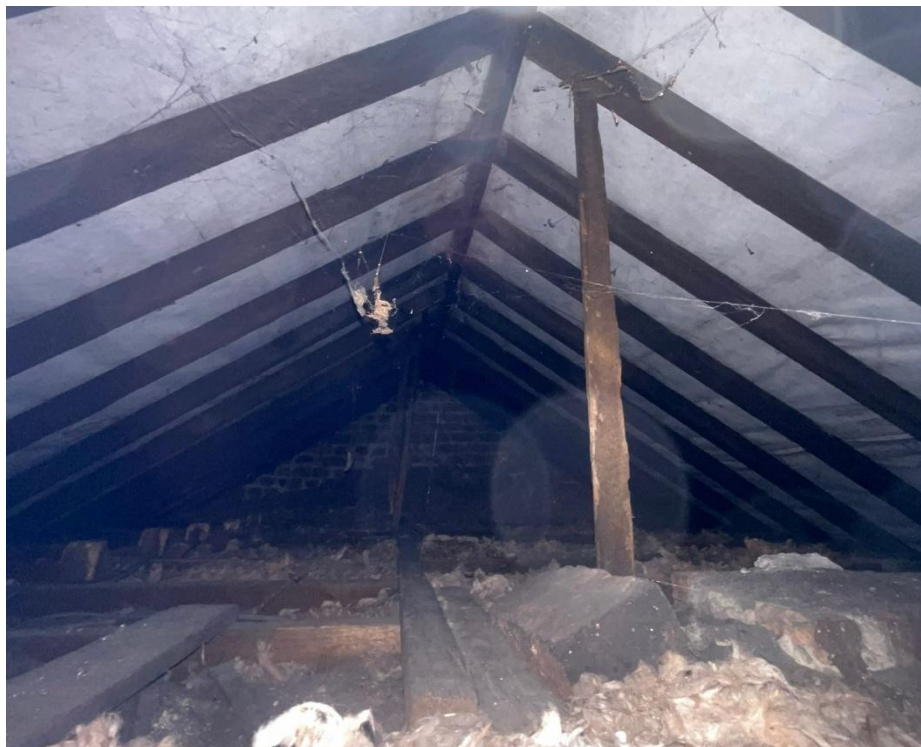
Internally, the upper floor rooms extend into the roof void space, however there is a small loft space present extending along the building's ridge. The loft space is approximately 1m in height and extends the length of the ridge line (approximately 8 m). The internal face of the roof is lined with modern breathable roof membrane and the loft is lined with mineral felt insulation. The loft space was observed to be cobwebbed including cobwebs spanning the internal void space. The roof membrane extends over the ridge, sealing the loft space interior. Consequently, the loft is inaccessible to roosting bats.

No bat droppings or other bat field signs were identified in association with the building.

*Photograph 4 - Interior of the loft space*
