## **APPENDIX D**

# **EXPLORATORY HOLE RECORDS**

| Contract: <b>Talbot Mill</b> | | | Client: <b>Capital &amp; Centric (Adored) Ltd</b> | | Borehole: <b>JBH01</b> |
| Contract Ref: <b>11264</b> | Start: <b>16.05.18</b><br>End: <b>16.05.18</b> | Ground Level: <b>26.43</b> | National Grid Co-ordinate: <b>E:382661.6 N:397306.8</b> | | Sheet: <b>1 of 4</b> |

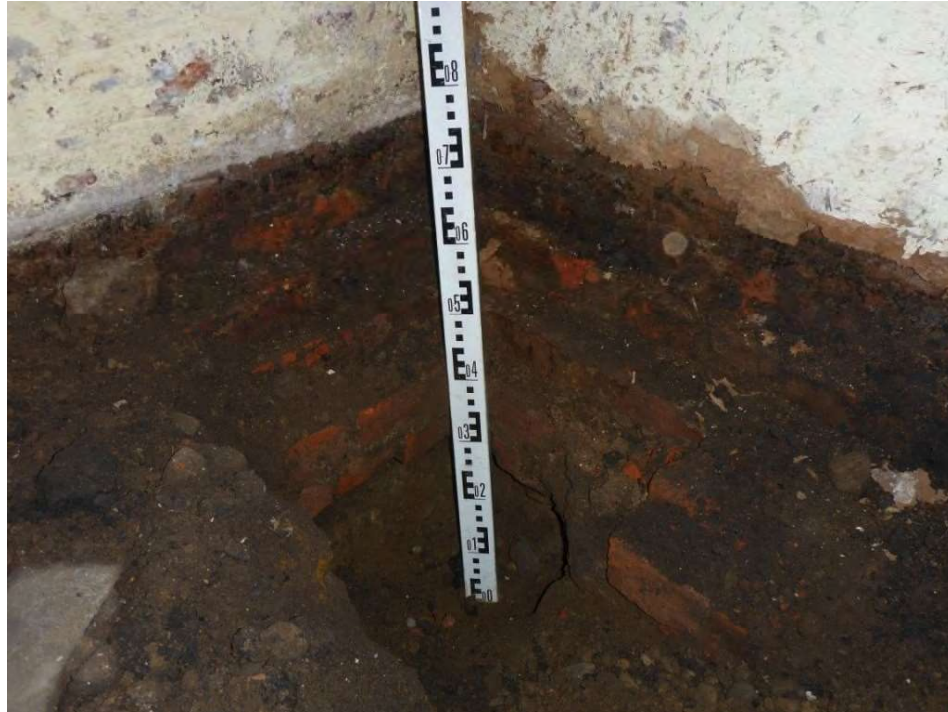
Trial Pit JTP04 - Photo 1

| | | <ol style="list-style-type: none"> <li>Scanned with CAT and Genny prior to excavation.</li> <li>Ease of trial pit excavation: moderate.</li> <li>No groundwater encountered.</li> <li>Trial pit remained dry and stable during excavation.</li> <li>Trial pit terminated at base of foundations.</li> <li>On completion, trial pit backfilled with arisings and finished with concrete.</li> </ol> | | | |
