## CCTV SURVEY INSPECTION REPORT

| <b>Location:</b> | Blackley Fire Station, Rochdale Road,<br>M9 7EQ |

**Project Name:** 287594 -Cheltenham Green Civils -Blackley Fire Station - Manchester -12-11-25

**Inspection Standard:** MSCC5 Sewers & Drainage GB (SRM5 Scoring)

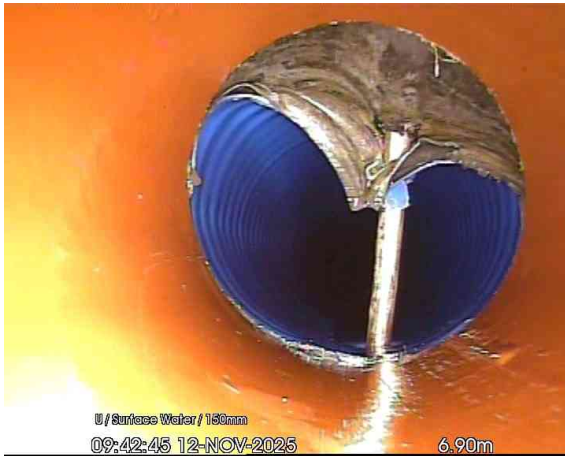
Other obstacles, protruding through wall at joint from 12 o'clock to 6 o'clock, 50% cross-sectional area loss

Deformed sewer or drain, 40%

1, 00:00:23, 6.92 m

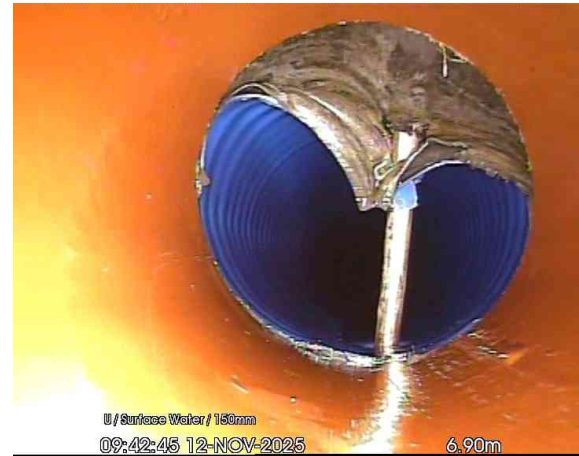
Survey abandoned: Due to obstacle intruding through pipe wall

2, 00:00:23, 6.92 m

Survey abandoned, Due to obstacle intruding through pipe wall

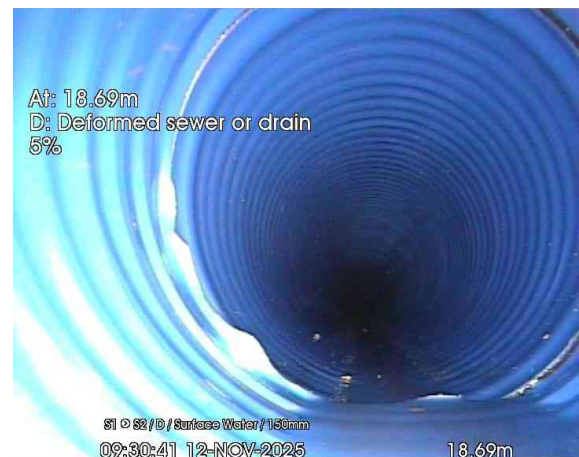
| Scale: 1:323 | Position [m] | Code | Observation | MPEG | Photo | Grade |
|---|---|---|---|---|---|---|
| | 18.69 | D | Deformed sewer or drain, 5% | 00:01:25 | 4 | 1 / 2 |

4, 00:01:25, 18.69 m  
Deformed sewer or drain, 5%

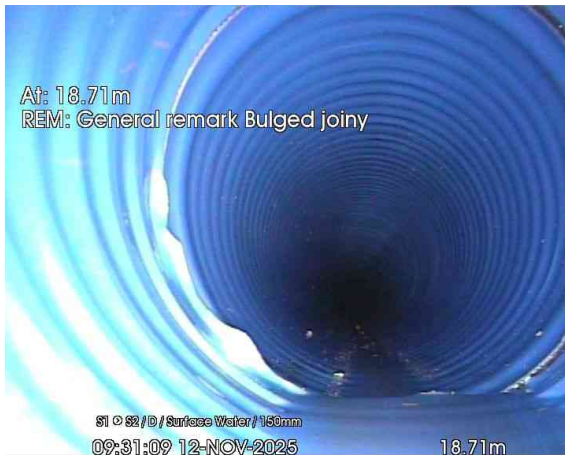
| Scale: 1:323 | Position [m] | Code | Observation | MPEG | Photo | Grade |
|---|---|---|---|---|---|---|
| | 18.71 | REM | General remark: Bulged joiny | 00:01:28 | 5 | |

5, 00:01:28, 18.71 m  
General remark, Bulged joiny

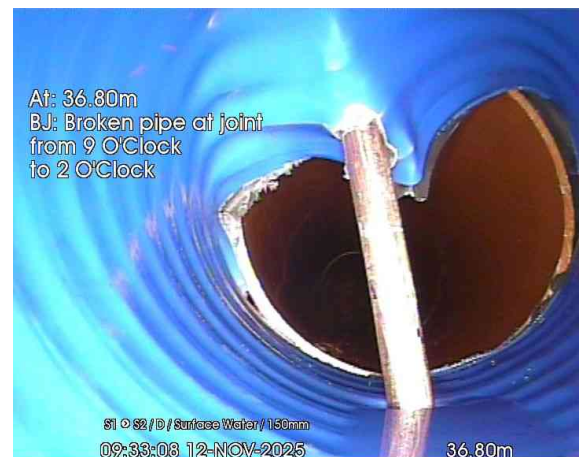
| Scale: 1:323 | Position [m] | Code | Observation | MPEG | Photo | Grade |
|---|---|---|---|---|---|---|
| | 36.80 | BJ | Broken pipe at joint from 9 o'clock to 2 o'clock | 00:02:46 | 8 | 4 |

8, 00:02:46, 36.80 m  
Broken pipe at joint from 9 o'clock to 2 o'clock

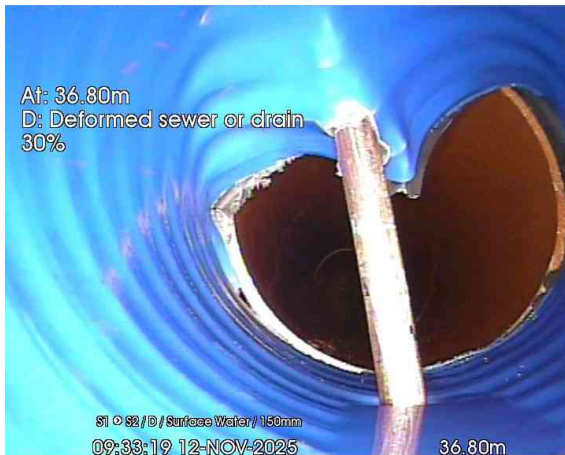
| Scale: 1:323 | Position [m] | Code | Observation | MPEG | Photo | Grade |
|---|---|---|---|---|---|---|
| | 36.80 | D | Deformed sewer or drain, 30% | 00:02:47 | 9 | 4 / 4 |

9, 00:02:47, 36.80 m  
Deformed sewer or drain, 30%

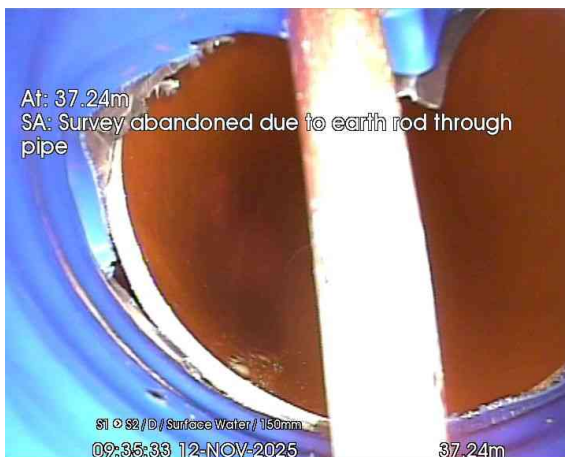
| Scale: 1:323 | Position [m] | Code | Observation | MPEG | Photo | Grade |
|---|---|---|---|---|---|---|
| | 37.24 | SA | Survey abandoned: due to earth rod through pipe | 00:03:42 | 11 | |

11, 00:03:42, 37.24 m  
Survey abandoned, due to earth rod through pipe

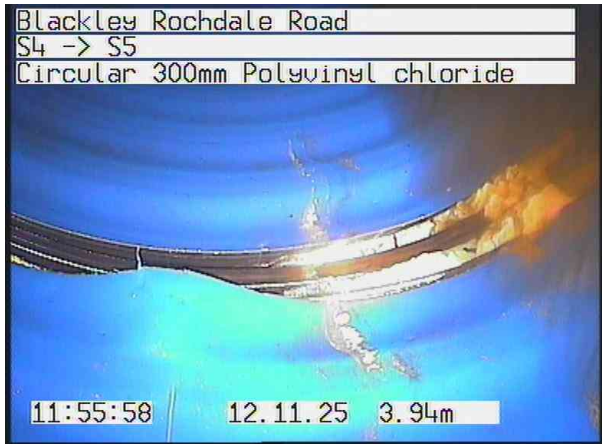
1, 00:00:39, 3.93 m  
Deformed sewer or drain, 5%

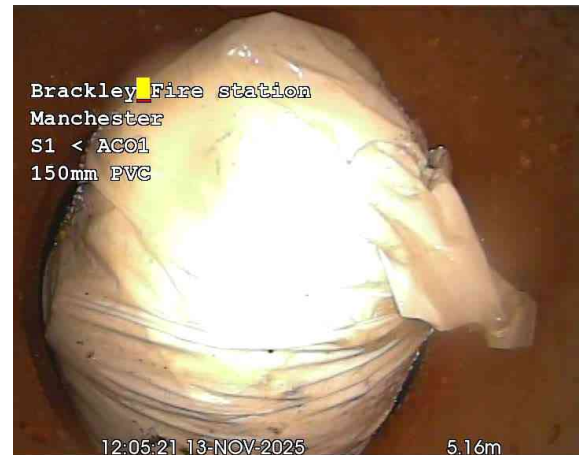
2, 00:00:24, 5.16 m  
Survey abandoned, ACO outlet bagged off
