## Phase 2: Site Investigation

**53-55 Heathbank Road, Manchester**

## PHASE 2 SITE INVESTIGATION REPORT

### 53-55 HEATHBANK ROAD, MANCHESTER

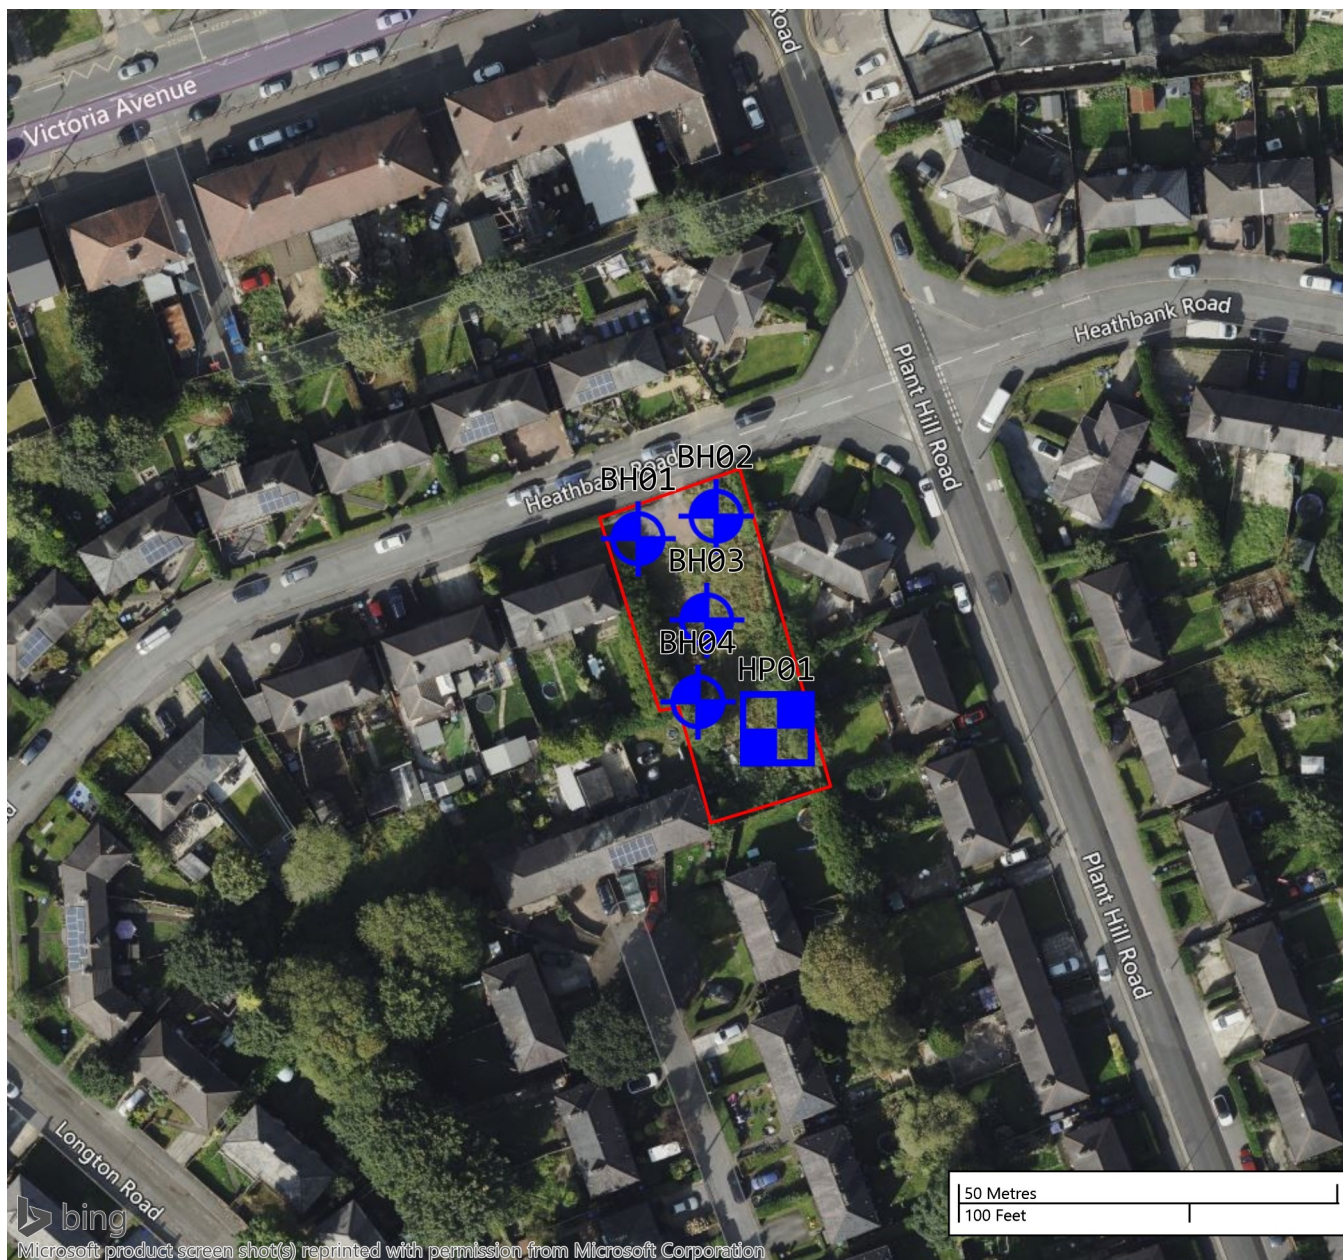
**Figure Title**

Descriptions of the strata encountered in the boreholes together with details of sampling and groundwater are presented in Appendix B of this report. A plan showing the location of the boreholes can be found in Appendix A (Figure 2).
