**Project Name:** W.P.I. - BENNETT STREET MANCHESTER

**Inspection Standard:** MSCC5 Sewers & Drainage GB (SRM5 Scoring)

## Section Inspection - 02/06/2023 - S1X

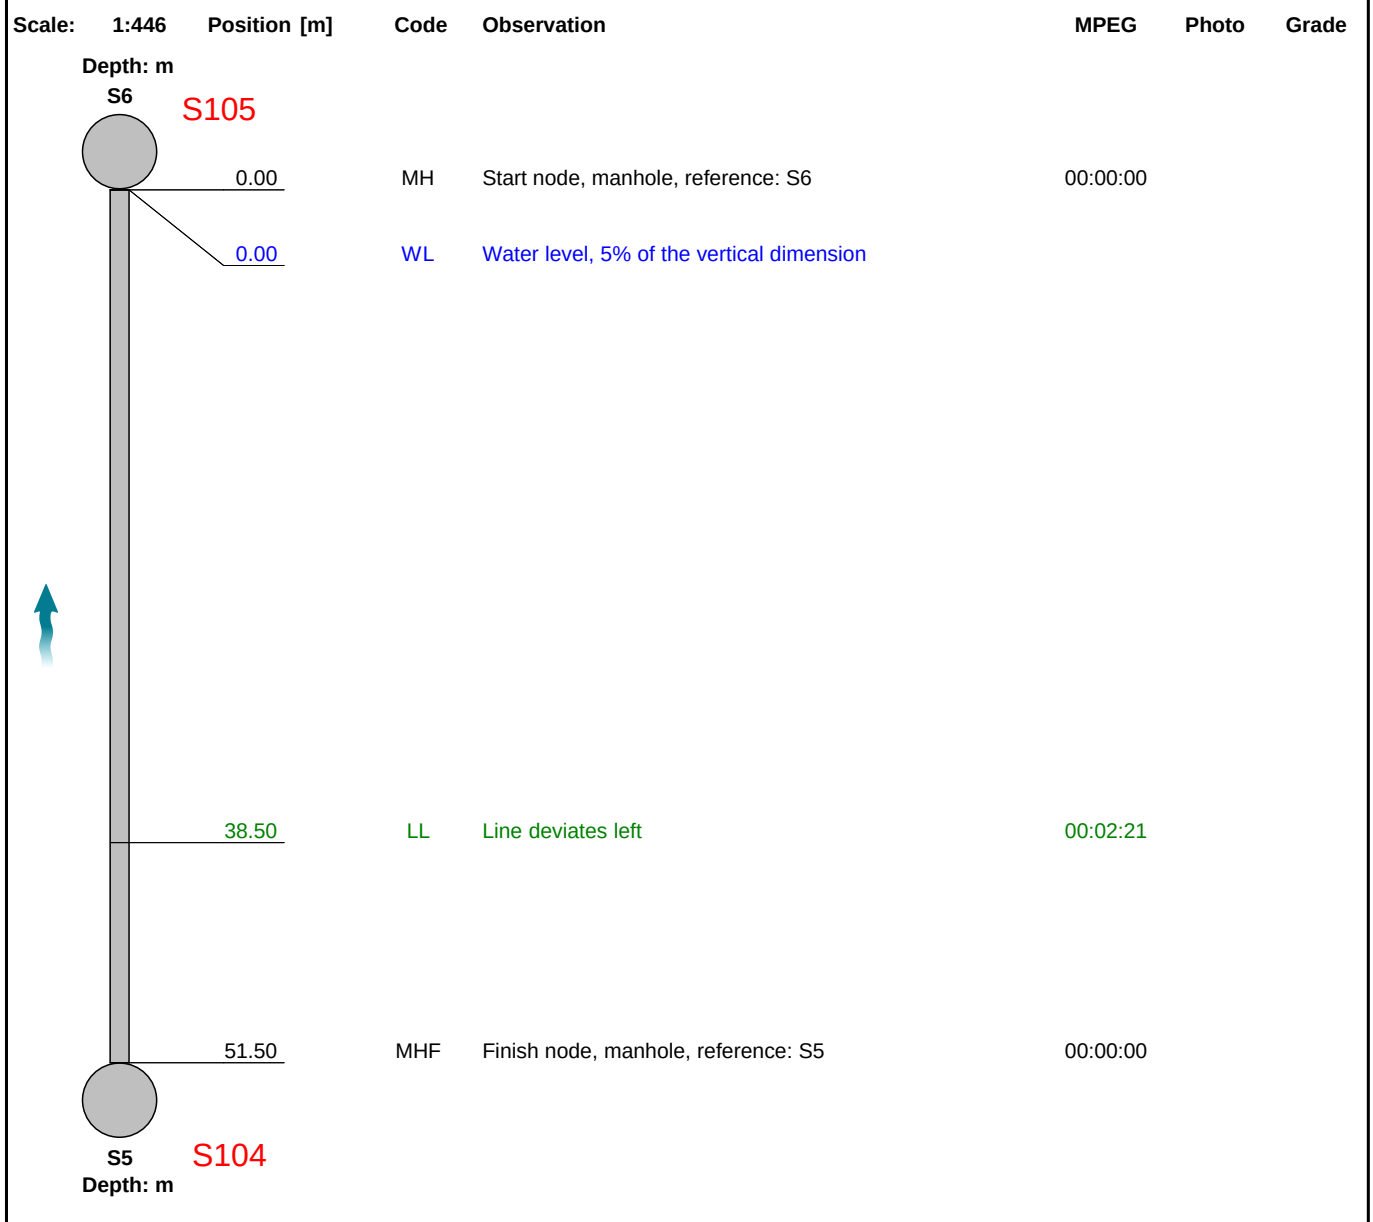
## Section Inspection - 02/06/2023 - S5X

| Location: | Property or buildings | Total Length: | 51.50 m | Downstream Node: | S6 |
| Type of Pipe: | Gravity drain/sewer | Dia/Height: | 1,500 mm | Width: | 1,500 mm |
| Flow Control: | No flow control | Material: | Concrete | | |

| Construction Features | | | | | Miscellaneous Features | | | | |
|---|---|---|---|---|---|---|---|---|---|
| 0 | 0.0 | 0.0 | 0.0 | 1.0 | 0 | 0.0 | 0.0 | 0.0 | 1.0 |

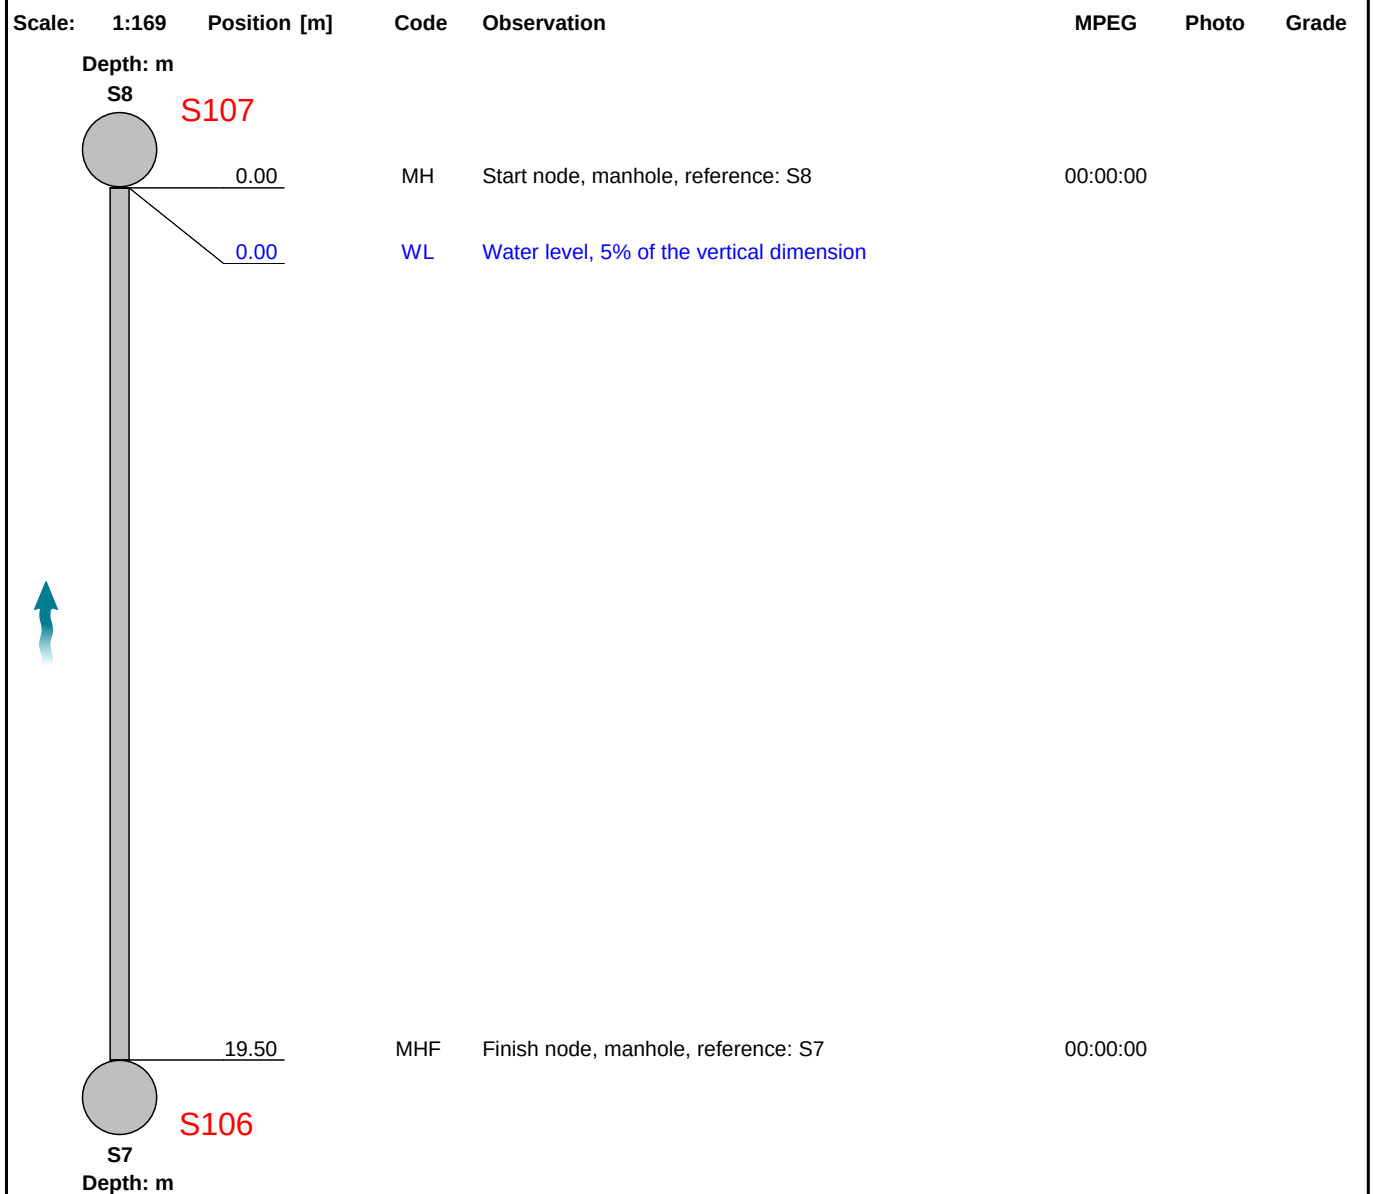
## Section Inspection - 02/06/2023 - S7X

| Location: | Property or buildings | Total Length: | 19.50 m | Downstream Node: | S8 |
| Type of Pipe: | Gravity drain/sewer | Dia/Height: | 1,500 mm | Width: | 1,500 mm |
| Flow Control: | No flow control | Material: | Concrete | | |

| Construction Features | | | | | Miscellaneous Features | | | | |
|---|---|---|---|---|---|---|---|---|---|
| 0 | 0.0 | 0.0 | 0.0 | 1.0 | 0 | 0.0 | 0.0 | 0.0 | 1.0 |
