## Phase II GeoEnvironmental Ground Investigation

54 Derby Street, Cheetham Hill

Manchester

**Report No. A6542/25/SI**

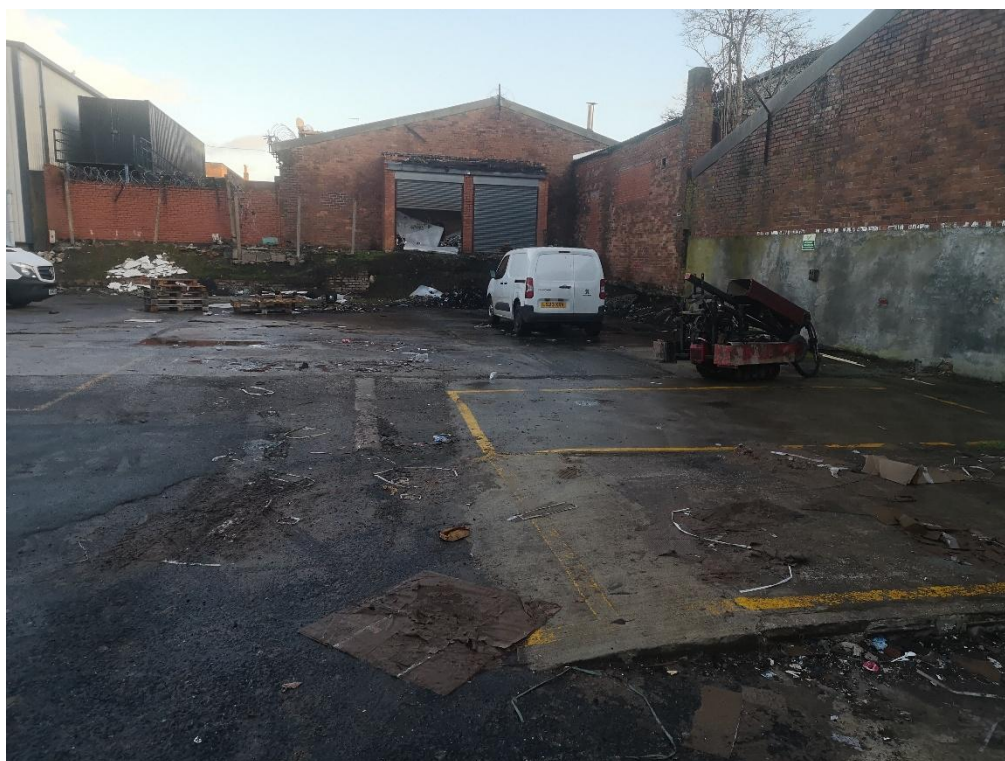
**Figure 2: General Site Photographs**

Photograph facing north, showing overview of existing site layout

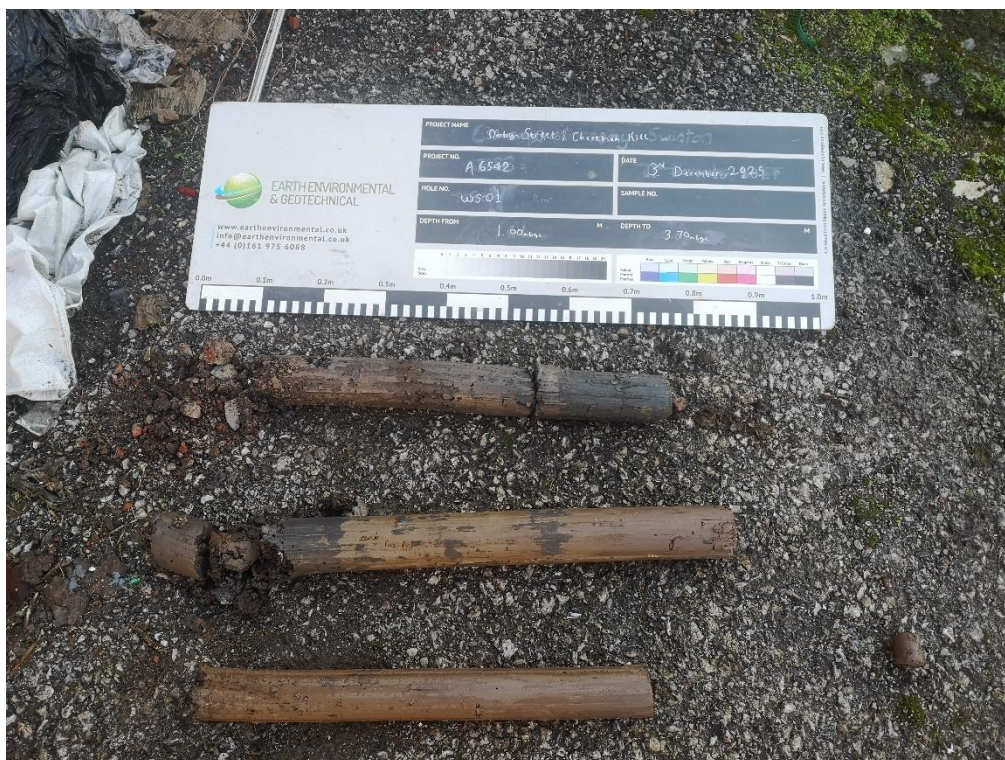
Photograph showing natural strata, exclusively observed in WS01
