## HERITAGE PAINT COLOUR STRATEGY

**project :** 1526 – Rylands Building, Manchester.

**date :** 29.10.2025

**our ref :** 1526-01Bb20251029\_HERITAGE PAINT COLOUR STRATEGY

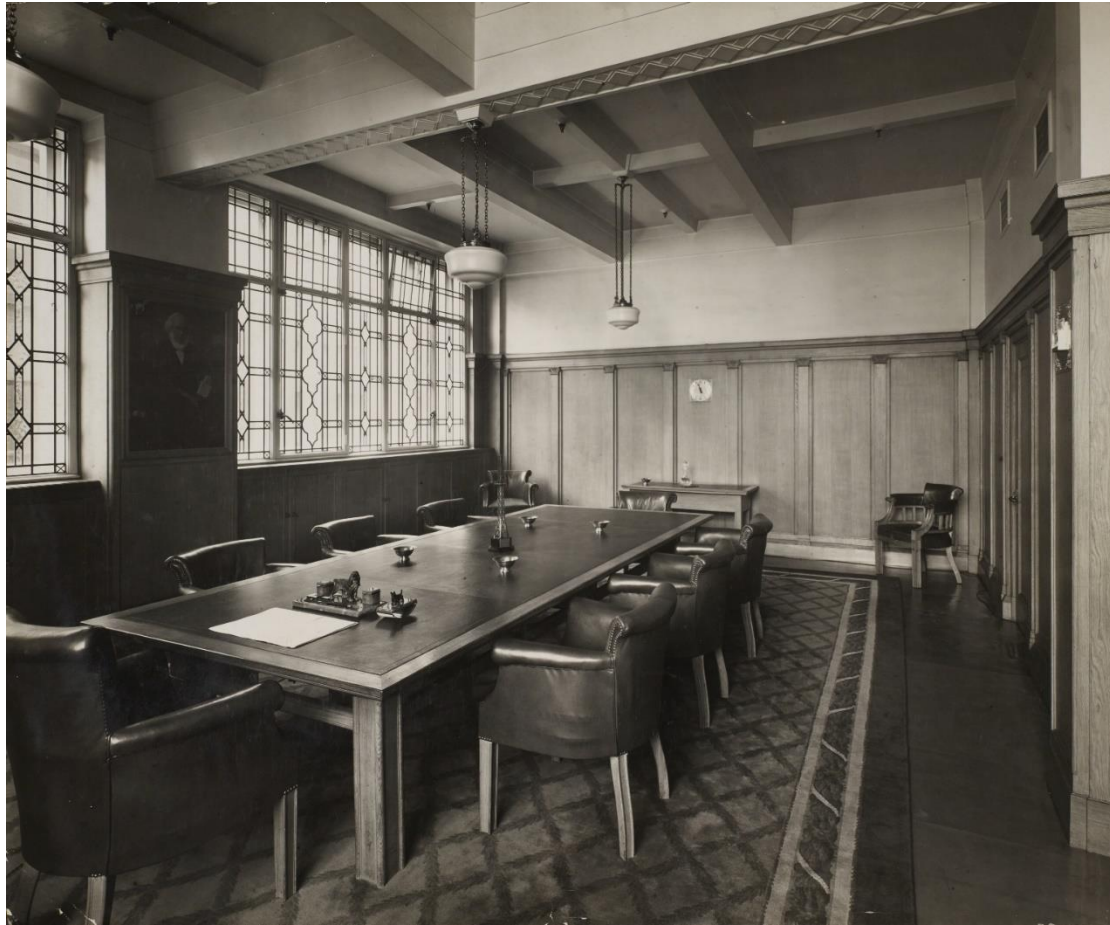
Referring to the original photograph of this space, there does not appear to be any indication that the cornice and ornamental plaster work is picked out in a colour different to the ceiling.

The proposal is to use the paint scrapes as reference, but to moderate the range of swatches. Pale Walnut is chosen over Warm Stone as the more neutral colour, allowing the eye to focus on the leaded glass and panelling which are the defining features of this room. Across other rooms in the building, Pale Walnut re-occurs and would seem to be an appropriate consistent colour choice in the proposals for the building.

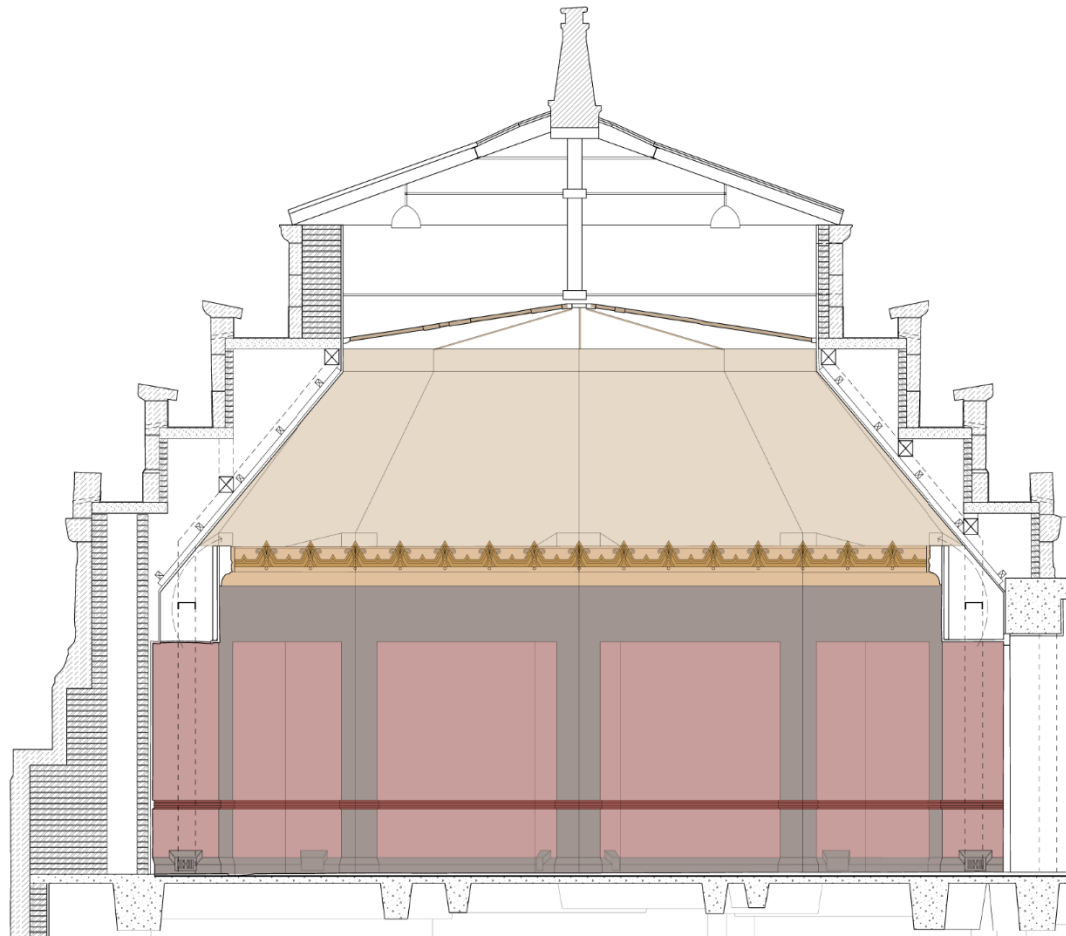
Referring to the below mock ups, there are questions whether the 9 samples that identify paint are truly representative of the original condition. The effect appears to be overbearing and detract from the coloured glass to the laylight.

Where there are questions over the sampling the proposals seek to moderate the use swatch list and take cue from the results above and those on the main L7 floorplate which either validate the use of some colours or provide validation relative to colours seen elsewhere in the building. Note L7 is described separately later in this document.

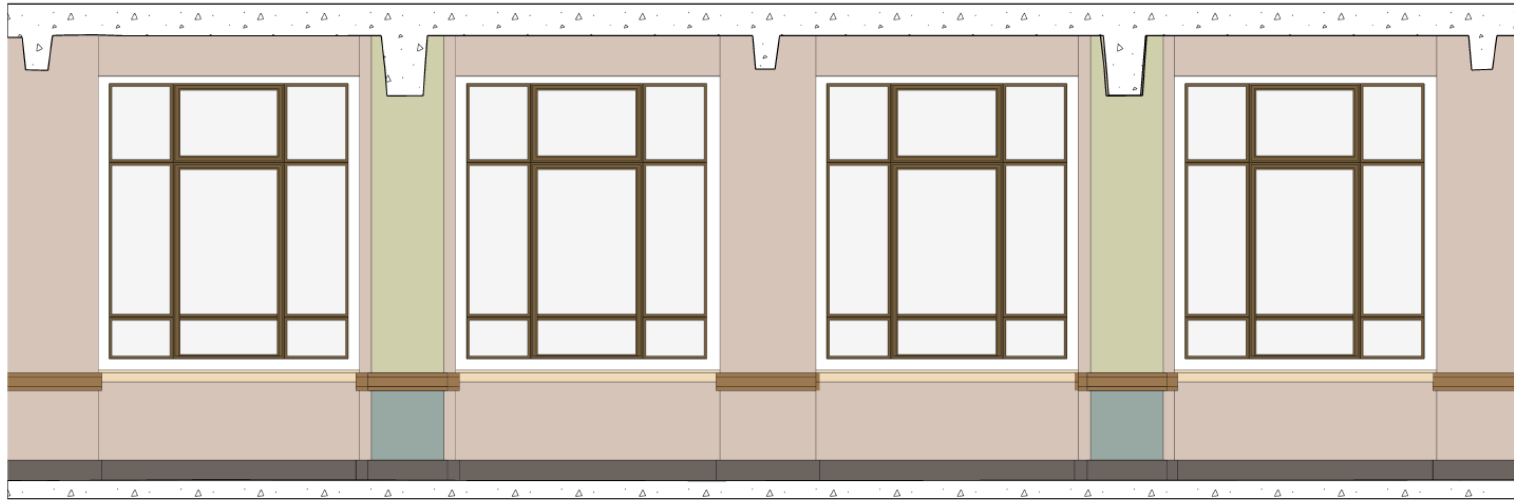
Use of Pale Olivine appears consistent with the intact lobby at L7 and Stair 3. Biscuit Beige appears to sit within the range of neutrals seen elsewhere in the building, along with Buff and Stone.

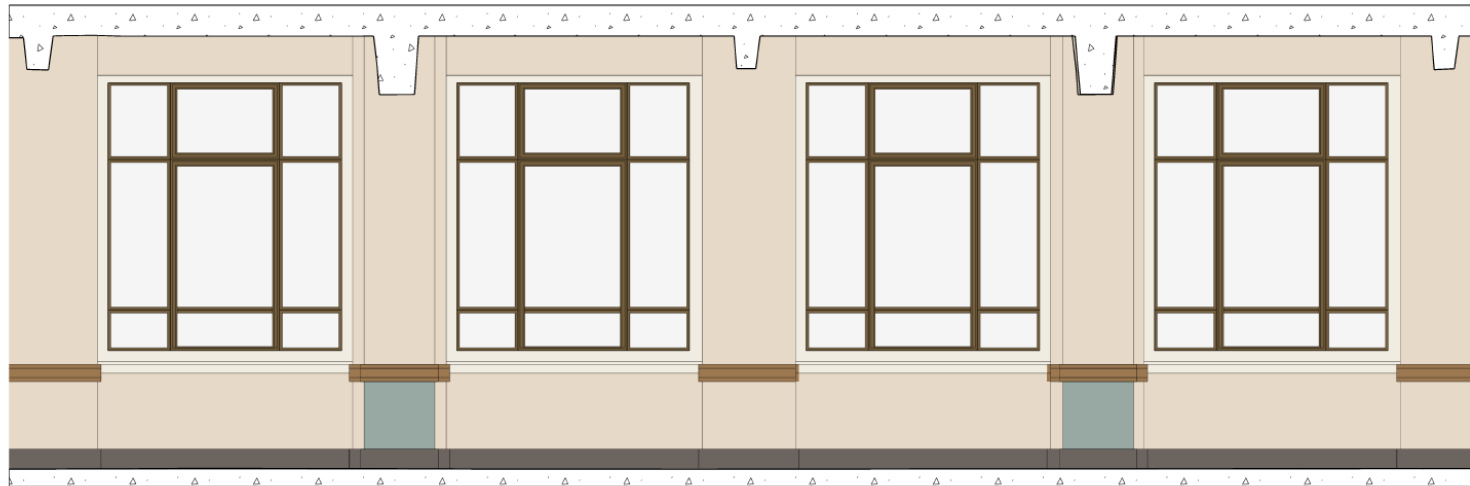
When considered alongside the scheme for the cupolas, the proposal for the L7 main floor is to use the common neutral York White alongside the judicious contrasting colours identified in the paint scrapes.
