### **Garden Capping Validation Certificate - Land at Greenbrow Social Club, Wythenshawe – POS Area**

BEK Enviro (BEK) has been commissioned by The Casey Group (TCG) to supervise and validate the installation of the clean cover system required at the former Greenbrow Social Club, Greenbrow Road, Wythenshawe, Manchester, M23 2TU (hereafter referred to as 'the site')

The approved remediation works are detailed in the BEK Remediation & Enabling Works Strategy (REWS), Report Ref: BEK-24100-1 (Rev A), dated October 2024. This letter relates to the validation of the clean cover system only.

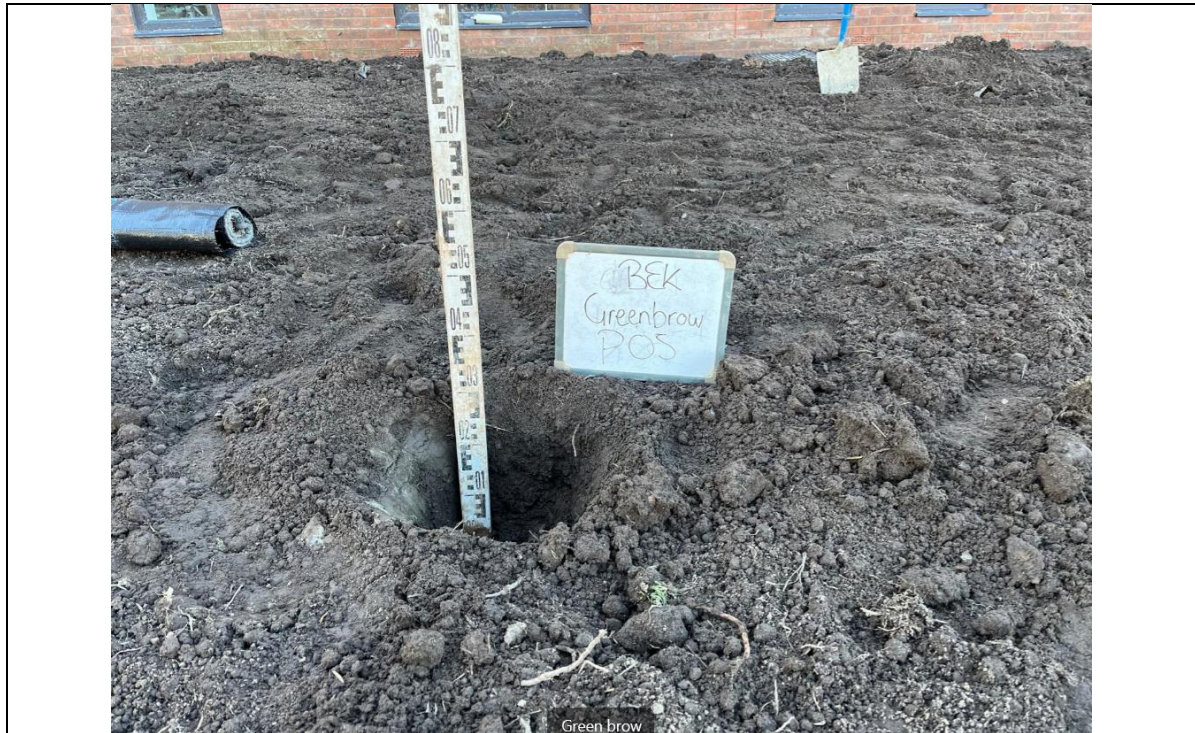
**Photograph 1: Validation of POS**

Following placement of the soils by TCG, an engineer from BEK attended site to confirm that the clean cover system has been installed in accordance with approved remediation recommendations. This was carried out using a validation hole to show the profile of the soils within the capping layer and expose the geotextile at the base. A measuring staff was used to confirm the 300 mm depth. See validation photographs in Annex C.
