# TV RECEPTION SURVEY REPORT

**DATE OF SURVEY:** 16<sup>th</sup> January 2026  
Towers B&C and midrise B (section 1)

VICTORIA RIVERSIDE, Towers B&C, and midrise B (section 1)  
DANTZIC STREET  
MANCHESTER

The development is a new build at Dantzic Street,  
Tower B - 18 Storeys  
Tower C - 26 Storeys  
Midrise section B - 6 Storeys

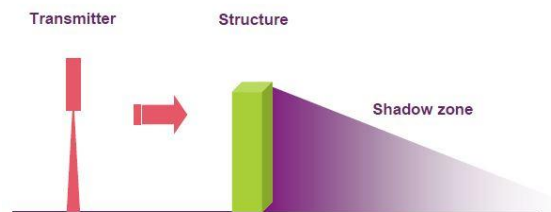
Wireless signals, especially those using relatively high frequencies such as television, behave much like light. Therefore, it is desirable to have a clear line of sight path between the transmitter and a receiving aerial to achieve the most reliable reception. The presence of a tall structure between the transmitter and receiver will cause a 'shadow' to be cast behind the structure on the side opposite the transmitter. This effect is like the way that an obstruction between a lamp and an observer's eye blocks out the light.

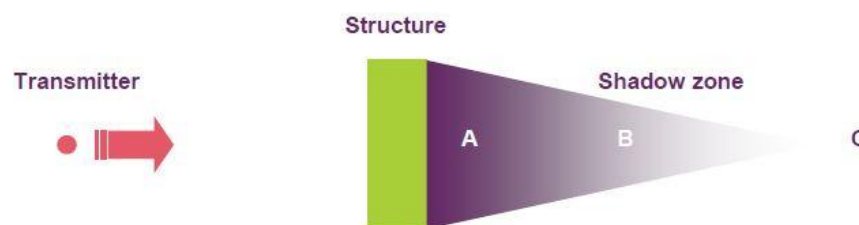
The shadow cast by a structure does not have hard edges though and does not usually extend indefinitely. While there would be a large reduction in signal levels immediately behind the structure, the blocking effect of the structure diminishes with distance because of diffraction. Diffraction is a process where signals appear to bend behind the structure and partially fill in the shadow.

Zone A - close behind the structure (typically a few tens of metres) there may be a large reduction in signal level with a possible complete loss of reception.

Zone B - further away (typically a few hundred metres) the signal reduction is less severe, and the shadow will be smaller as diffraction effects partially fill in the shadow. Depending on the size of the structure, some locations could still lose reception completely.

Zone C - some distance away (1-5km) the shadow will effectively have disappeared. The resulting shadow is therefore a triangular shape as shown in Figure 2.

It should be noted that the severity of the reduction and the actual size of the shadow will depend upon many factors including the construction of the structure and its height – the distances given above are for guidance only.

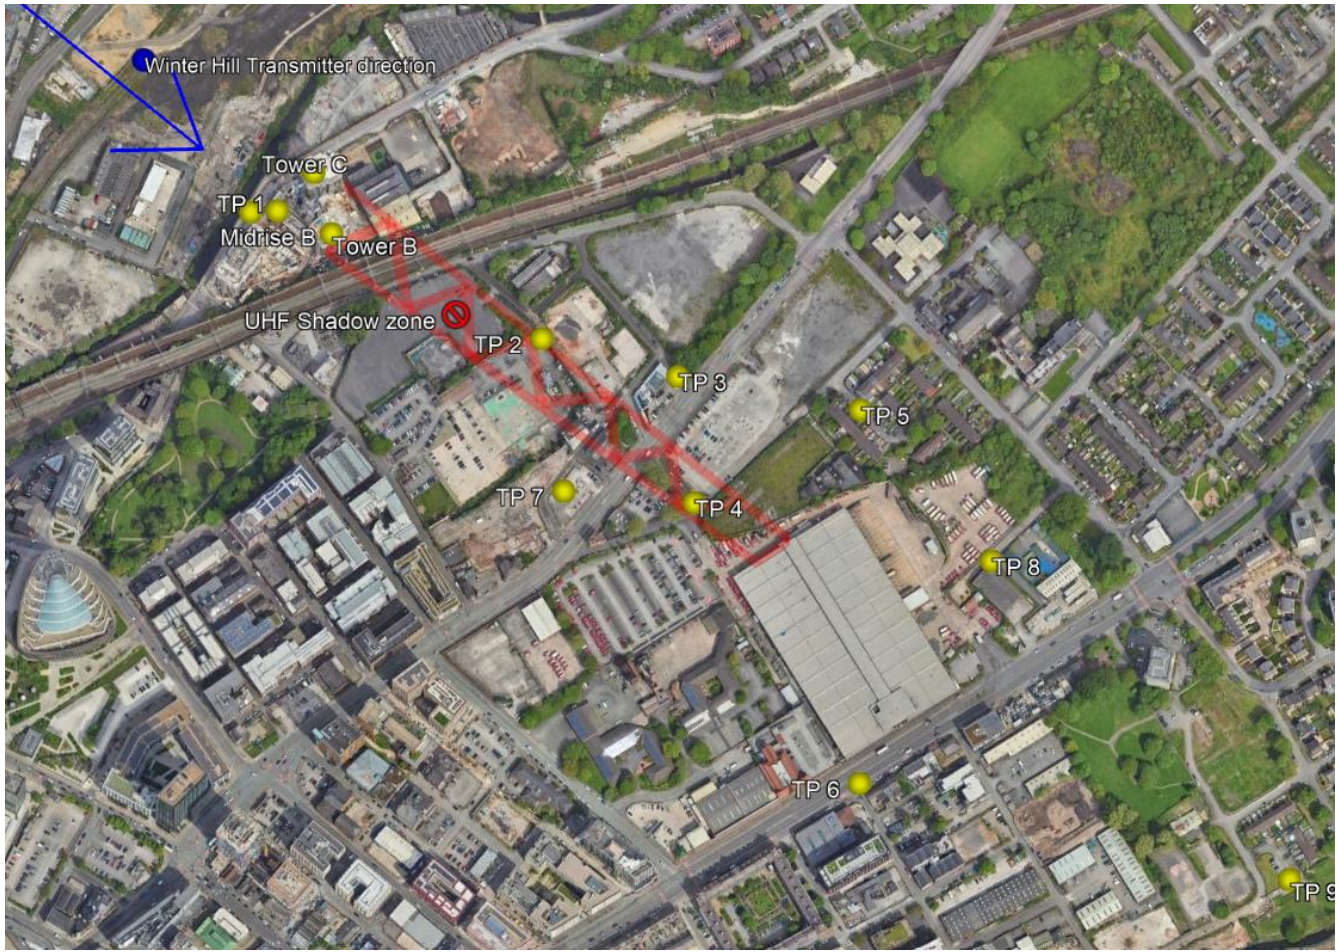
## POTENTIAL IMPACT ZONE – MAP 1

There has been a slight reduction in aerial signal to the southeast of the proposed development covering test points 2 and 4. This is as largely as predicted in the initial pre-construction report, however as this area has predominantly car park areas and only a small amount of commercial properties we expect minor impact.

**The need for such mitigation would need to be determined on a case-by-case basis.**
