# ARBORICULTURAL IMPLICATIONS ASSESSMENT

10 DEER PARK ROAD  
WHALLEY RANGE

Author: C. Salisbury  
Date: 01 November 2025  
Ref: TRE/10DPRWR/Rev B

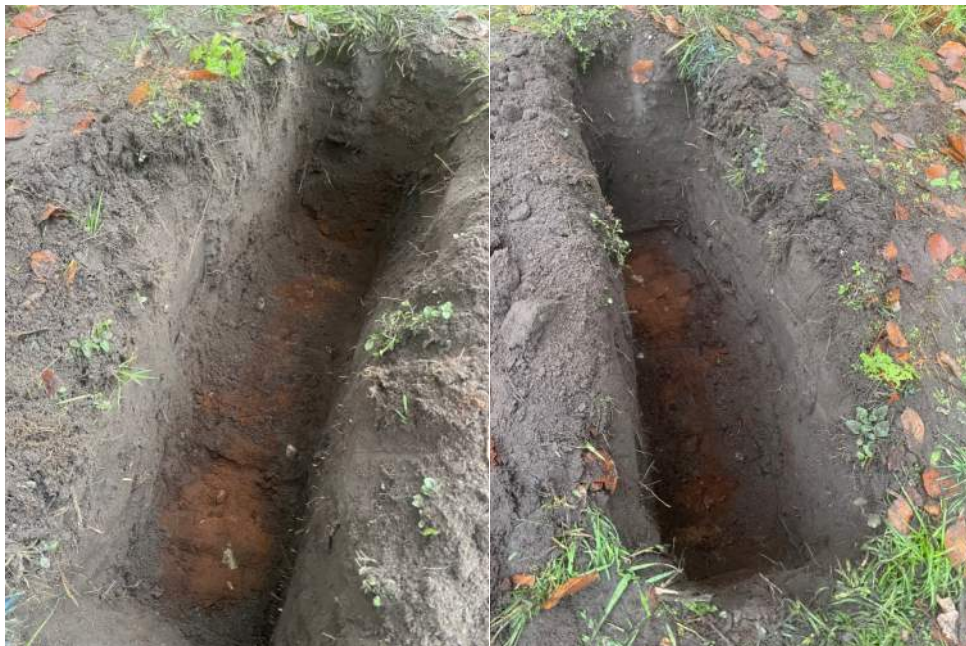
5.1.6 In terms of the extension and the rooting environment within the foundation as requested a trial hole has been dug which identified the presence of fibrous roots only (see below images). As detailed within BS5837:2012 section 7.2.3 roots smaller than 25mm may be pruned back; furthermore section A.2.2 advises that the fine roots are short-lived, with the majority dying each winter and new ones developing in response to the needs of the tree. Taking this into account it is felt that the severance of these roots conforms with BS5837 and would be acceptable.

5.1.5 The foundation design for the extension and its encroachment into G1 will be slightly deeper. This is due to the need to get a internal floor build up and carry the levels through the house at a similar level. Again details of how the foundation is to be installed are contained within the supporting Arb Method Statement.

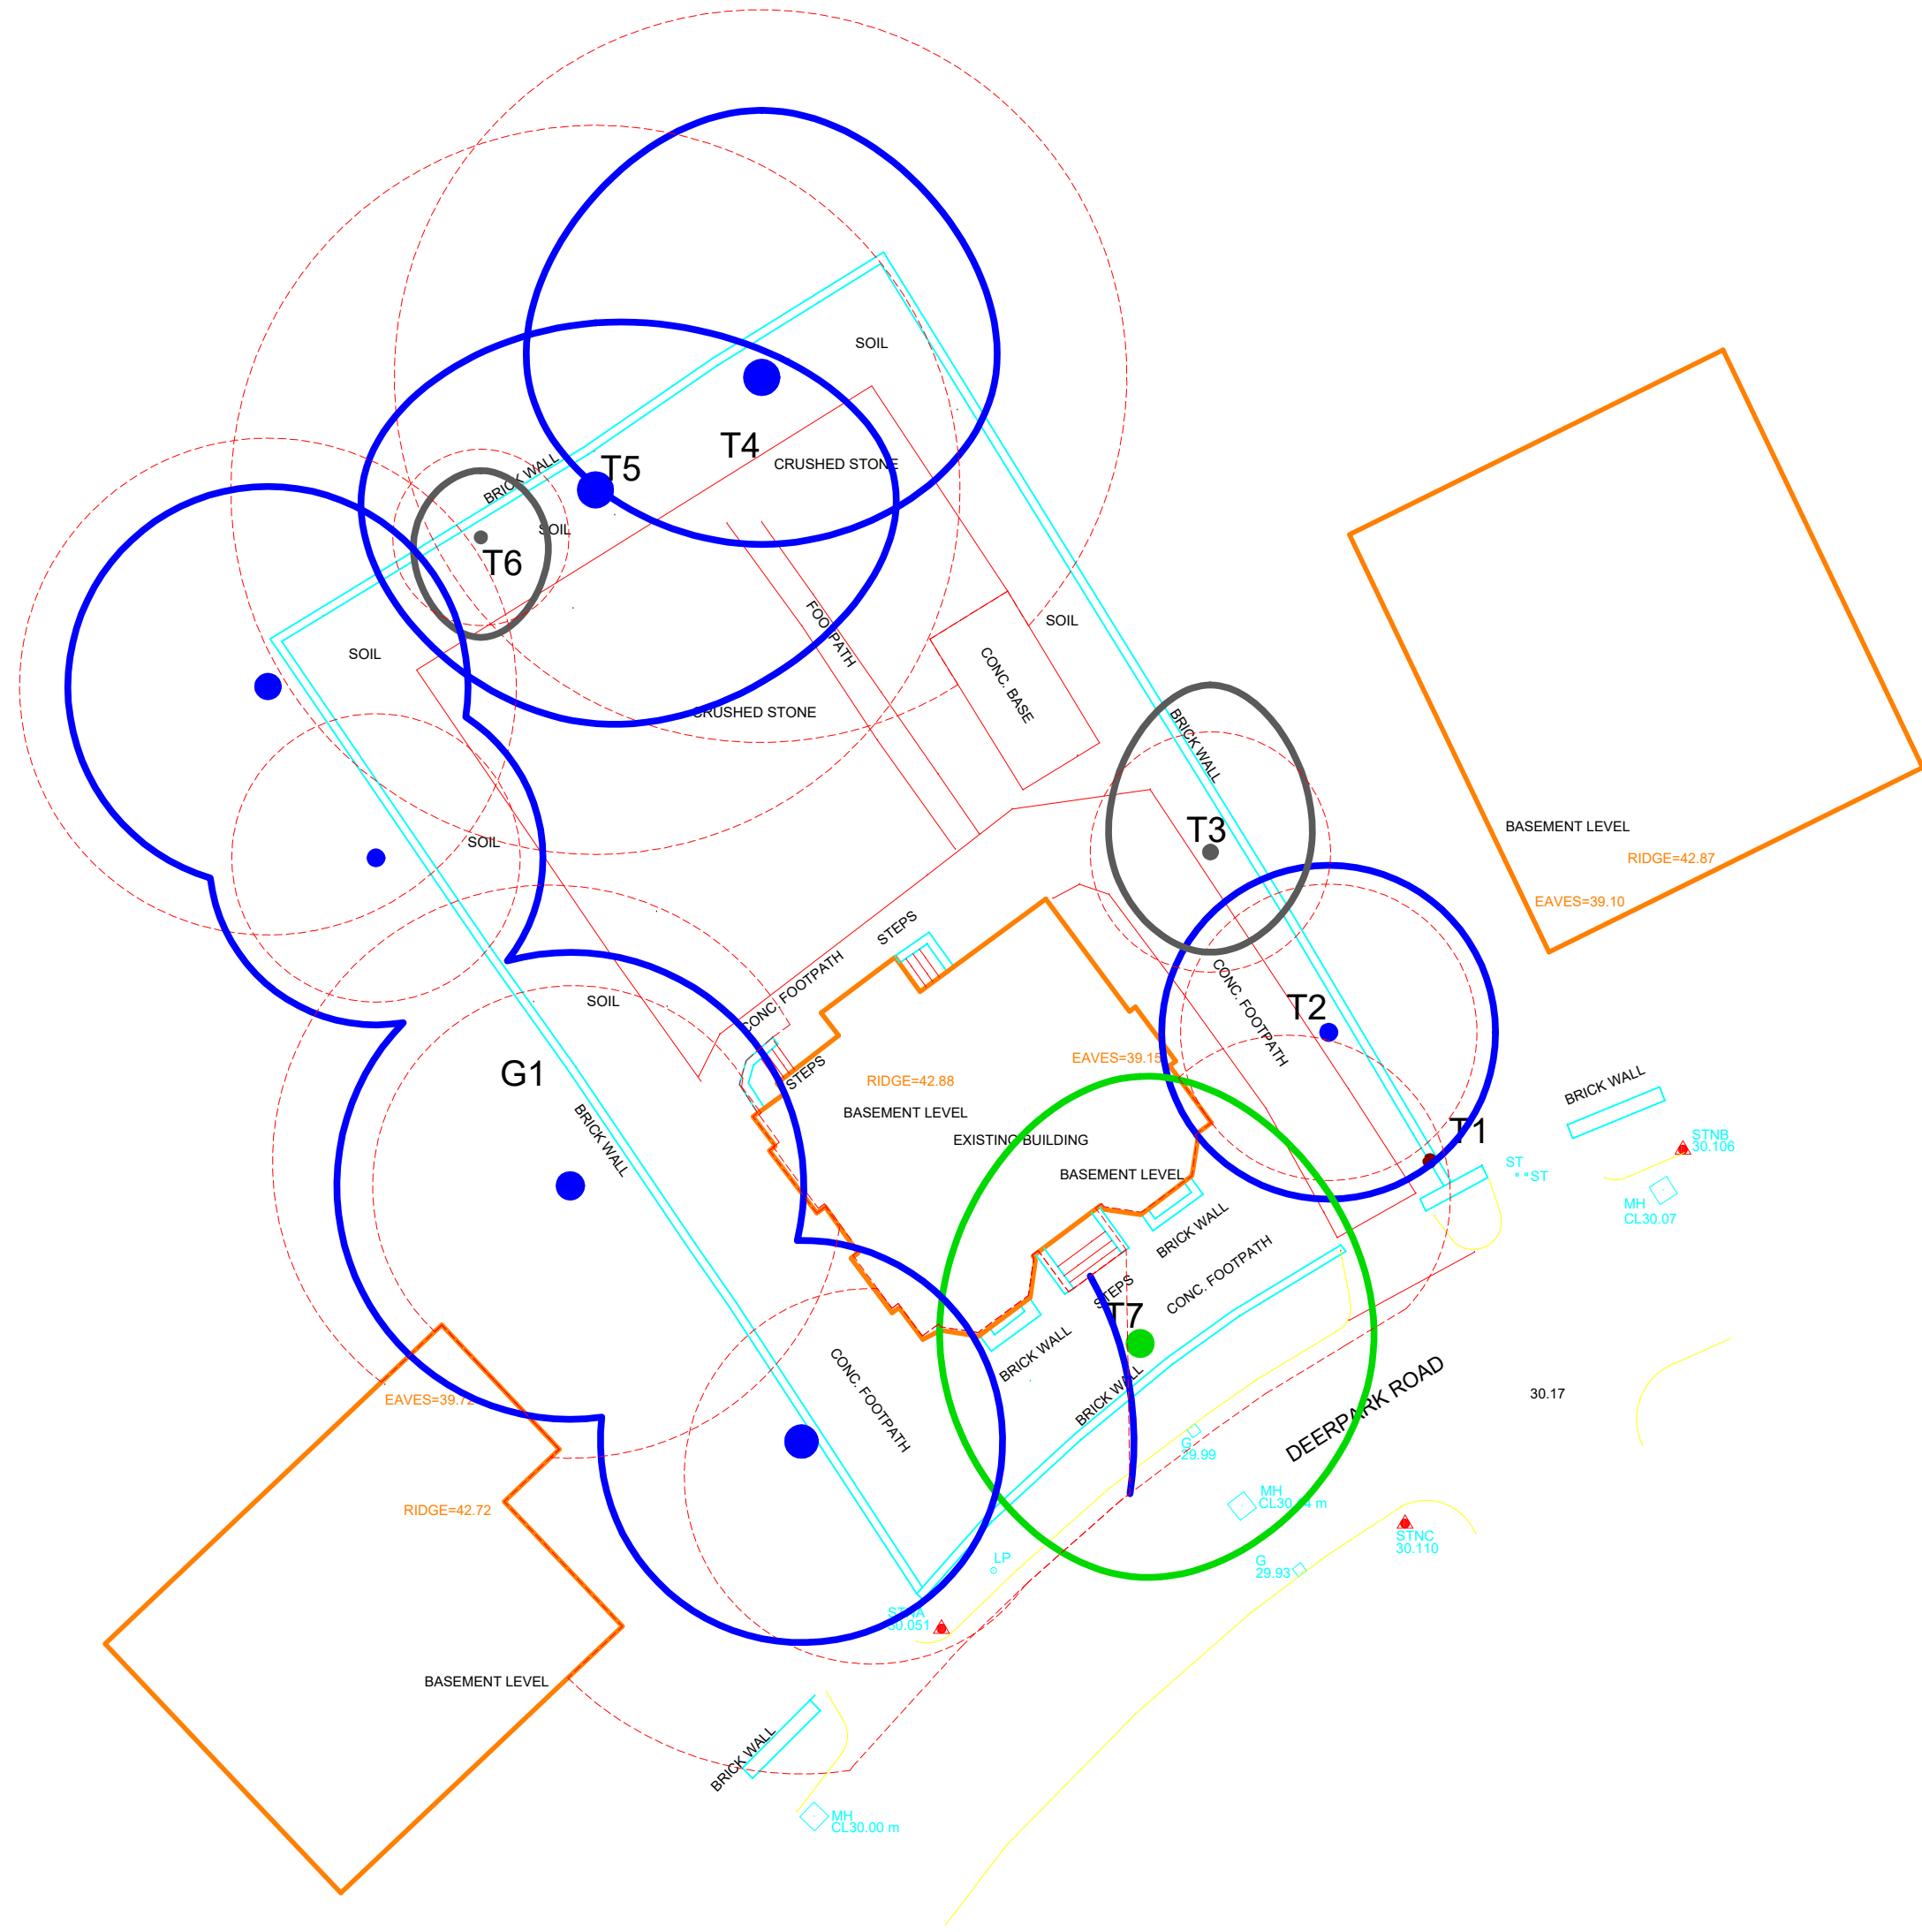
Drawing Title:  
BS5837 Plan

Root protection area

- 3.1 Due to the proposed development and its associated infrastructure there are a number of locations where the proposals are in close proximity to the trees surveyed. The Site Layout Plan within appendix three identifies the trees in relation to the proposed development.
- 3.2 In order to fully assess the impact of the proposals an Impact Table has been created detailing each tree, which shows the proximity of the associated works to the tree.
- 3.3 This can then be assessed in accordance with BS 5837:2012 to determine whether the development will have a detrimental impact on the health of each tree. Once this has been determined remedial measures can be detailed to reduce the impact the proposals will have on the treescape.

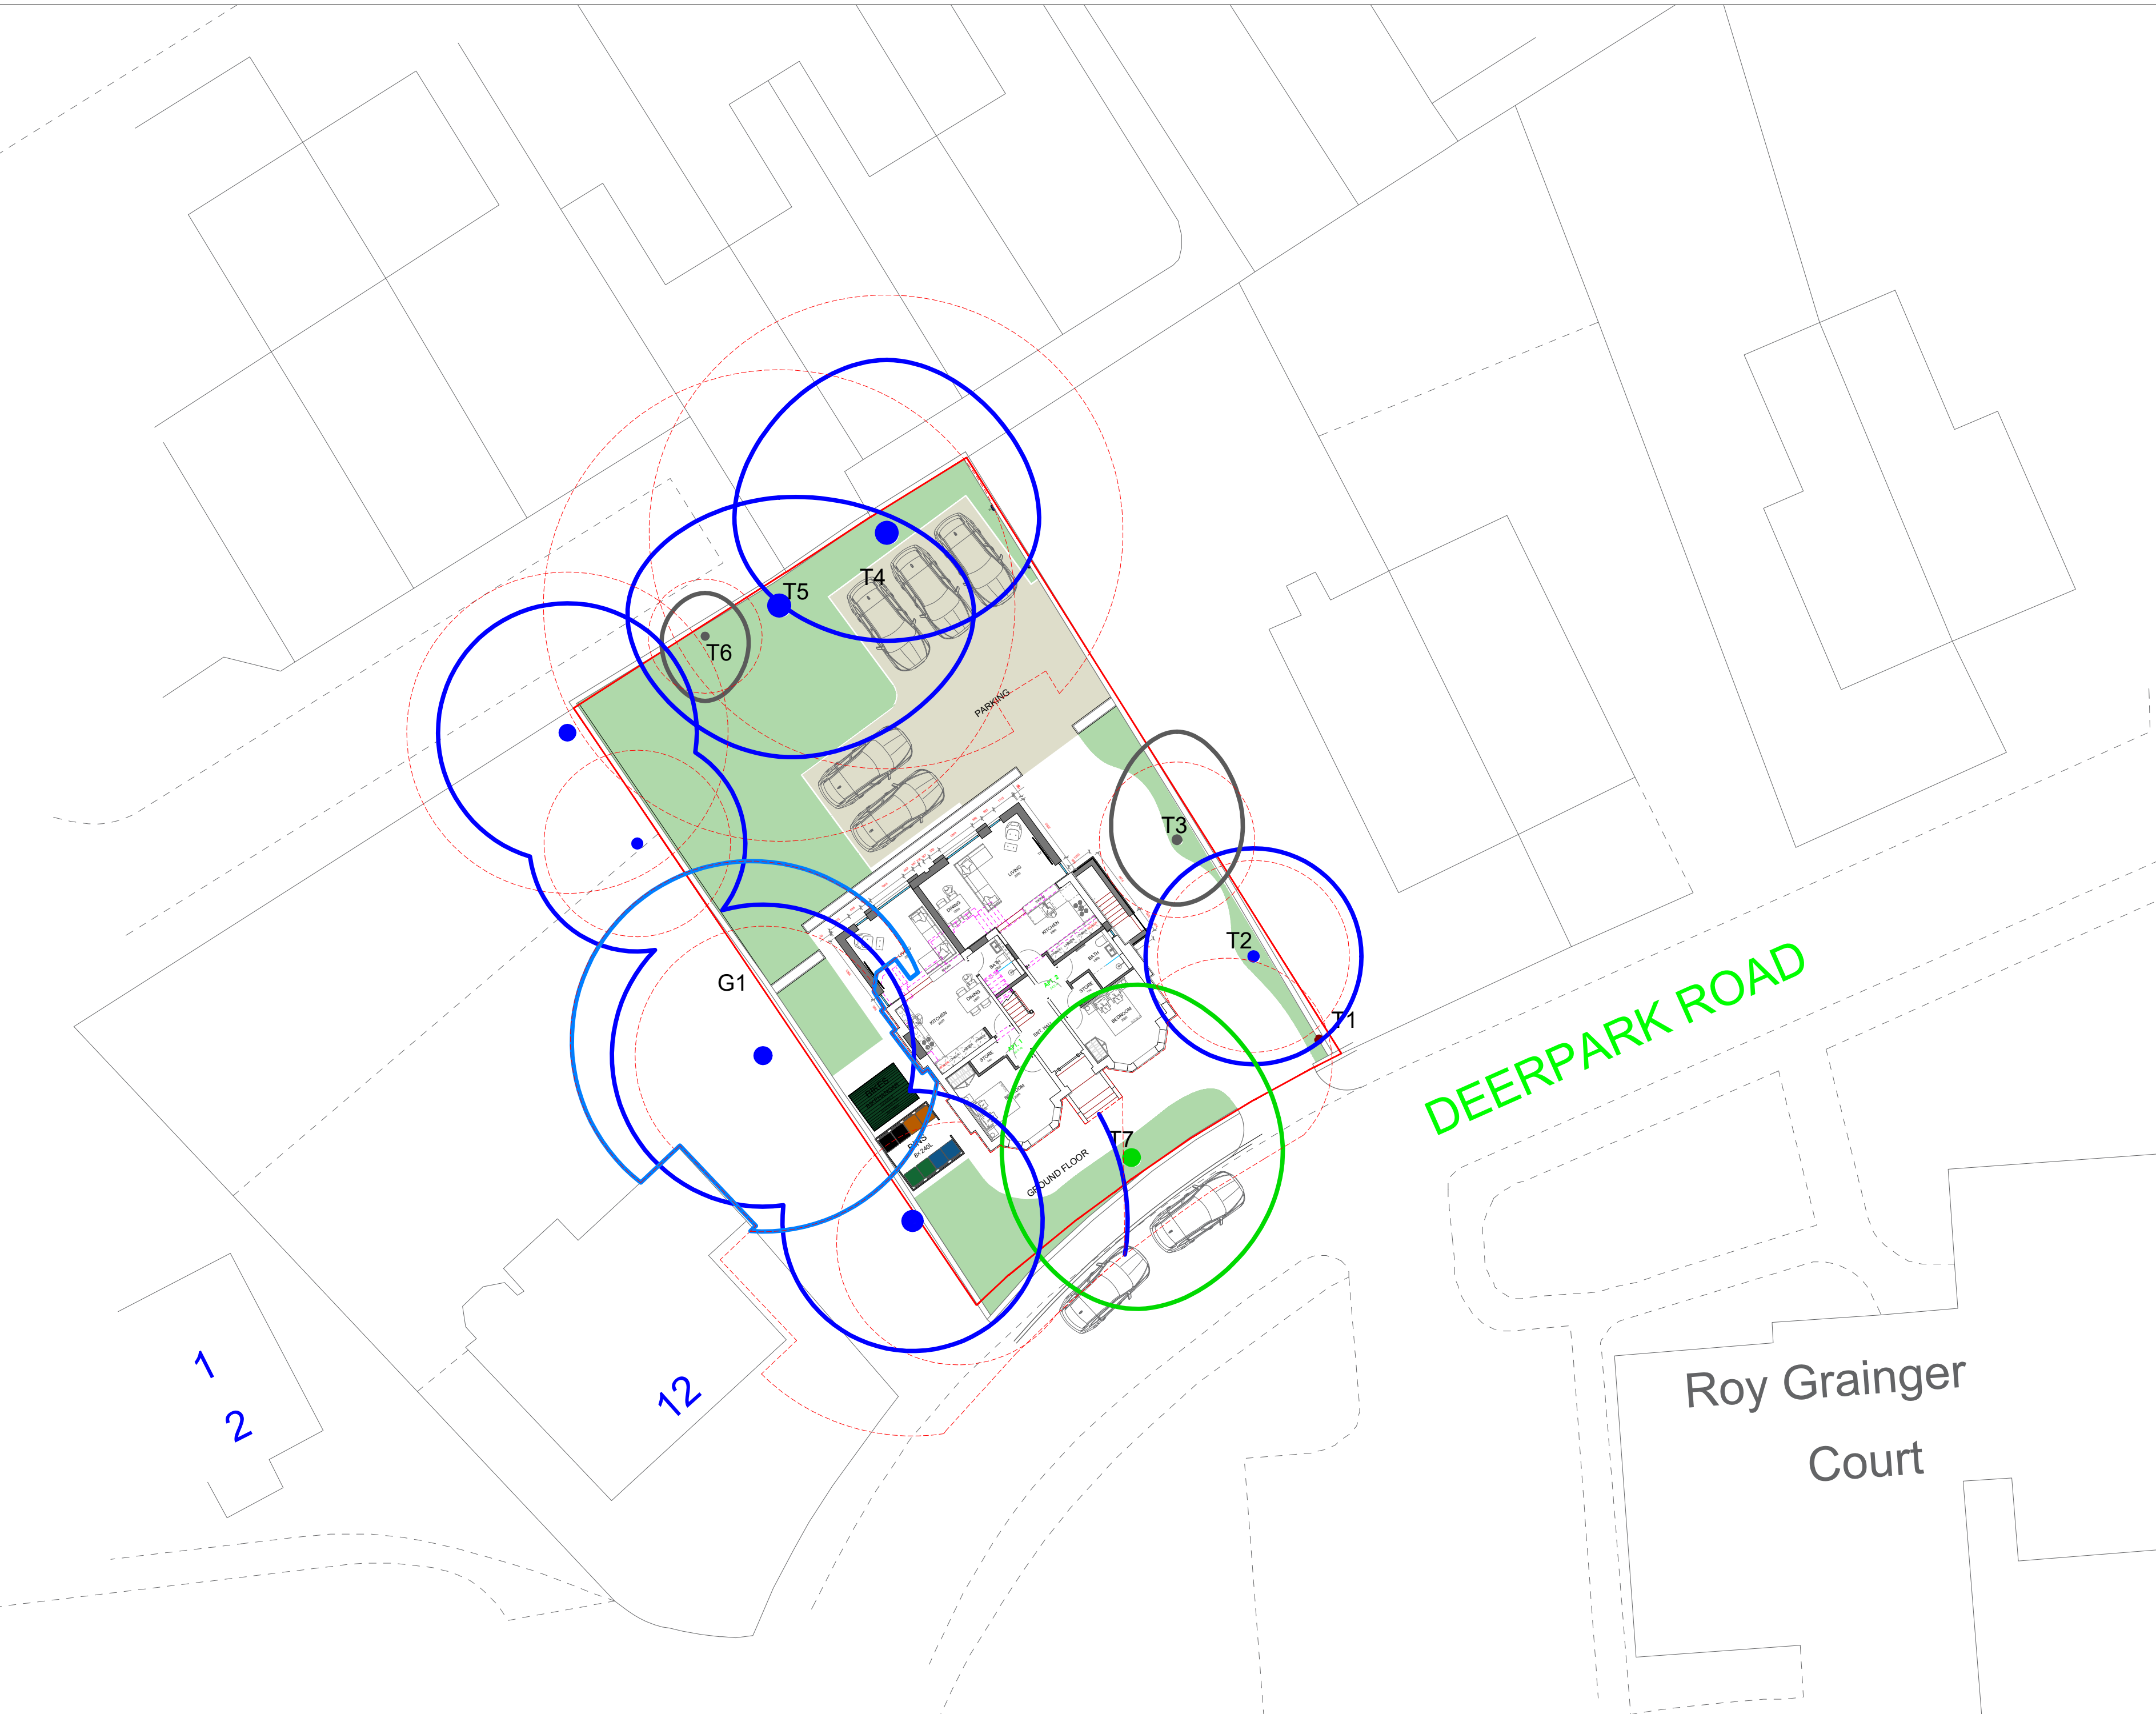
Drawing Title:  
AIS Plan

Root protection area
