# Terrestrial Television and Radio Baseline Survey Report

C2 The Birtles

Muse Places Limited and Wythenshawe Community Housing Group

November 2025

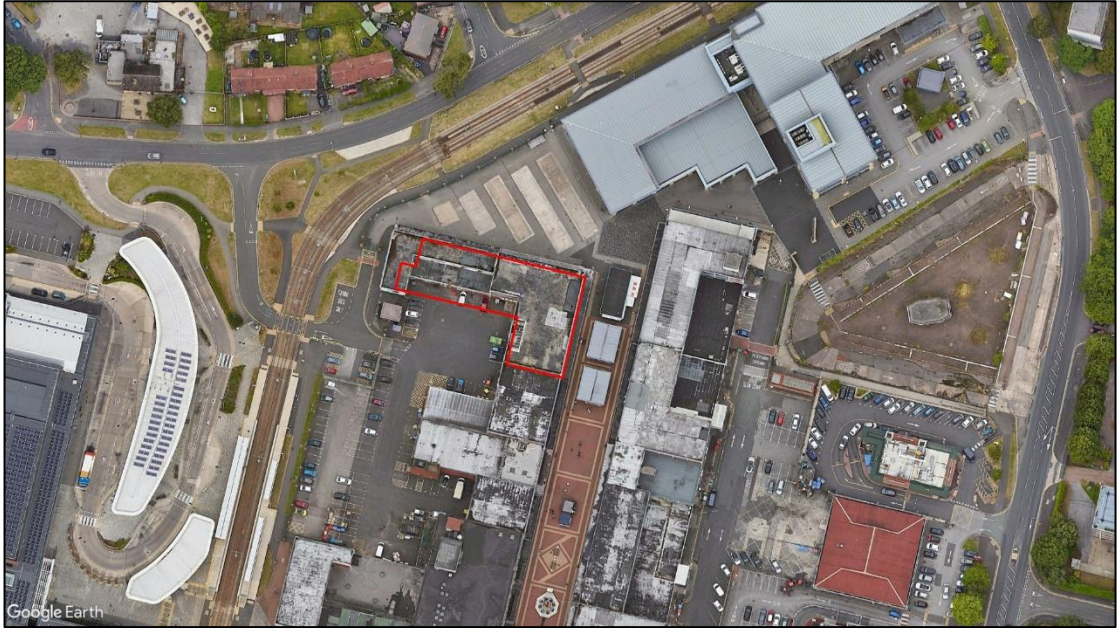
Figure 2 Proposed development site layout (red) – aerial image

The approximate development footprint (red) overlaid on aerial imagery is shown in Figure 2 below.

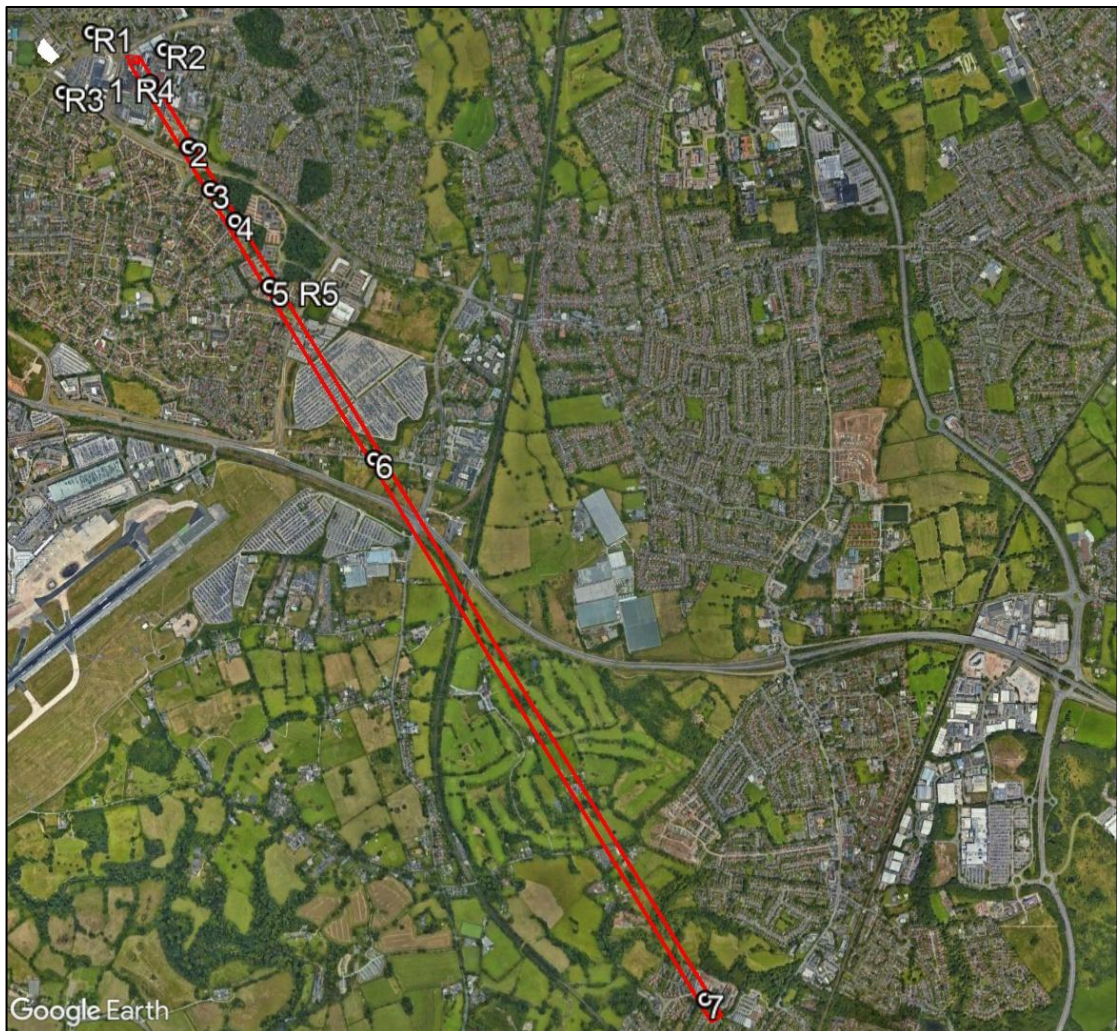
Figure 7 Survey locations

Figure 7 below shows the survey locations overlaid onto aerial photography. The development location and the shadow zone are also shown. More readings are typically carried out closer to the building. This is because interference is generally more likely the closer the location is to the obstruction. Survey locations were chosen pre-survey (within the shadow zone); however, safe and available access influenced the specific position on the day. Figure 7 shows the actual survey locations. Television measurements were taken at survey locations 1 to 7, and radio measurements were taken at survey locations R1 to R5. No suitable survey locations within the shadow zone that were accessible during the survey were found between locations 5 and 6, and 6 and 7.
