# Preliminary Roost Assessment and Ecological Walkover

541 Wilbraham Road, Chorlton-cum-Hardy

Reference: 82-194-R1-2

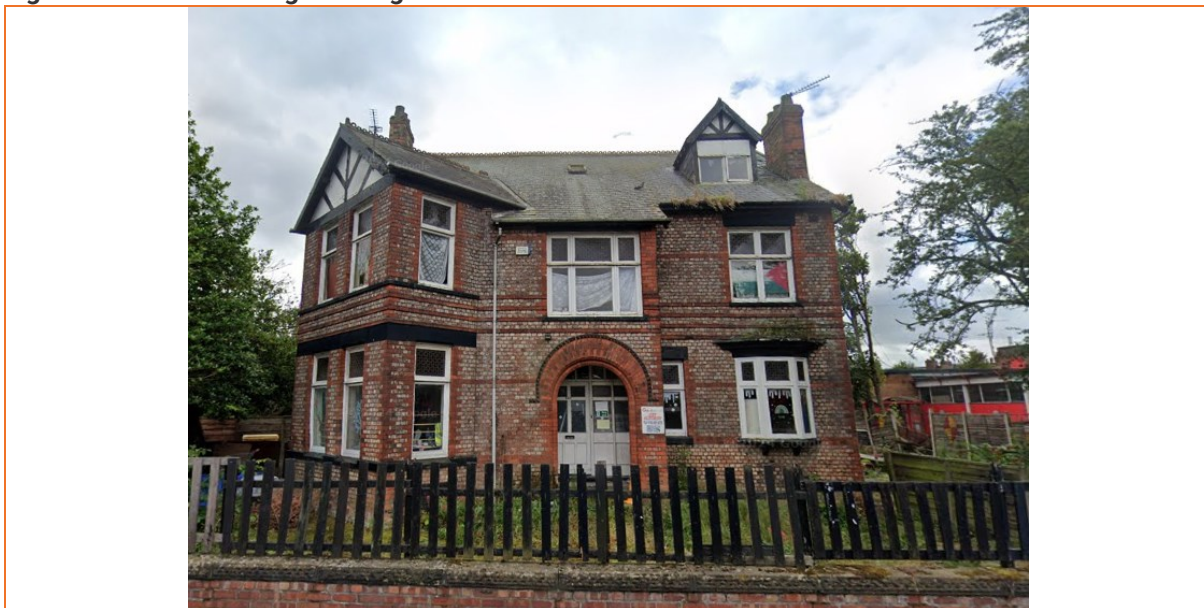
**Figure 3**      **Showing Building Exterior**

The building comprises a three-storey detached house. The building has previously been used as a daycare centre but was unused and had become derelict. The building is constructed with a red brick exterior with a number of gable ends and extensions that have been added to the structure. The building has a steep slated roof that was in relatively poor condition and much of the roof now has moss growing across it. Furthermore, numerous cracks within the brickwork, particularly surrounding the windows, were identified which are likely to provide roosts for crevice-dwelling species. No features allowing internal access were visible from the building's exterior from the ground-floor perspective.

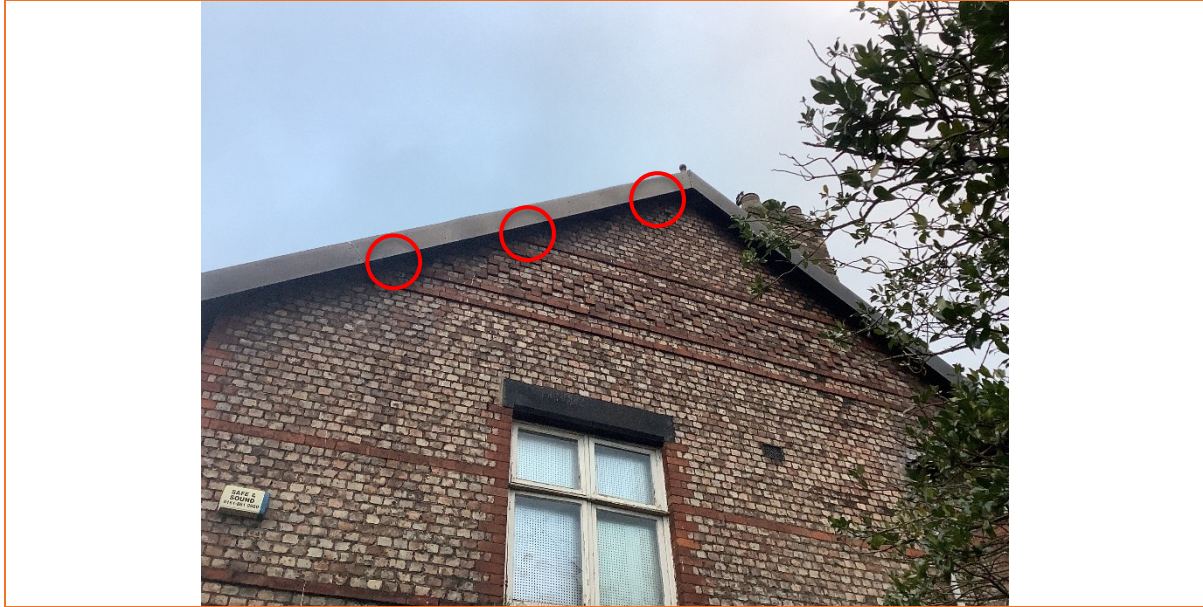
**Figure 4** Showing Features A, B, C

Small gaps between the soffit and gable end were identified on the eastern-facing (Features A-C, north-east facing (Feature D, north-facing (Feature E) and west-facing (Features F & G) aspects of the building. As these features were approximately between 5 and 10 m high, close inspection to determine their depth/internal access was not possible. However, it is likely these gaps may provide roosts for a small number of bats on a regular basis, particularly during the summer months.

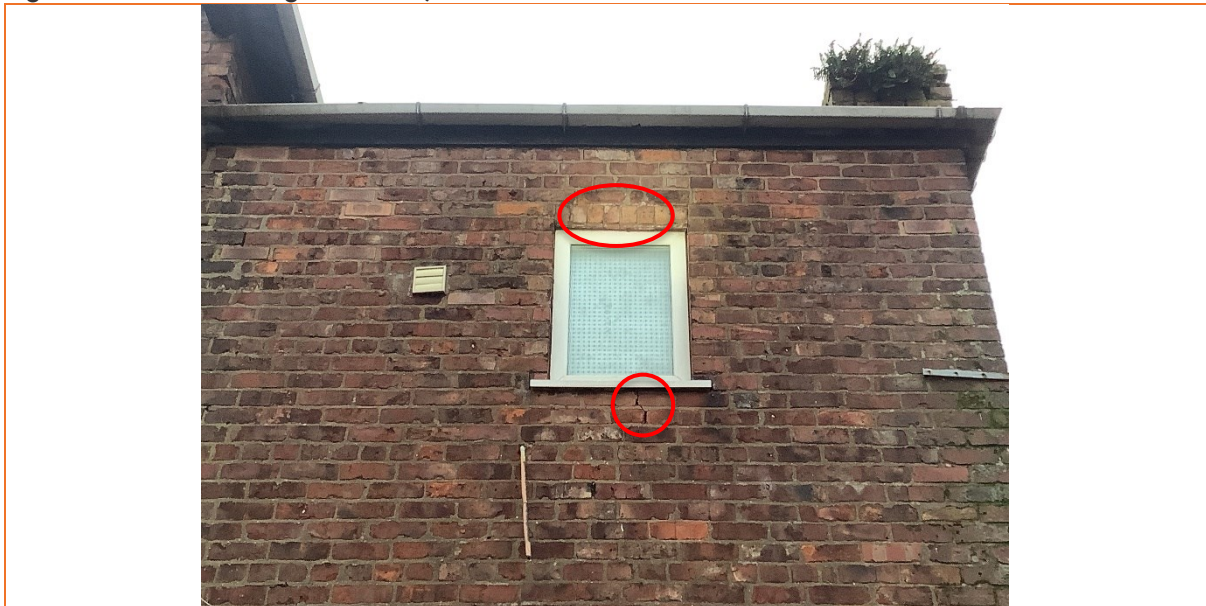
**Figure 9** Showing Features I, J

Additionally, numerous cracks in the brickwork were identified on the building's exterior, predominantly on the building's western aspect. Features F and G were around 5 m and 4 m high respectively underneath the soffit. Elsewhere, features H-L were clustered in close proximity and descended from 4 m high (H) to 1 m (L). Features H, I and J were surrounding windows, while K and L were beneath piping. Given that the building has been unused for some time, the amount of disturbance from noise and light is reduced, which increases the potential for these external cracks and cavities to be utilised by crevice-dwelling species, despite the drainpipe potentially limiting access to K and L. Furthermore, given the number of features and their size and depth, small numbers of bats may utilise these on a regular basis.

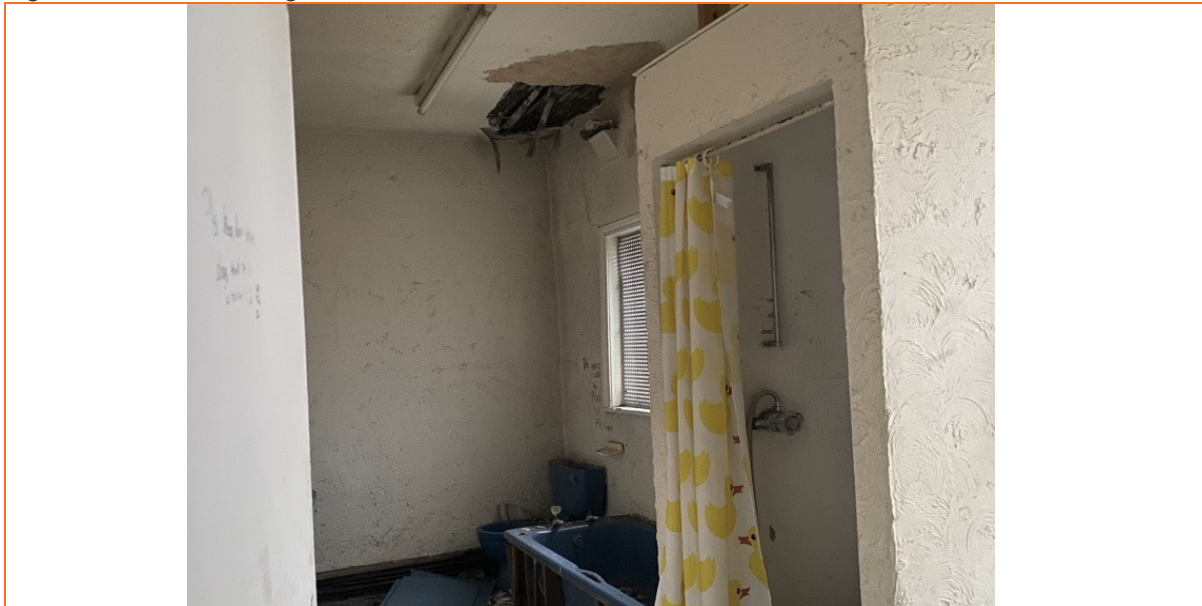
**Figure 11** Showing Ground Floor

The interior of the ground floor is in relatively good condition. All windows have been blocked up using metal screens, limiting internal access at this level. No features that would allow internal access, bat droppings or field signs were identified on the ground floor.

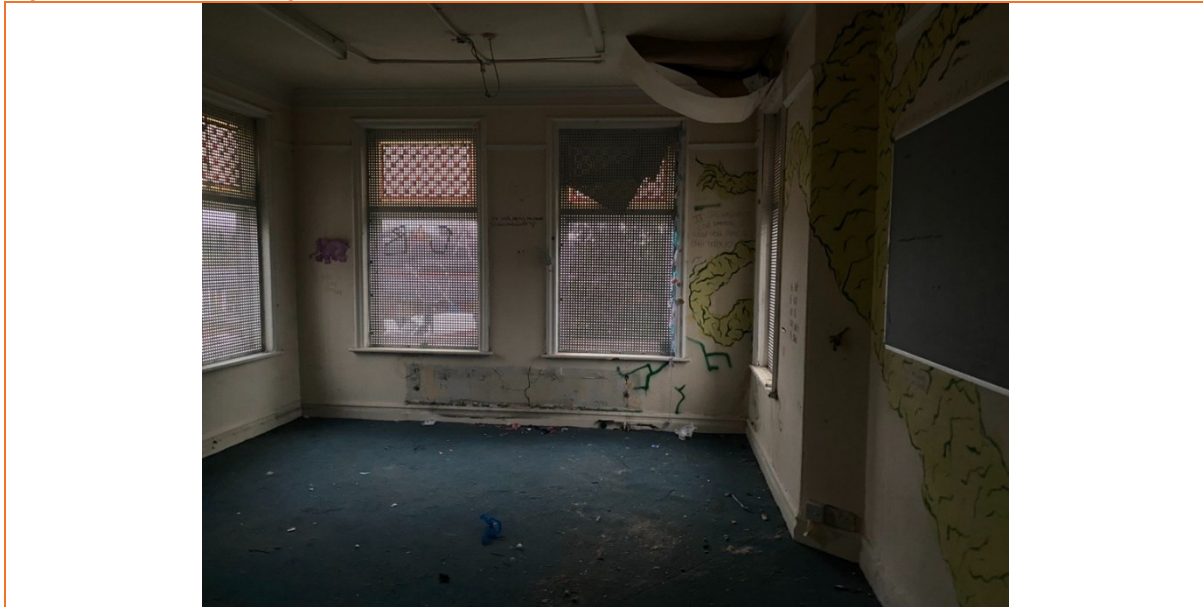
Figure 12 Showing First Floor

The first floor contains a number of small rooms. As with the ground floor, all windows are blocked up using metal screens. As such, internal access at this level was not possible and no field signs or droppings were identified.

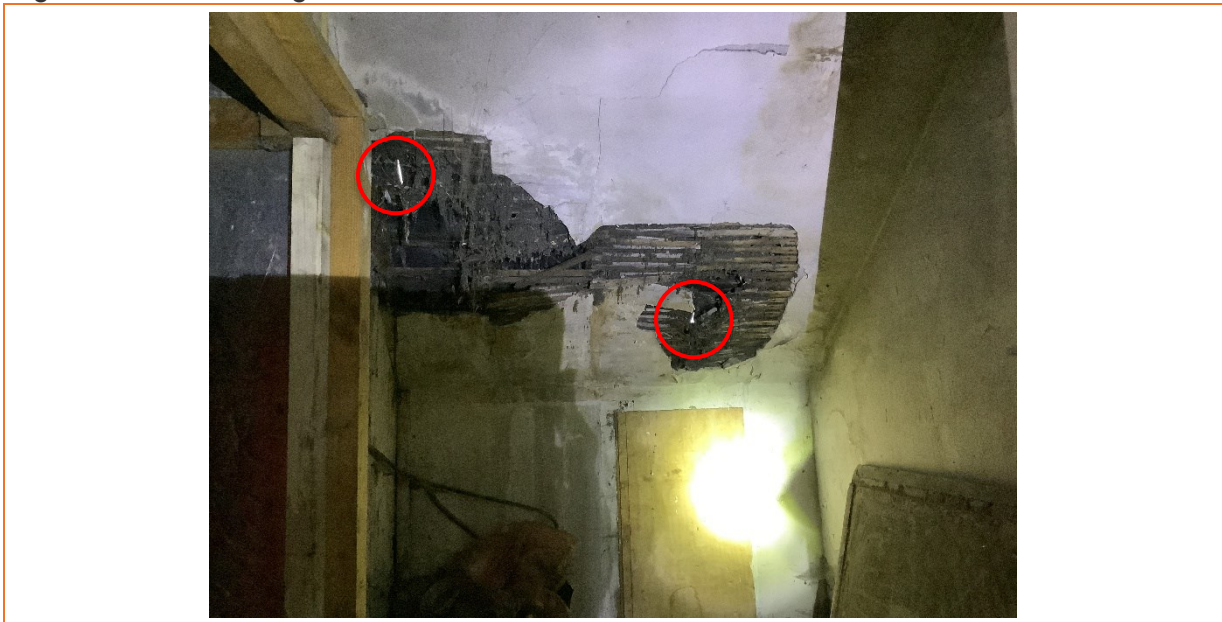
**Figure 14**      **Showing AP1 and AP2**

The second floor is in a state of disrepair. Two access points were identified on the north-facing aspect of the building (AP1 & AP2); gaps in the roof tiles and underlying ceiling had collapsed due to water damage and exposure. No other access points were visible, however, two holes in the ceiling were identified in a room in the north of the building (Features M & N), through which feral pigeons (*Columba livia*) could be heard. While not visible from within the building, the presence of birds suggests internal access is possible through the roof. No bat droppings or field signs of bats were identified on the second floor.

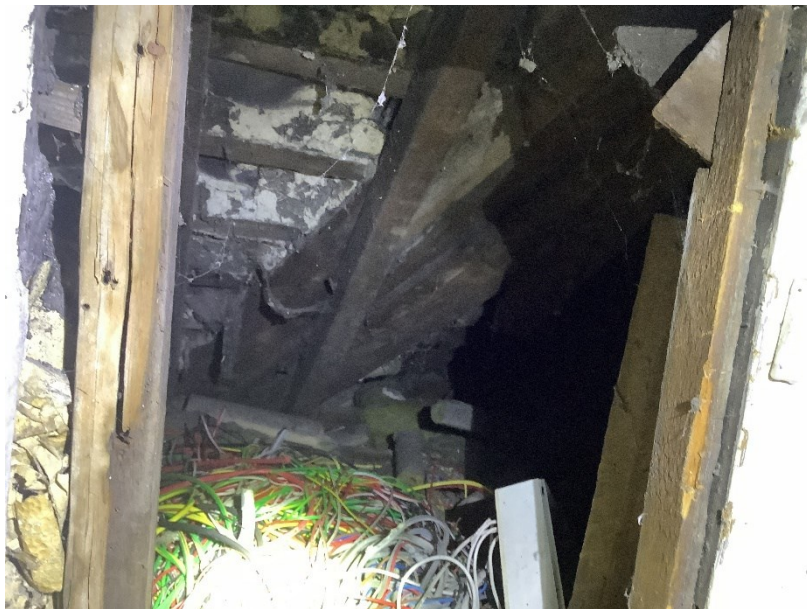
**Figure 17**      **Visible loft interior**

However, the building is deemed as being unsuitable for high-value roosts, such as hibernation and maternity roosts. This is due mainly to the location of the building, as the surrounding urban development and associated disturbance limits its suitability for maternity roosts. Furthermore, as Figure 17 shows, there is no roof lining where the loft interior is visible, meaning a stable internal temperature is unlikely. Finally, AP1, AP2 and features M and N all appeared to be caused by water damage; if a leak in the roof is present, it is unlikely the loft will be suitable for high-value roosts. Therefore, two Nocturnal Bat Surveys spaced three weeks apart are required between May and September (inclusive) on the building with at least one survey undertaken between May and August (inclusive). If bats are identified roosting within the building, a further survey would be required to characterise the roost and a European Protected Species Licence will be required, with up-to-date surveys from the survey season prior to the application submission.
