# Terrestrial Television Baseline Survey Report

Ellesmere Manchester Operations Ltd

The Trilogy

September 2025

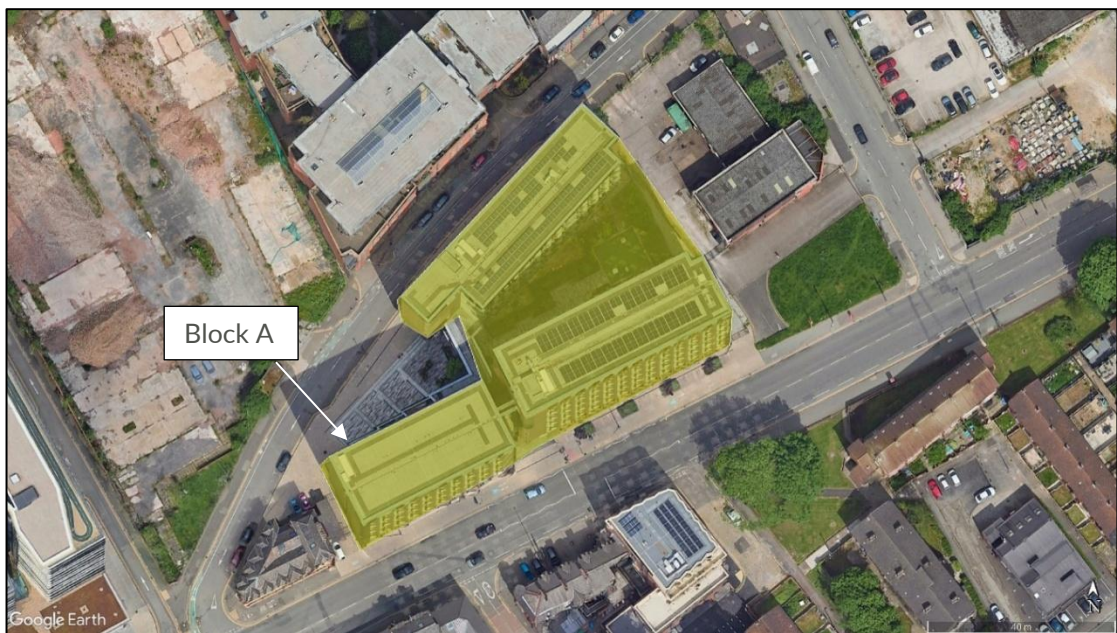
Figure 1 Google earth imagery of the trilogy buildings highlighted in yellow

The existing block A is to be made taller by a floor. There is a ground floor extension planned however this hasn't been assessed in detail as it won't affect TV reception. The location of the existing trilogy building is shown in Figure 1 below.

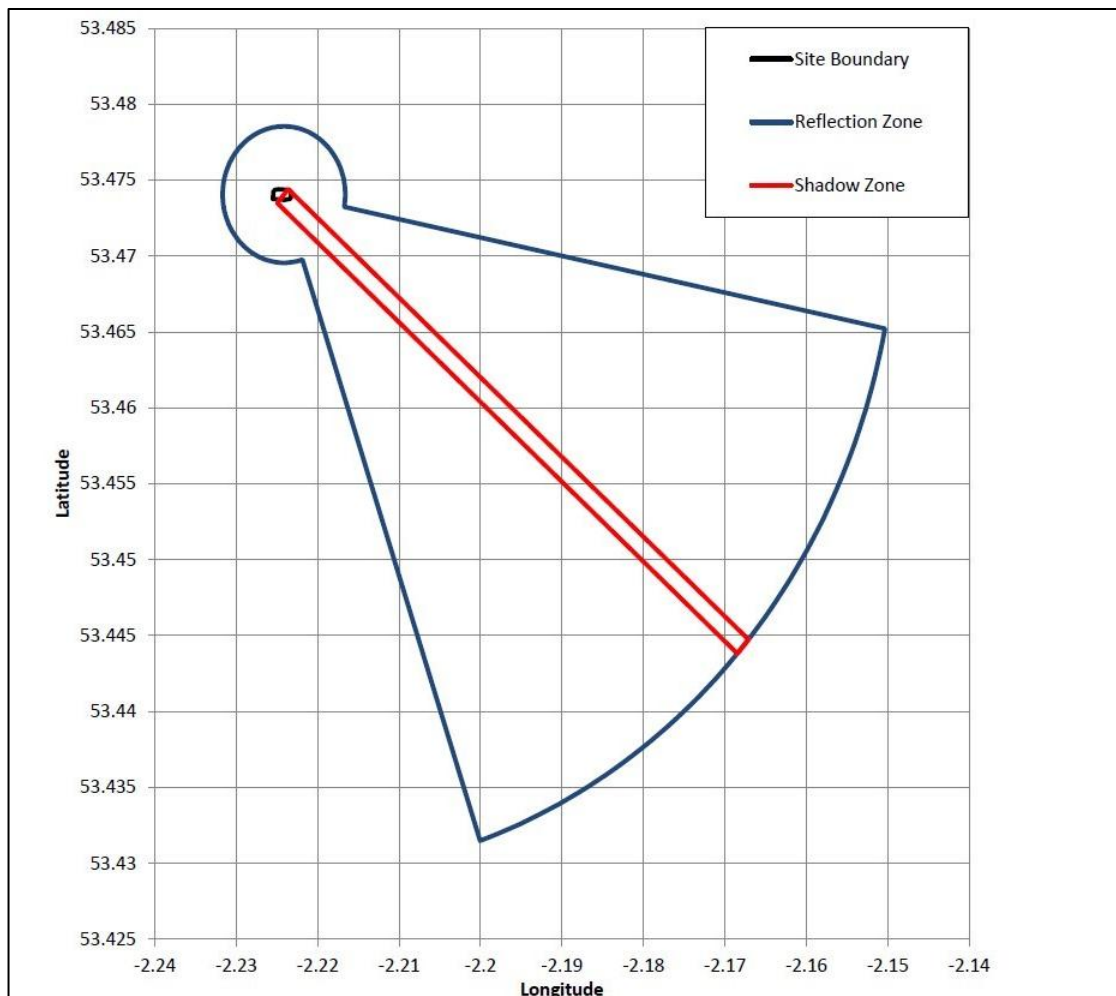
Figure 4 Interference areas

The shadow and reflection zones have been defined based on the geometry as set out in the previous section. Both zones extend to a distance of 5km beyond the development location in accordance with the Ofcom guidance.

In the case of the shadow zone, this has been modelled as having straight sides in order to be conservative. In actuality, due to diffraction effects, the zone would have a more triangular shape as shown in Figure 3 in the previous section. Figure 4 below shows the potential interference areas associated with the existing building and the proposed extensions.

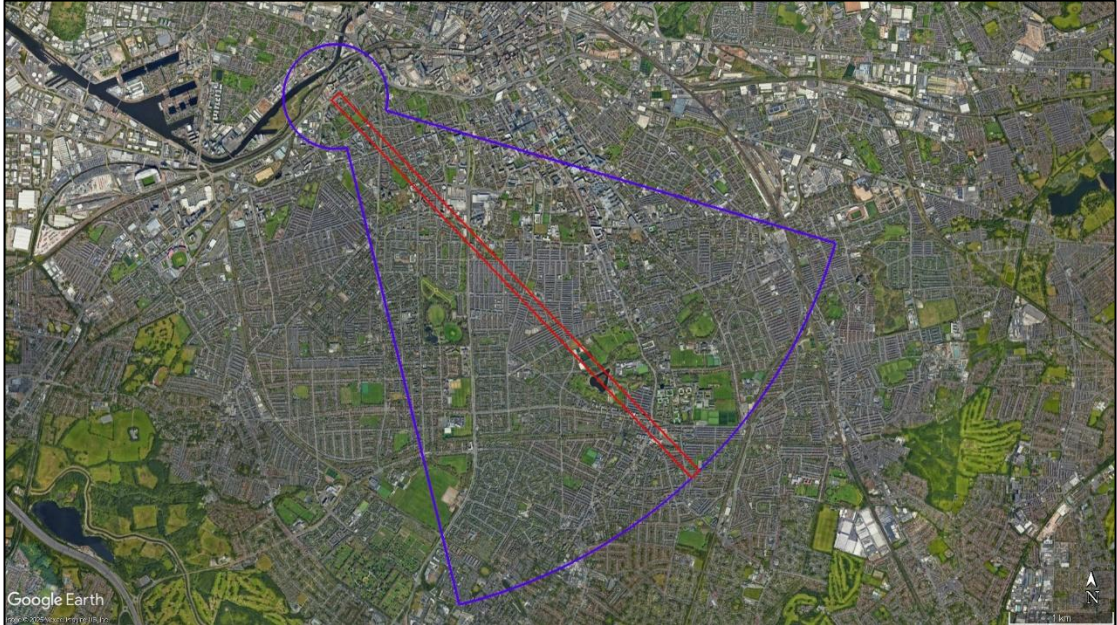
Figure 5 Interference zones map

Figure 5 below shows the interference zones overlaid onto aerial imagery.

The shadow zone passes over urban areas that contain commercial and residential buildings. Areas closest to the development are at the highest risk of experiencing television interference. This is typically limited to 1km based on Pager Power's assessment experience. Commercial buildings and multi-storey flats are located within 1km of the development shadow zone.

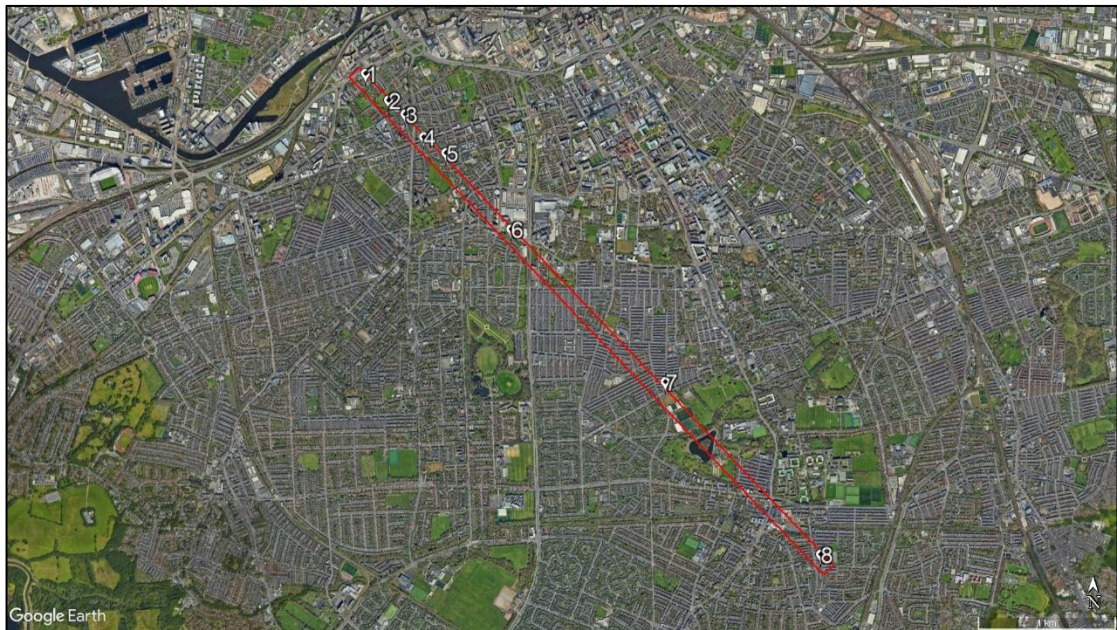
Figure 6 Survey locations

Figure 6 below shows the survey locations overlaid onto aerial photography. More readings are typically carried out closer to the building. This is because interference is generally more likely the closer the location is to the obstruction. Survey locations were chosen pre-survey (within the shadow zone); however, safe and available access influenced the specific position on the day.

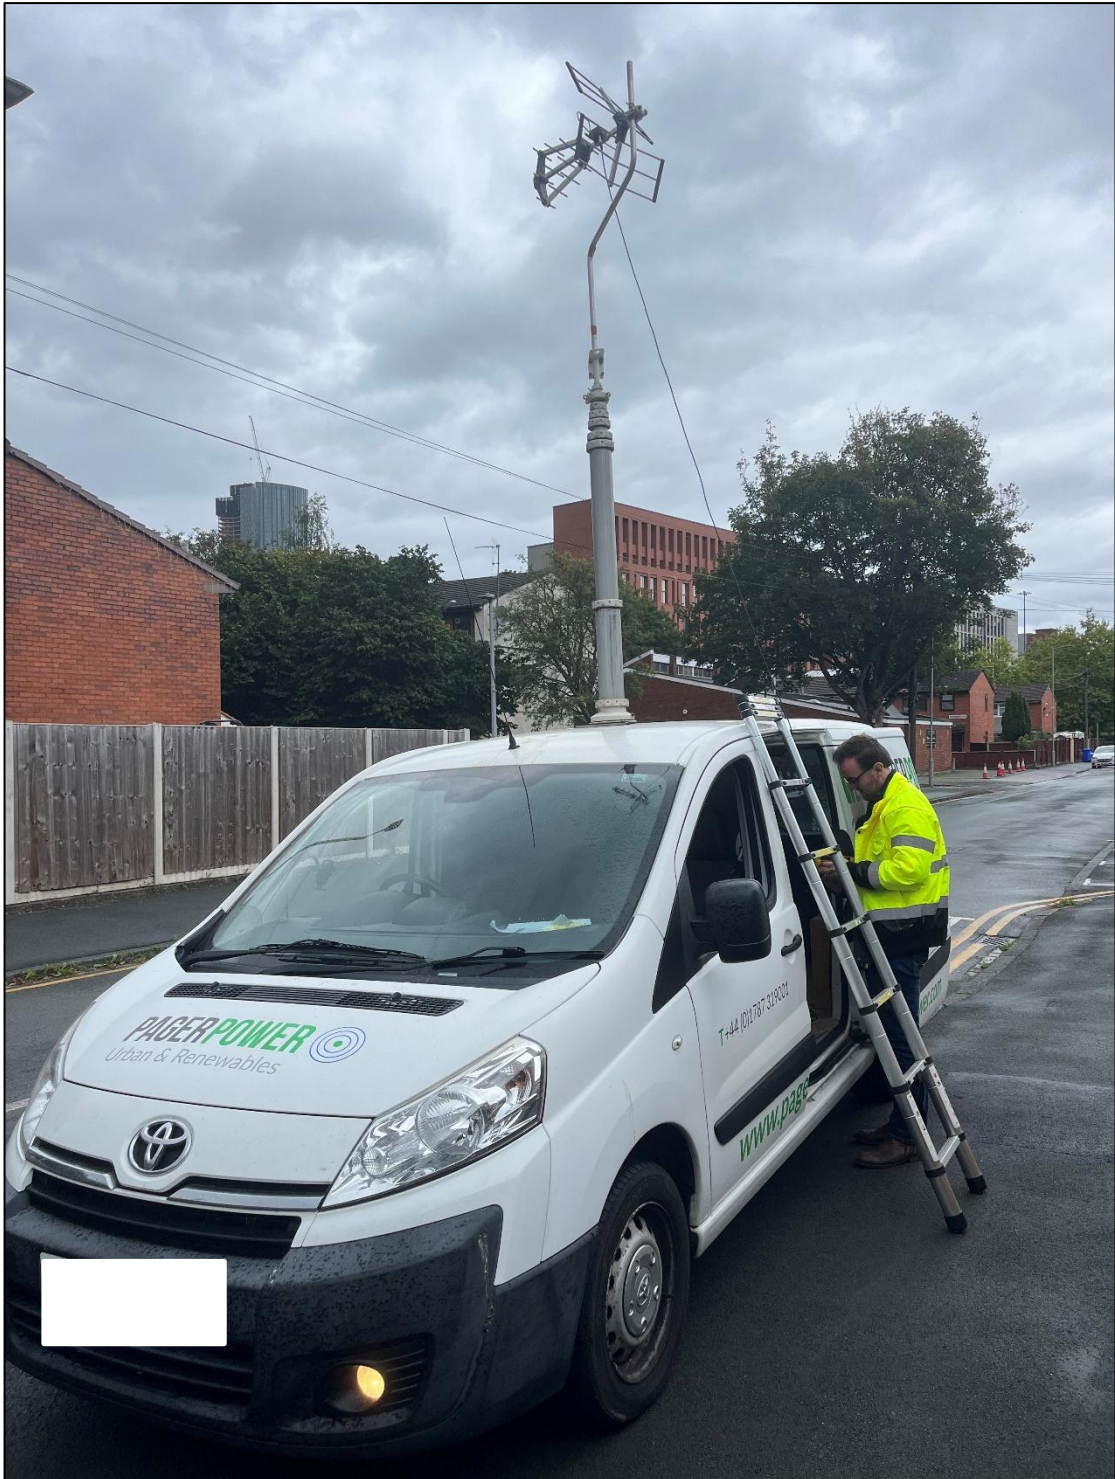
### Location 1

| Location | Average Measured Signal Strength (dB) | Remarks | High Level Conclusion |
|---|---|---|---|
| 1 | <p>Average: 44.7 (Moderate)</p> <p>Main TV MUX: 47.9 (Good)</p> <p>Local TV MUX: 35.1 (Moderate)</p> | <p>Multiple horizontally polarised aerials and satellite dishes were observed.</p> <p>All main multiplexes displayed fine picture and audio quality. An average of good signal strength and signal fluctuations of less than or equal to 0.3dB.</p> <p>One local multiplex displayed fine picture and audio quality. The other local multiplex did not decode. An average of moderate signal strength and signal fluctuations of less than or equal to 0.1dB.</p> | <p>The survey location was within 150m of the proposed development and within its shadow zone. A reduction in signal strength is possible based on the proximity to the development. Effects in this area are likely to be low but cannot be entirely ruled out, particularly for the local multiplexes.</p> |

Notes; Multiple horizontally polarised aerials and satellite dishes observed.

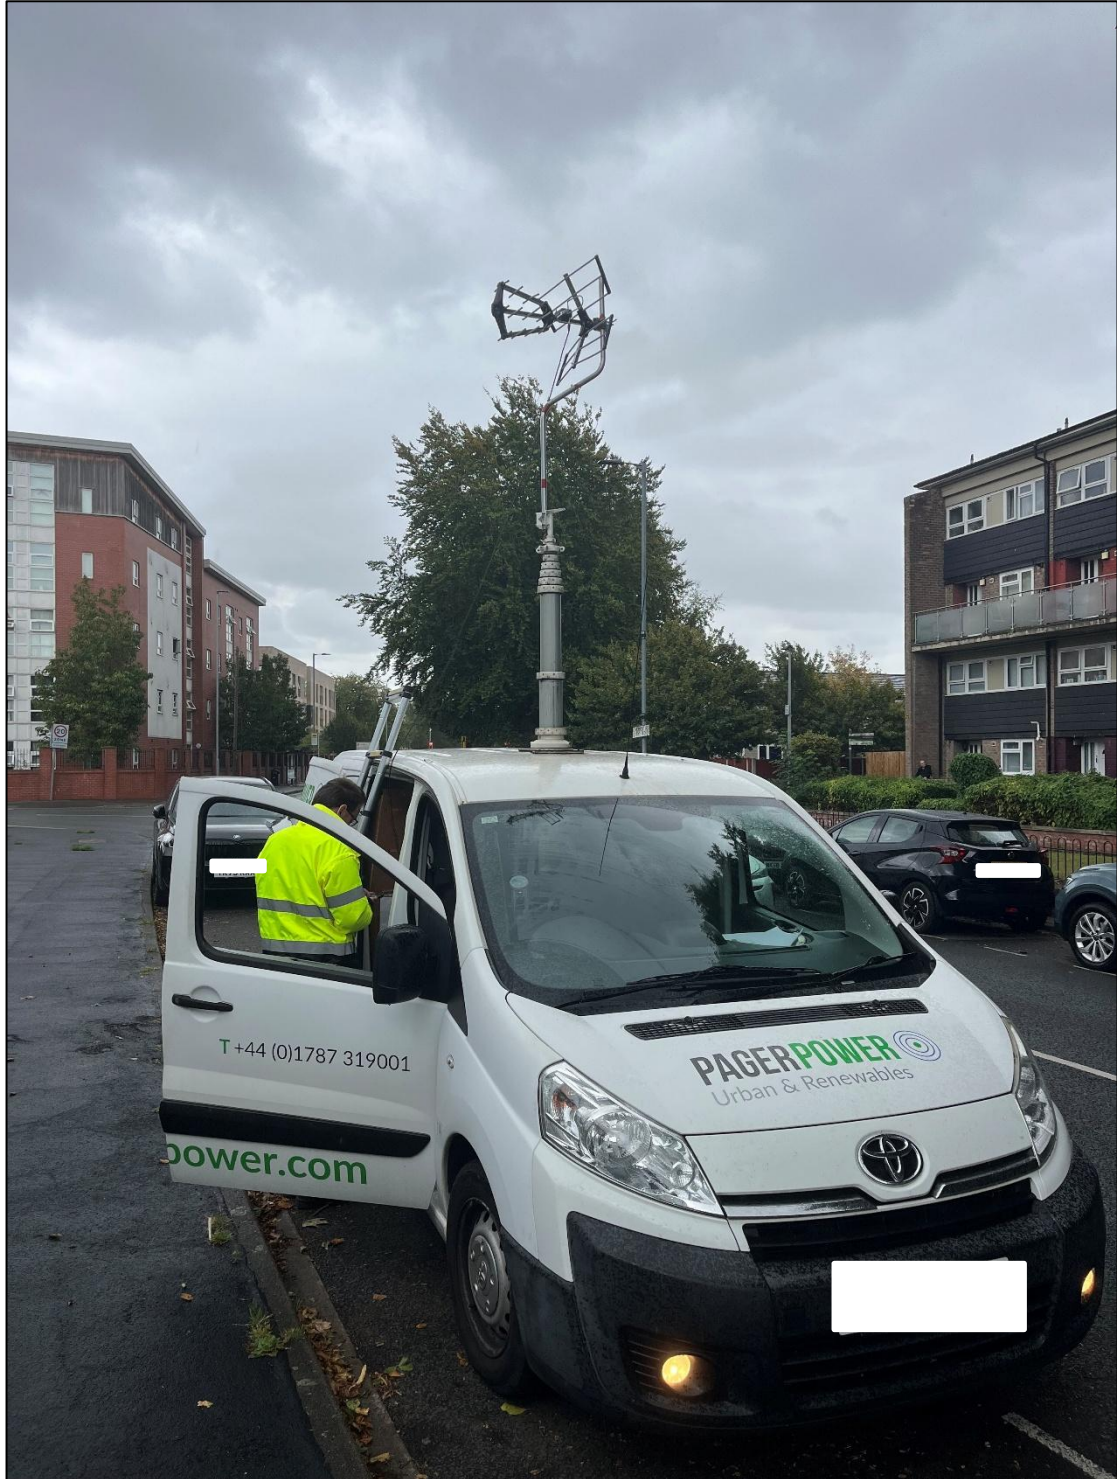
Location 2

| Location | Average Measured Signal Strength (dB) | Remarks | High Level Conclusion |
|---|---|---|---|
| 2 | <p>Average: 44.3 (Moderate)</p> <p>Main TV MUX: 47.1 (Good)</p> <p>Local TV MUX: 35.9 (Moderate)</p> | <p>Multiple horizontally polarised aerials and satellite dishes were observed.</p> <p>All main multiplexes displayed fine picture and audio quality. An average of good signal strength and signal fluctuations of less than or equal to 0.4dB.</p> <p>Both local multiplex displayed fine picture and audio quality. An average of moderate signal strength and signal fluctuations of less than or equal to 0.5dB.</p> | <p>The survey location was within 400m of the proposed development and within its shadow zone. A reduction in signal strength is possible based on the proximity to the development. Effects in this area are likely to be low but cannot be entirely ruled out, particularly for the local multiplexes.</p> |

Notes: Multiple horizontally polarised aerials and satellite dishes observed.

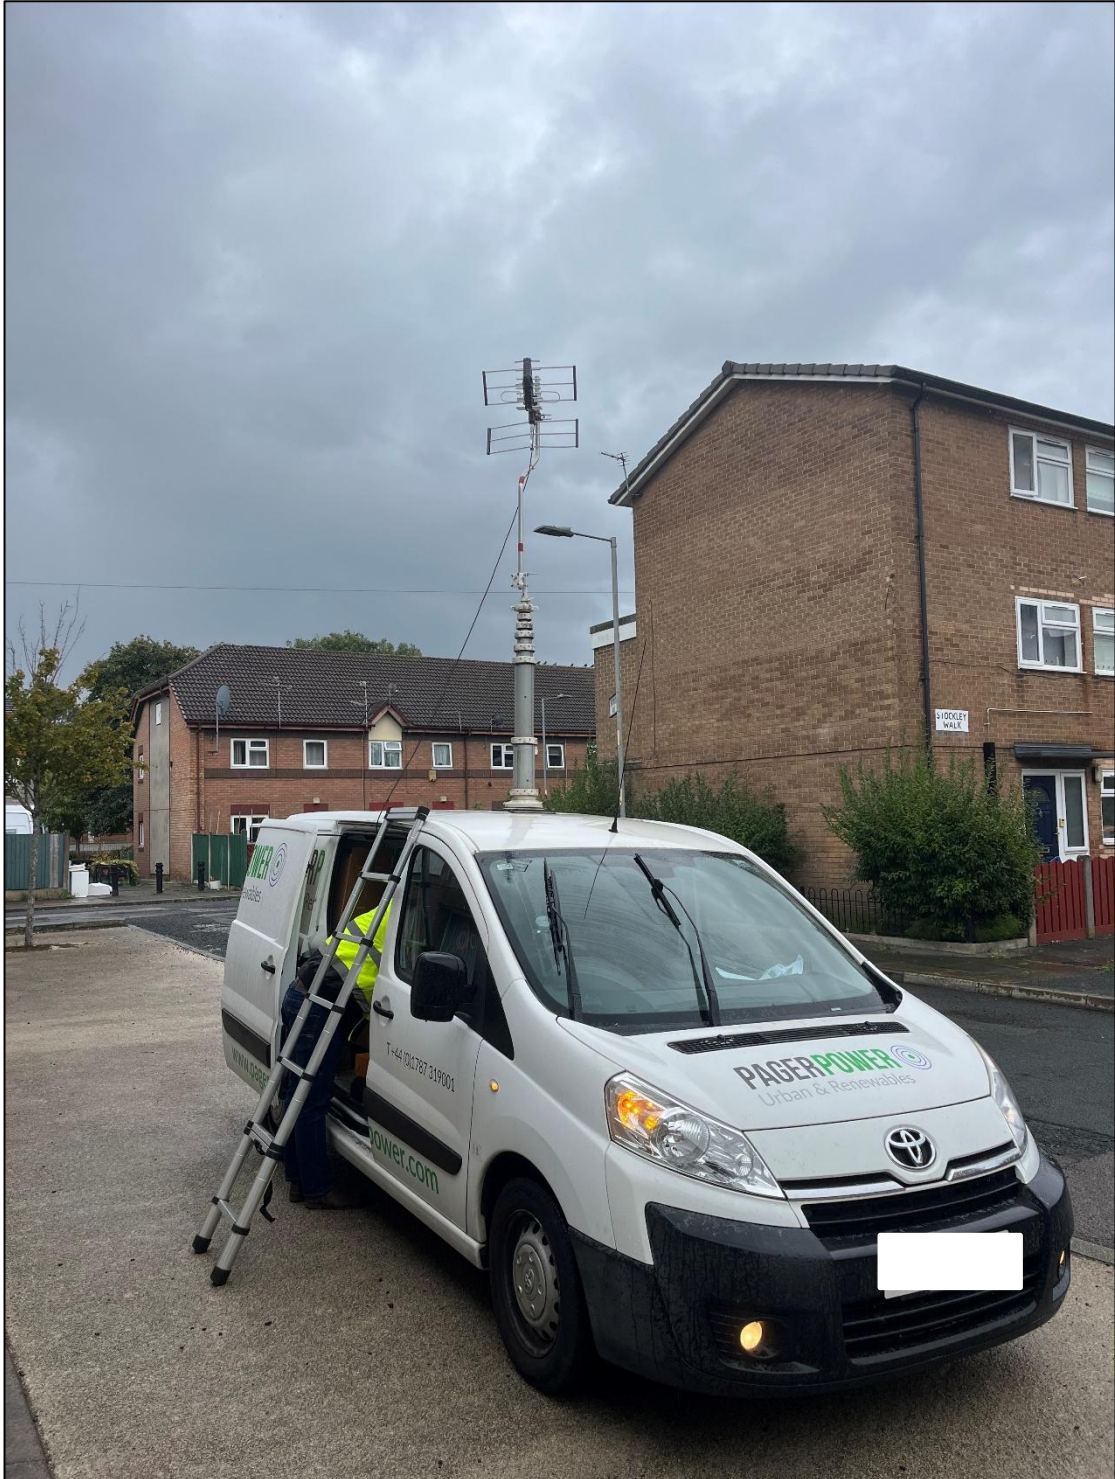
Location 3

| Location | Average Measured Signal Strength (dB) | Remarks | High Level Conclusion |
|---|---|---|---|
| 3 | <p>Average: 44.0 (Moderate)</p> <p>Main TV MUX: 48.3 (Good)</p> <p>Local TV MUX: 31.1 (Low)</p> | <p>Multiple horizontally polarised aerials and satellite dishes were observed.</p> <p>All main multiplexes displayed fine picture and audio quality. An average of good signal strength and signal fluctuations of less than or equal to 0.3dB.</p> <p>One local multiplex displayed fine picture and audio quality. The other local multiplex did not decode. An average of moderate signal strength and signal fluctuations of less than or equal to 0.4dB.</p> | <p>The survey location was within 550m of the proposed development and within its shadow zone. A reduction in signal strength is possible based on the proximity to the development. Effects in this area are likely to be low but cannot be entirely ruled out, particularly for the local multiplexes.</p> |

Notes: Multiple horizontally polarised aerials and satellite dishes observed.

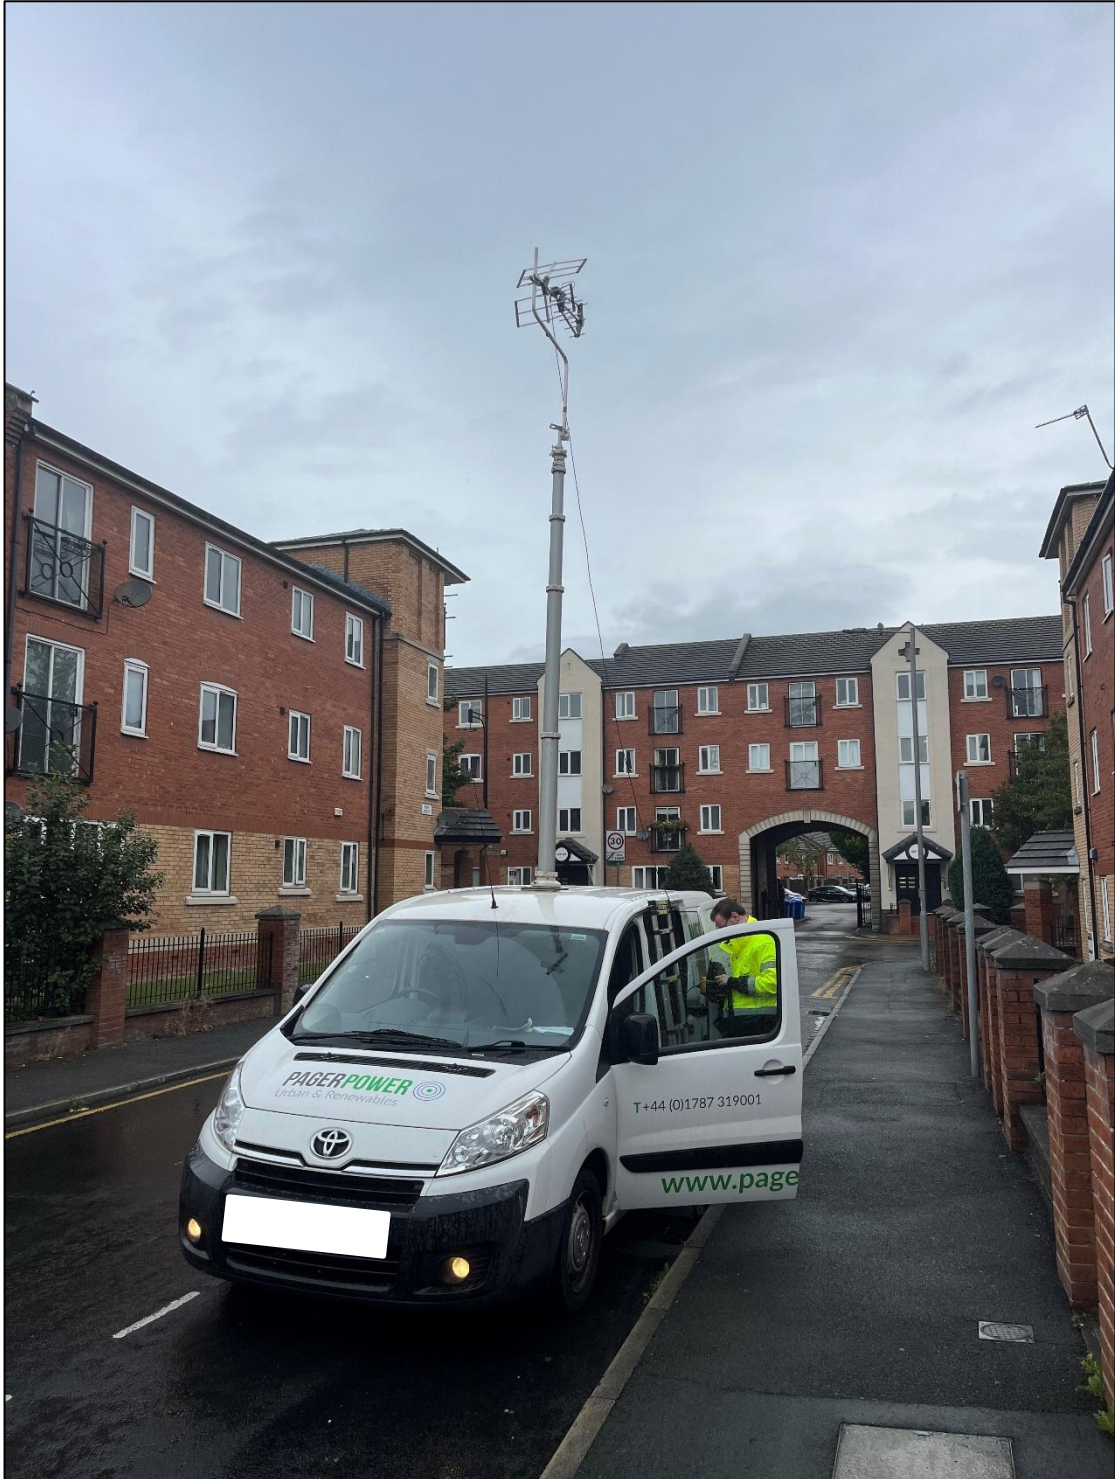
Location 4

| Location | Average Measured Signal Strength (dB) | Remarks | High Level Conclusion |
|---|---|---|---|
| 4 | <p>Average: 50.3 (Good)</p> <p>Main TV MUX: 54.2 (Good)</p> <p>Local TV MUX: 38.7 (Moderate)</p> | <p>Multiple horizontally polarised aerials and satellite dishes were observed.</p> <p>All main multiplexes displayed fine picture and audio quality. An average of good signal strength and signal fluctuations of less than or equal to 0.3dB.</p> <p>Both local multiplex displayed fine picture and audio quality. An average of moderate signal strength and signal fluctuations of less than or equal to 0.2dB.</p> | <p>The survey location was within 750m of the proposed development and within its shadow zone. A reduction in signal strength is possible based on the proximity to the development. Effects in this area are likely to be low but cannot be entirely ruled out, particularly for the local multiplexes.</p> |

Notes: Multiple horizontally polarised aerials and satellite dishes observed.

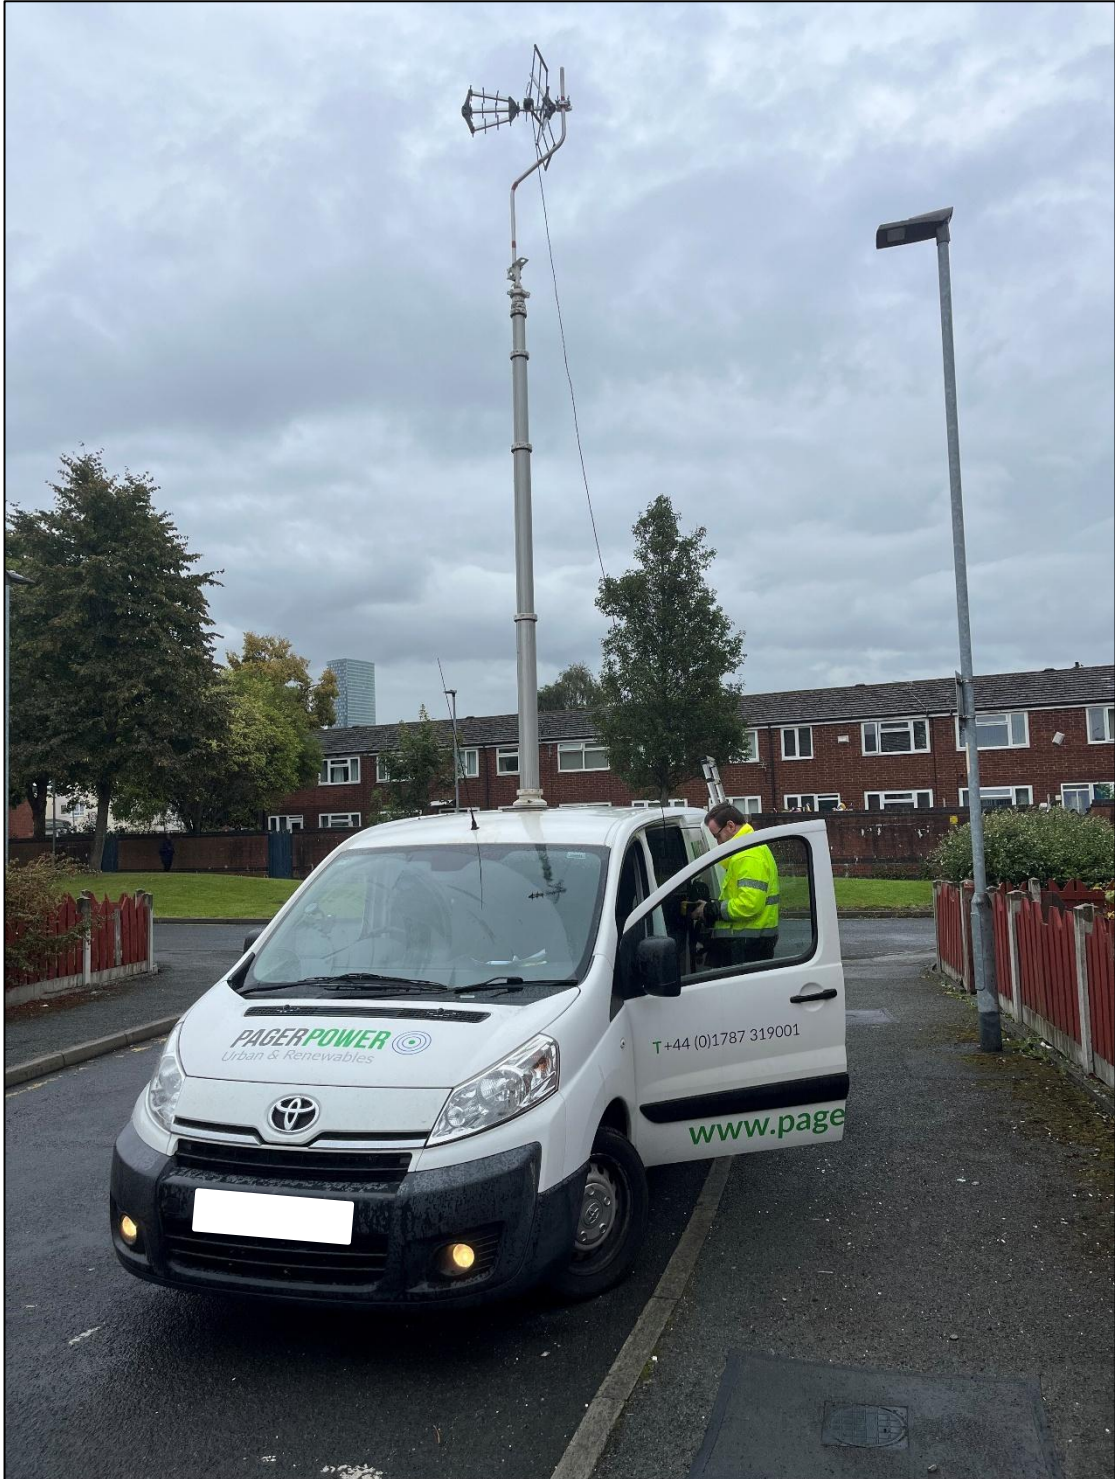
Location 5

| Location | Average Measured Signal Strength (dB) | Remarks | High Level Conclusion |
|---|---|---|---|
| 5 | <p>Average: 60.5 (Very Good)</p> <p>Main TV MUX: 66.1 (Very Good)</p> <p>Local TV MUX: 43.9 (Moderate)</p> | <p>Multiple horizontally polarised aerials and satellite dishes were observed.</p> <p>All main multiplexes displayed fine picture and audio quality. An average of good signal strength and signal fluctuations of less than or equal to 0.3dB.</p> <p>Both local multiplex displayed fine picture and audio quality. An average of moderate signal strength and signal fluctuations of less than or equal to 0.3dB.</p> | <p>The survey location was within 950m of the proposed development and within its shadow zone. Signal losses at this range are likely to be small, considering the attenuation from existing buildings, and the baseline main signal strength, which is Very Good. Interference is likely for local multiplexes.</p> |

Notes: Multiple horizontally polarised aerials and satellite dishes observed.

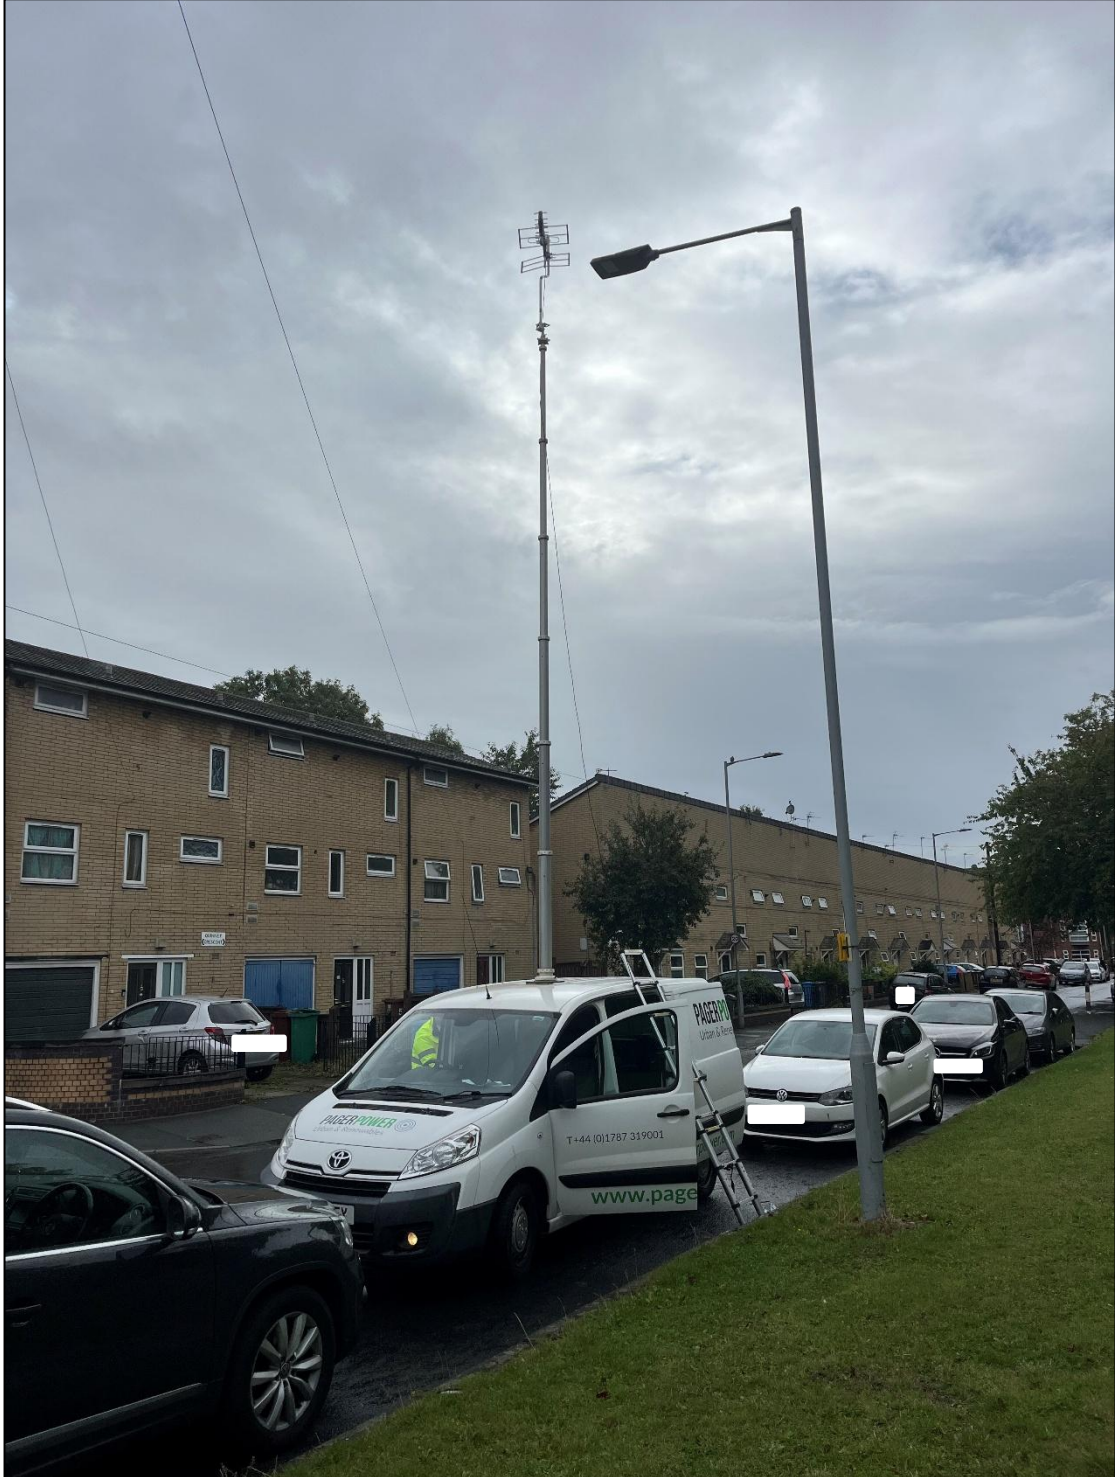
Location 6

| Location | Average Measured Signal Strength (dB) | Remarks | High Level Conclusion |
|---|---|---|---|
| 6 | <p>Average: 50.1 (Good)</p> <p>Main TV MUX: 54.3 (Good)</p> <p>Local TV MUX: 37.6 (Moderate)</p> | <p>Multiple horizontally polarised aerials and satellite dishes were observed.</p> <p>All main multiplexes displayed fine picture and audio quality. An average of good signal strength and signal fluctuations of less than or equal to 0.4dB.</p> <p>One local multiplex displayed fine picture and audio quality. The other local multiplex displayed intermittent picture and audio quality. An average of moderate signal strength and signal fluctuations of less than or equal to 0.5dB.</p> | <p>This location is approximately 1.7km from the proposed development. Effects at this range are likely to be relatively small based on previous experience. Based on the current signal quality, effects are likely to be negligible.</p> |

Notes: Multiple horizontally polarised aerials and satellite dishes observed.

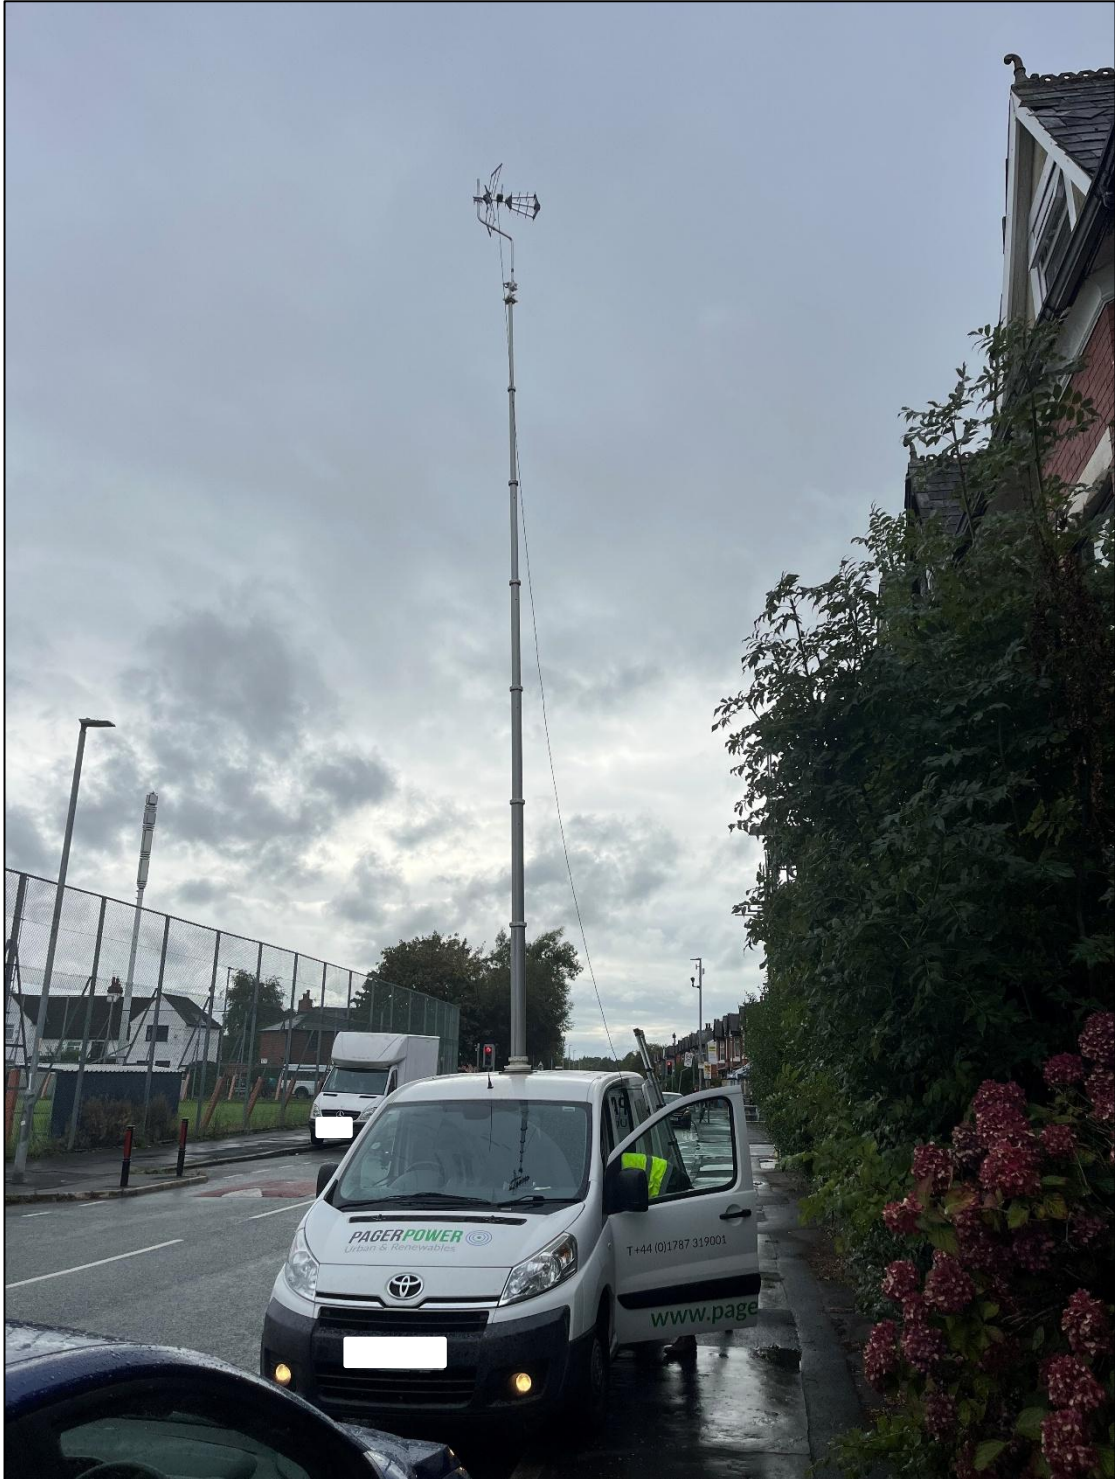
Location 7

| Location | Average Measured Signal Strength (dB) | Remarks | High Level Conclusion |
|---|---|---|---|
| 7 | <p>Average: 64.5 (Very Good)</p> <p>Main TV MUX: 69.2 (Very Good)</p> <p>Local TV MUX: 50.3 (Good)</p> | <p>Multiple horizontally polarised aerials and satellite dishes were observed.</p> <p>All main multiplexes displayed fine picture and audio quality. An average of good signal strength and signal fluctuations of less than or equal to 0.2dB.</p> <p>Both local multiplex displayed fine picture and audio quality. An average of moderate signal strength and signal fluctuations of less than or equal to 0.3dB.</p> | <p>This location is approximately 3.25km from the proposed development. Effects at this range are likely to be relatively small based on previous experience. Based on the current signal quality, effects are likely to be negligible.</p> |

Notes: Multiple horizontally polarised aerials and satellite dishes observed.

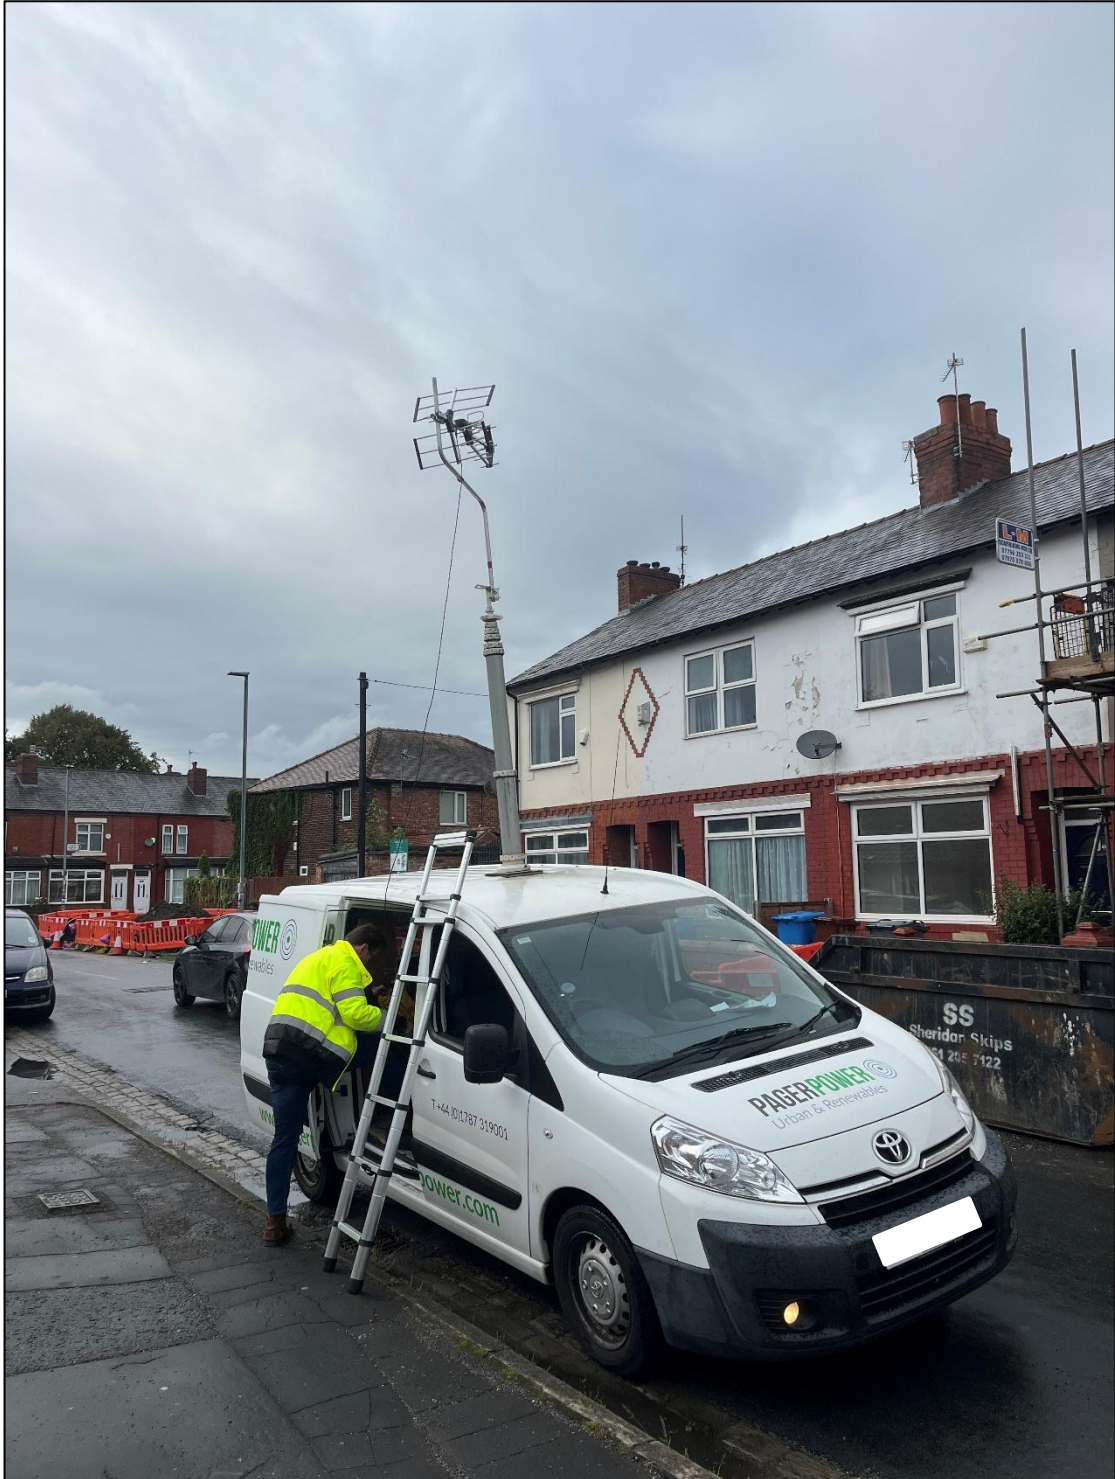
Location 8

| Location | Average Measured Signal Strength (dB) | Remarks | High Level Conclusion |
|---|---|---|---|
| 8 | <p>Average: 64.2 (Very Good)</p> <p>Main TV MUX: 69.2 (Very Good)</p> <p>Local TV MUX: 49.2 (Good)</p> | <p>Multiple horizontally polarised aerials and satellite dishes were observed.</p> <p>All main multiplexes displayed fine picture and audio quality. An average of good signal strength and signal fluctuations of less than or equal to 0.2dB.</p> <p>Both local multiplex displayed fine picture and audio quality. An average of moderate signal strength and signal fluctuations of less than or equal to 0.2dB.</p> | <p>This location is approximately 4.95km from the proposed development. Effects at this range are likely to be relatively small based on previous experience. Based on the current signal quality, effects are likely to be negligible.</p> |

Notes: Multiple horizontally polarised aerials and satellite dishes observed.
