## Store Street Aqueduct – Ashton Canal – Leakage (23/10/2025)

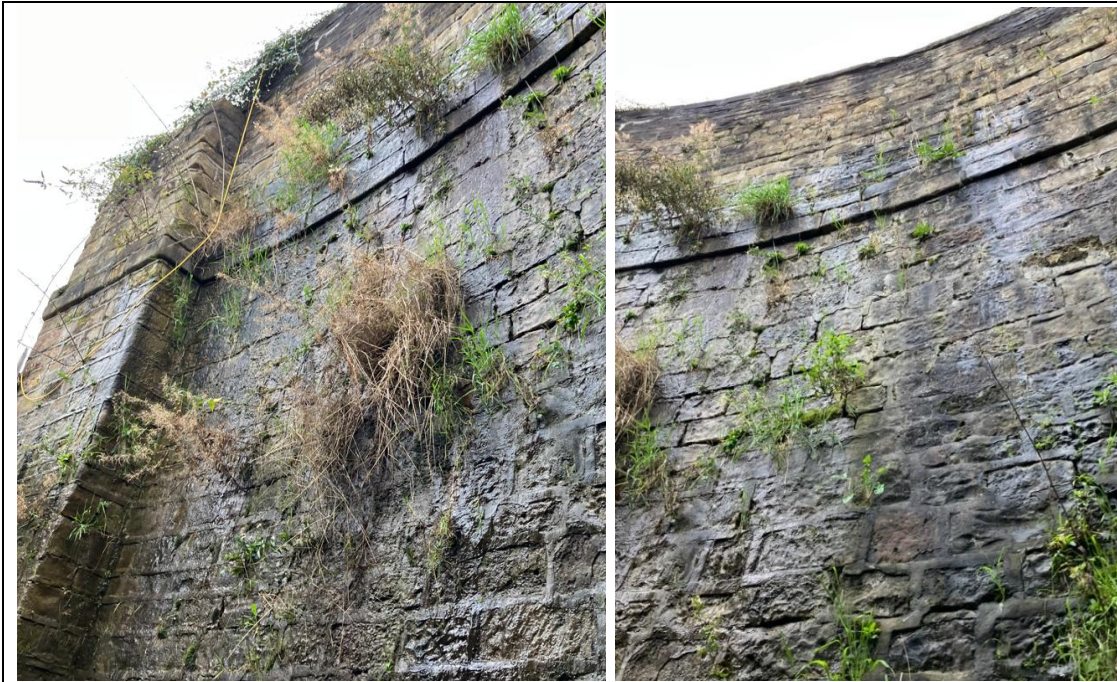
The leakage is seeping left to right along the wall and this was seen to be further along than it was in the summer, though the extra water in the canal is a contributing factor, the flow is increasing. The amount of water and potential erosion at the back of the masonry structure is a concern going into winter.

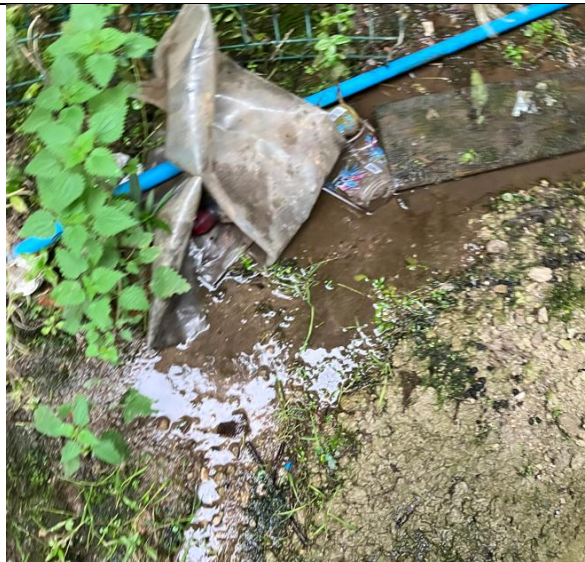
At ground level the flows are combining and causing a problem for the site team who are working hard to stop it impacting the road & road drainage.

The leak at the wing wall was running freely as of 23/10/25 and there was a constant stream at the back of the cabins that the site team are dealing with. Compared with inspection photos from earlier in the year it does look to be seeping further along the back of the masonry and then coming through the wall suggesting the flow path is growing.
