Land at Station Road (The Secret Lake) Nelstrop  
Rd N, Levenshulme, Stockport M19 3WH.  
Riparian Mammal Survey.

Version One. 03.11.2025  
Prepared for: The Northern Group

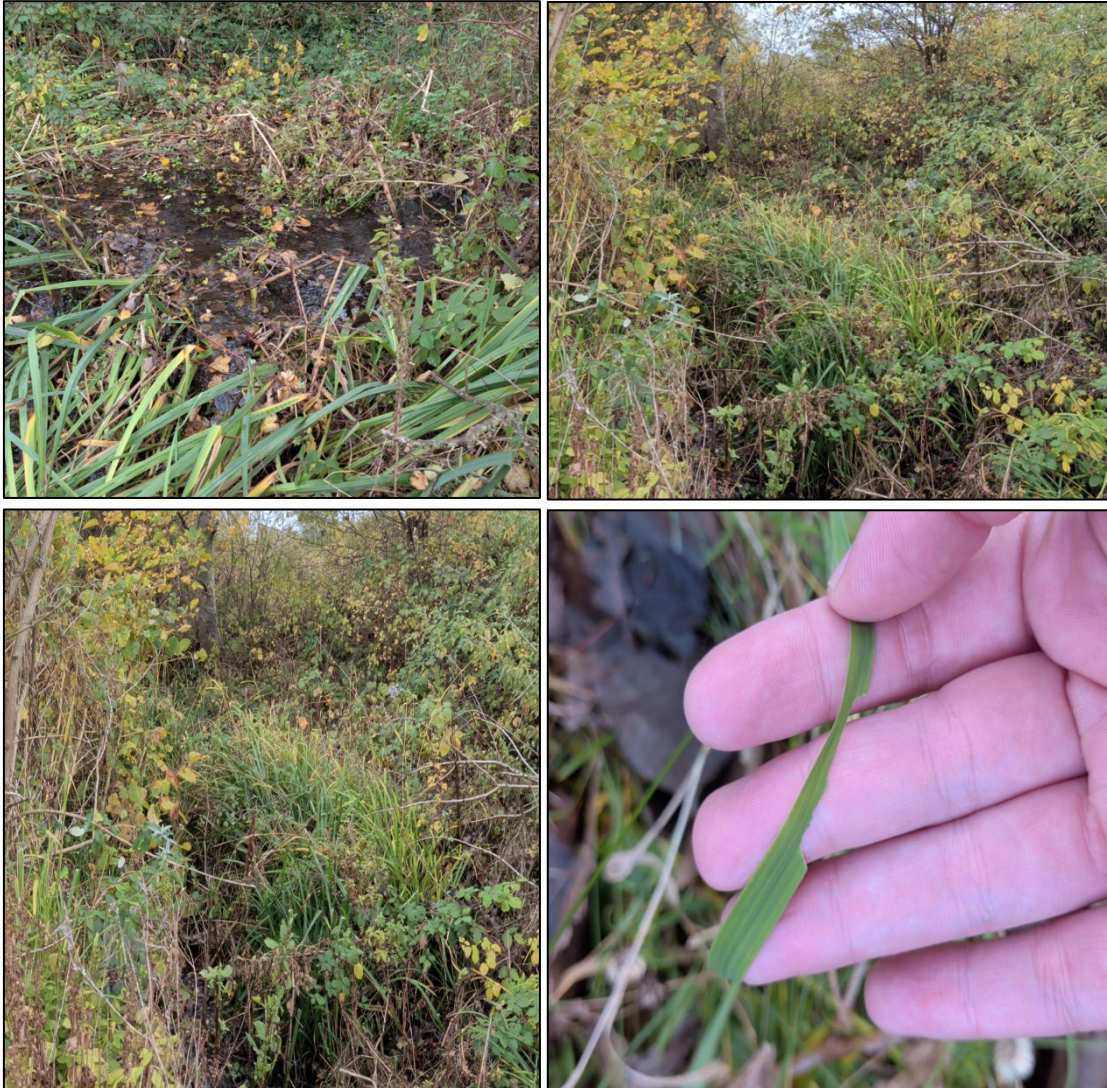
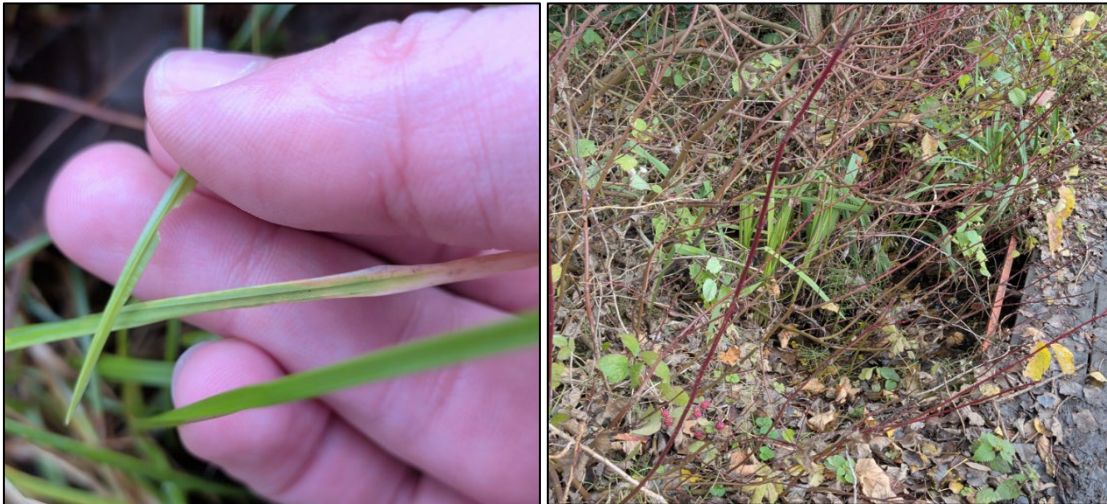
- 3.1 No evidence of water vole was found. Small mammal burrows were recorded along the bankside of the ditch, but these were non-diagnostic of water vole. There was frequent foraging evidence that appeared to be from other rodents (i.e., mice or shrew); none that was cut at a 45-degree angle which is typical of water vole. Water quality in the ditch is good, but it was heavily shaded by woodland canopies.

The culverted ditch was approximately 20-30m in length and has a maximum depth of 60mm; it also feeds into the main lake. Suitable perennial vegetation is present including, False oat grass, Yorkshire fog, Annual meadow grass, Hard rush, Pendulous sedge, Rosebay willowherb, Common nettle and Cock's foot; although it is densely vegetated so it may lack water during the summer months.

The banks of the watercourse had steep banks that were suitable for burrowing, but the site was subject to high levels of antisocial behaviour (ASB), these levels of disturbance will likely deter water vole from using the ditch. The watercourse was accessible, and it was possible to walk through it for the survey.

Overall, the ditch habitat was considered of low suitability for water vole species. Other habitats onsite were considered unsuitable for other UK protected mammal species. Water voles are likely absent from site at the time of survey.

There is no evidence of water vole or otter on this site and therefore no further actions are necessary to mitigate for the presence of this species within this development. The ditch habitat is also retained through the development.

However, the improvement of the habitat to encourage the species to be present is recommended as part of development and as part of general biodiversity enhancements.

Additional shelter for wildlife could be introduced by transplanting localised clumps of yellow iris into the stream margins and by introducing localised patches of a native wetland plants for example a seed mix and / or plugs containing species such as Meadowsweet (*Fillipendula ulmaria*), Purple loosestrife (*Lythrum salicaria*), Greater bird's foot trefoil (*Lotus pedunculatus*) and Water forget-me-not (*Myosotis scorpioides*). Hand weeding of the existing tall ruderal plants to include the removal of Willowherb and Bramble is required. The pruning back of overhanging woodland trees would also be beneficial to the biodiversity near the stream edge.
