Date: 19<sup>th</sup> August 2025  
Ref: 17-403-L3

## ENVIRONMENTAL HEALTH OFFICER RESPONSE LETTER RYEBANK, CHORLTON

- ✳ **142223/FO/2025** - Erection of a residential development comprising 120 dwellings (including a mix of housing types and tenures) together with open spaces, landscaping, sustainable drainage features, cycleways and pedestrian footways, vehicular accesses and highways, parking provision and other associated works.

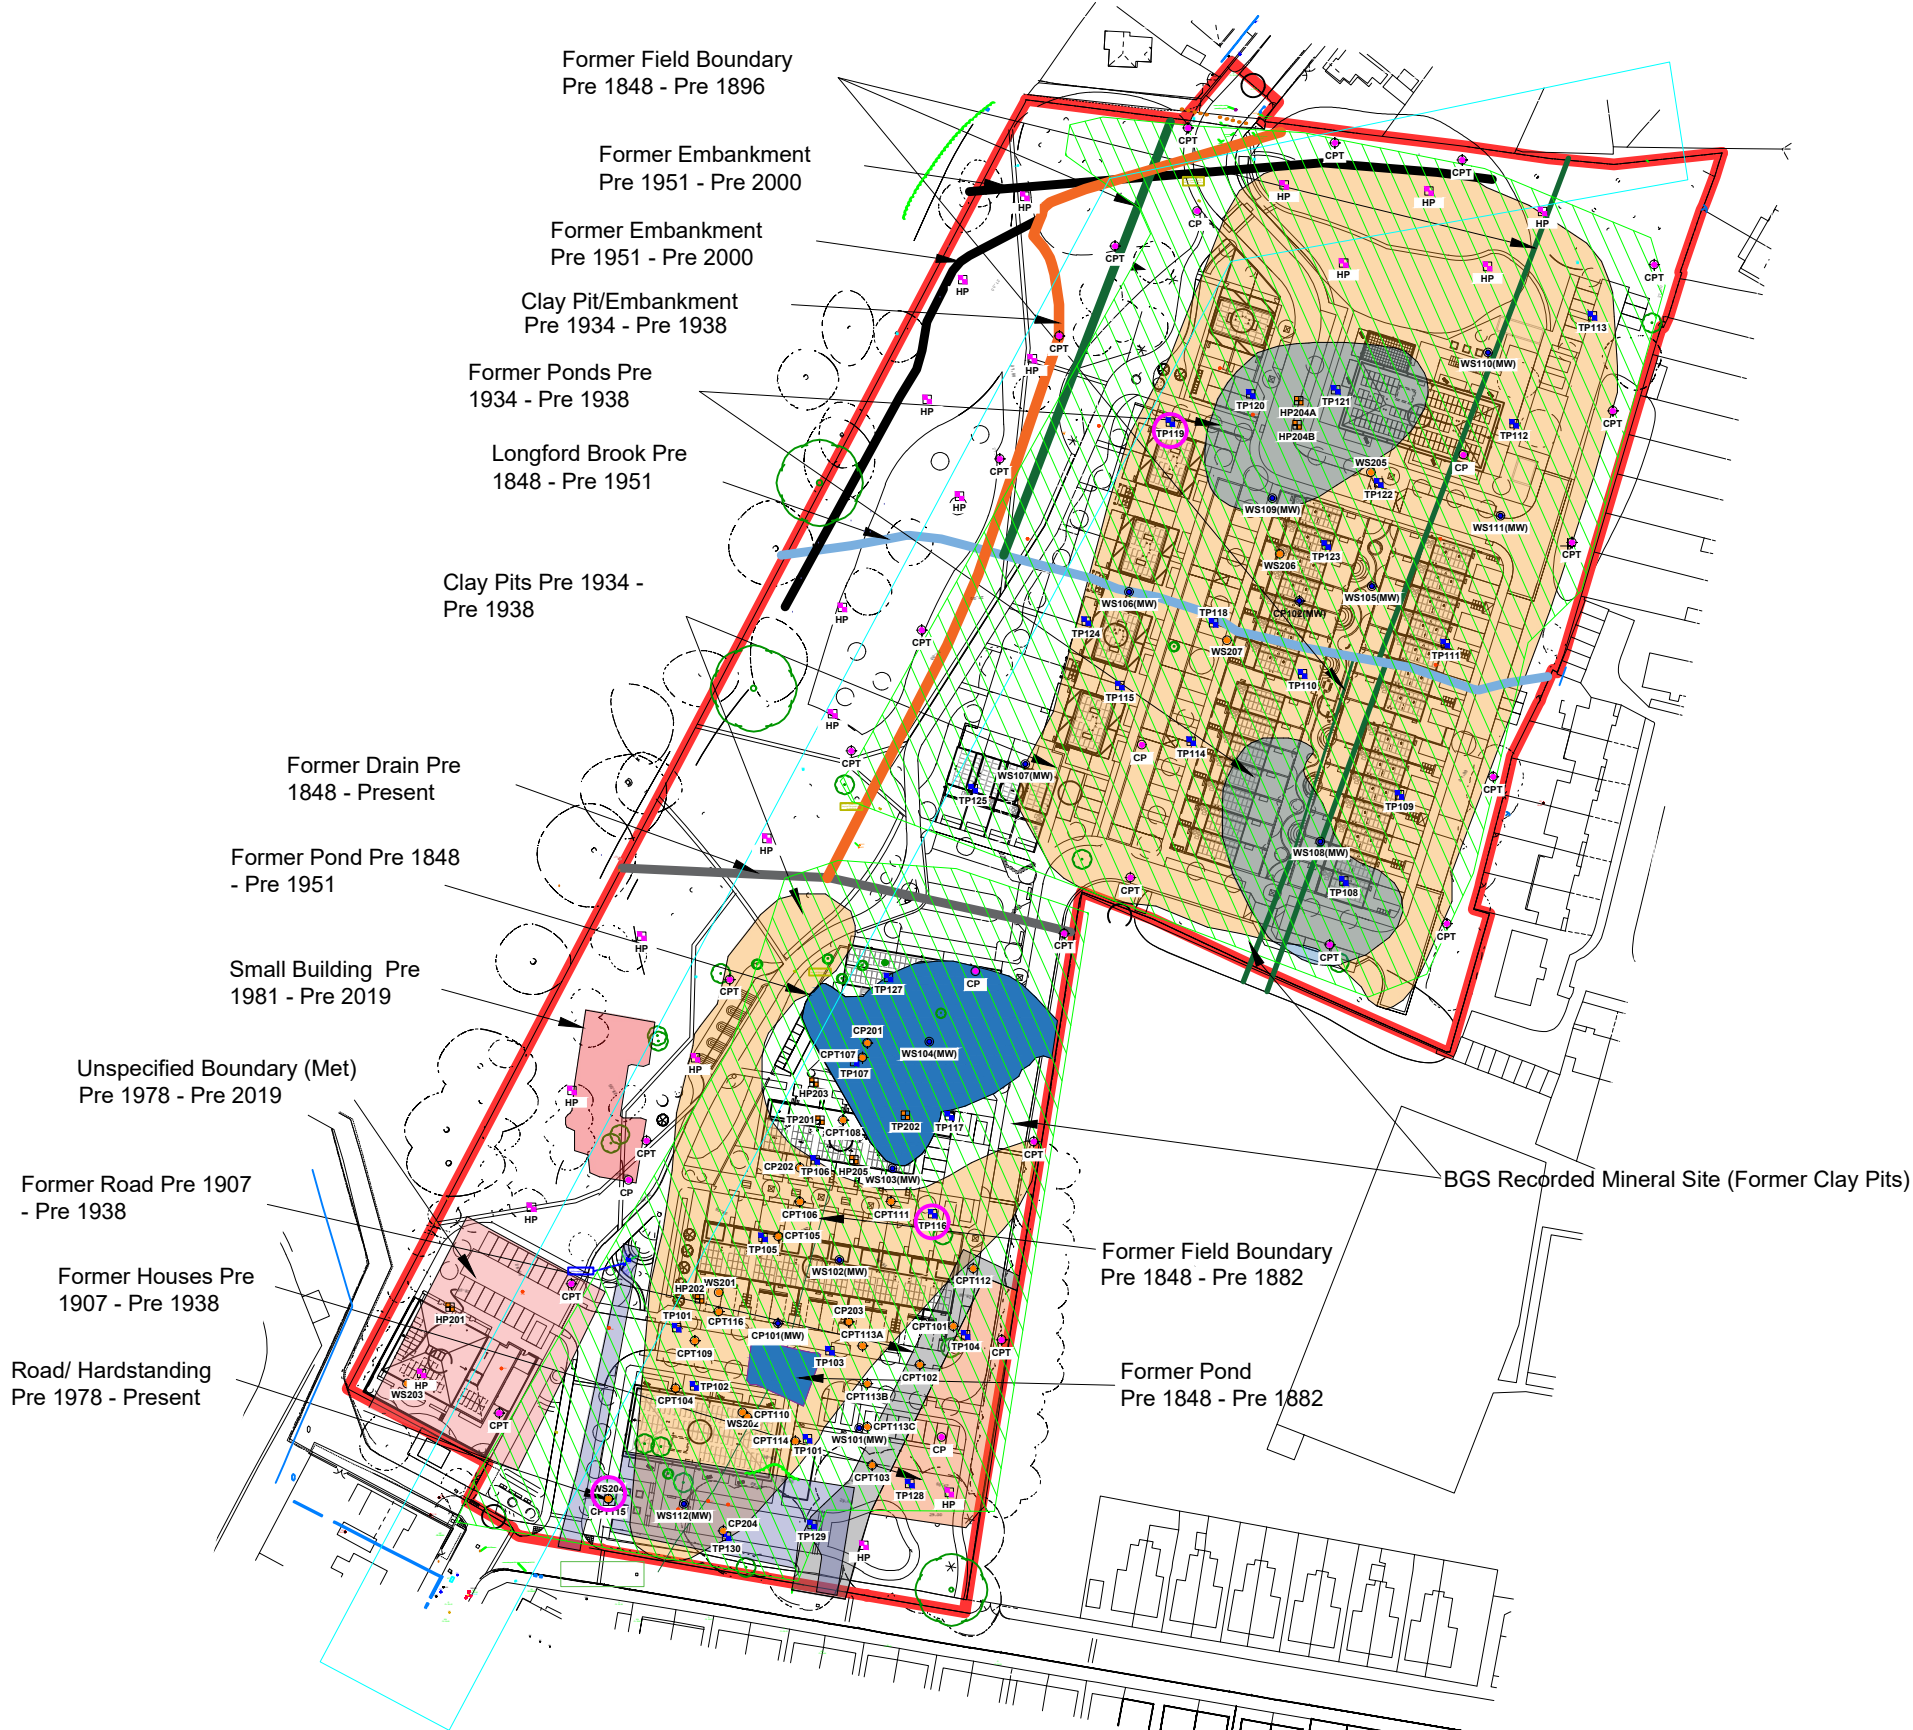
- Historical Features**
- Small Building Pre 1981 - Pre 2019
  - Former Pond Pre 1848 - Pre 1951 / Pre 1934 - Pre 1938
  - Former Houses Pre 1907 - Pre 1938
  - Former Road Pre 1907 - Pre 1938
  - Unspecified Building Pre - 1848 - Pre 1894
  - Unspecified Boundary (Met) Pre 1978 - Pre 2019
  - Former Clay Pits Pre 1934 - Pre 1938
  - Road/Hardstanding Pre 1978 - Present
  - Longford Brook Pre 1848 - Pre 1951
  - Former Field Boundary Pre 1848 - Pre 1896
  - Former Drain Pre 1848 - Present
  - Former Embankment Pre 1951 - Pre 2000
  - Former Clay pit/embankment Pre 1934 - Pre 1938
  - BGS Recorded Mineral Site (Former Clay Pits)

- Location Symbols**
- Approximate Window Sample Probehole Location (E3P Locations 2024)
  - Approximate Trial Pit Location (E3P Locations 2024)
  - Approximate Cable Percussive Borehole Location (E3P Locations 2024)
  - Approximate Cone Penetrometer Test Location (E3P Locations 2024)
  - Approximate Window Sample Probehole Location (E3P Locations 2019)
  - Approximate Window Sample Probehole Location with Install (E3P Locations 2019)
  - Approximate Trial Pit Location (E3P Locations 2019)
  - Approximate Cable Percussive Borehole Location (E3P Locations 2019)

A plan showing the proposed exploratory hole locations and additional assessment has been included as an attachment to this letter.

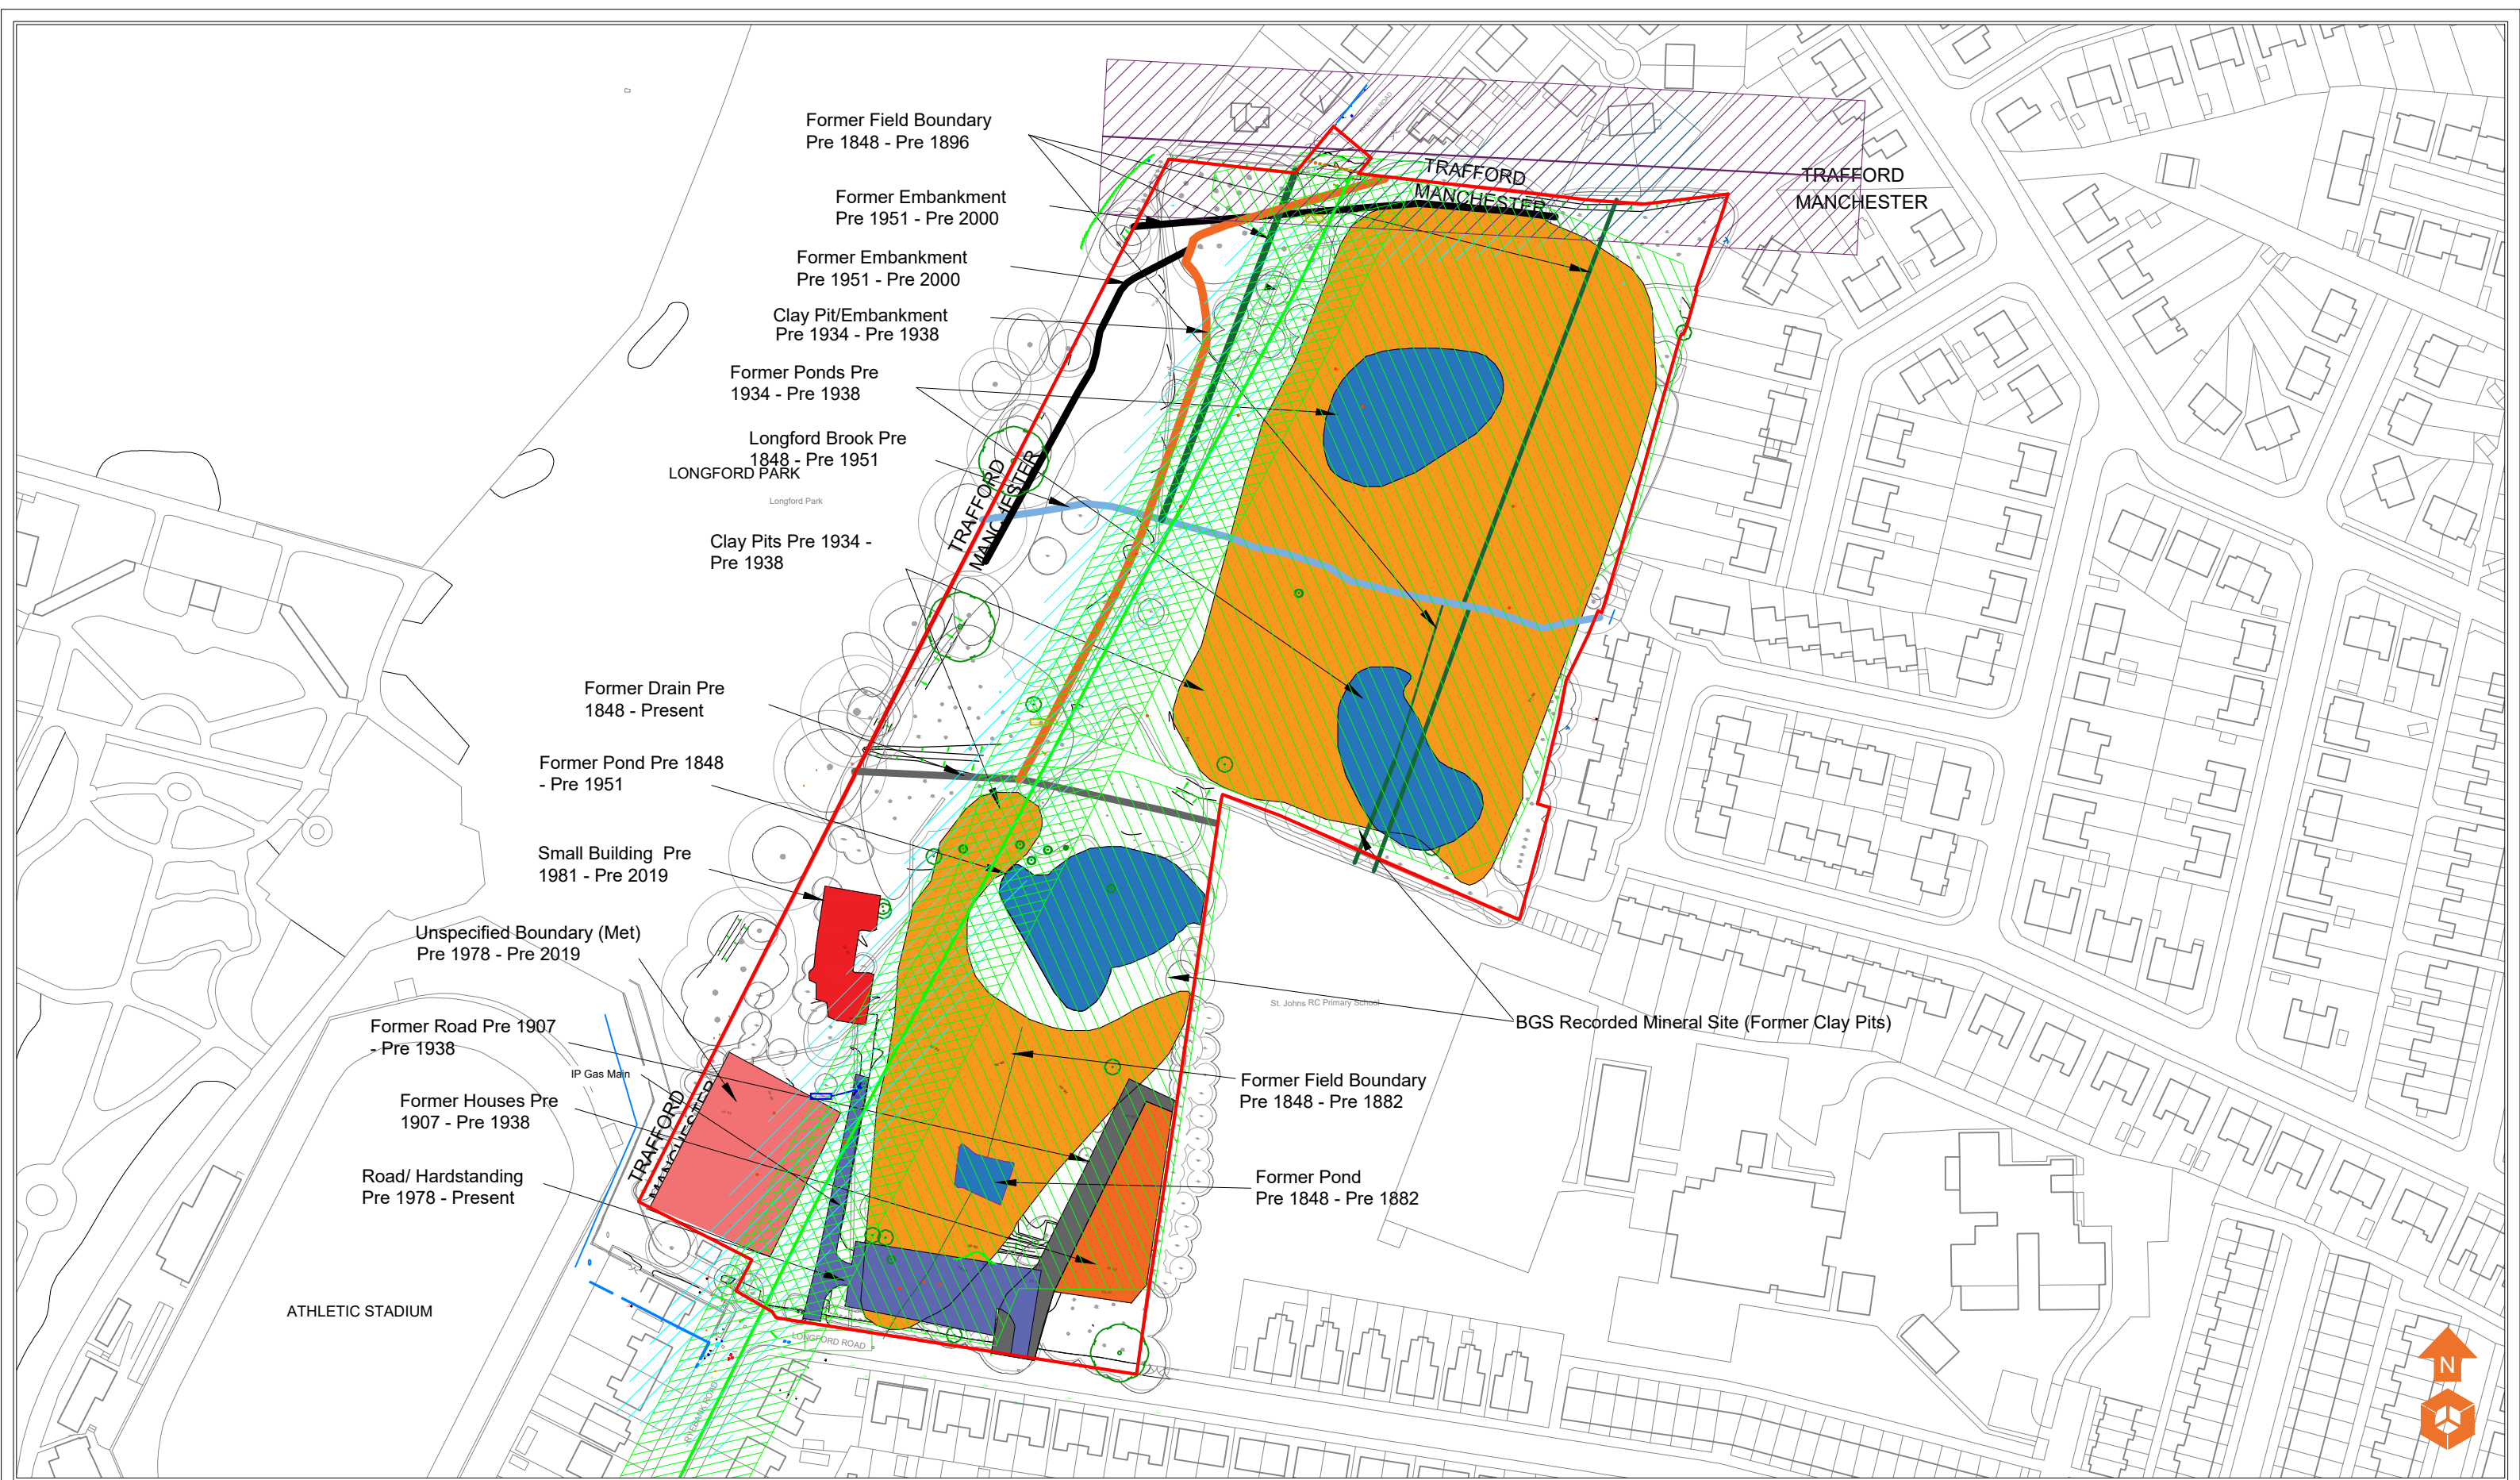
Historical Features

Small Building Pre 1981 - Pre 2019

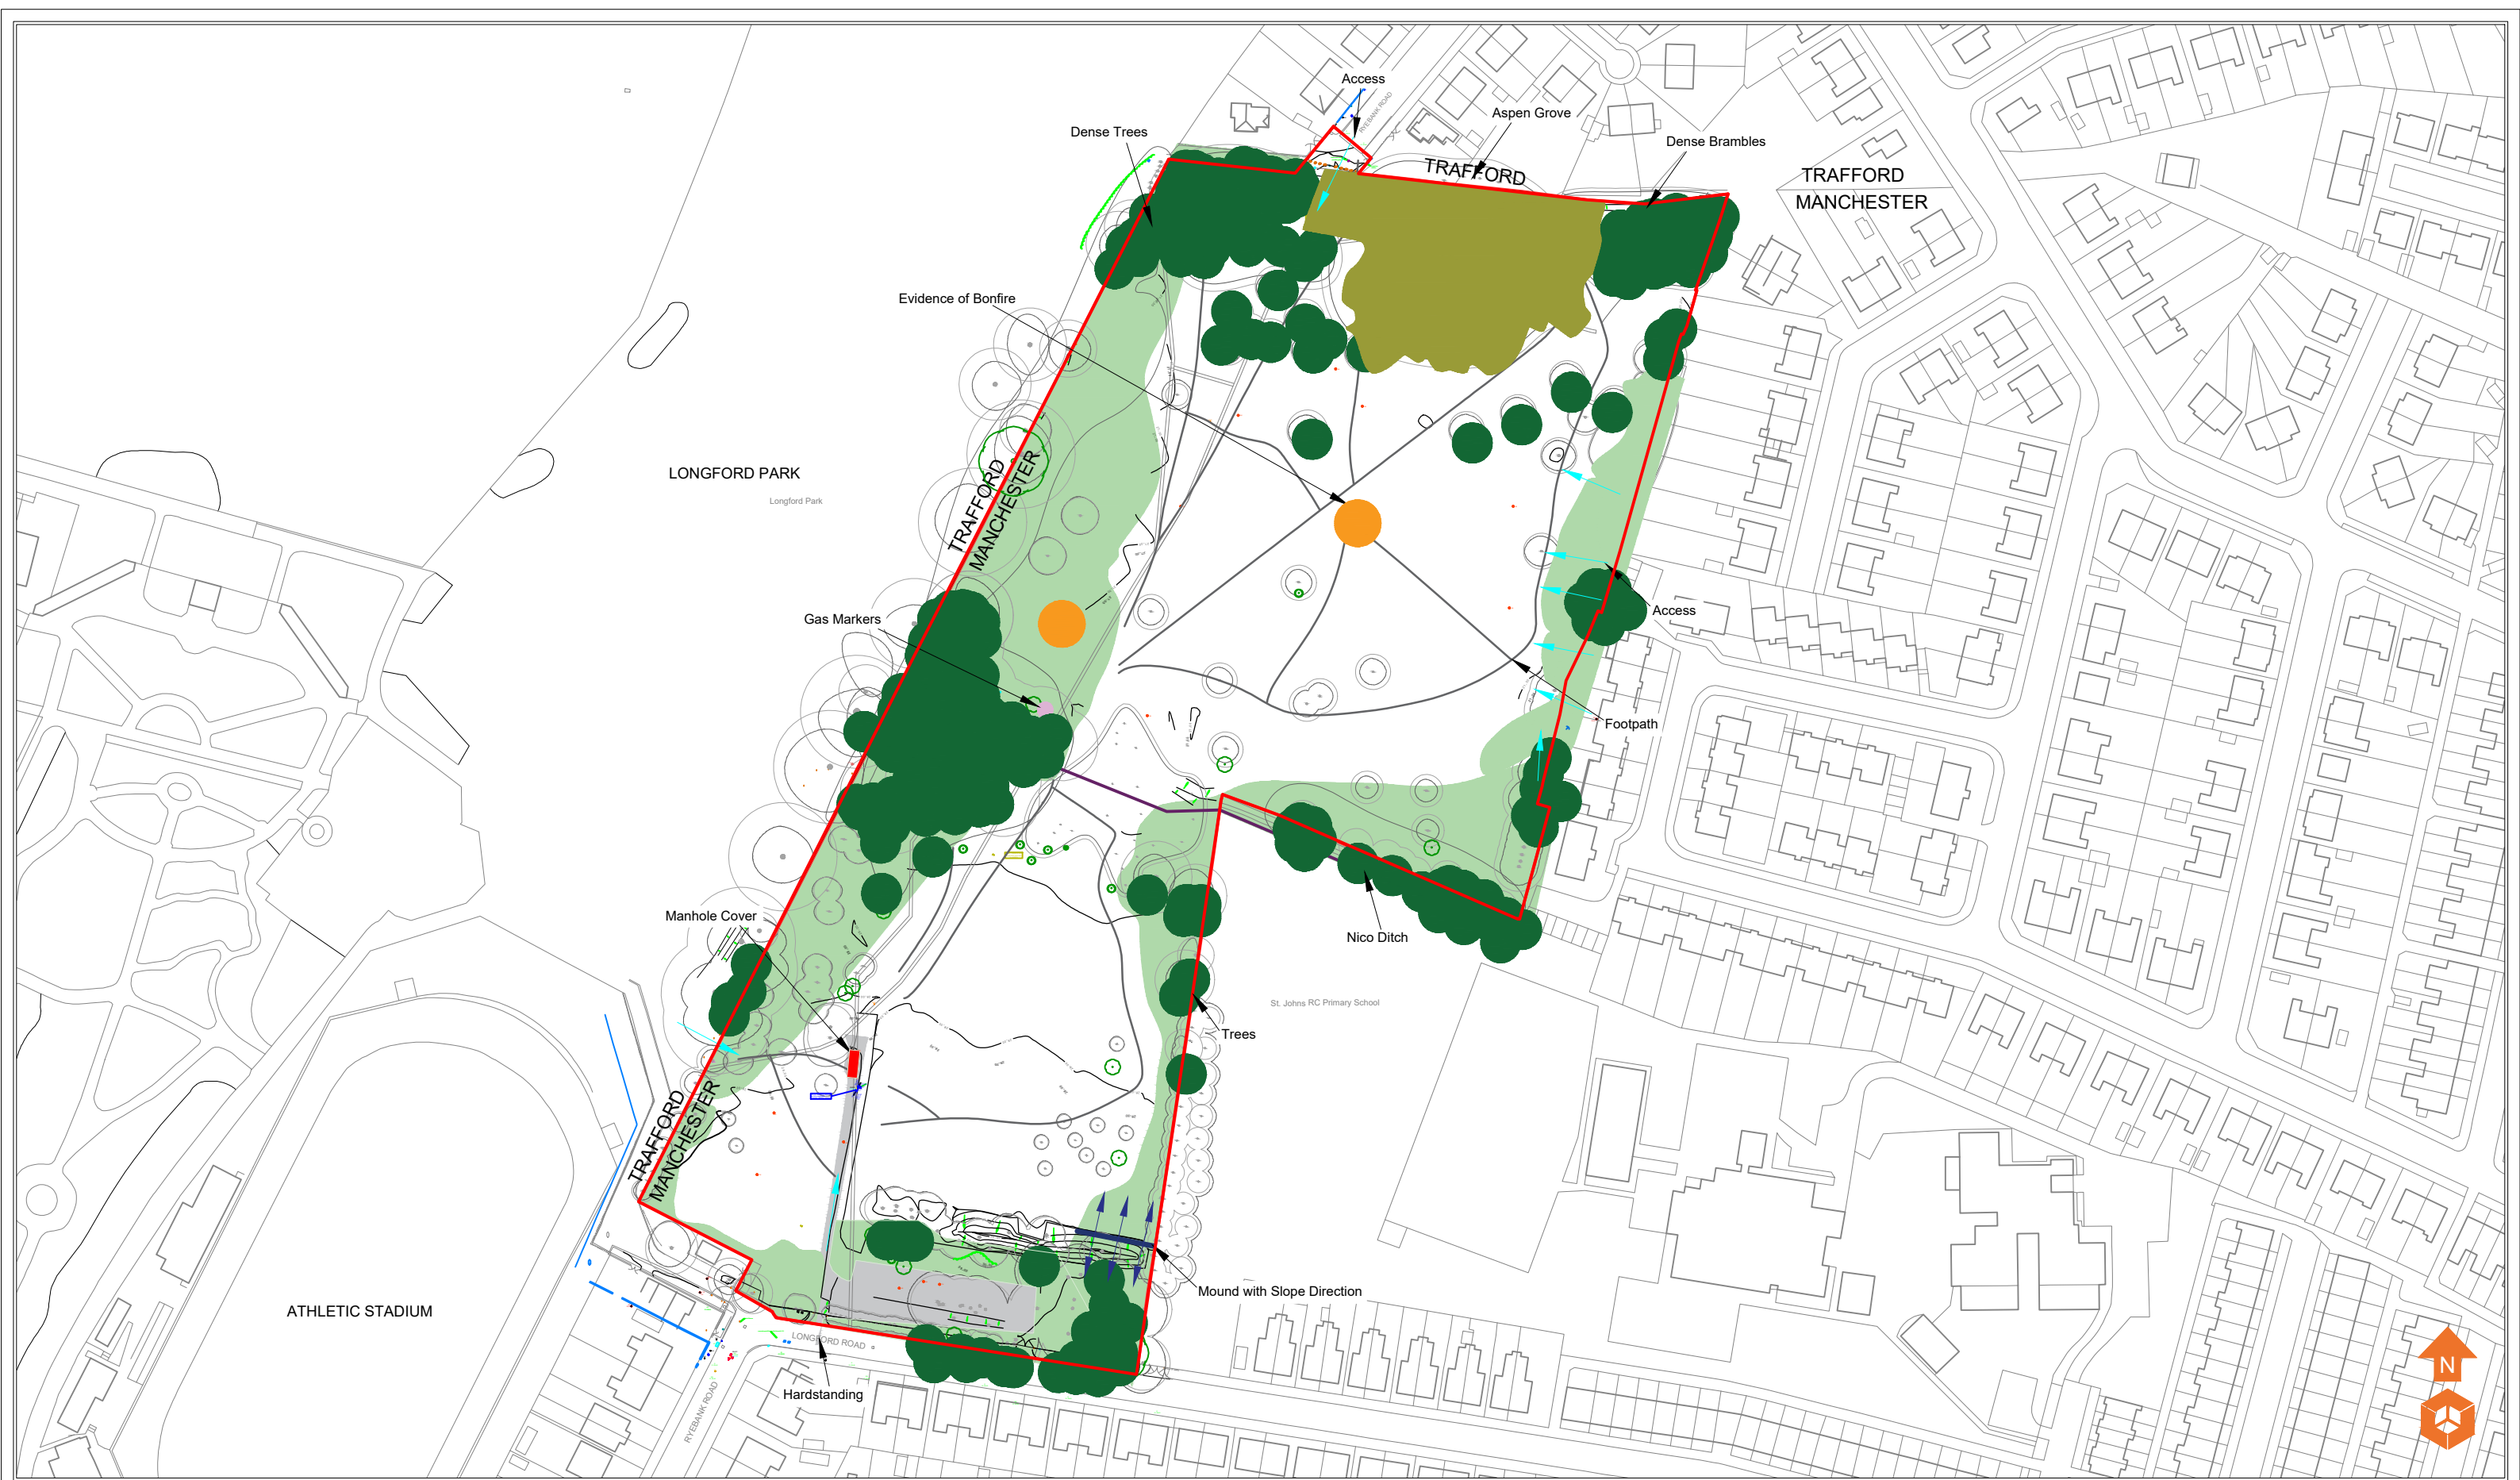
Site Features

Trees

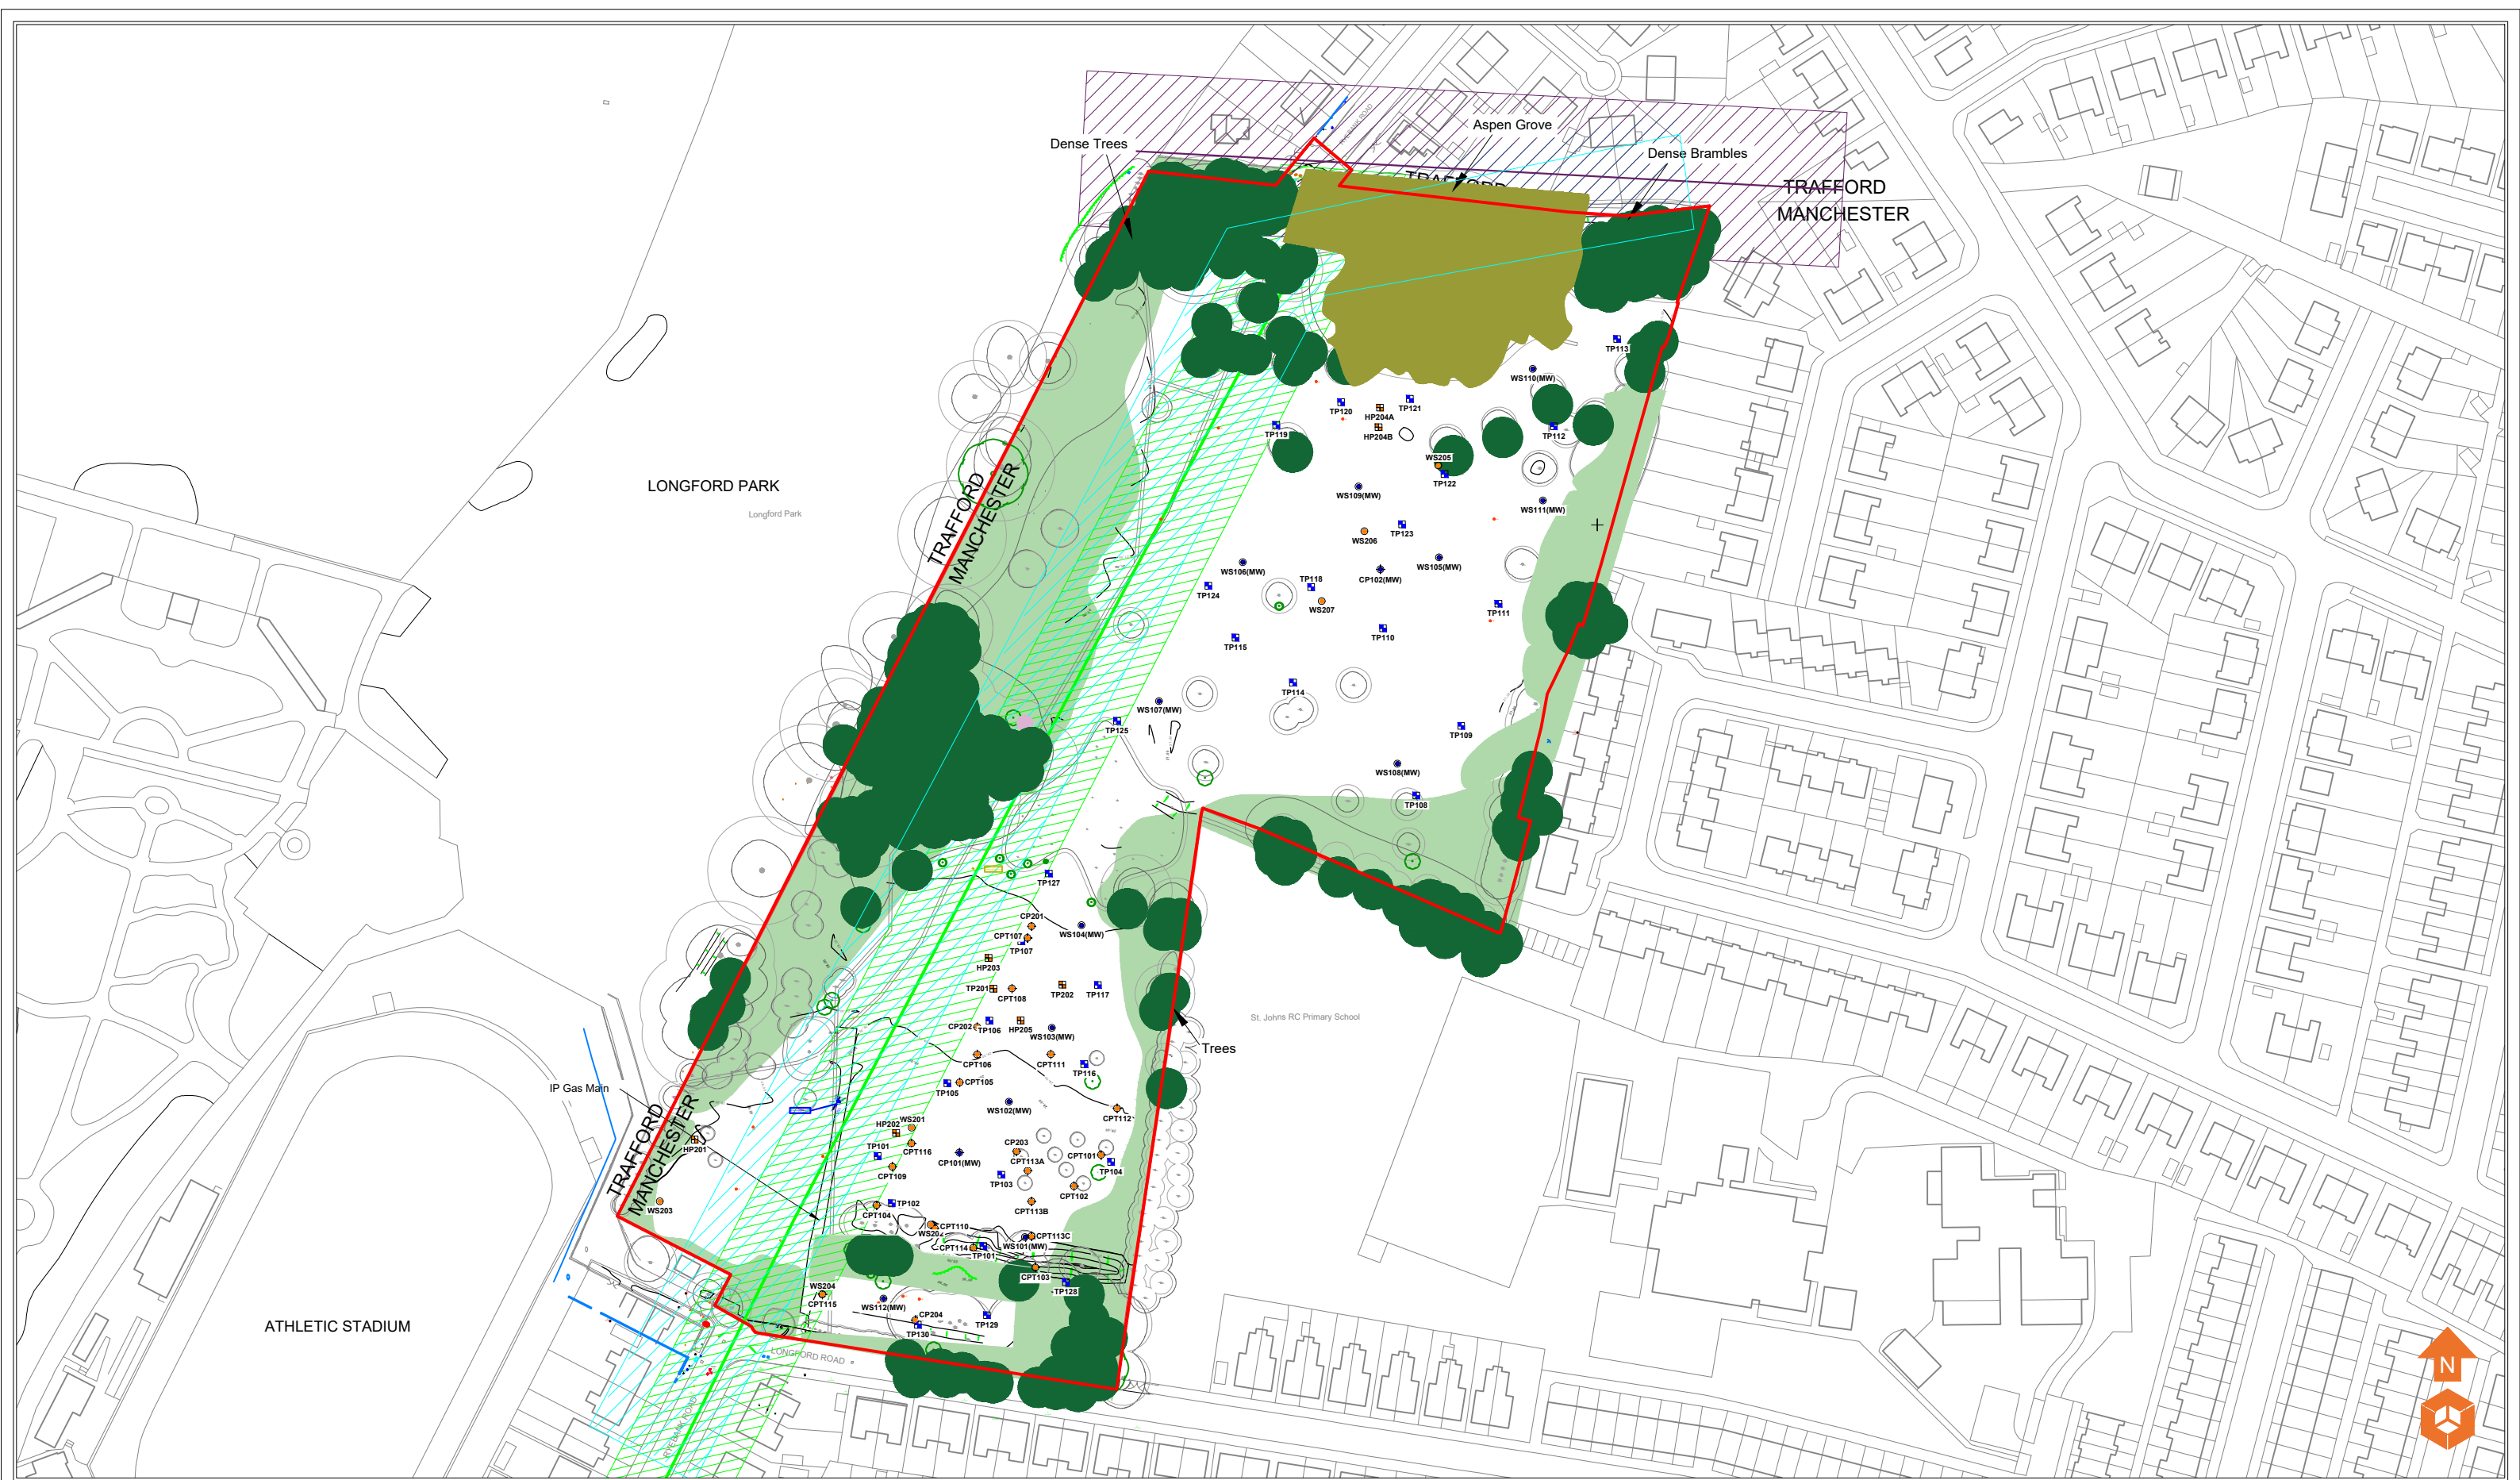
Exploratory Hole (Site Constraints - Redacted) Plan

| Location Symbols | | Site Features | |
| | Approximate Window Sample Probehole Location (E3P Locations 2024) | | IP Gas Pipe with 15m Easement |

Drawings from the Phase 2 Report have been included as an attachment to this letter.

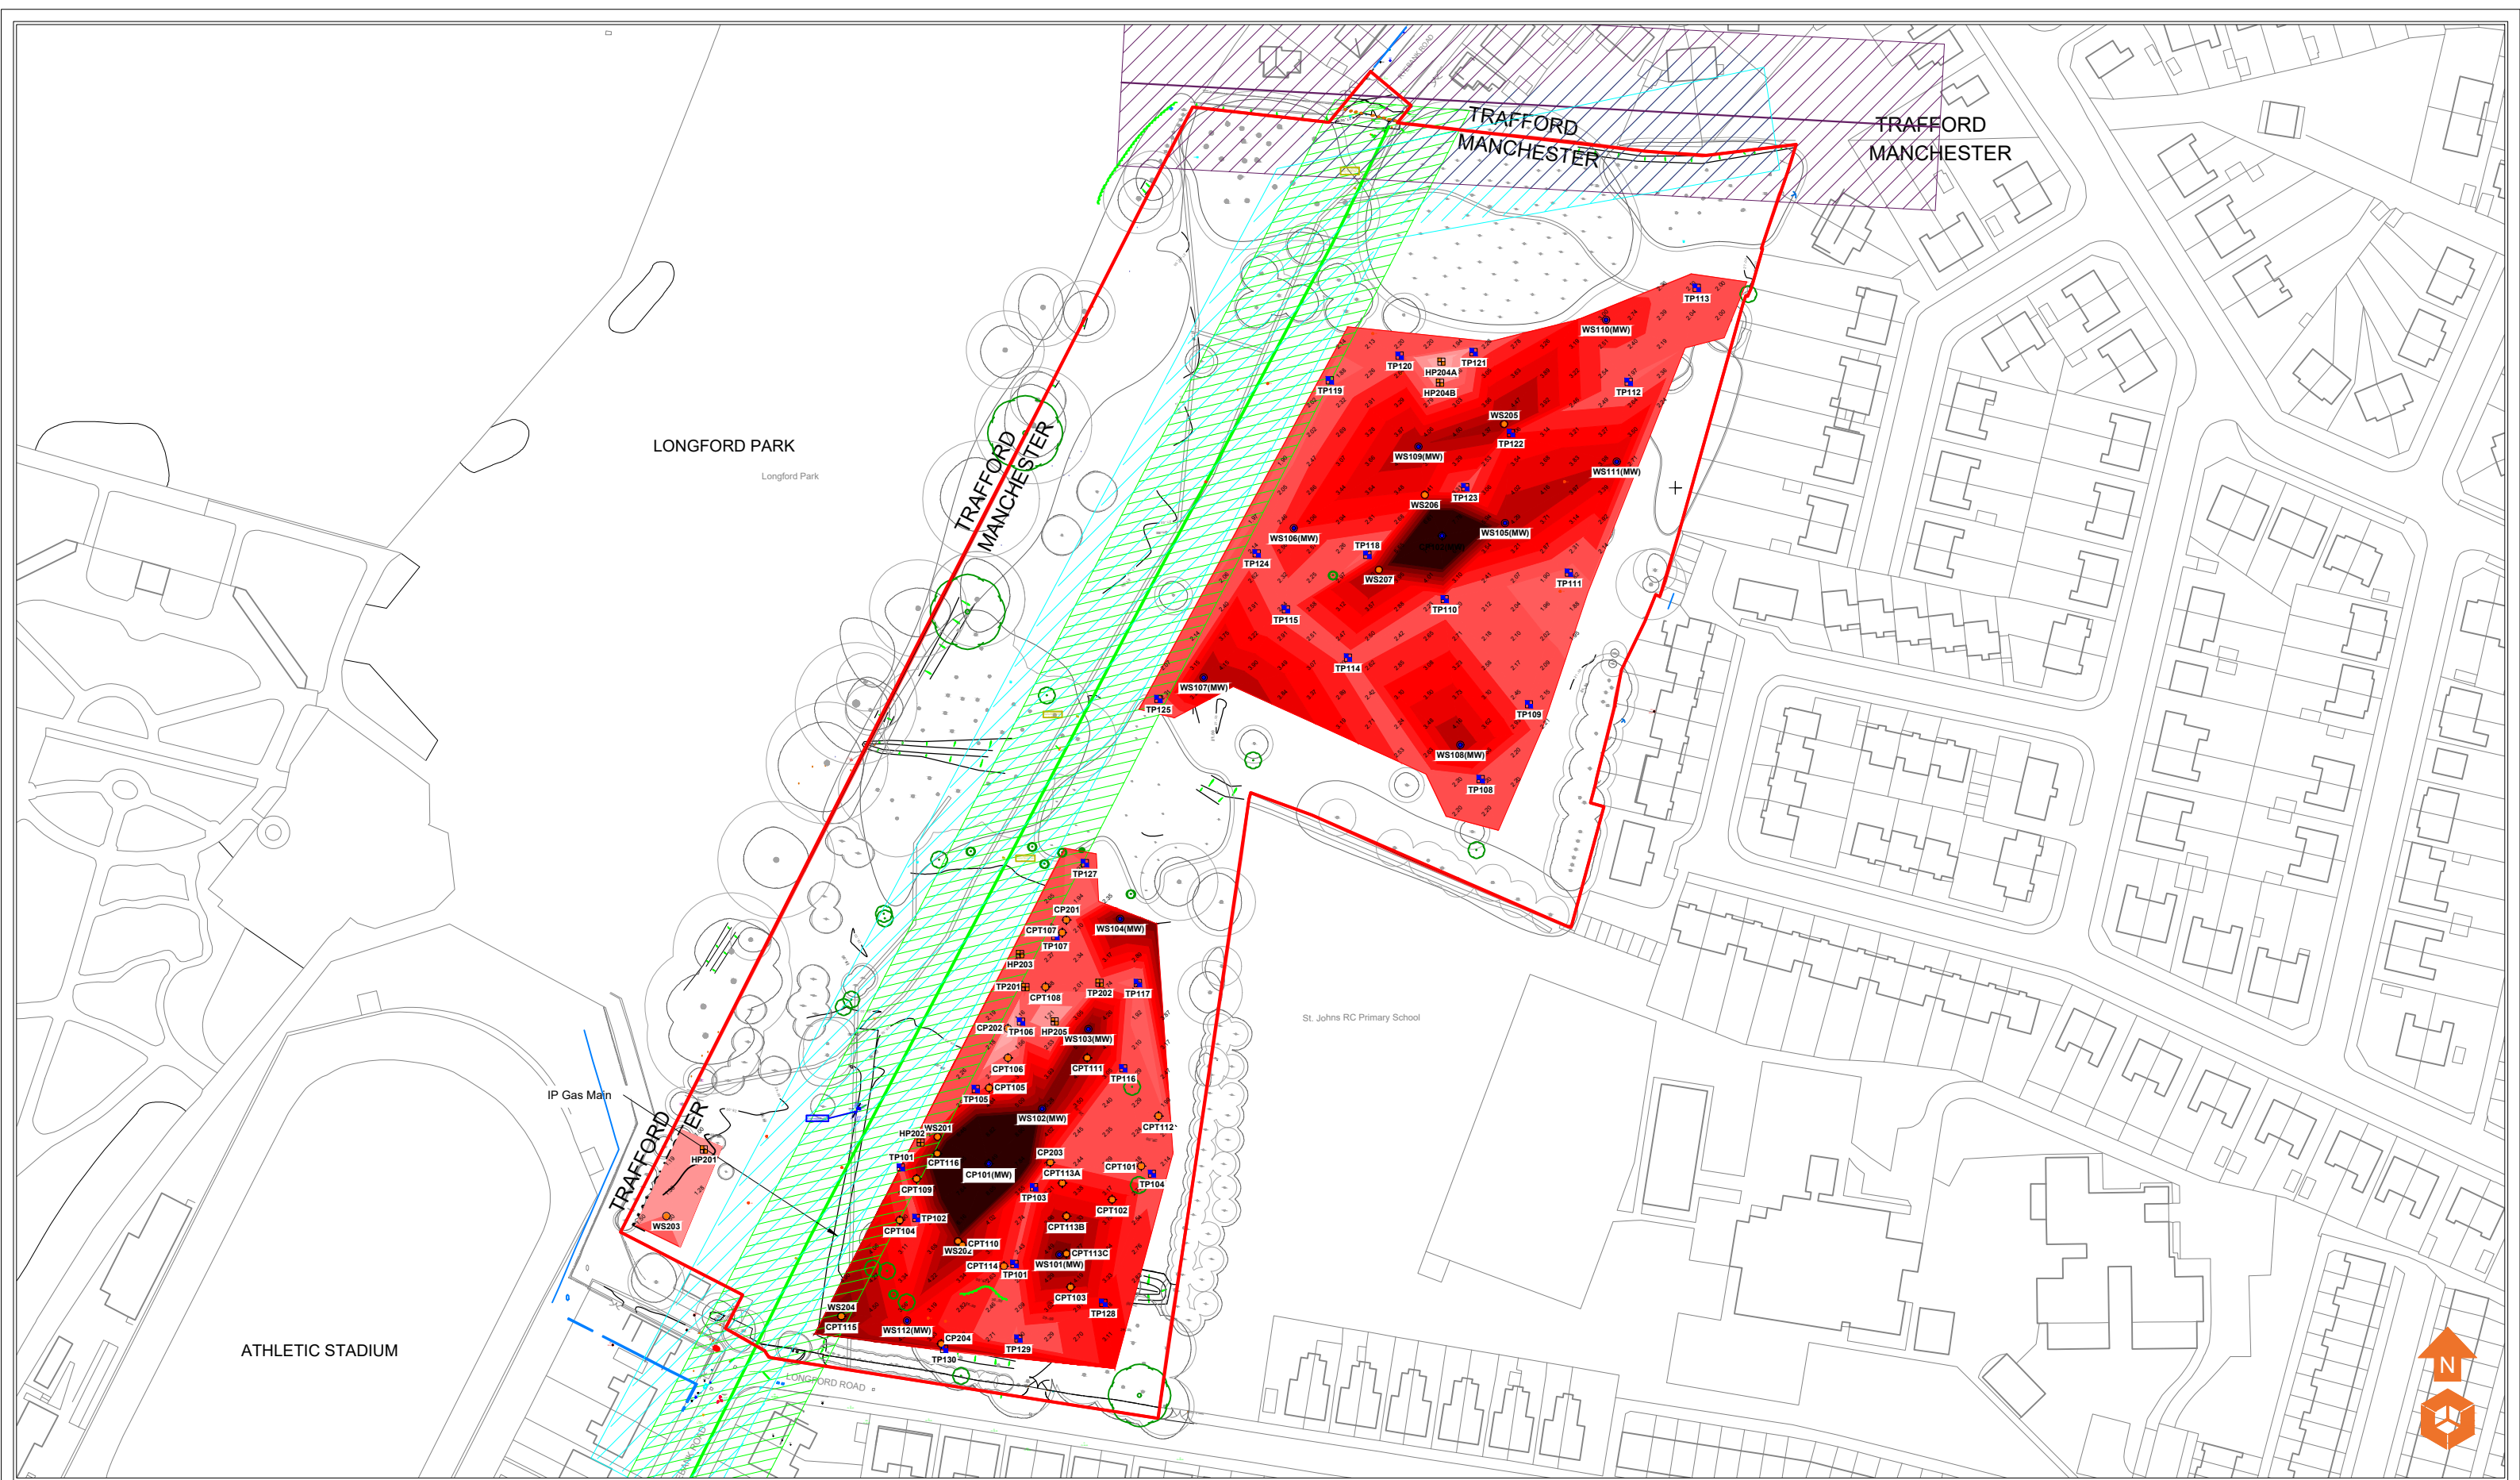
- Approximate Window Sample Probehole Location (E3P Locations 2024)
- Approximate Trial Pit Location (E3P Locations 2024)
- Approximate Cable Percussive Borehole Location (E3P Locations 2024)
- Approximate Cone Penetrometer Test Location (E3P Locations 2024)
- Approximate Window Sample Probehole Location (E3P Locations 2019)
- Approximate Window Sample Probehole Location with Install (E3P Locations 2019)
- Approximate Trial Pit Location (E3P Locations 2019)
- Approximate Cable Percussive Borehole Location (E3P Locations 2019)

**Drawings are missing from the site investigation appendix, including a clear plan showing all the site investigation locations to date.**

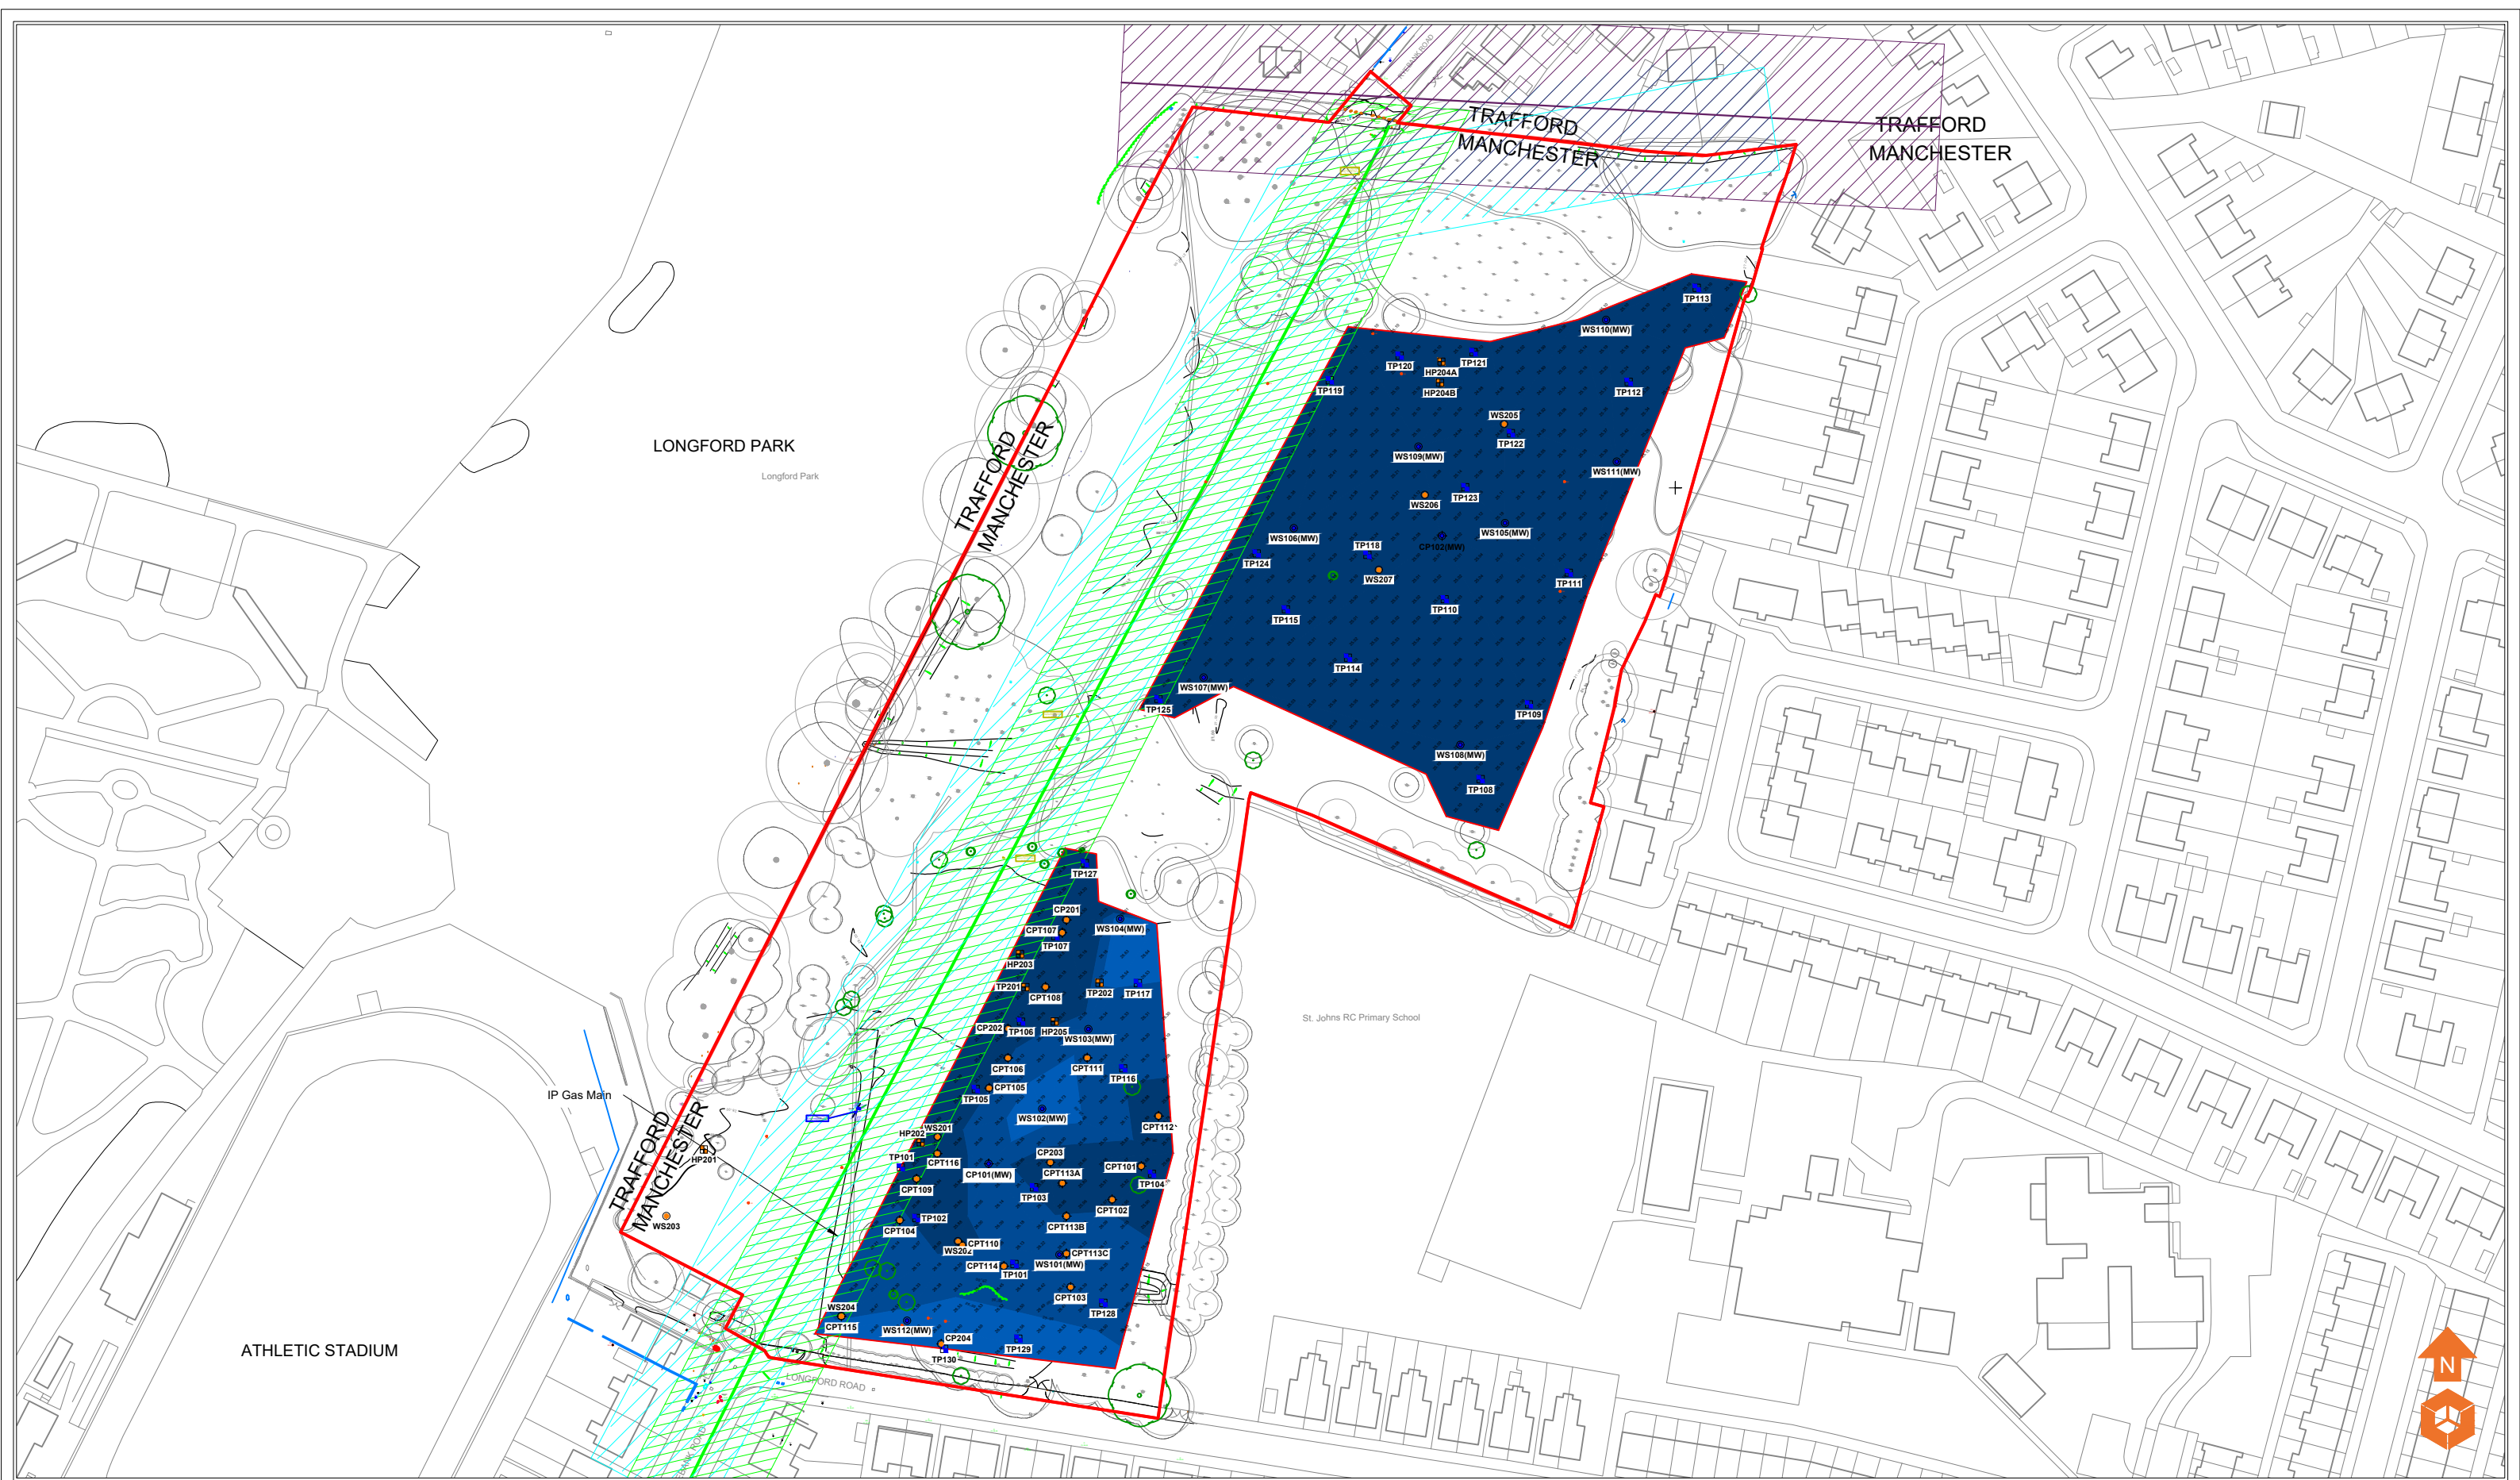
| <div>Geology Key</div> <div><div>Made Ground</div><div>Glacial Till</div><div>Wilslow Sandstone Formation</div><div>Glaciofluvial Deposits</div><div>Perched Ground Water</div><div>Assumed True Groundwater</div></div> | <div>Sources</div> <div><div>1</div>Heavy Metals, Non Volatile PAH's, Non Volatile TPH's</div> <div><div>2</div>Asbestos</div> <div><div>3</div>Volatile Contaminants</div> <div><div>4</div>Ground Gases</div> <div><div>5</div>Mobile Contaminants (TPH, VOC)</div> <div><div>6</div>Sulphate</div> <div><div>7</div>Phytotoxic Contaminants</div> |

- Approximate Window Sample Probehole Location (E3P Locations 2024)
- Approximate Trial Pit Location (E3P Locations 2024)
- Approximate Cable Percussive Borehole Location (E3P Locations 2024)
- Approximate Cone Penetrometer Test Location (E3P Locations 2024)
- Approximate Window Sample Probehole Location (E3P Locations 2019)
- Approximate Window Sample Probehole Location with Install (E3P Locations 2019)
- Approximate Trial Pit Location (E3P Locations 2019)
- Approximate Cable Percussive Borehole Location (E3P Locations 2019)
