## MCFC Project Taverna

### Phase 2 Geo-Environmental Investigation Report

For: Manchester City Football Club

| <b>Report Reference:</b> | | <b>4490-03</b> |

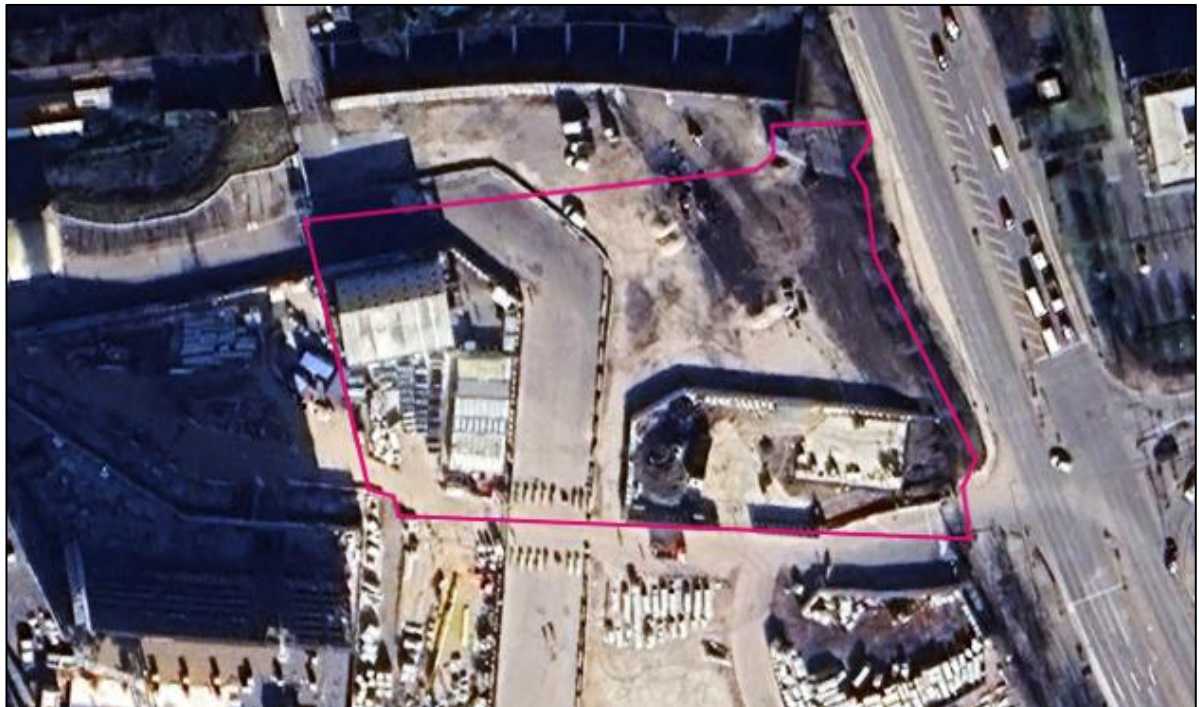
*Figure 1: Aerial image of the site dated March 2025. The approximate site boundary is highlighted in magenta.*

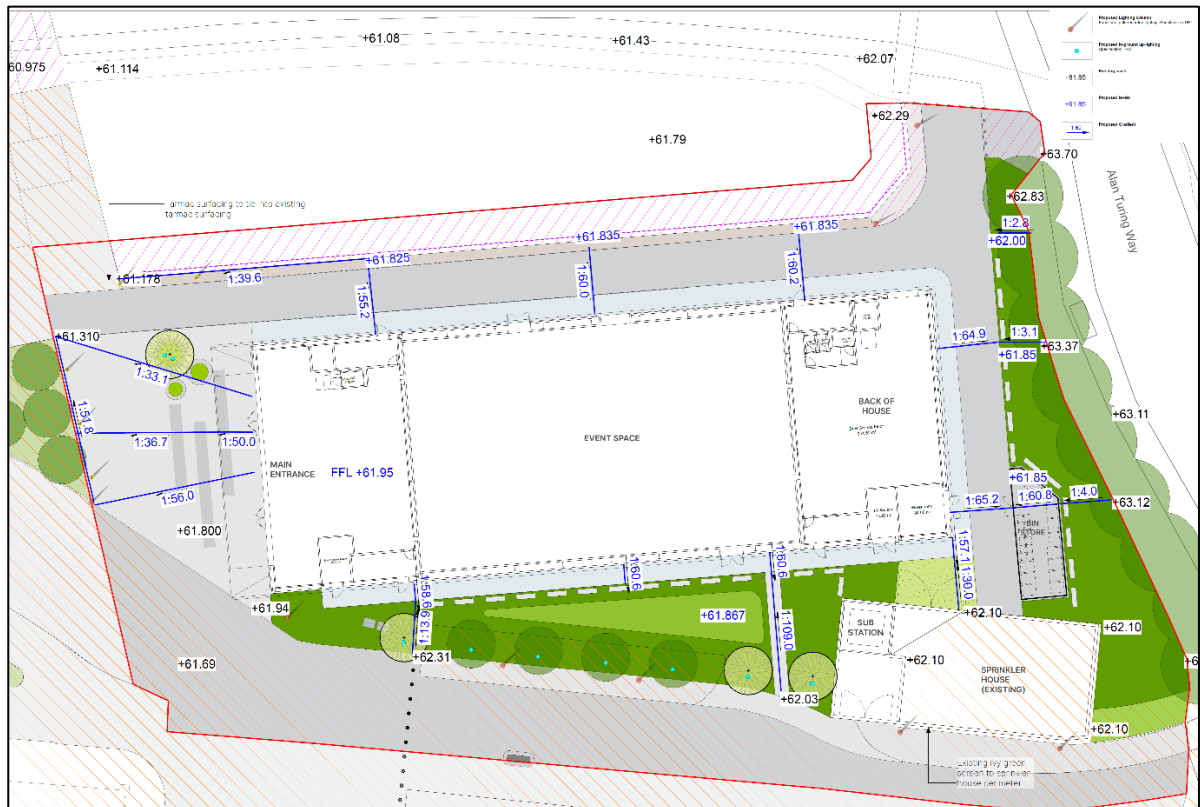
Figure 2: Extract of the proposed development plan

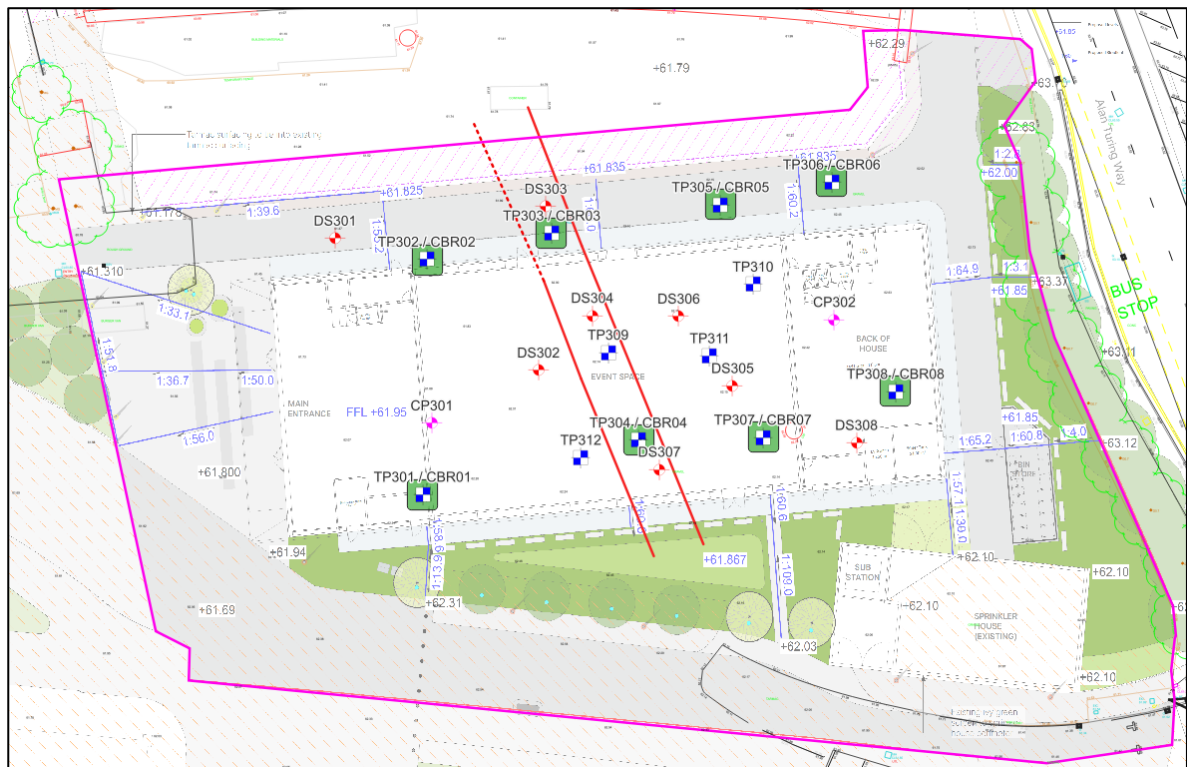
Figure 3: Extract of the exploratory hole location plan

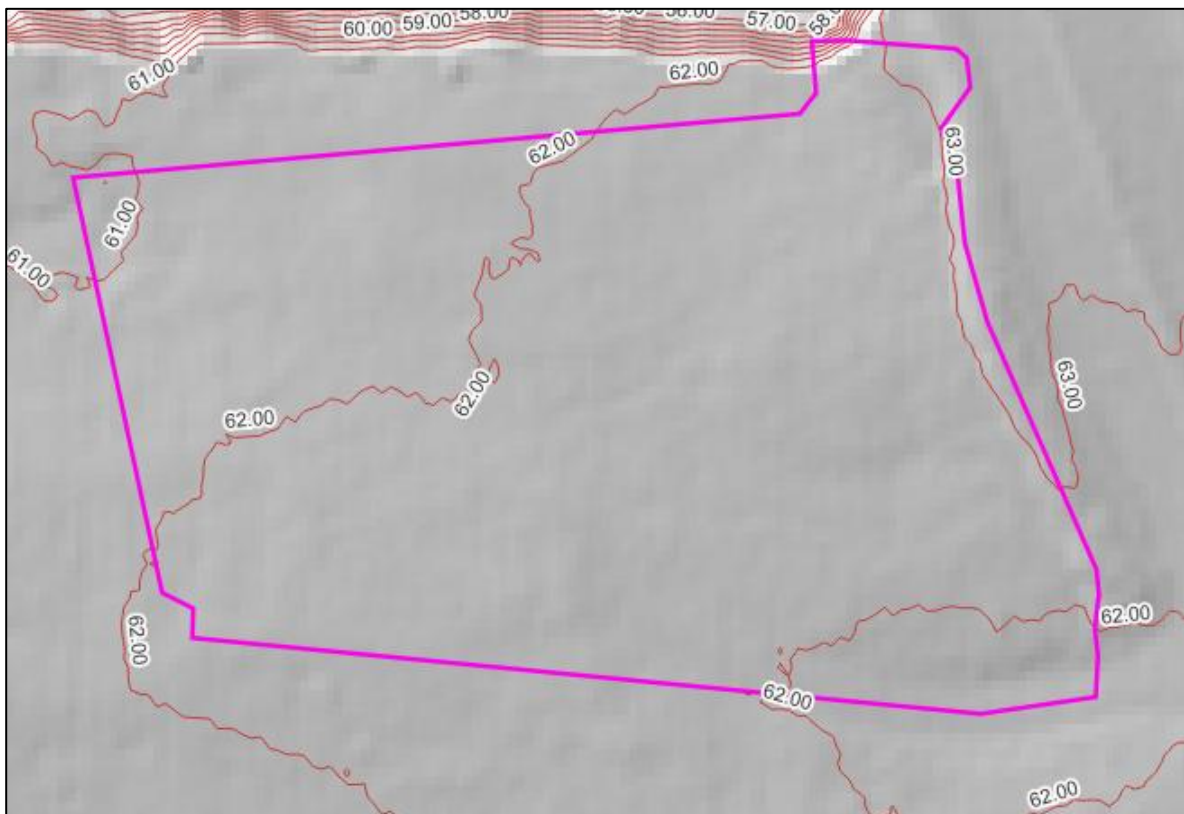
The site currently consists of a gravel surfaced car park in the eastern section and a site compound in the western site section separated by an asphalt road, predominantly utilised for pedestrian access. The site topography is consistent at c. 62.00m AOD with a gentle slope to the west. Figure 4, below, shows elevations across the site based on LIDAR data:

Figure 4: Site location plan showing current site elevations based on LIDAR data

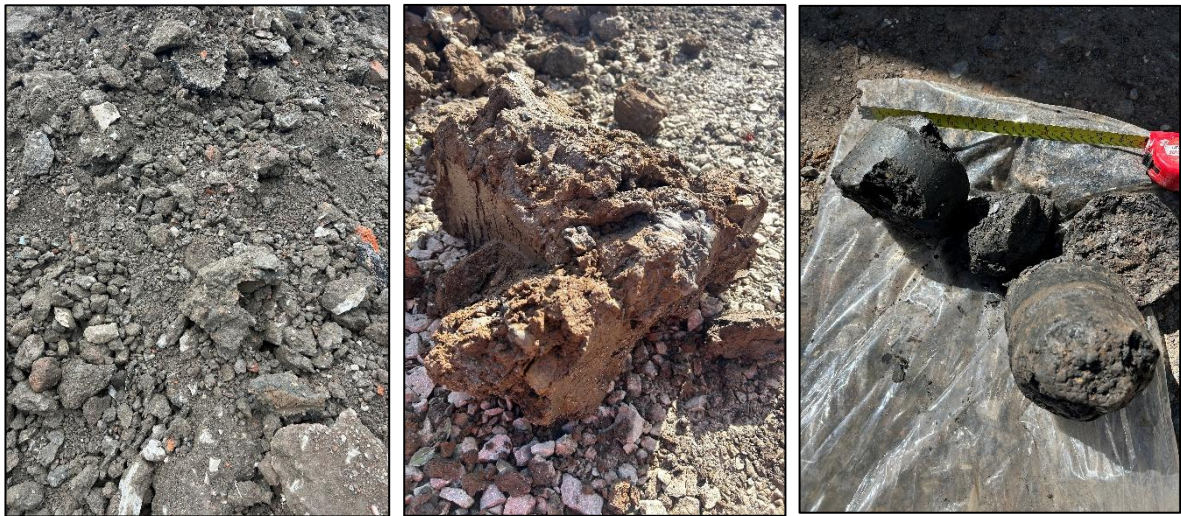
Figure 5: Typical Made Ground encountered in TP301 (left), typical Glacial Till encountered in TP305 (centre) and Pennine Upper Coal Measures in CP302 (right).

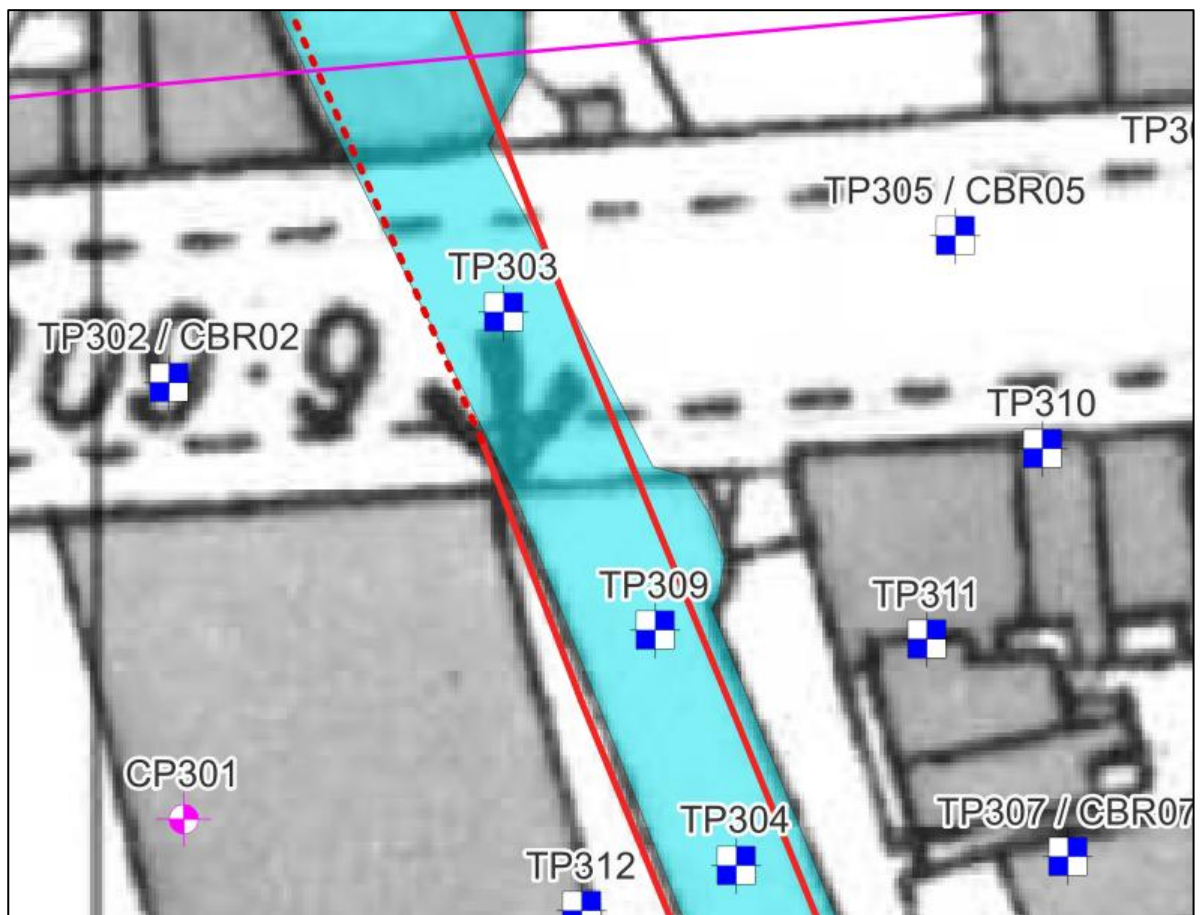
Trial pits TP303, TP304, TP309 and TP312 were undertaken within the extents of the historical infilled canal in order to identify and delineate this feature. During this delineation exercise, a mild to strong hydrocarbon odour and sheen was noted in the Made Ground deposits between 2.60m and 4.40m bgl (59.52m and 57.72m AOD).

Figure 6: Locations of exploratory holes targeting the historical infilled canal overlain onto the 1893 historical OS map. The location of the canal on the historical map is shown in blue. Extents measured during ground investigation are shown with red lines and inferred extents are shown with a dashed red line.

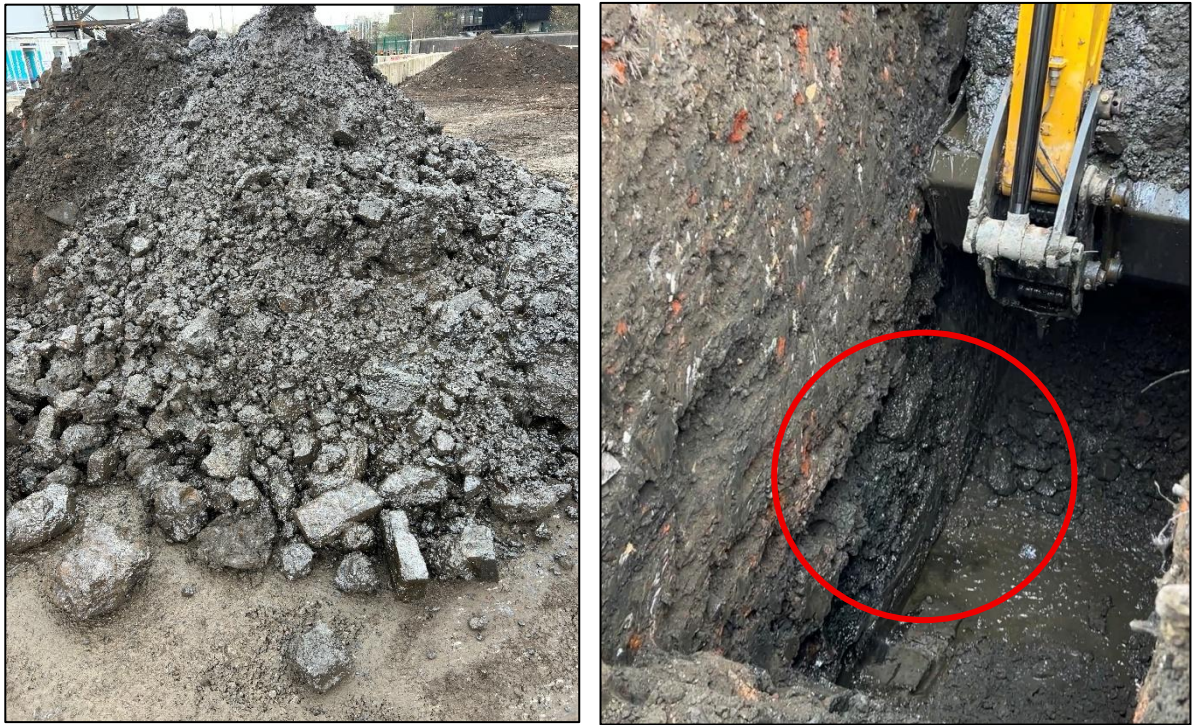
Evidence of TPH impact was noted to be the strongest in TP309 and significantly weaker in TP304 and TP303. Representative samples were taken from these deposits and sent for chemical laboratory testing to confirm contaminant concentrations. Chemical testing results are included in Appendix 8 and summarised in Section 3.7. Photographs of the recovered material in which strong odours and sheens were recorded are included below as Figure 7:

Figure 7: Photographs of Made Ground where strong hydrocarbon odours and sheens were recorded (TP303, left and TP309, right)

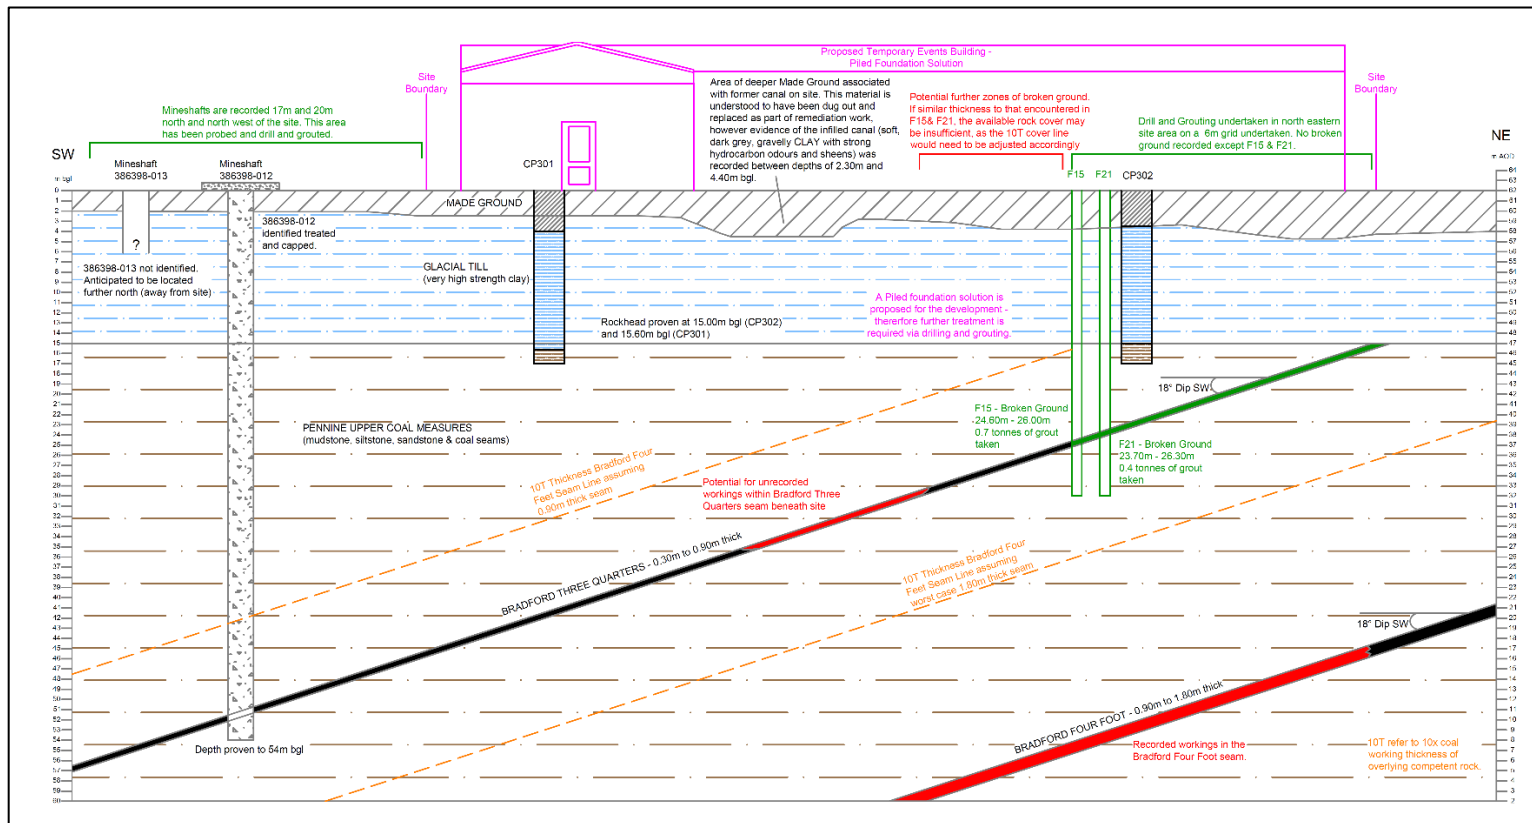
The findings of the Phase 2 ground investigation works have been used to create a conceptual ground model of the site. The model illustrates the typical ground conditions outlined in Section 3.1 as well as the deeper Made Ground encountered in the infilled canal. An extract of the conceptual ground model is included below as Figure 8 and presented in Appendix 2:

Figure 8: Extract of the conceptual ground model for the site.

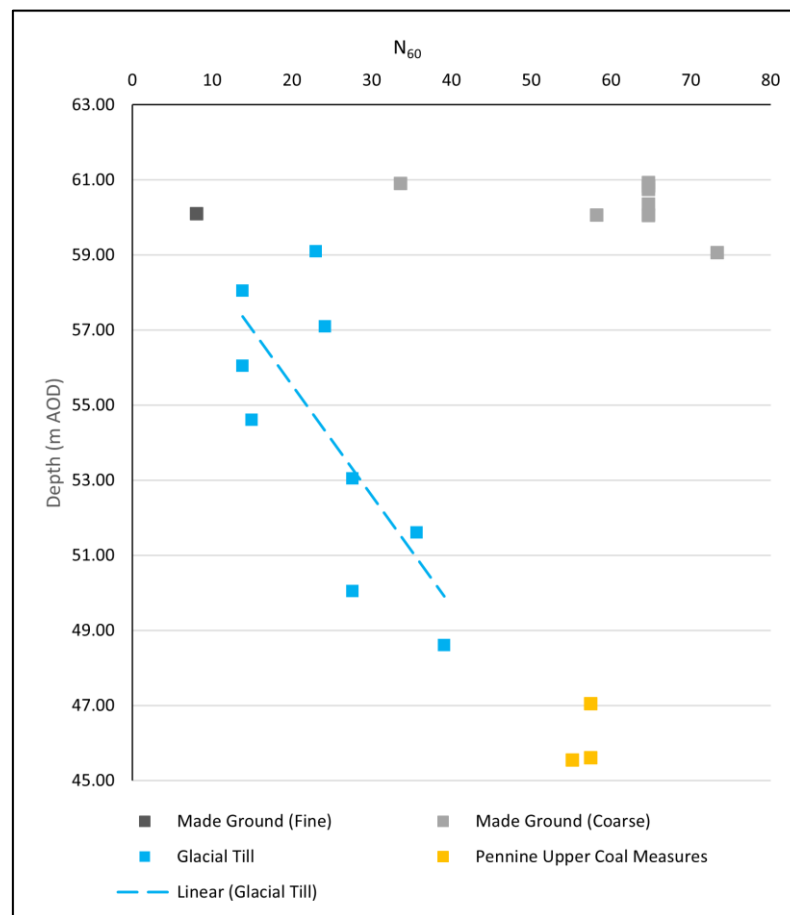
Standard penetration tests (SPTs) were undertaken at regular 1.00m intervals during the construction of the cable percussion and dynamic sampling boreholes. The following scatter graph outlines the corrected  $N_{60}$  (energy ratio of 69) derived from the standard penetration tests undertaken during the ground investigation works.

The scatter graph shows that there was a positive correlation between increasing corrected  $N_{60}$  with depth within Glacial Till deposits. SPTs undertaken within Made Ground and Pennine Upper Coal Measures mostly resulted in refusals.

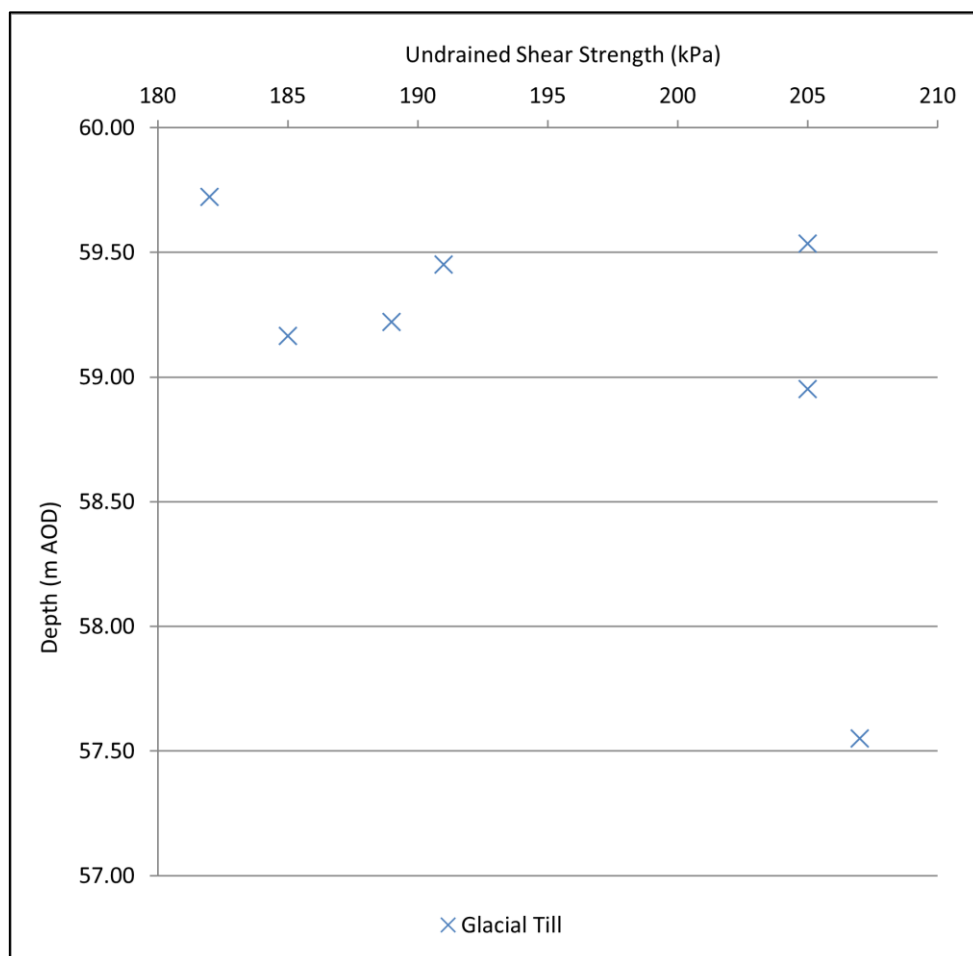
Given the depth of Made Ground encountered across the site and the general recovery of fine Glacial Till deposits as fine gravel to cobble sized pieces, only 7 No. undrained shear strength tests were conducted via hand shear vane during the ground investigation. A correlation between undrained shear strength and depth could not be established with the available data although results were recorded between 185 kPa and results in excess of 205 kPa (average 195). The Glacial Till on

site can therefore be classified as a very high strength clay. Hand shear vane test results are included on the trial pit logs, contained within Appendix 3.

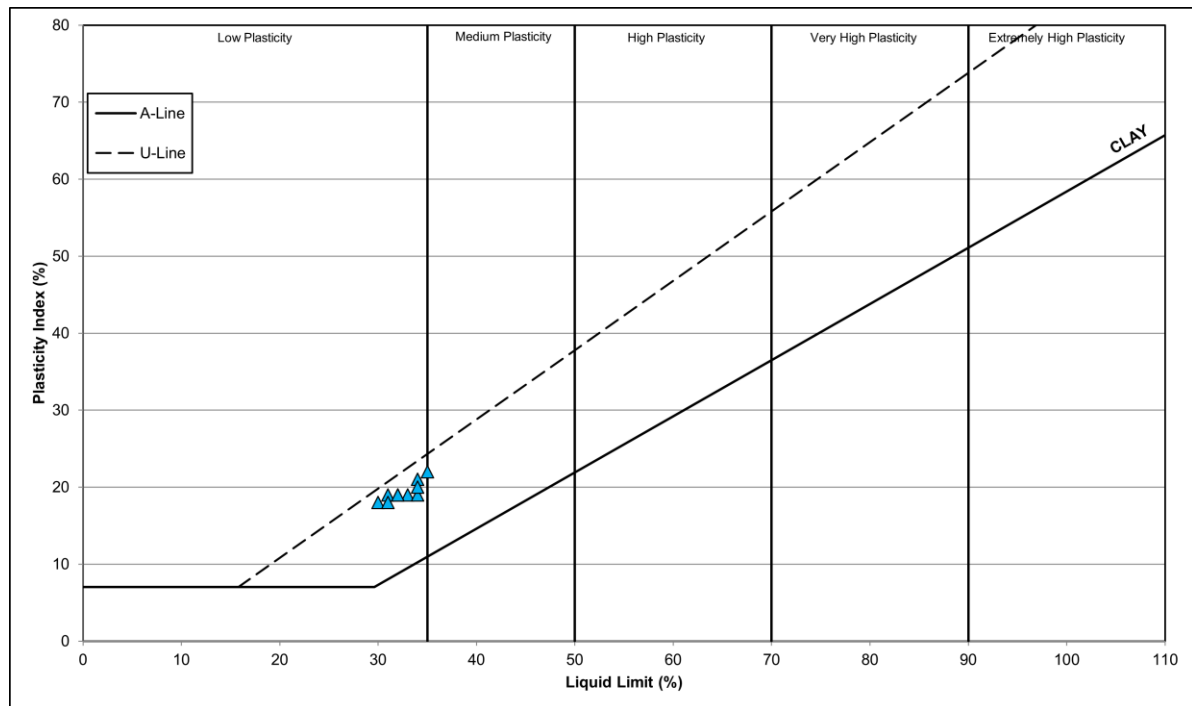
The Atterberg Limit tests indicate that the Glacial Till deposits are generally of low plasticity with the exception of 1 No. sample (TP302 at 2.70m bgl) which is medium plasticity in-line with BS14688 Part 2. The Glacial Till is of low volume change potential as indicated by all Atterberg limit tests.

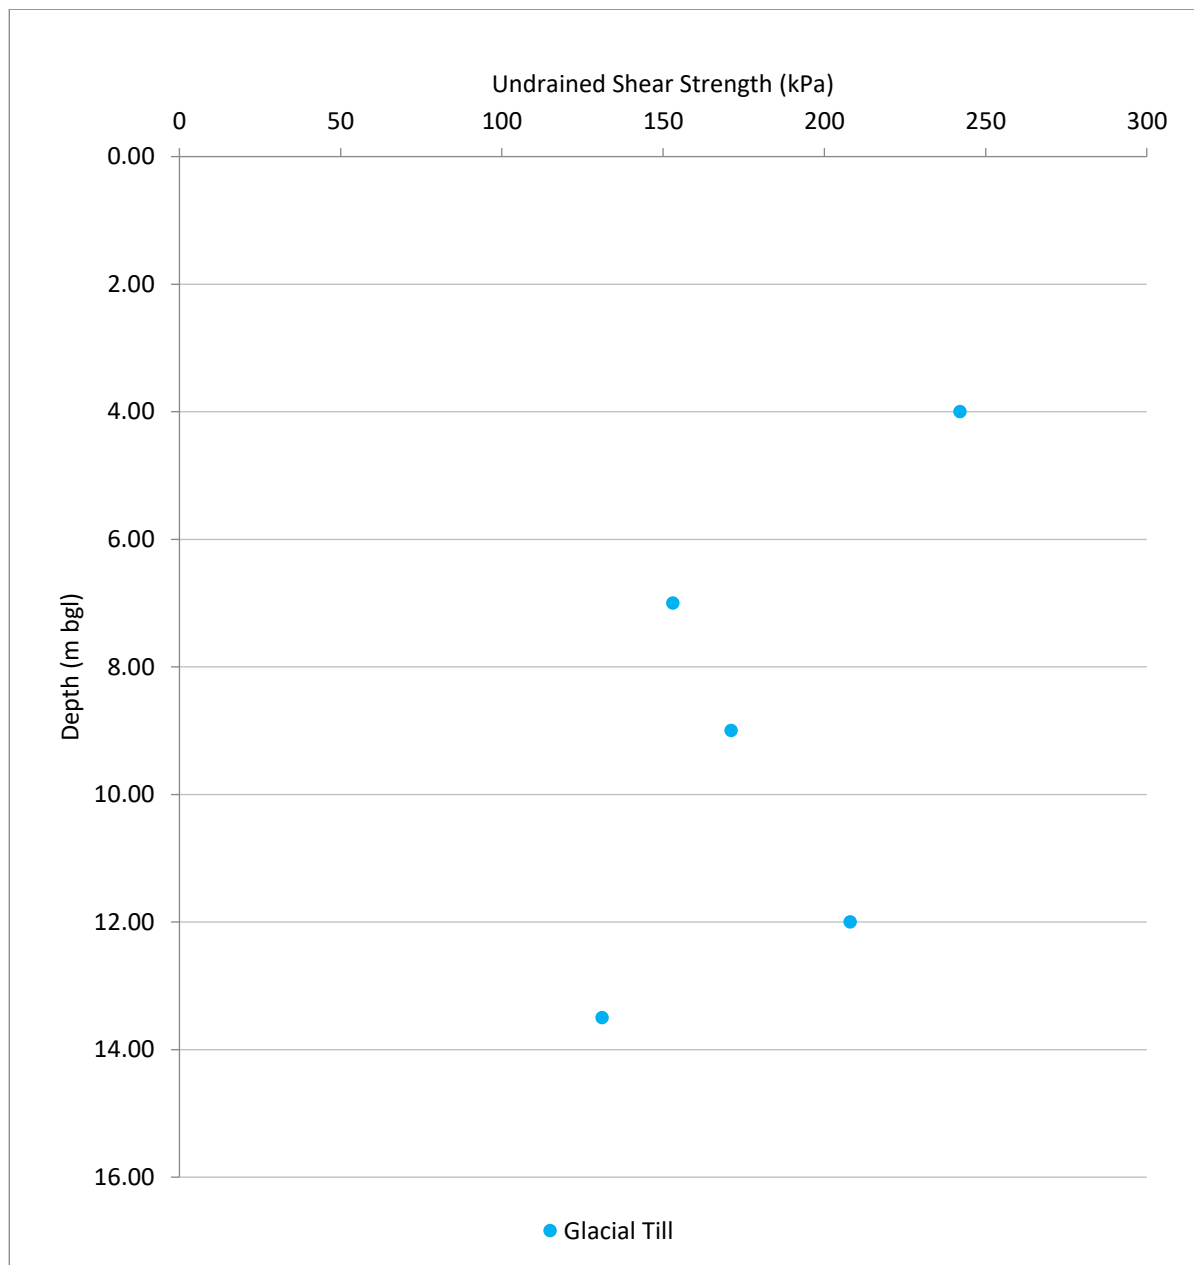
The triaxial testing indicates that the Glacial Till is of very high strength aside from 1 No. test (CP302 at 13.50m bgl) recorded as high strength. The below graph illustrates the undrained shear strength plotted against increasing depth:

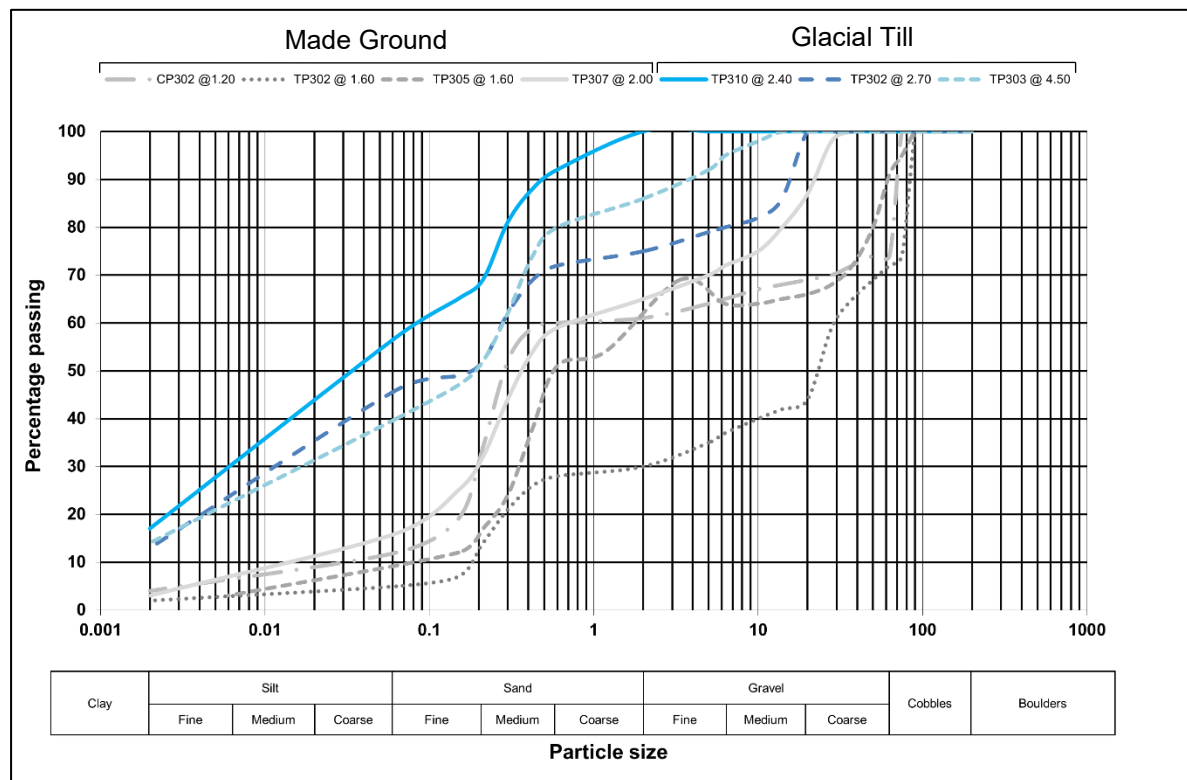
The PSD test results indicate that the Glacial Till is typically a slightly gravelly, slightly sandy to sandy clay. The tests indicate that the Made Ground is a very sandy, slightly clayey gravel or a gravelly to very gravelly, slightly clayey sand with medium to high cobble content. Given the assessed behaviour observed in the field, fine soils encountered on site have been classified as a clay as opposed to a silt, despite the relatively high proportion of silt recorded in the laboratory testing.

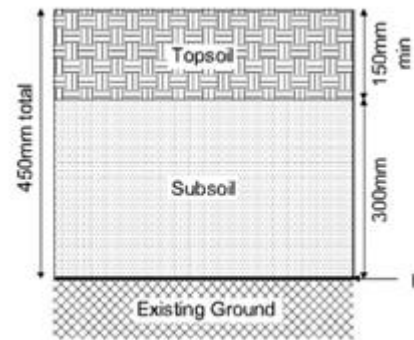
1. Excavate to 450mm bgl in soft landscaping areas;
2. A 450mm clean cover system is recommended to be added to the proposed soft landscaping. This is to consist of:
  - No less than 150mm suitable topsoil, underlain by;
  - 300mm suitable subsoil to a total (topsoil + subsoil) depth of 450mm, underlain by;
  - A high vis geotextile marker;
  - Validate in line with the below strategy.

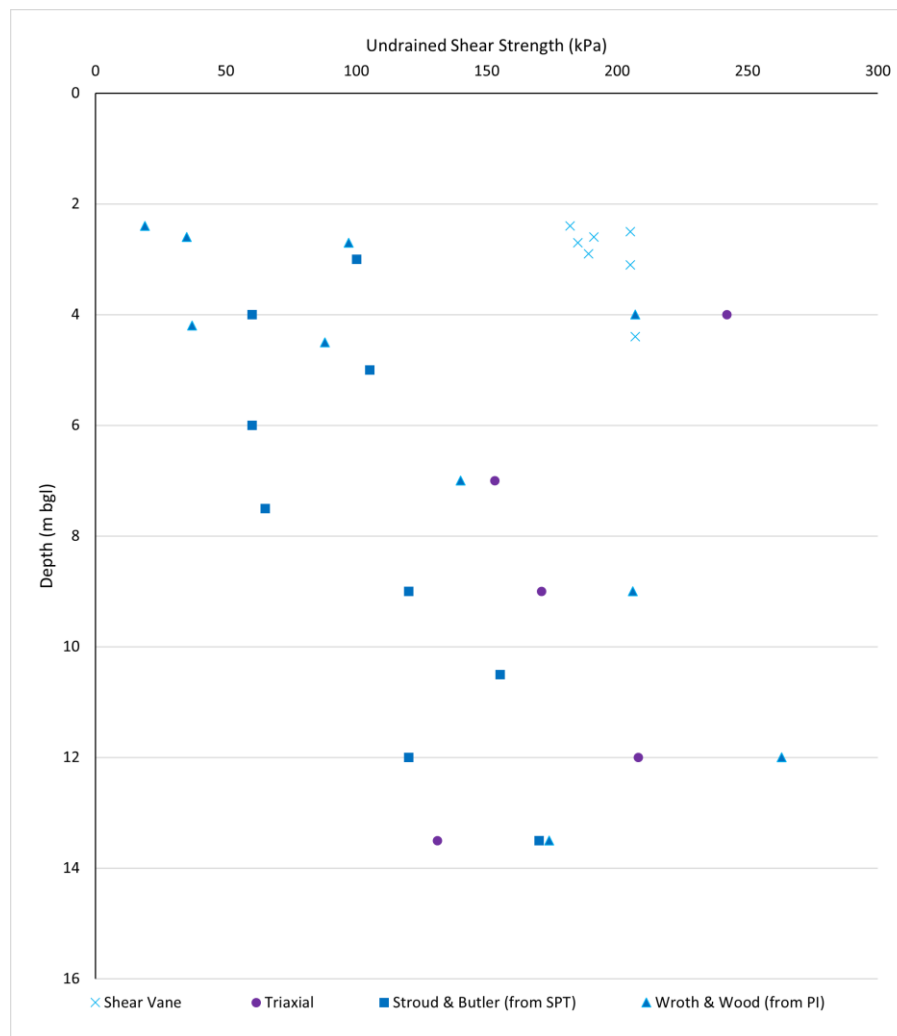
The correlations between uncorrected N-values and undrained shear strength proposed by *Stroud & Butler* and between undrained shear strength and plasticity indices proposed by *Wroth & Wood* have been used to augment the dataset of undrained shear strength. The direct measurements (hand shear vane and triaxial) are presented alongside the empirical estimations, below. The undrained shear strength of the Glacial Till generally increases with depth, with no direct measurements below 100kPa.
