# Preliminary Ecological Appraisal and Roost Assessment

Premier inn Manchester Airport (Heald Green) Finney Lane, Wythenshawe, Stockport SK8 3QA

Whitbread Group PLC

This report is prepared to inform a planning application with Stockport Metropolitan Borough Council. The proposal is described as:  
Demolition of public house and construction of building to form extension of existing hotel and renovations to existing hotel.

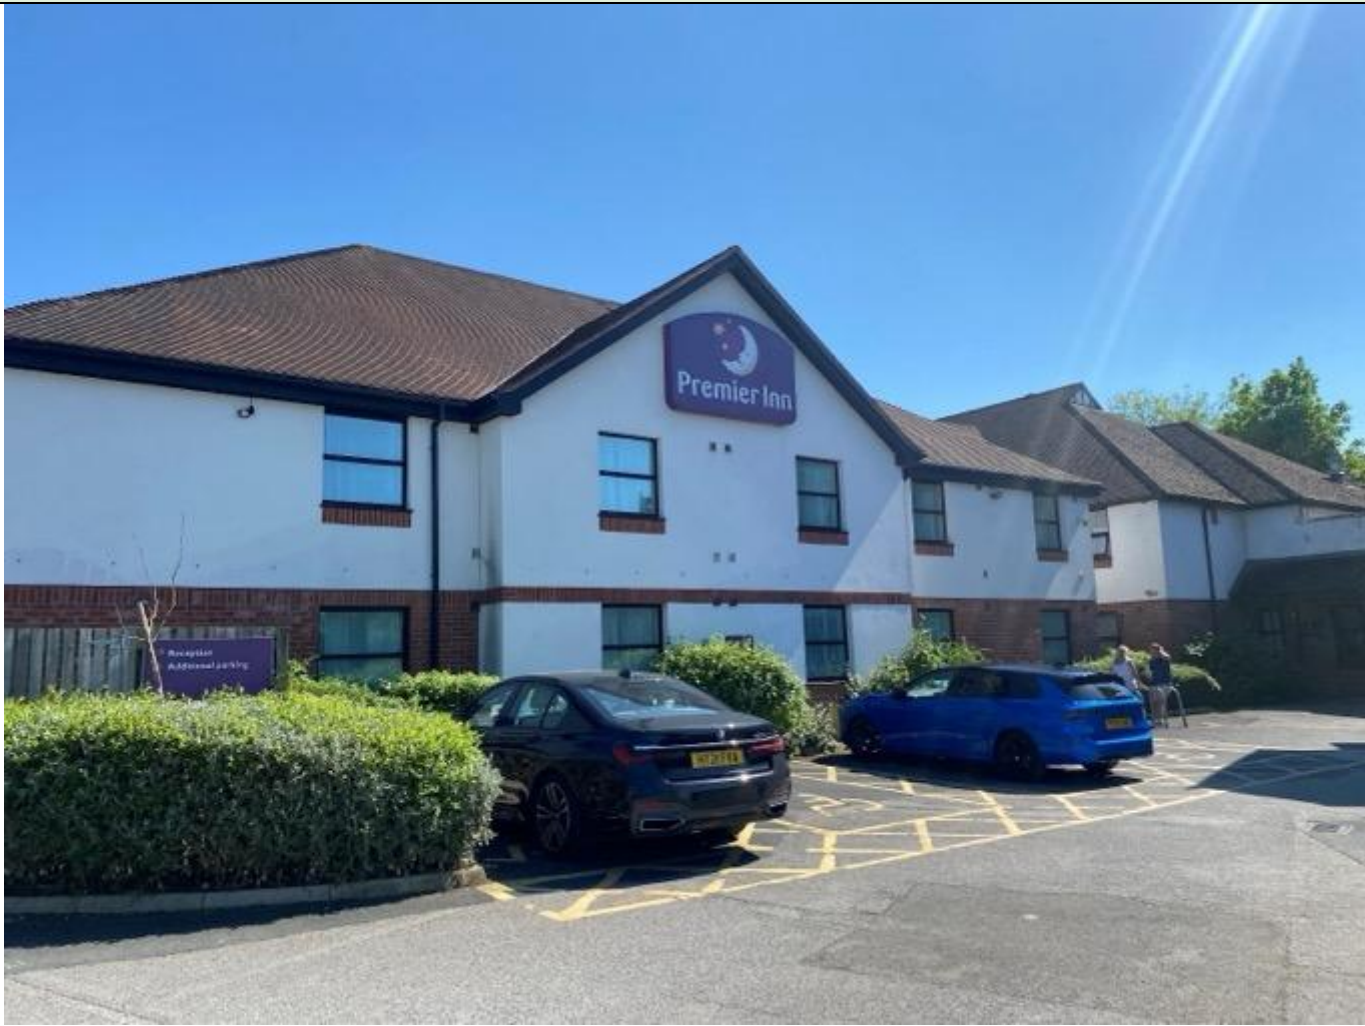
| North-western elevation of B1 | |
|---|---|
| A photograph of the north-western elevation of a two-story Premier Inn building. The building has white rendered walls, a dark brown tiled roof, and a brick base. A large Premier Inn sign is mounted on the upper part of the building. In the foreground, there is a parking lot with yellow markings, a dark grey car, and a blue car. A small signpost with a purple sign is visible near the bushes. The sky is clear blue. | Northwestern elevation of B1. The building is rendered throughout and is in excellent condition, with no gaps or cracks present in the render which bats could utilise for roosting. |

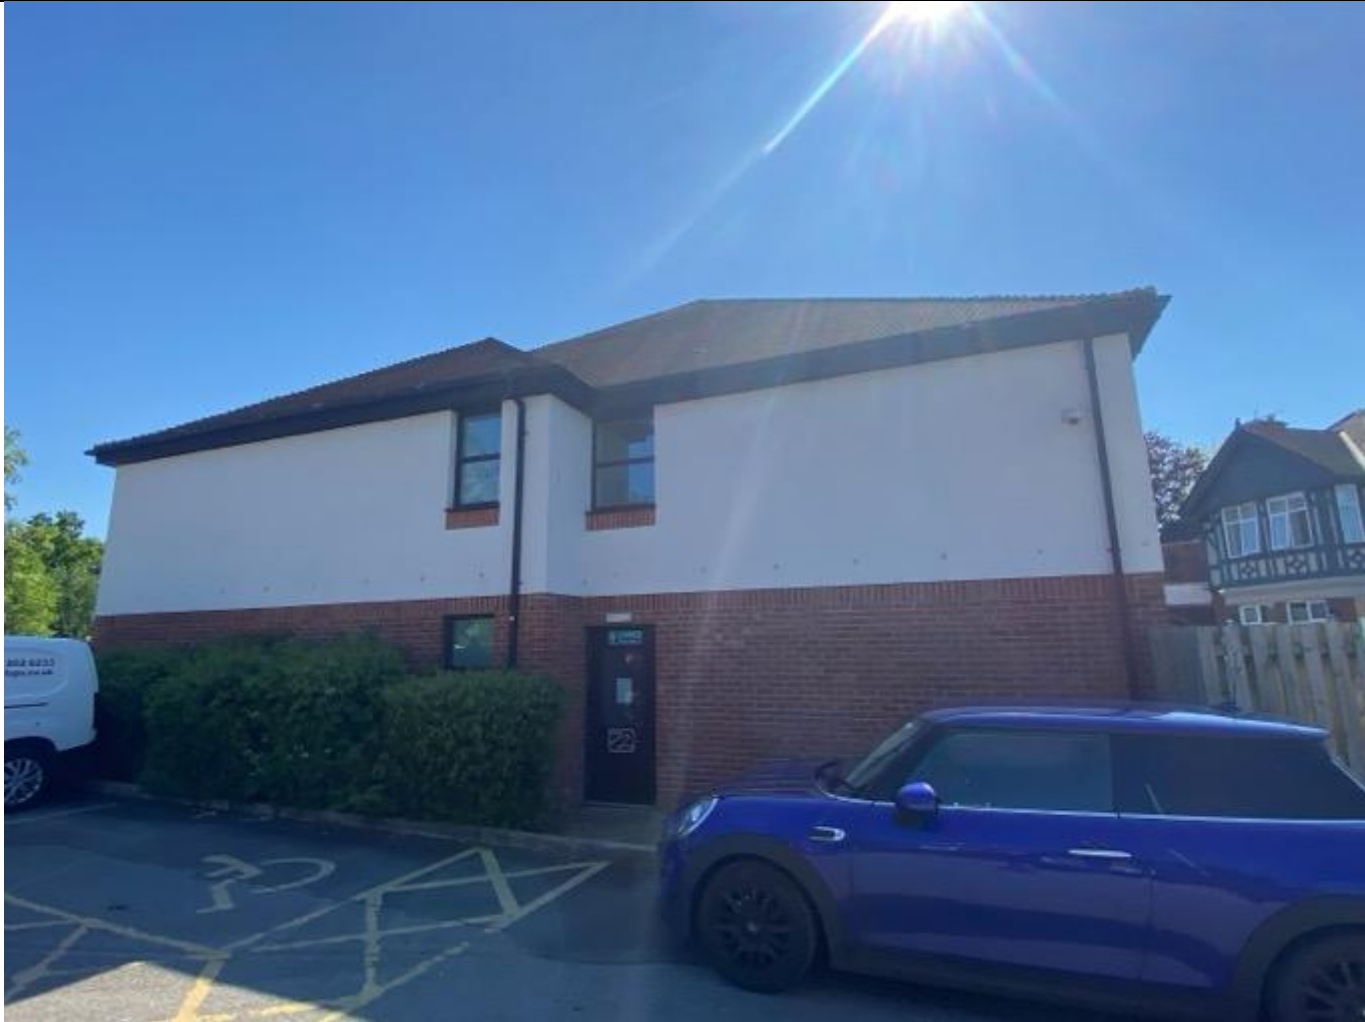
| Northern elevation of B1 | |

| Northern elevation of B1 | |
|---|---|
| | One of the north-eastern elevations of B1. All of the roof tiles are in excellent condition throughout B1, with no gaps or holes present that provide suitability for roosting bats. |

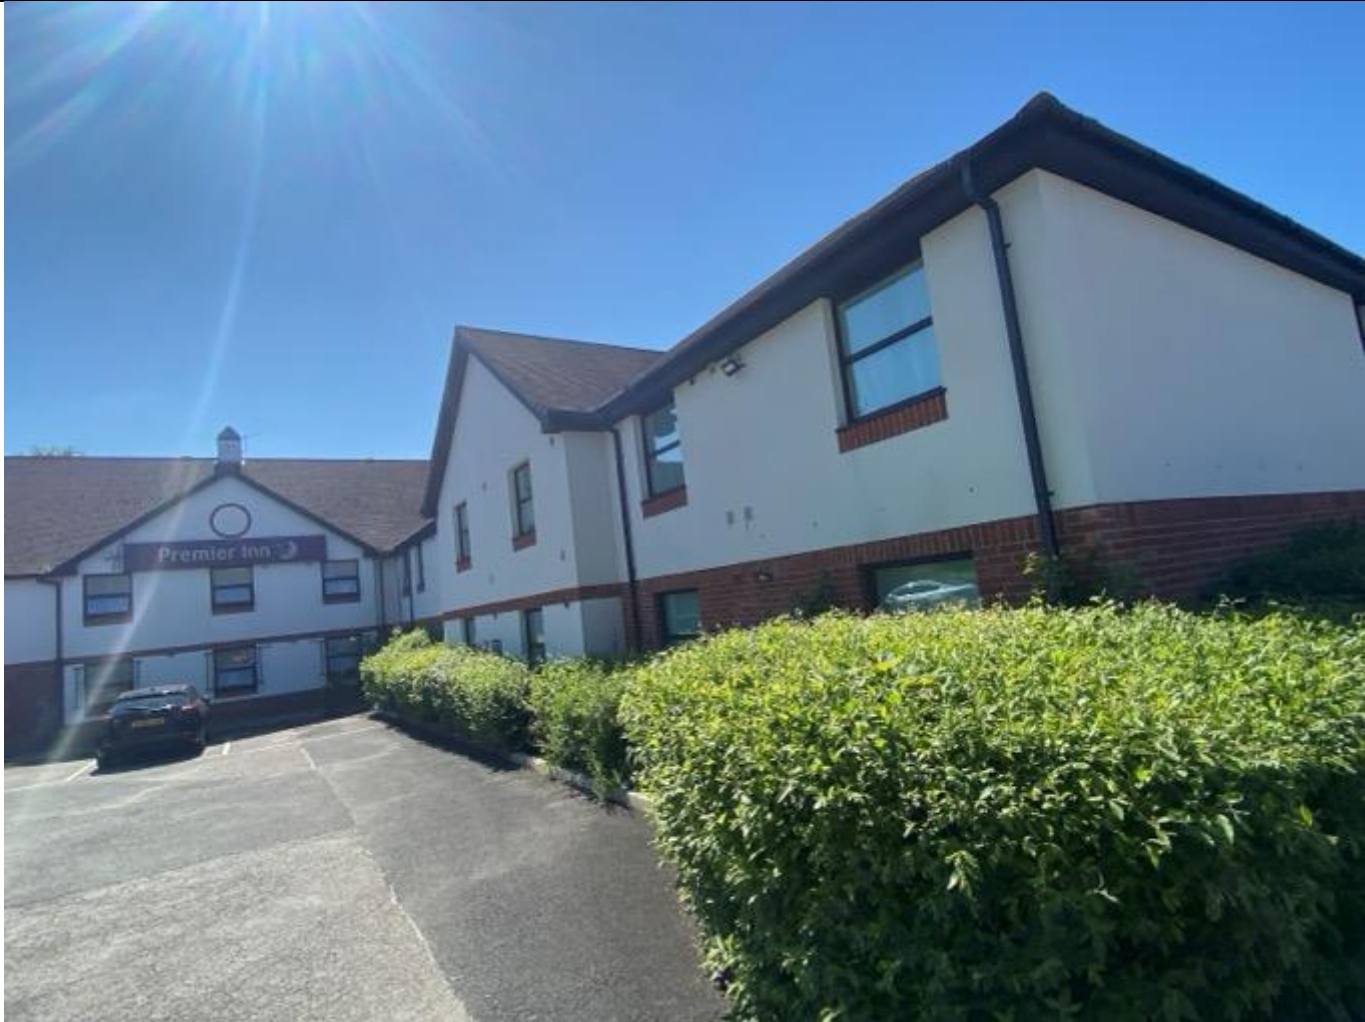
| Eastern elevation of B1 | |
|---|---|
| | <p>The eastern elevation contains two gables, part of which form a previous extension. There are no gaps present within the gable end as in fitting with the building which is in excellent condition.</p> <p>The ornamental hedgerows can be seen in the image, also, that are consistent in composition and structure throughout the site.</p> |

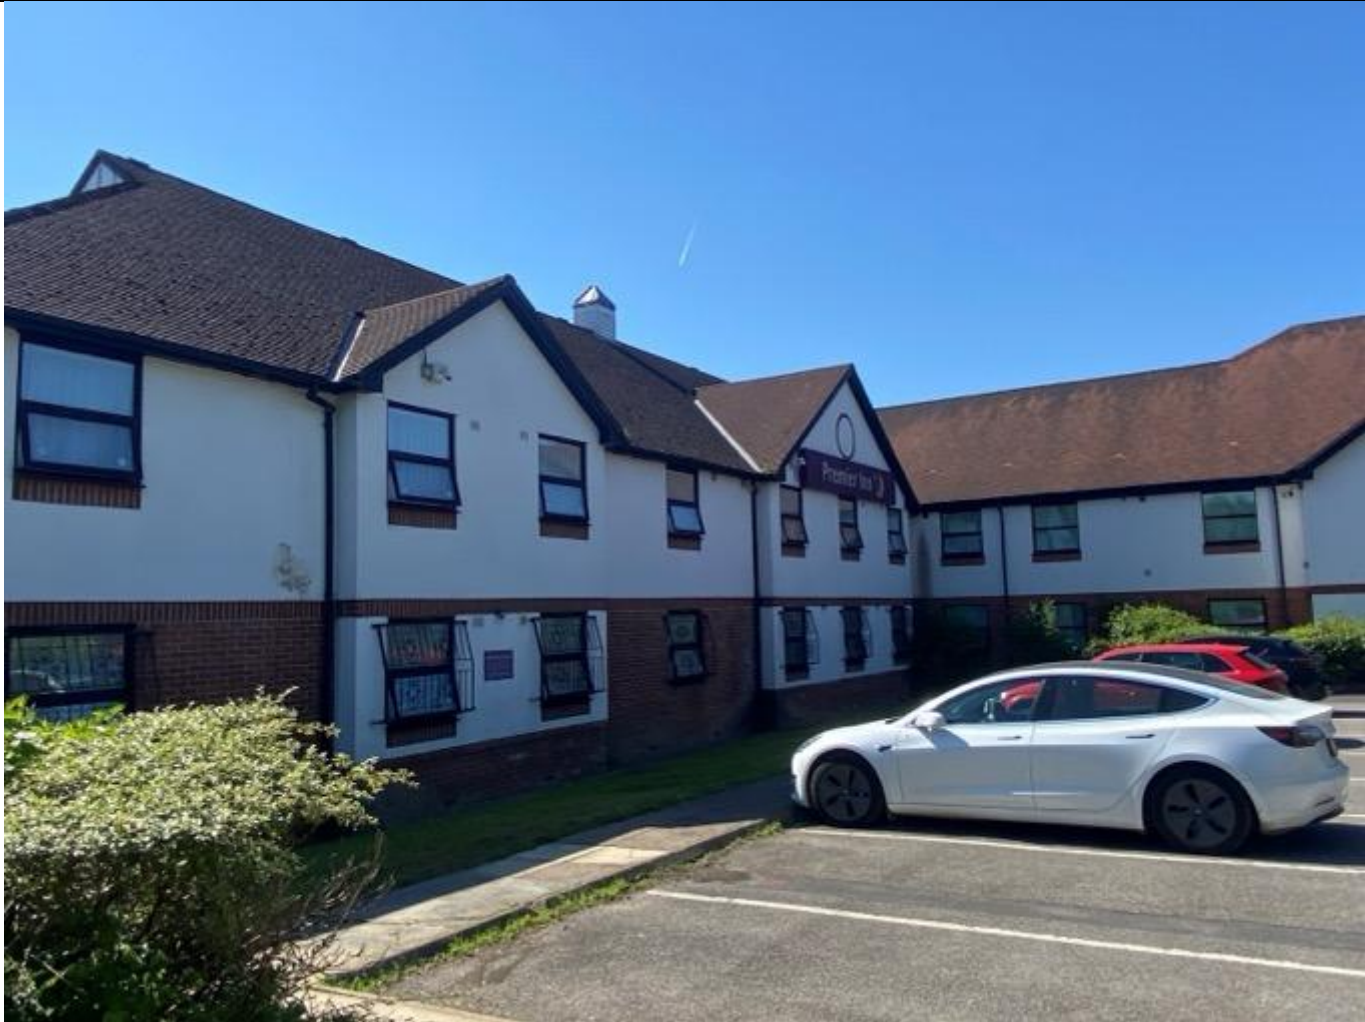
| Northern elevation of B1 | |
|---|---|
| | <p>The northern elevation on the eastern most arm of B1 also contains two gable ends that are in excellent condition. The valleys between the gables are also in excellent condition, with no gaps or holes present between the valley and roof tile where bats could roost.</p> |

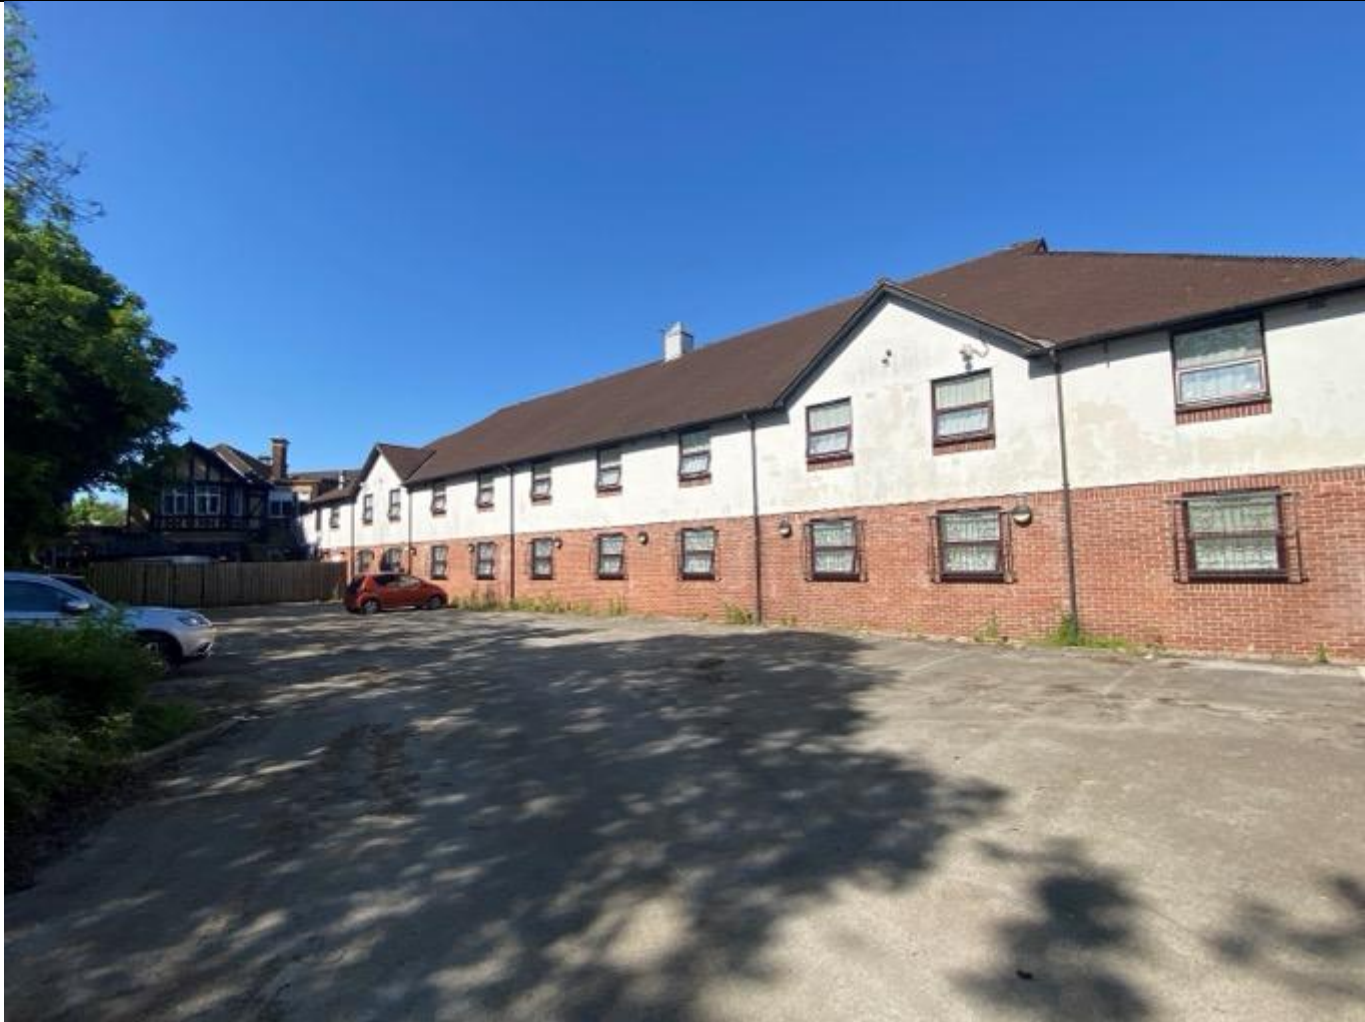
| Southern elevation of B1 | |

| Southern elevation of B1 | |
|---|---|
| | <p>In fitting with the rest of B1, the southern elevation is in excellent condition, with no gaps or holes present that provide suitability for roosting bats.</p> |

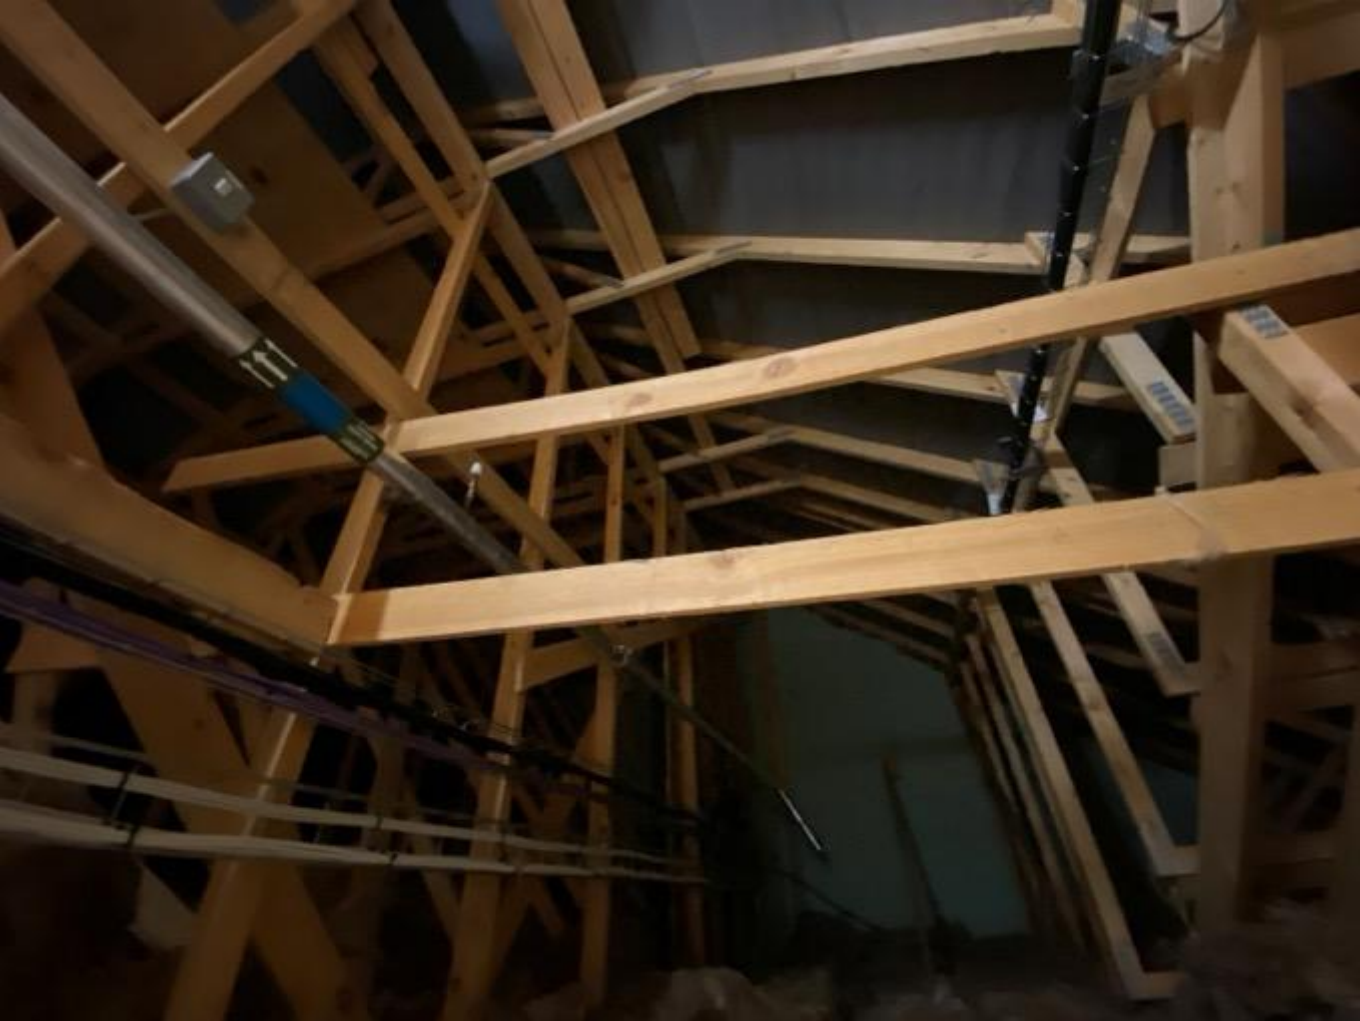
| B1 roof space | |

| B1 roof space | |
|---|---|
| | <p>The roof space of B1 is well sealed and no light was observed to be entering the roof space. A plastic roofing membrane was present between the tiles and the roof structure.</p> |

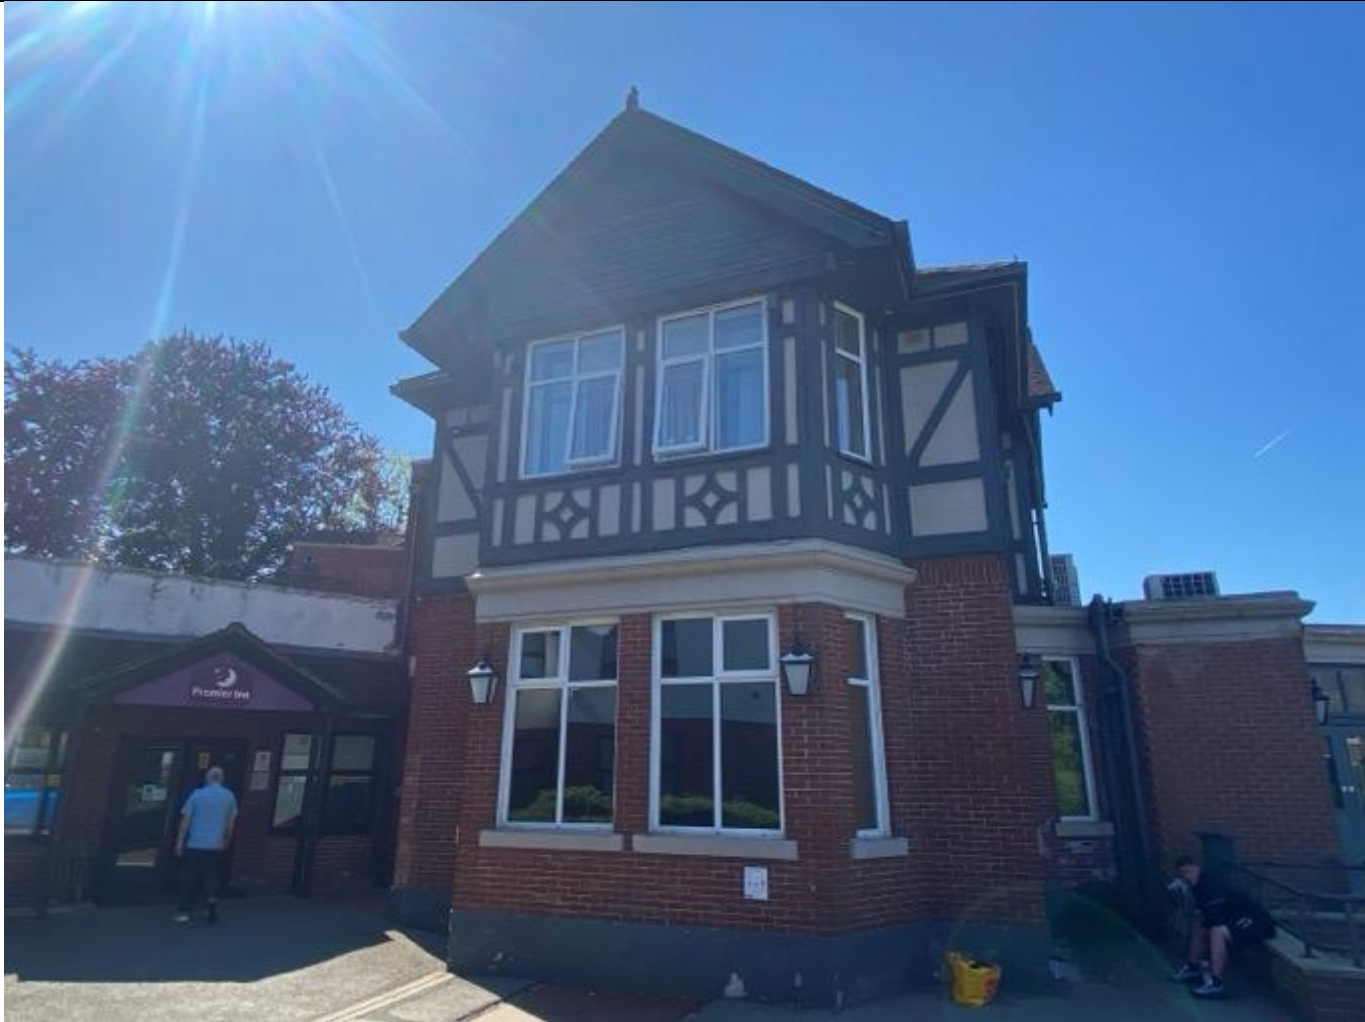
| Eastern elevation of B2 | |

| Eastern elevation of B2 | |
|---|---|
| | <p>The eastern elevation of B2 contains one of the various gables present throughout the building. The gable end contains no gaps or holes and is in good condition.</p> |

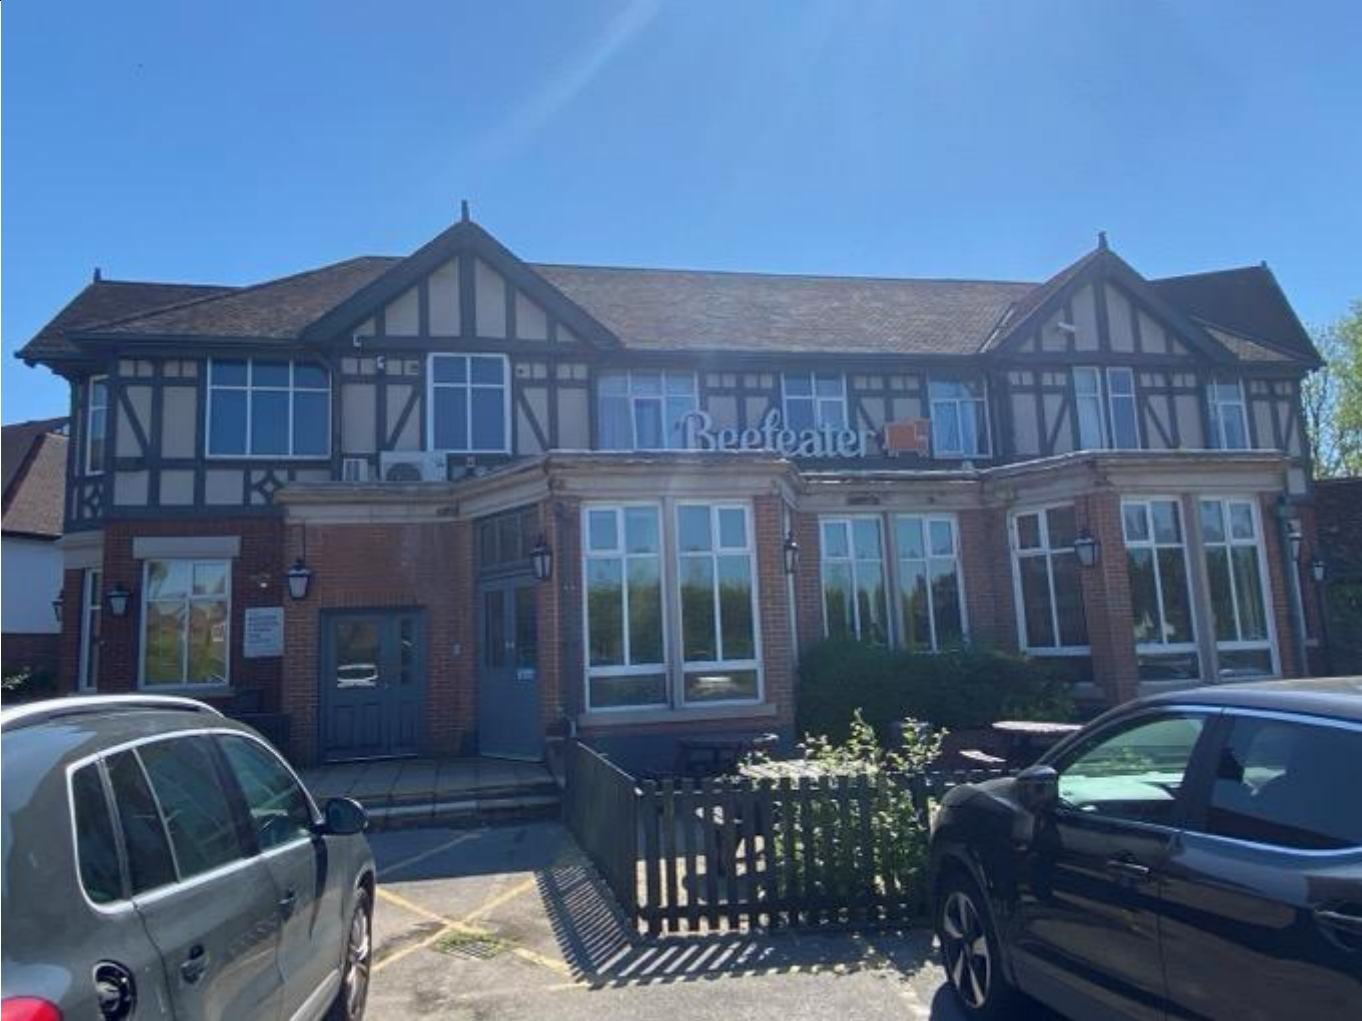
| | <p>In addition to the above, on the southern elevation, a gap was observed in a ridge tile on the roof structure, which bats could potentially utilise for roosting.</p> <p>No internal assessment was undertaken on B2, due to access restrictions.</p> <p><i>B2 Suitability Assessment</i></p> <p>Given the presence of a few roosting features on B2, the building was determined to be of moderate value for roosting bats.</p> |

| Northern elevation of B2 | |
|---|---|
| | <p>The northern elevation of B2 contains two other gables, which are timber framed. On the eastern gable on the northern elevation (left hand one in this photograph), there are some missing tiles present, that provide a gap between the lead valley flashing that could provide suitable access for both crevice dwelling and void dwelling bat species.</p> |

| <i>Recommendations</i> | <p><b>Roosting habitat [Buildings]</b></p> <p>Two bat emergence/re-entry surveys are required on B2 during the active bat season (May – September) to confirm presence/likely-absence of bats roosting in or on the building.</p> <p>These survey visits should be completed during the optimal survey period mid-May to August inclusive. The survey visits should be at least three weeks apart.</p> <p>Sub-optimal: early May and September. Would require greater justification of timing e.g., weather conditions, known local bat activity.</p> <p>One of the surveys could be a dawn re-entry survey, or all three can be at dusk if supported by night vision aids (NVA).</p> <p>Four surveyors are required to provide full coverage of the building's elevations to look for emerging/re-entering bats. An infrared camera should also be employed as part of the survey to see where any specific roost locations are located.</p> <p>Lighting mitigation may be required based on the outcome of the night bat survey(s).</p> <p>If any bat roosts are confirmed from this survey schedule, a bat licence would be required to demolish the buildings as it would involve the destruction of roosts. This is applied for with the help of a class 2 licensed bat ecologist after planning permission is granted, but before commencement of works.</p> <p><b>Foraging and commuting habitat</b></p> <p>No further surveys are required.</p> |

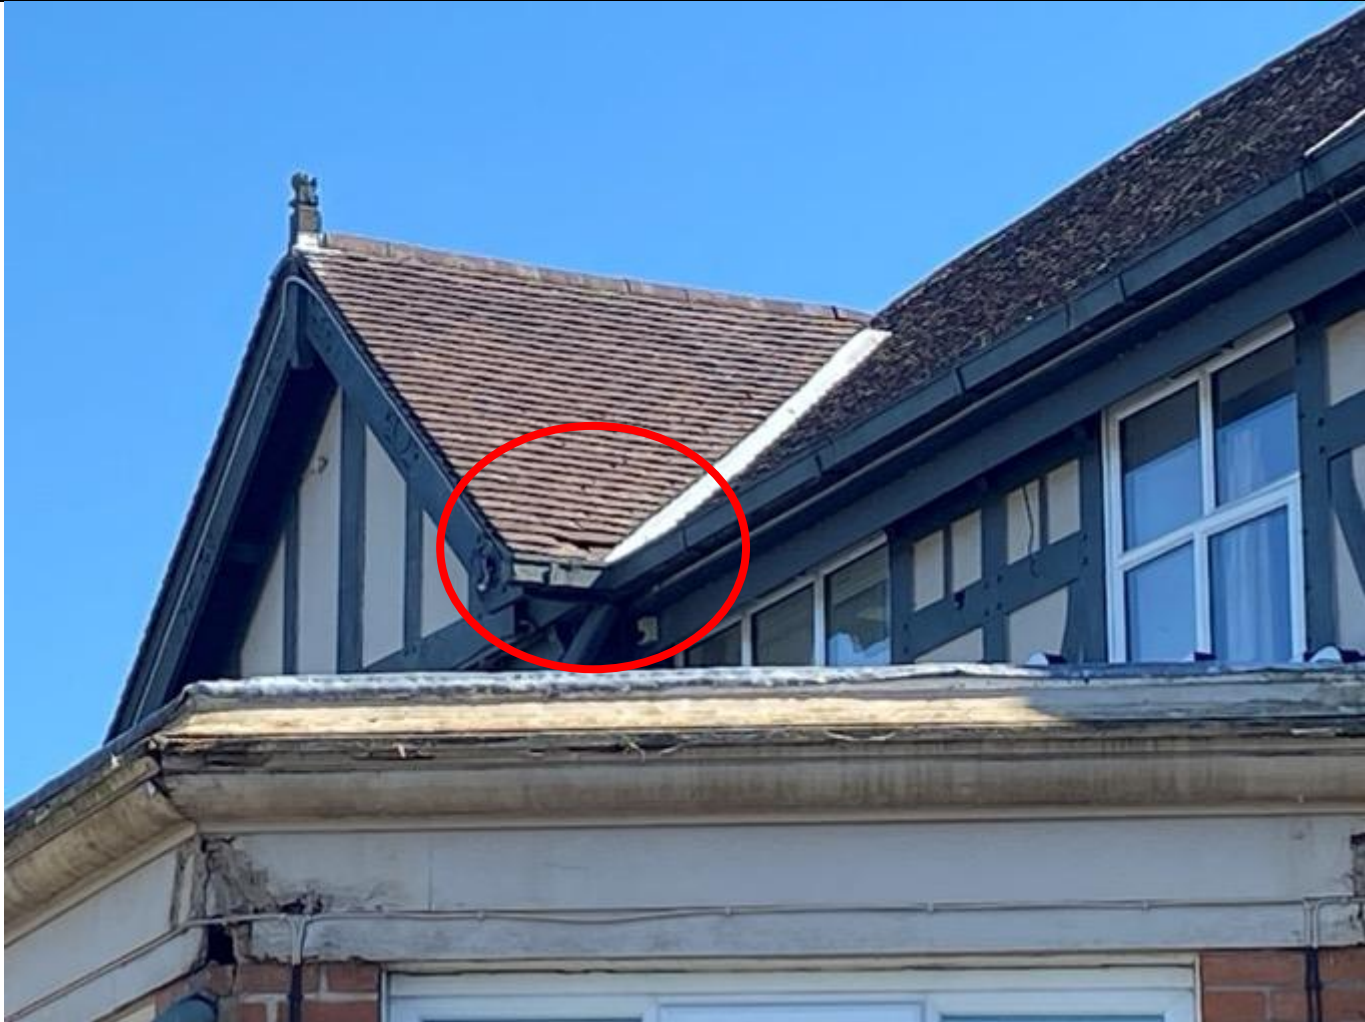
| Missing tile on northern elevation of B2 | |
|---|---|
| A photograph of a building's roofline under a clear blue sky. The roof is covered in dark brown tiles. On the left, there is a gable end with dark timber framing and white plaster. A red circle is drawn around a specific area on the roof slope where a tile is missing, revealing the underlying structure. To the right of the gable, there are several windows with white frames. Below the roofline, a portion of a brick wall and a white door or window frame are visible. | The gaps within the eastern gable on the northern elevation. |

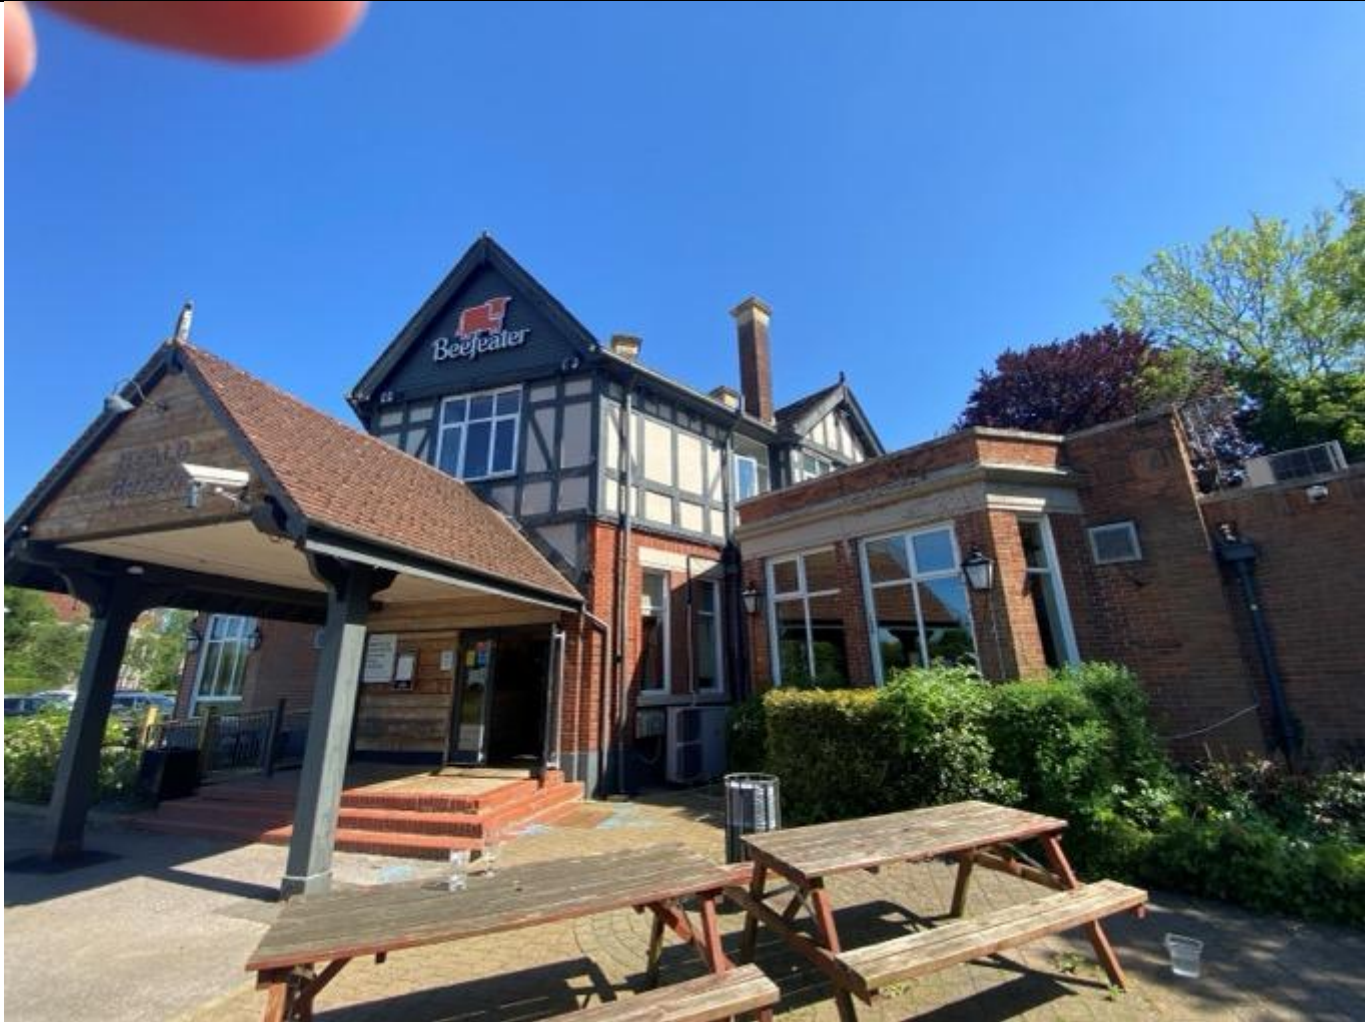
| Western elevation of B2 | |

| Western elevation of B2 | |
|---|---|
| | <p>The main entrance to the B2 is located on the western elevation. There are also gaps present within the valley, with missing tiles present once again.</p> |

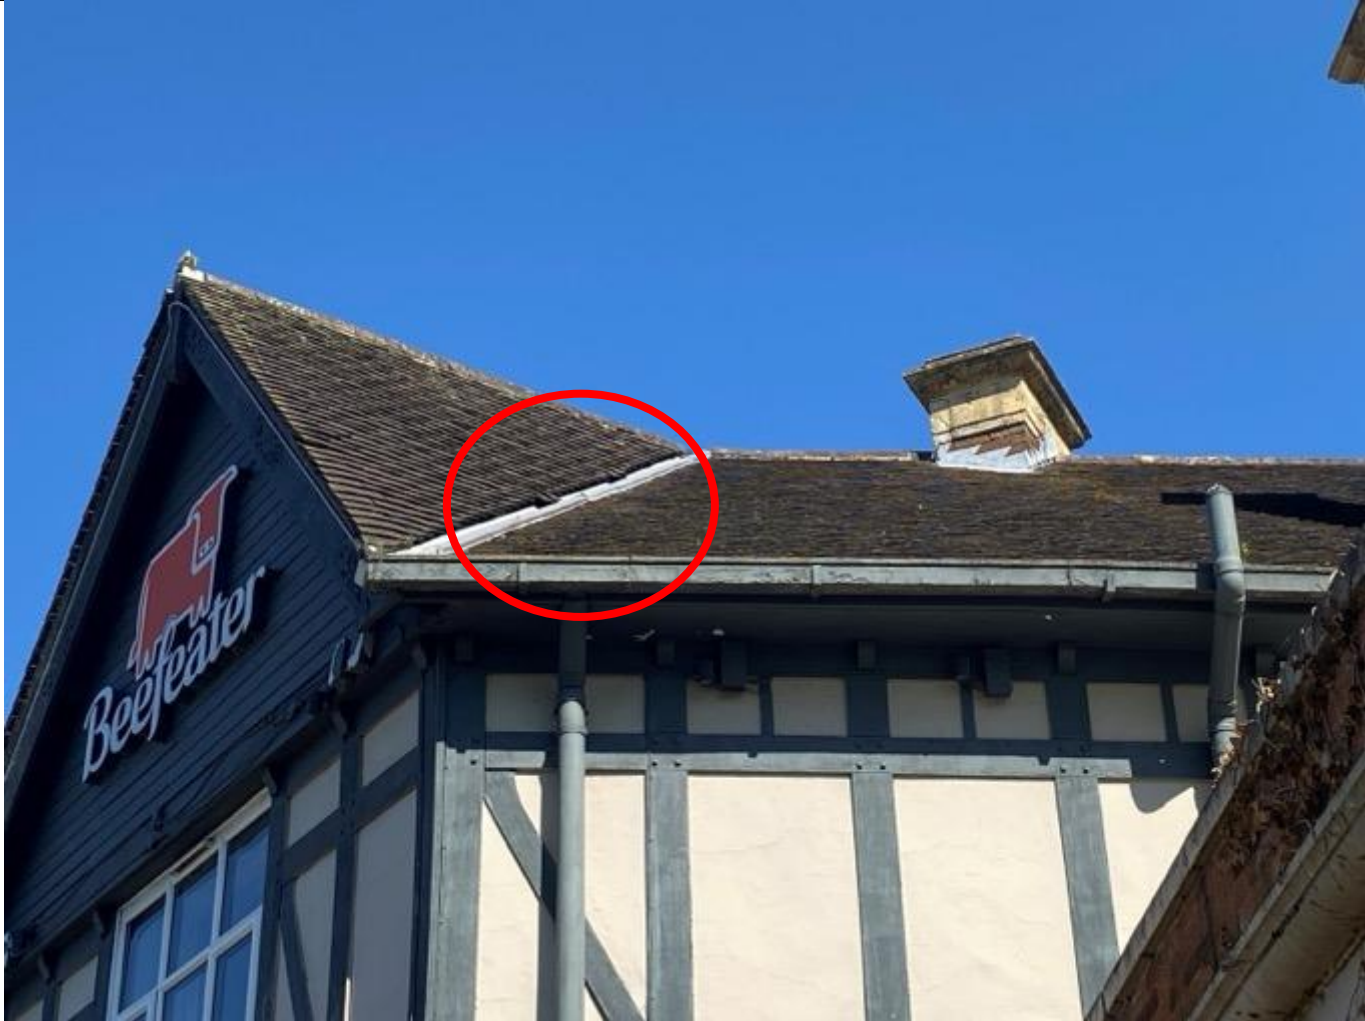
| Gaps present within valley on western elevation of B2 | |

| Gaps present within valley on western elevation of B2 | |
|---|---|
| | <p>As above there are gaps present where loose roof tiles have created suitability for roosting bats.</p> |

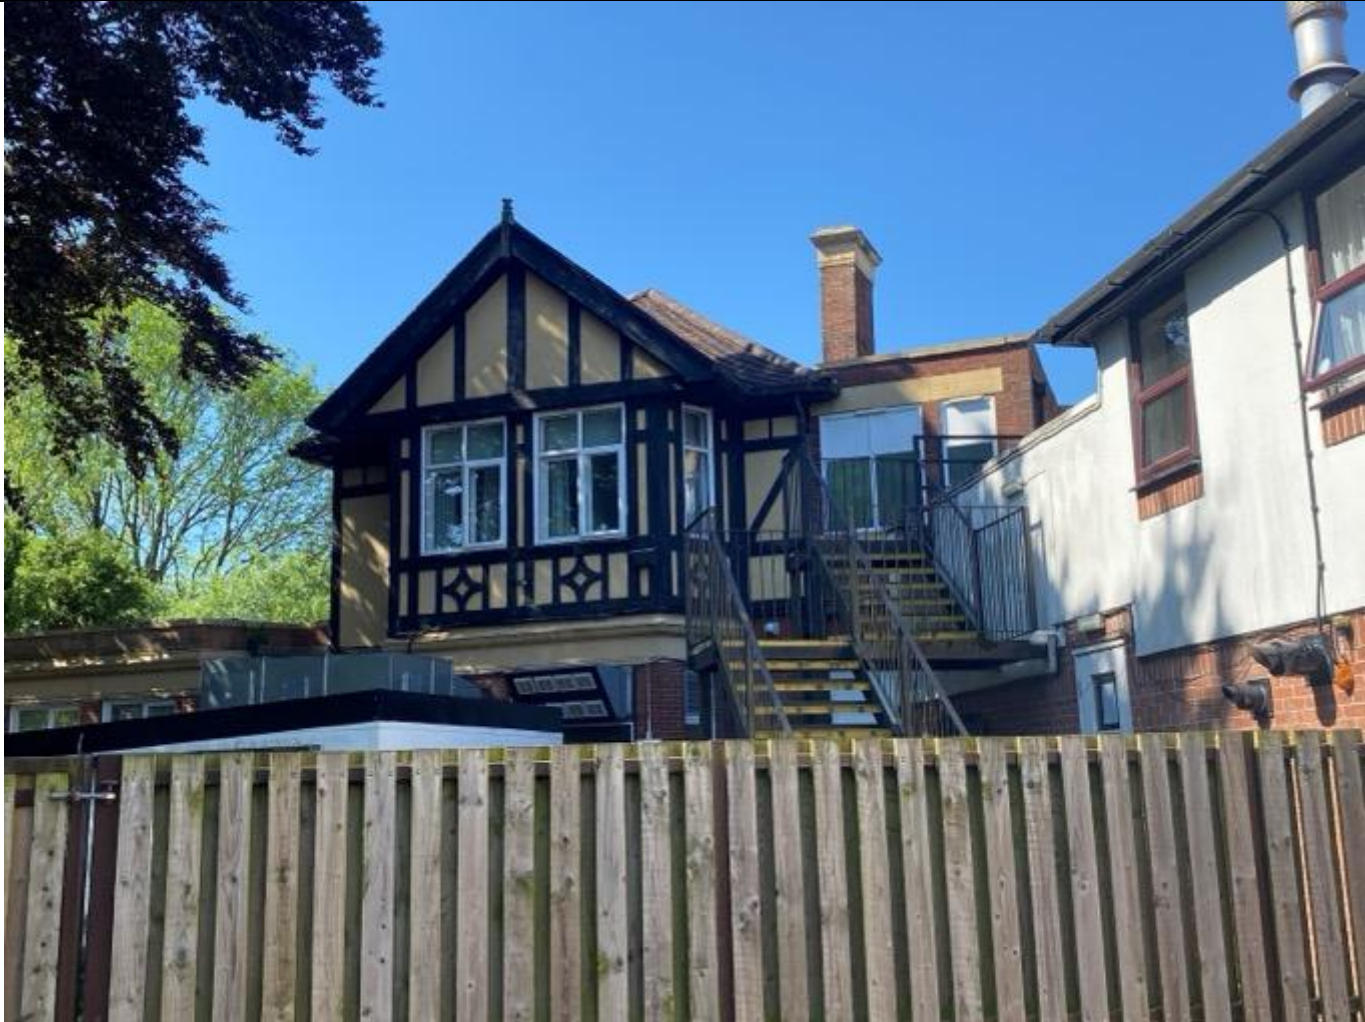
| Southern elevation of B2 | |

| Southern elevation of B2 | |
|---|---|
| | <p>Southern elevation of B2 also contains a gable end, similar in construction to the ones on all of the other elevations.</p> |

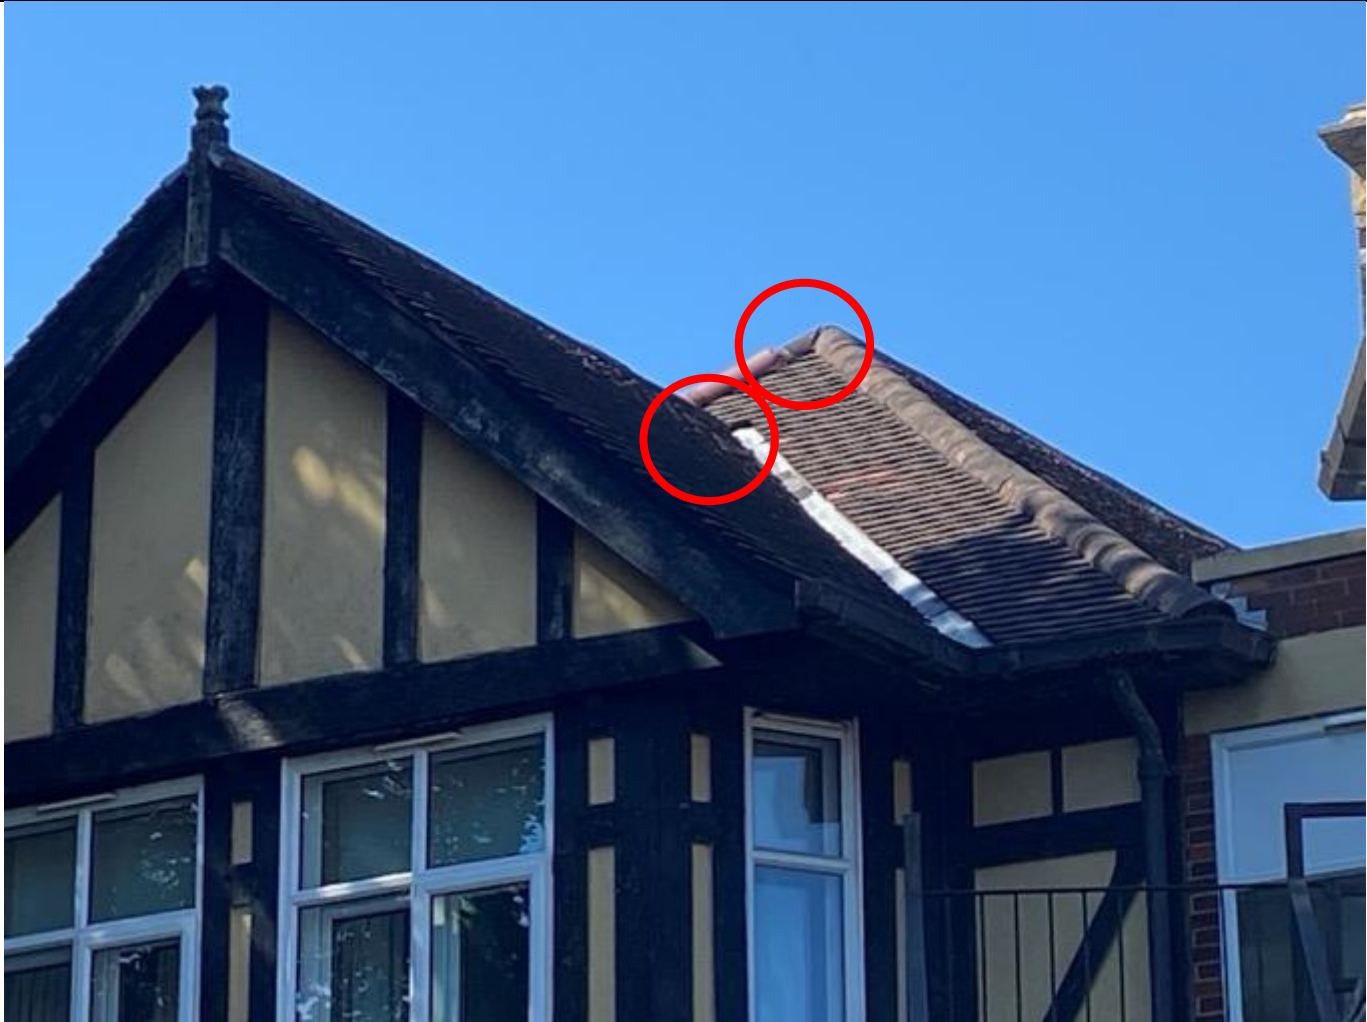
| Gaps on valley and small gap in ridge tiles on B2 | |

| Gaps on valley and small gap in ridge tiles on B2 | |
|---|---|
| | Gaps on valley and small gap in ridge tiles on B2. |

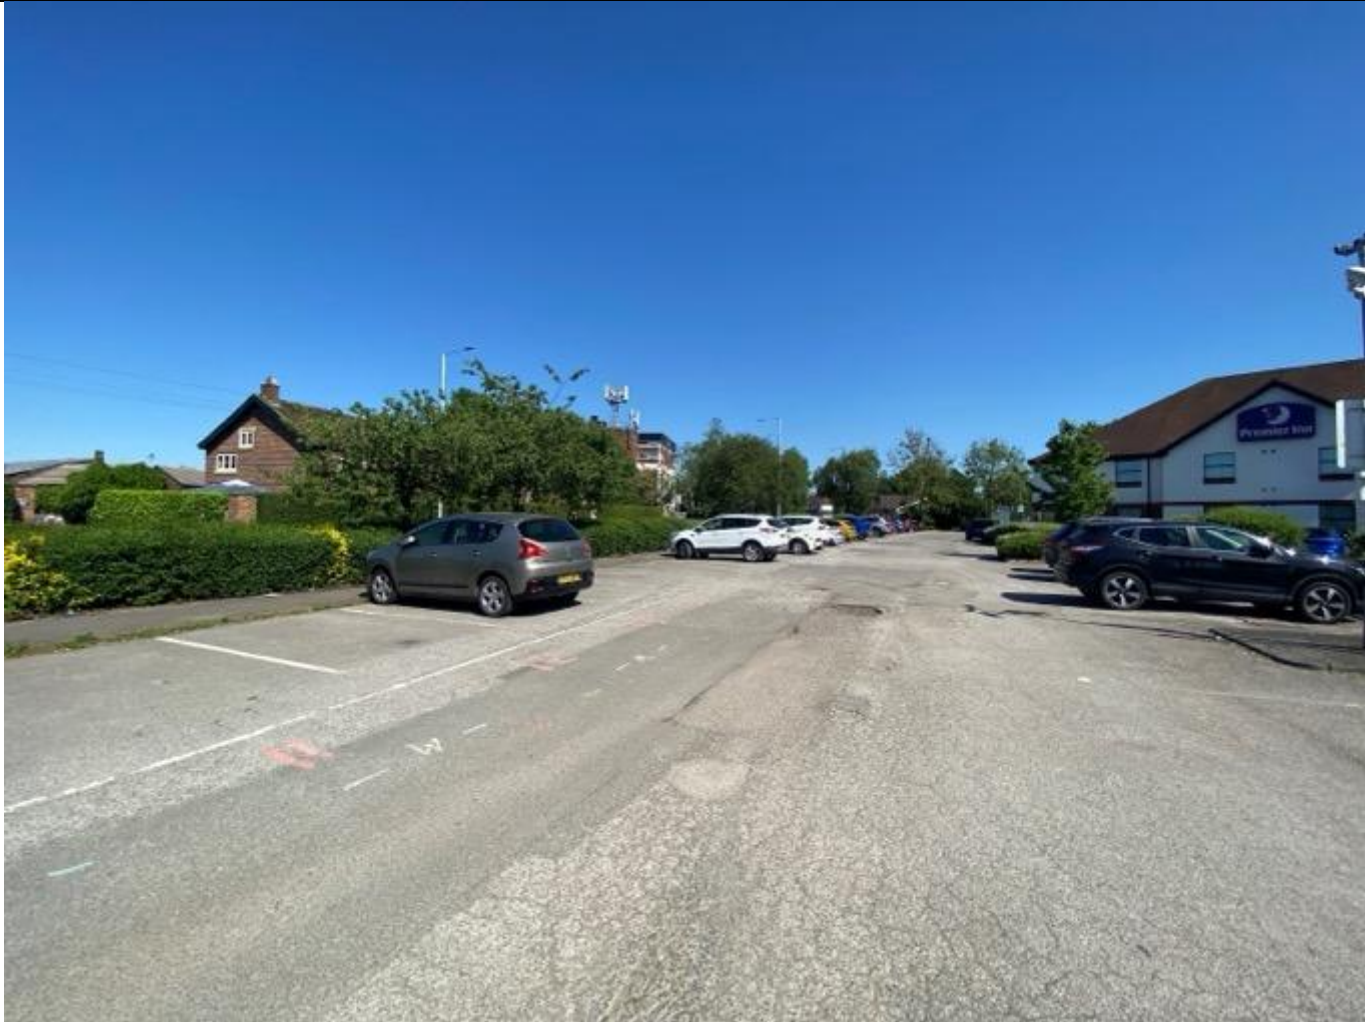
| Other developed land | |

| Other developed land | |
|---|---|
| | Extensive area of hardstanding present throughout the site. |

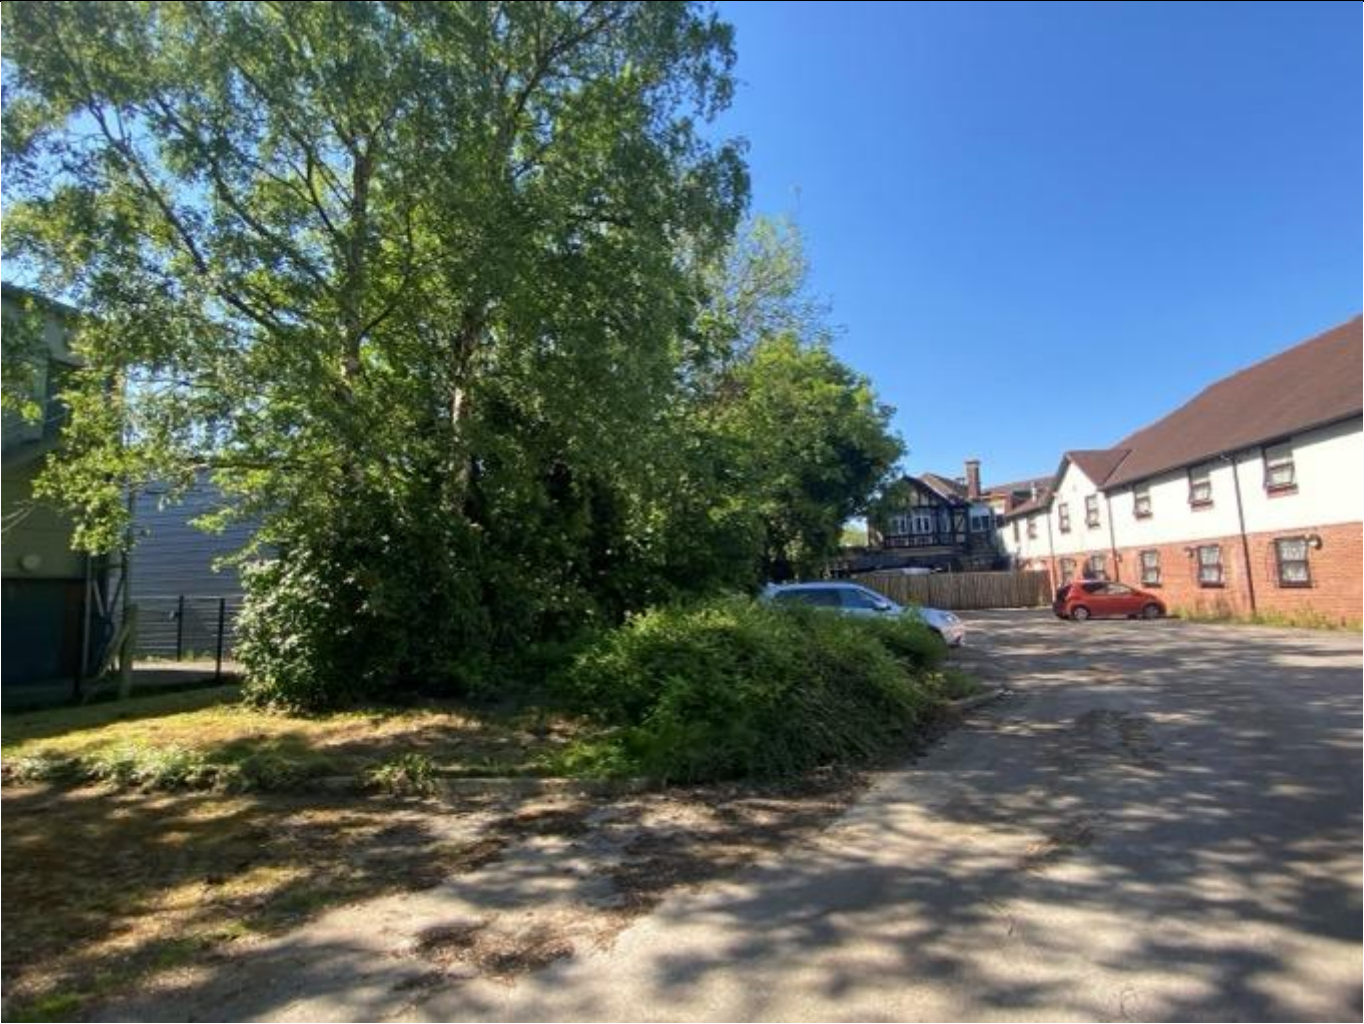
| Line of trees on southern boundary of the site | |

| Line of trees on southern boundary of the site | |
|---|---|
| | Line of trees on southern boundary of the site. |
