# BAT SURVEY REPORT

**140 Great Ancoats Street**  
Manchester,  
M4 6DU

| Title: | Bat Survey Report | | | |

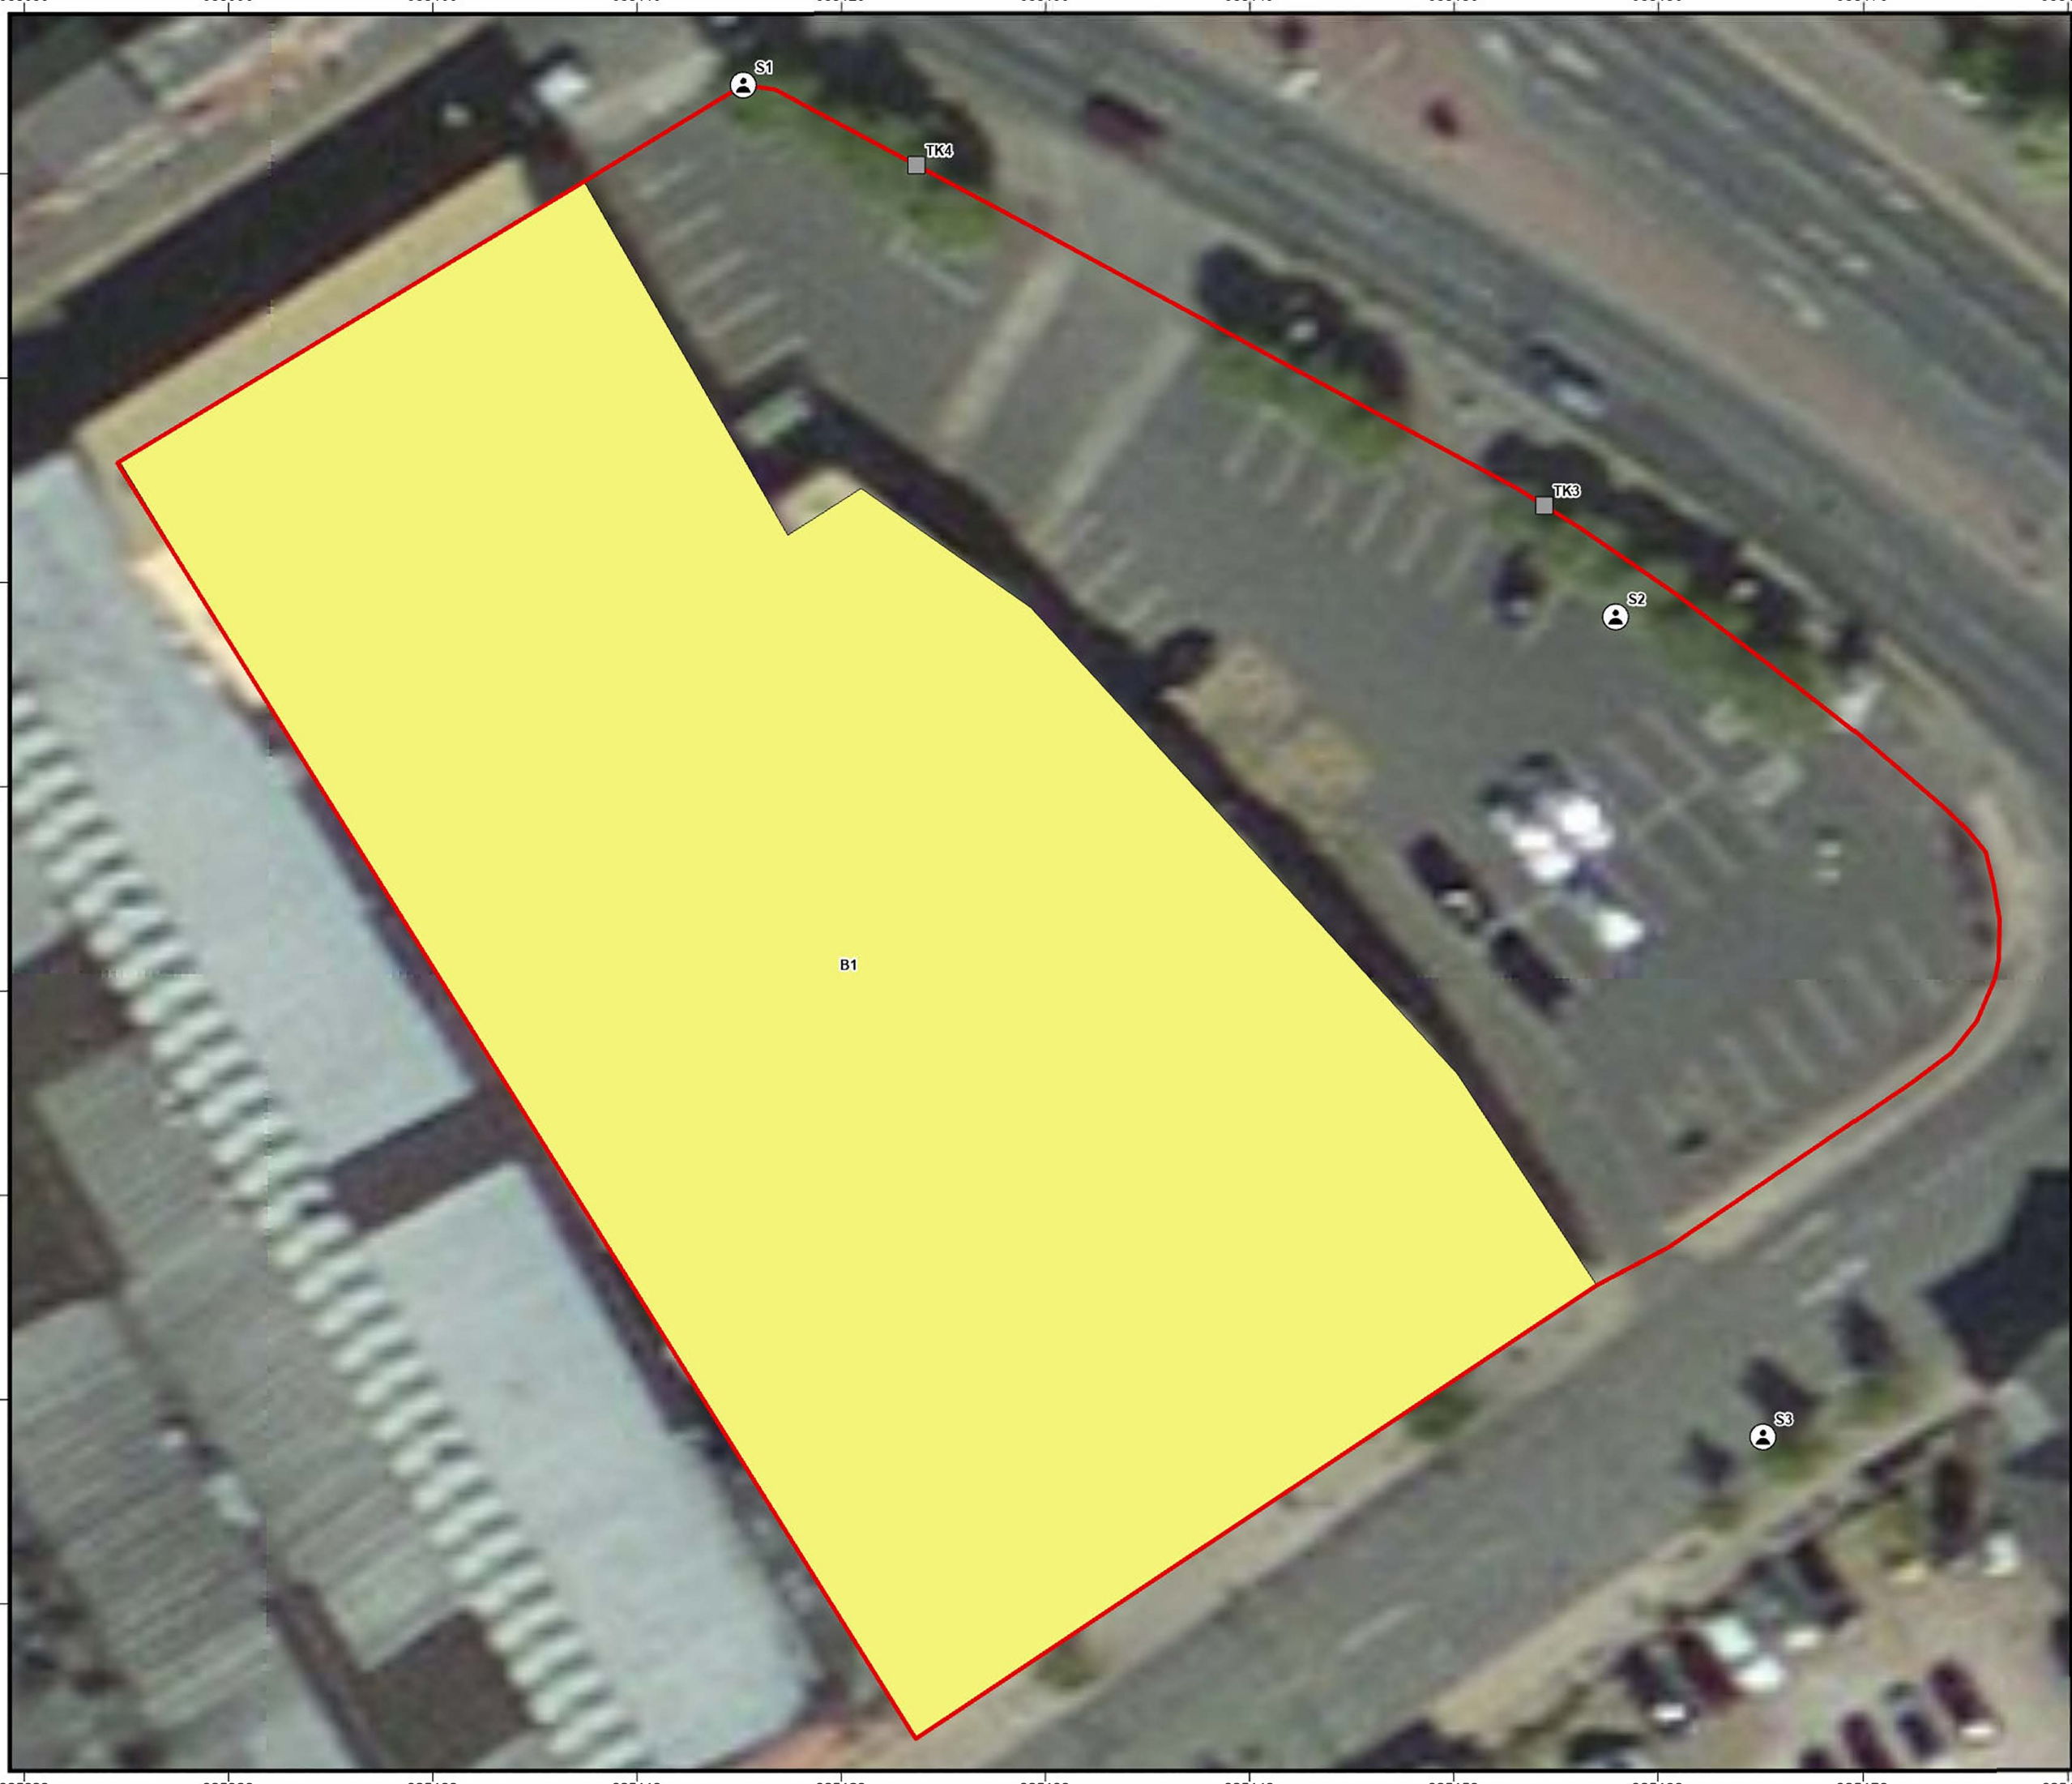
| Title: <b>Bat Emergence Surveyor Positions</b> | | |

3.2.1.1 One dusk emergence survey visit was conducted at the site in compliance with BCT guidelines (Collins, 2023). Figure 2 details the approximate surveyor positions. The following survey date was selected:

3.2.1.3 To enhance detection coverage and provide a reliable record for post-survey analysis, two Night Vision Aids (NVAs) (Guide TK16 thermal imaging monocular with Neewer F100 7-inch HD Field Monitors) were deployed during the dusk emergence survey. NVAs were positioned to capture clear footage of all identified Potential Roost Features (PRFs), including crevices, lifted tiles, fascia gaps, and other structural voids with bat roosting potential. NVAs were tripod-mounted and oriented to minimise backlighting and obstruction and were left recording continuously from the start to the end of the survey period. Figure 2 details approximate locations of the NVAs.

- 4.3.1.1 No bat emergences were recorded or confirmed within B1 during the dusk emergence surveys.
- 4.3.1.2 Overall bat activity across the site during the survey was low. Three surveyors were positioned facing north/northwest (S1), east (S3) and southwest (S5) with NVAs covering the full eastern aspect of B1 (S2 and S3). Surveyor positions are detailed in Figure 2.

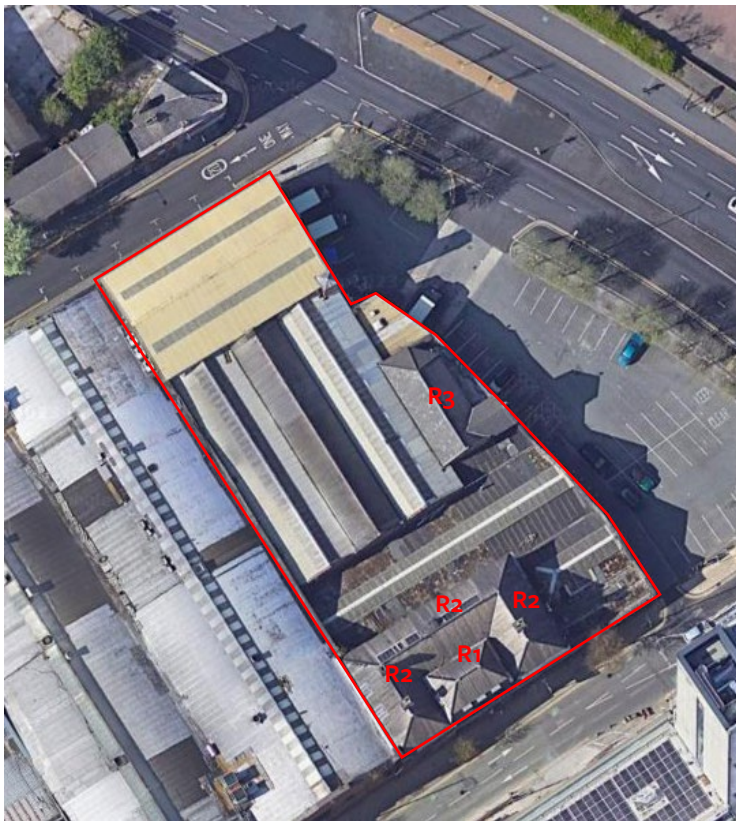
**Figure 2 – Roof locations**

The site's external structure featured a complex mosaic of longstanding historic commercial buildings and a large warehouse, all fully adjoined to form a single structure. Two independently pitched rooves, one located along the southern boundary (R1) with the other wrapping around the first (R2), were present atop three storeys, their loft voids accessible internally. The majority of the site comprised long pitched rooves of single layered, corrugated, transparent material, likely plastic, and featured no loft voids, nor any potential to support a roost. Another length of pitched roof was present along the eastern border of the structure (R3), also featuring an accessible loft void. A large warehouse was present at the northwestern corner of the site, which also featured a single layered pitched roof, with no loft void and no suitability for habitation by bats. Figure 2 shows the location of all accessible loft voids.

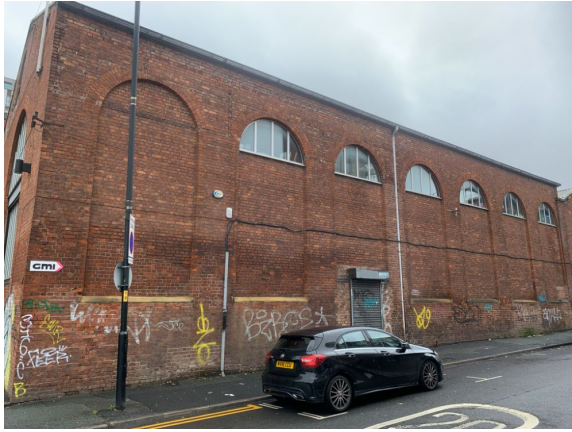
**Picture 1 – Northern aspect**

The northern & northeastern aspects of the site featured a well-sealed brick exterior with a pitched roof. A large grate was located at each gable end which was noted as a potential entrance into the loft void, however after following internal inspection both grates were found to be closed off (See Section 3.2.2.). The roof consisted single layered corrugated material with no potential PRFs following internal inspection. A turret was located at the eastern corner of the roof, also well sealed with no visible PRFs. The area was assessed as featuring negligible potential to support a bat roost.

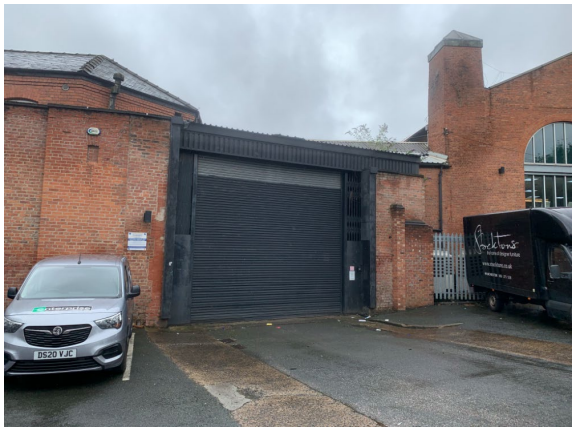
**Picture 3 – Eastern aspect & shutter gate**

The eastern façade was furthermore well sealed across its extent, featuring as a gable end for multiple pitched rooves across the site. This area was generally single storey, with one area (R3) raising up a second story and featuring a loft void. No PRFs were identified across the extent.

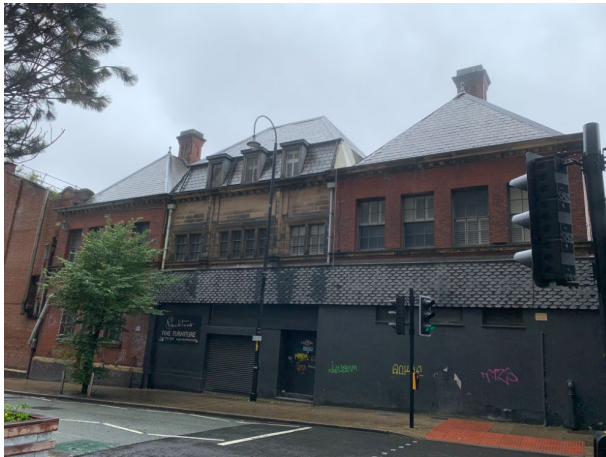
**Picture 7 – Southern extent featuring R1 & R2**

The southern aspect of the site was the most complex, featuring two pitched rooves with hipped ends and slate tiling, one roof partially encircling the other. Although all the tiling was observed well sealed, on the southern extent one hip cover was almost entirely removed, leaving large gaps into cavities between the tiling and inner roof insulation along its extent and serving as a large suitable PRF. Along the northern

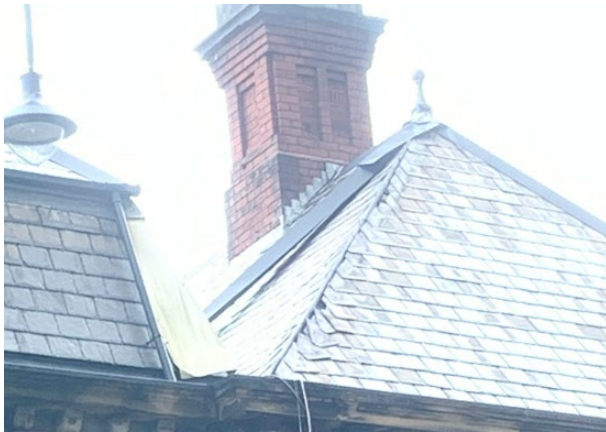
**Picture 9 – Lifted hip cover**

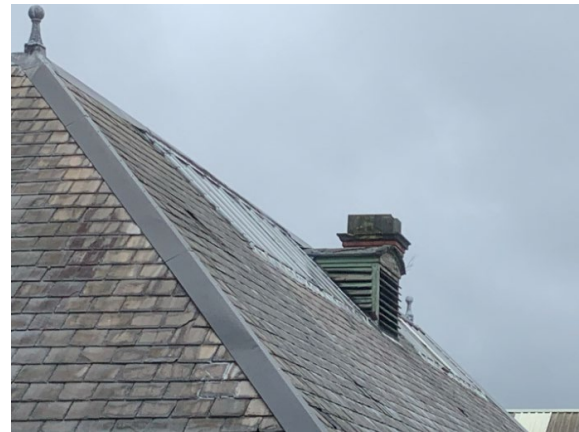
extent of these rooftops a dilapidated dormer was present, featuring a grate which served as a suitable PRF.

**Picture 10 – Dilapidated dormer**

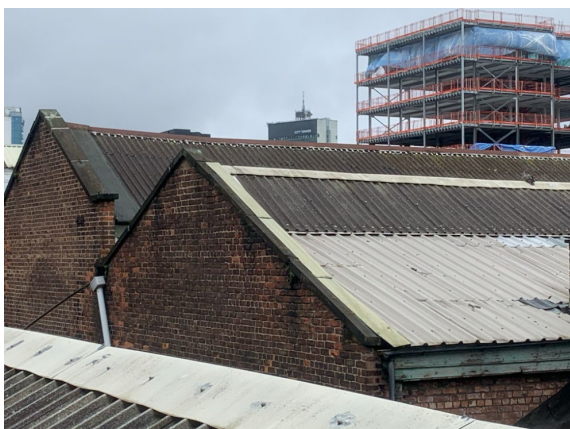
**Picture 11 – Central pitched roofs**

The central rooftop was accessible by surveyors and comprised of a mosaic of pitched roofs of single layer corrugated material, covering open plan commercial space beneath and featuring negligible suitability for roosting within (See Section 3.2.2). Where brick walls were present, they were well sealed and did not feature suitable PRFs.

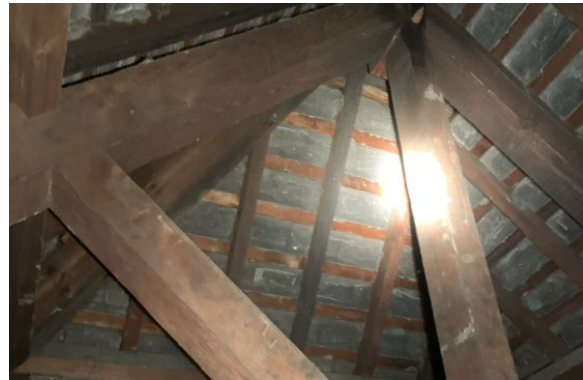
R1's loft void was well sealed from within apart from slight light spill entering the cavity from the eaves. No tears in the internal insulation were present, and the void was assessed as providing negligible potential to support a roost.

**Picture 14 – Well sealed internals of R1**

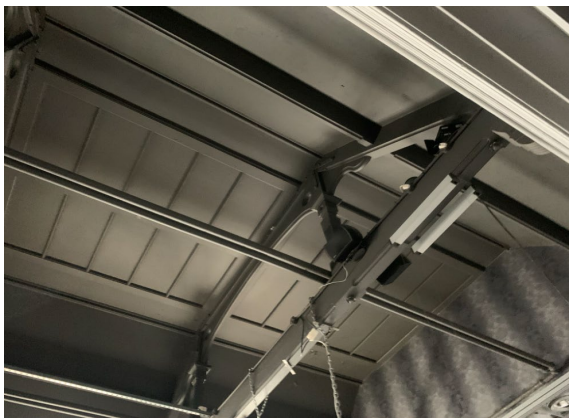
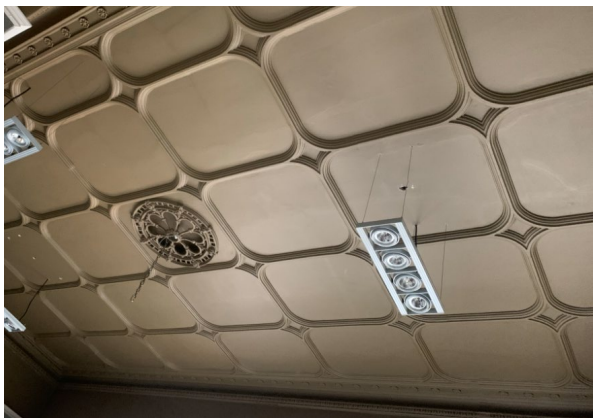
**Picture 15 – R2**

R2's loft voids served as publicly accessible showrooms and were fully sealed from within, featuring negligible potential to support a roost.

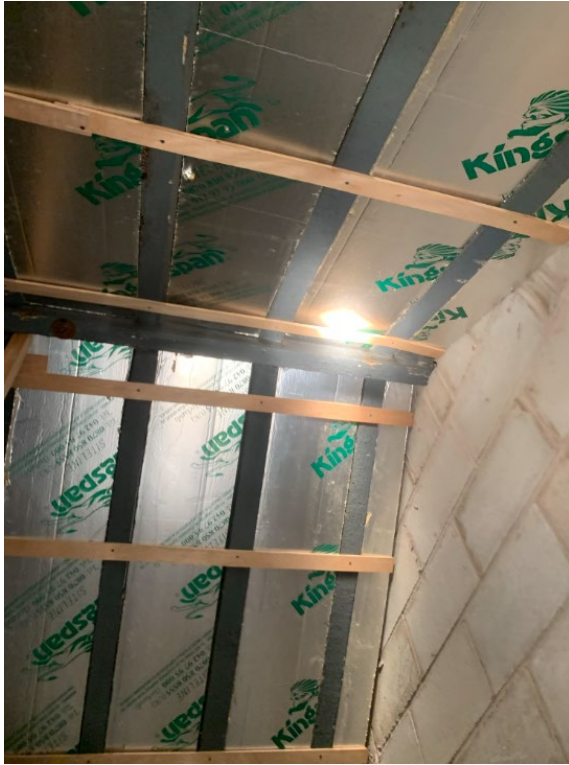
Picture 17 – R3

R3's loft void was similarly well sealed, featuring no light spill.
