# Health & Safety File

**Project Name:** B1515 Angel Square

| <b>Summary Description of Project Works:</b> | Construction of new 1200mm dia chamber with 4nr 150mm dia incoming line and 1nr 150mm dia outfall line, with new D400 cover and frame. | |

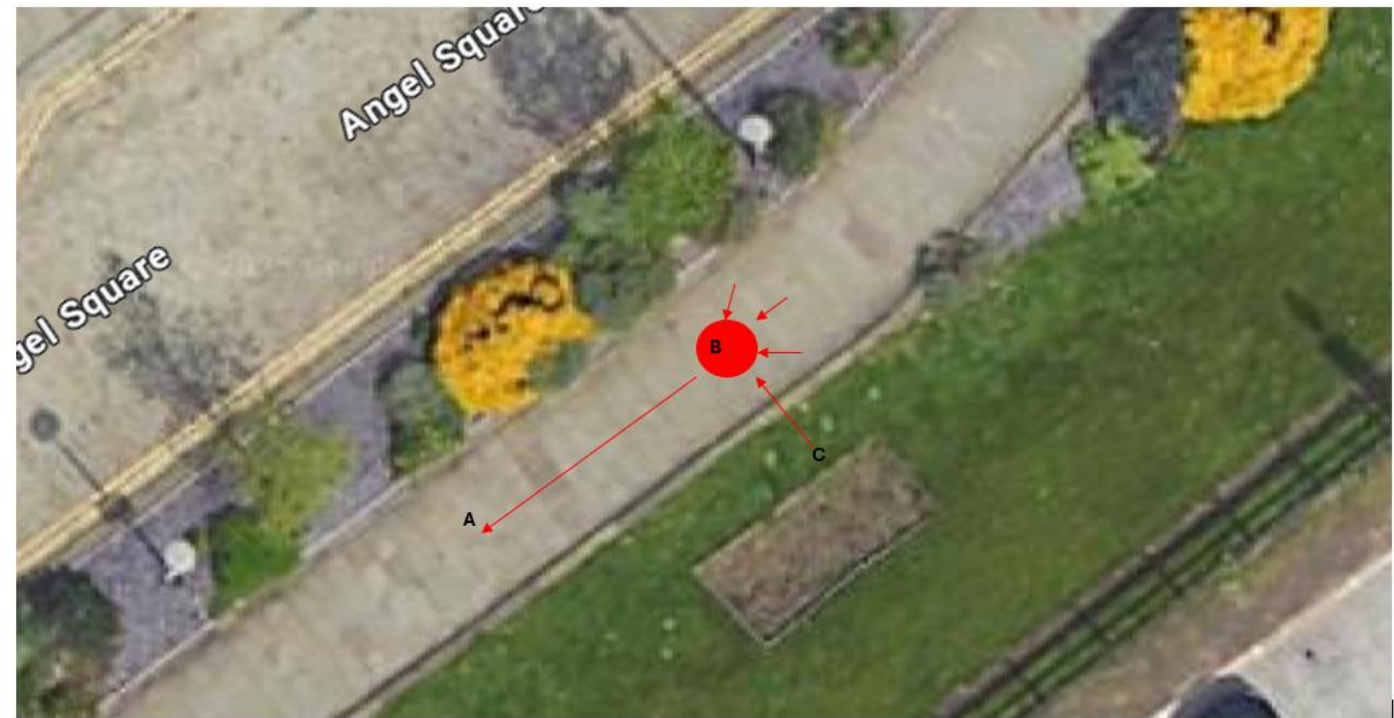
| Point A – End of Downstream Pipe | 384389.852,399028.895 | 42.510 | Angel Square, Manchester |
| Point B – Chamber SW11 (Invert) | 384393.887,399031.675 | 42.606 | |
| (Cover Level) | | 44.227 | Surveyed 28Feb2025 |
| Point C – end of Upstream Pipe | 384395.456,399029.324 | 43.386 | NOT TO SCALE |
