1 Dale Street - Existing Facade Repair works
1 : 50

Drawing No. **P16019-FCH-XX-XX-DR-A-6023** Rev. **P3**

Project Title **27 Dale Street, Manchester**

Drawing Title **Existing Facade Repair Works**

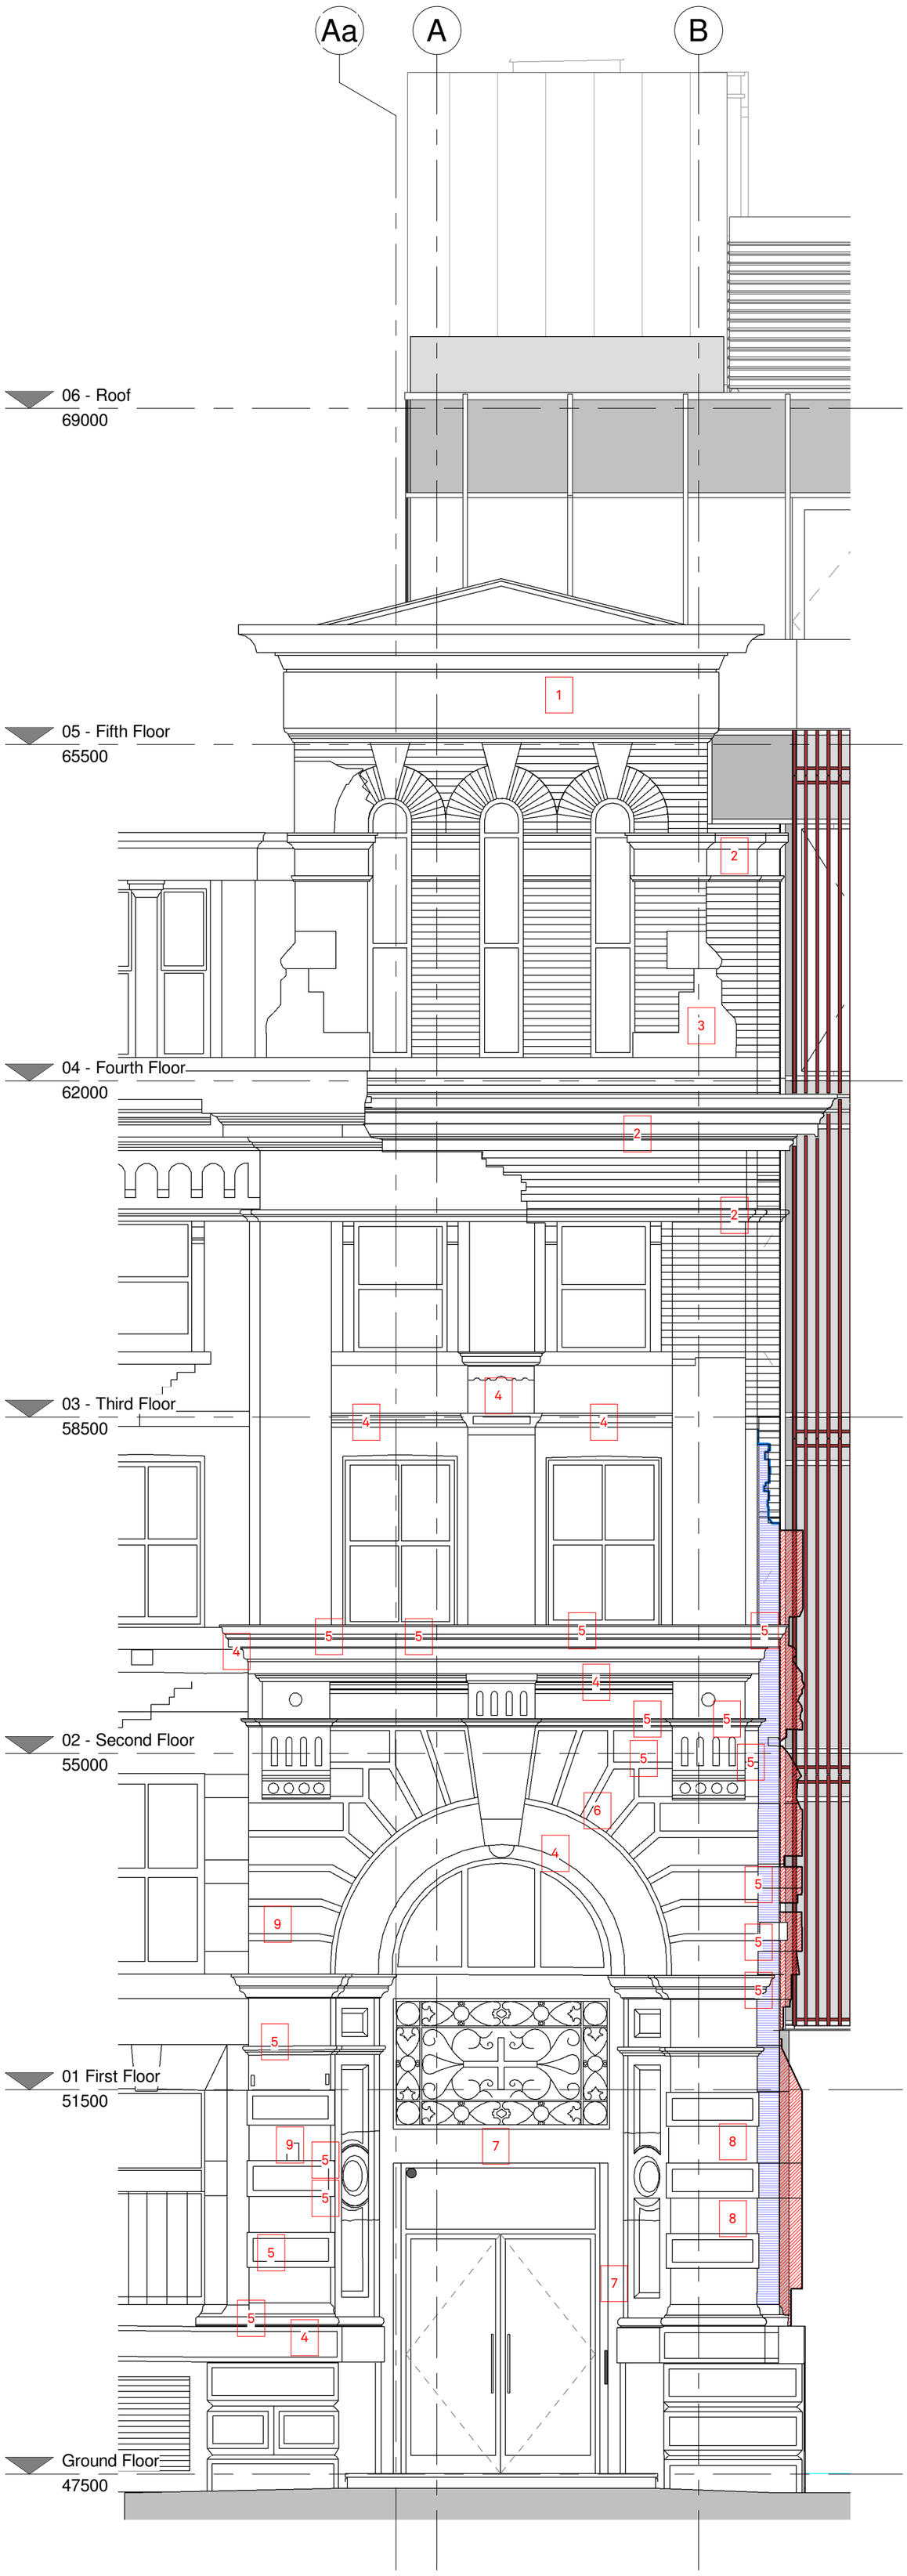
STONEWORK TO BE CARRIED OUT:

1. Replace Missing Tympanum
2. Replace missing stone string course
3. Replace complete buttress to match existing
4. Descale stone
5. Indent in stonework
6. Rework voussoir
7. Remove cermenticious coating
8. Rework flat ashlar face
9. Remove metal work

Doff/Thermatech clean to all stone work
Remove all existing ferrous fixings
Fill all existing fixing holes with colour matched mortar
Cut out and repoint all joints
Replace stone to upper section of building
Crack investigation where brick work meets the stonework to the left-hand side.
