PROJECT :
BARRACKS HOUSE
M15 4HA
-

DRAWING TITLE :
WINDOW INSPECTION RECORD

DWG BH-P-002 00

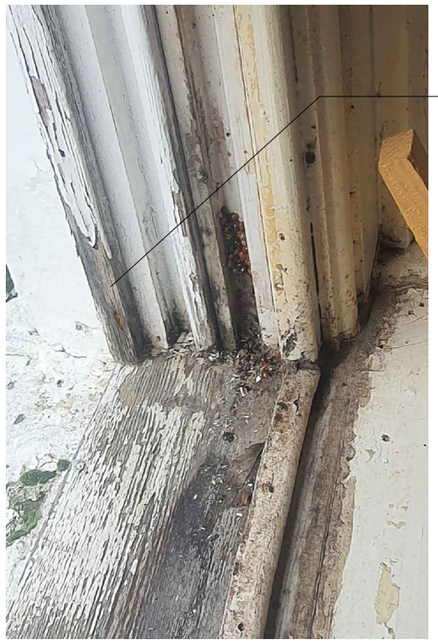
rot

mold and rot
repair by Resin-base "Epoxy"

Replace damage
area of timber

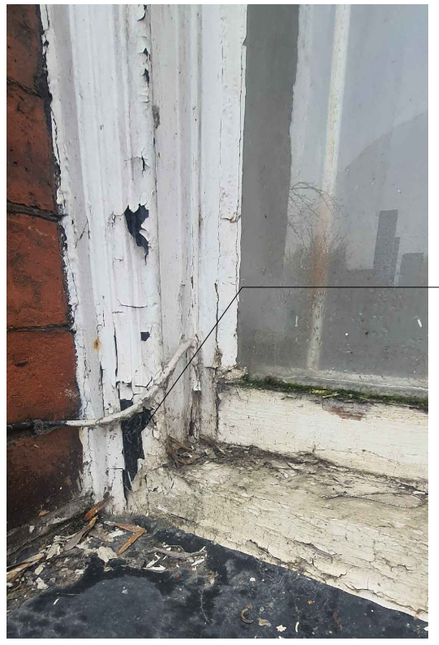
rot

Repair damage
timber by Epoxy
