THE POWER HALL: WALLS – REPAIR METHODOLOGY

Project
Science & Industry Museum
Manchester

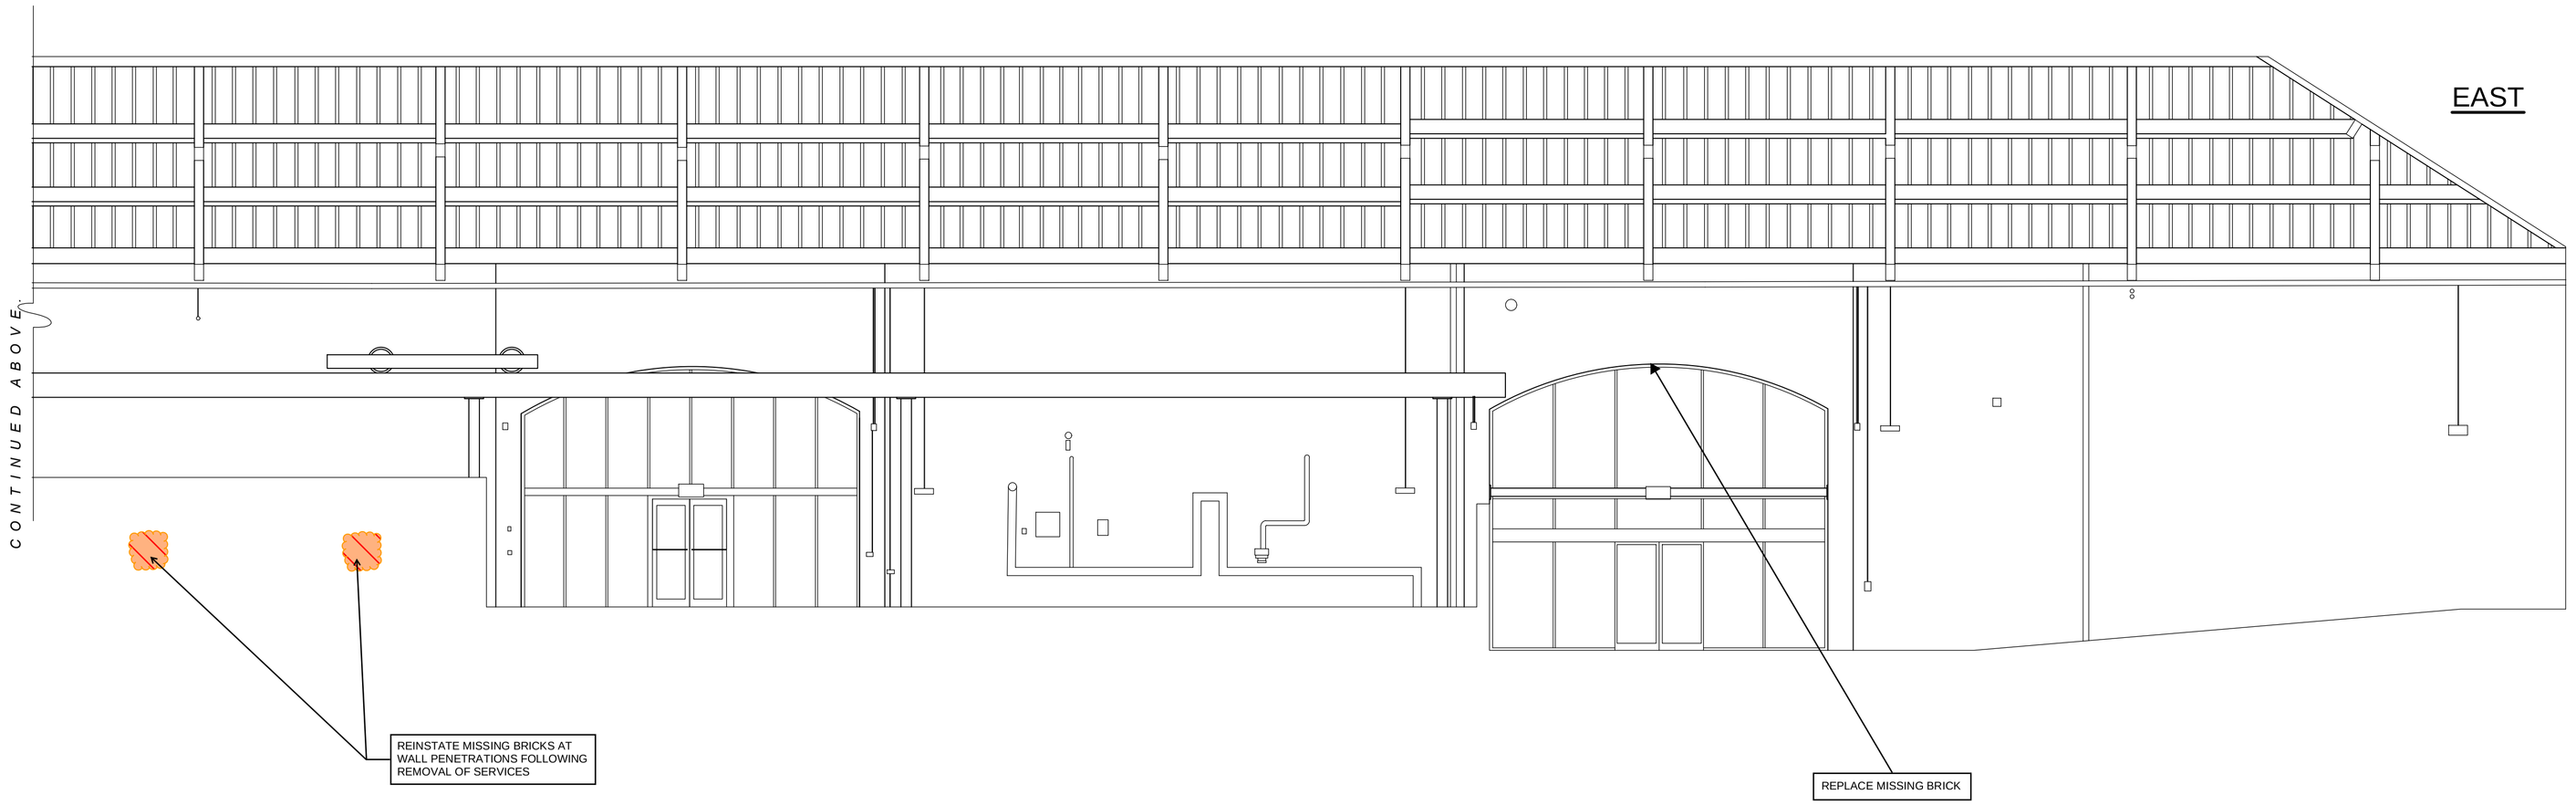
Title
Power Hall Repairs
North Elevation (Internal)

- We recommend reinstatement of the locally missing bricks in the north wall of the Power Hall which have been removed to accommodate M&E services penetrations.

3.1 Essential repair of localised defects to the Power Hall walls has been identified following our detailed inspection and assessment (see Conisbee drawings 180426-CON-PH-XX-DR-S-3100 to S-3105):

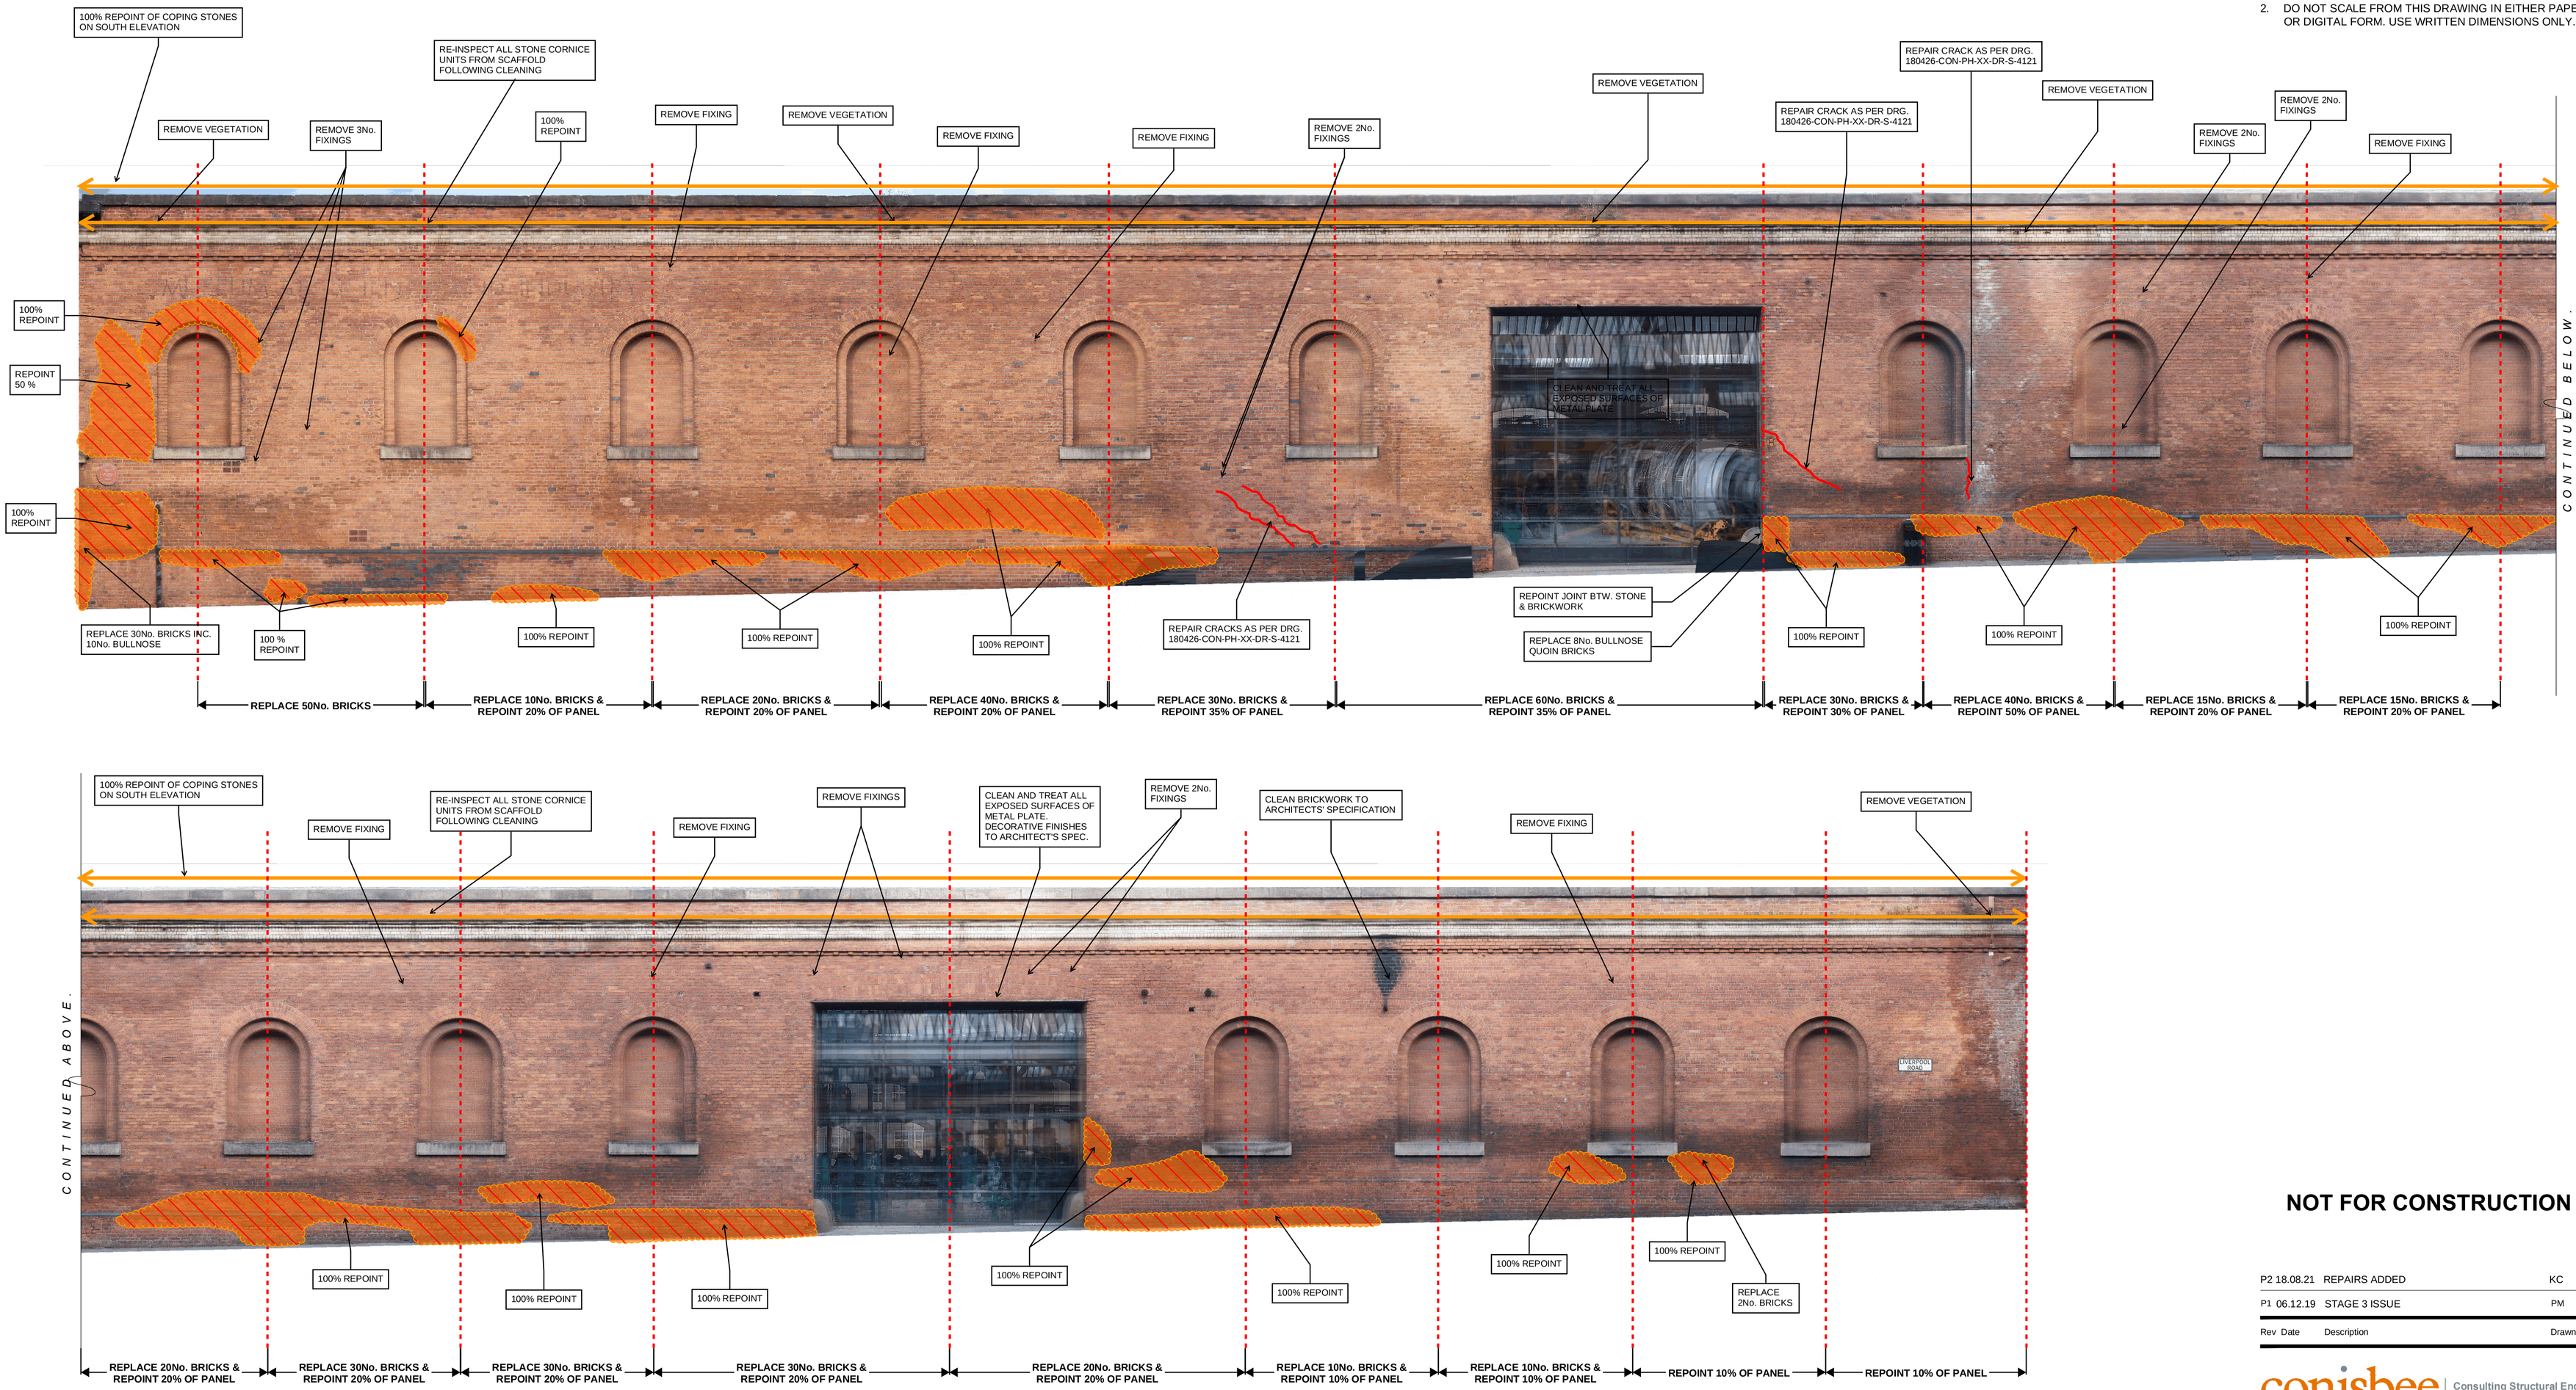
Title
Power Hall Repairs
South Elevation (External)

- The worst areas of damage are concentrated at the west elevation and at low level on the south elevation, consistent with greater exposure to water run-off and driving rain. The apparently random location of other damaged bricks most probably relates to inconsistent manufacturing standards during firing with some bricks being exposed to higher temperatures (and therefore being more durable) than others.

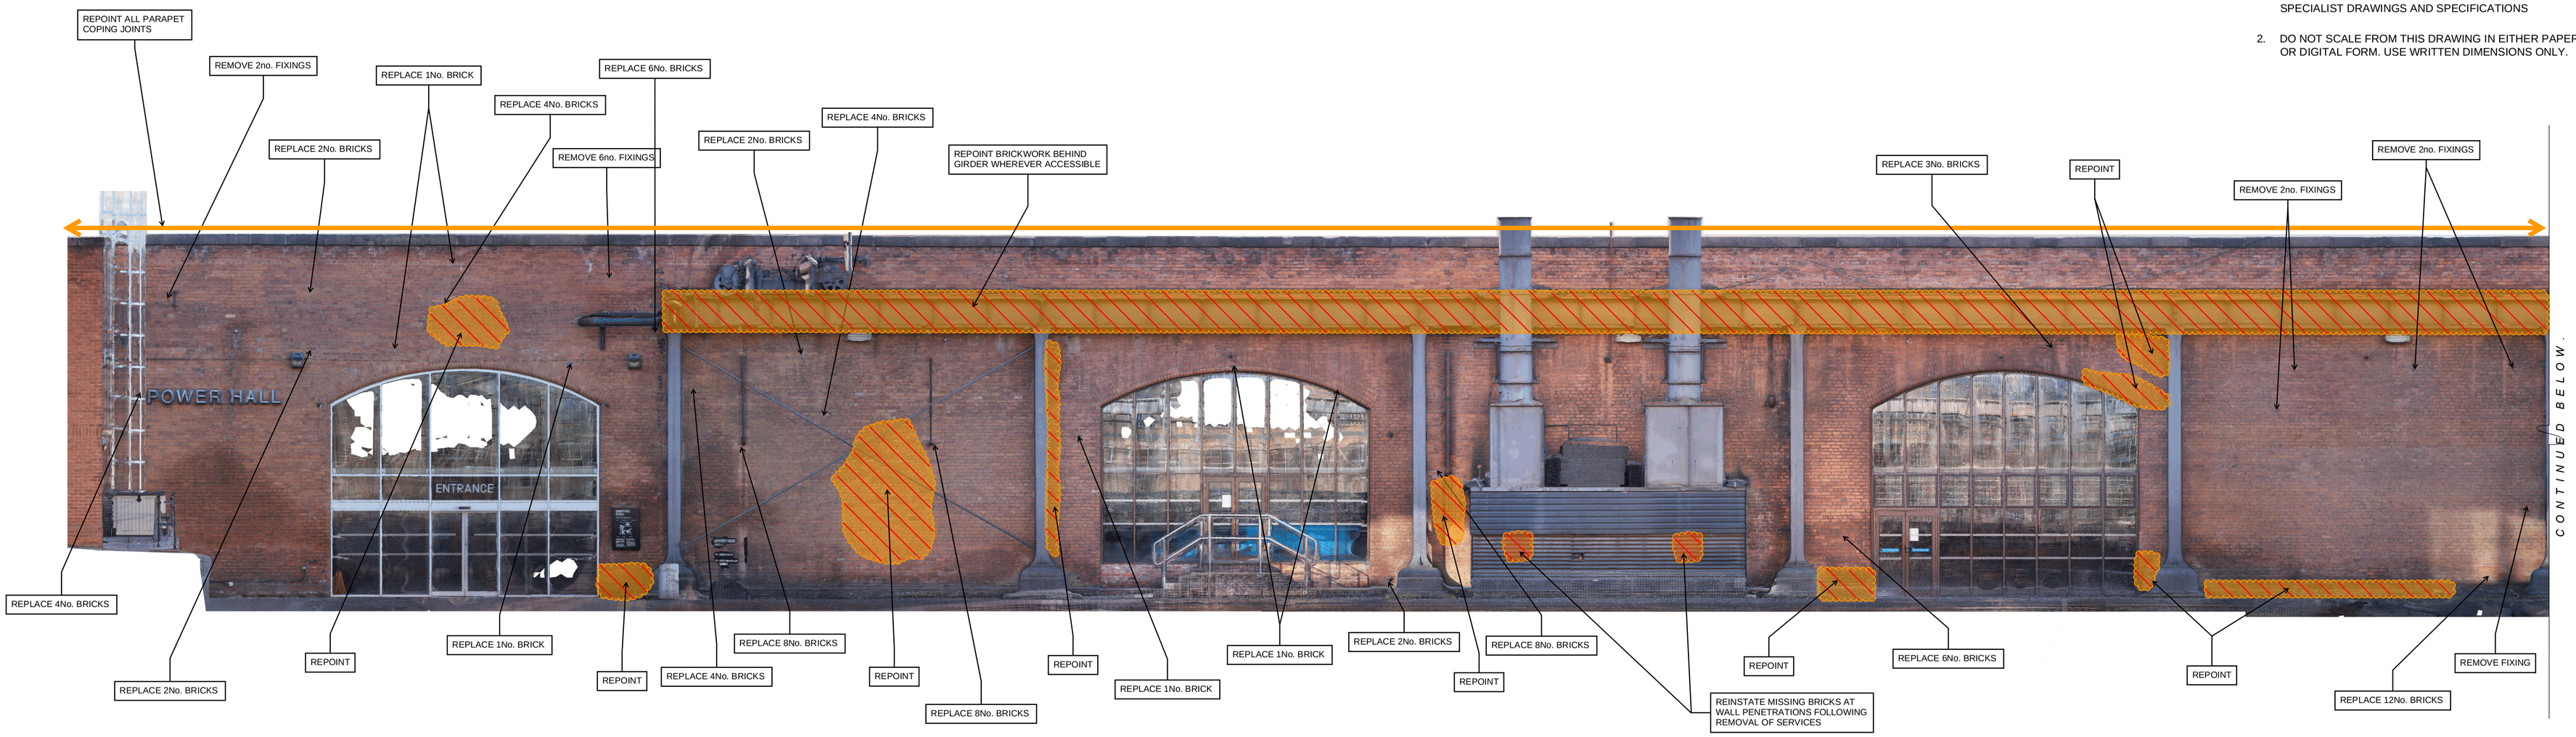
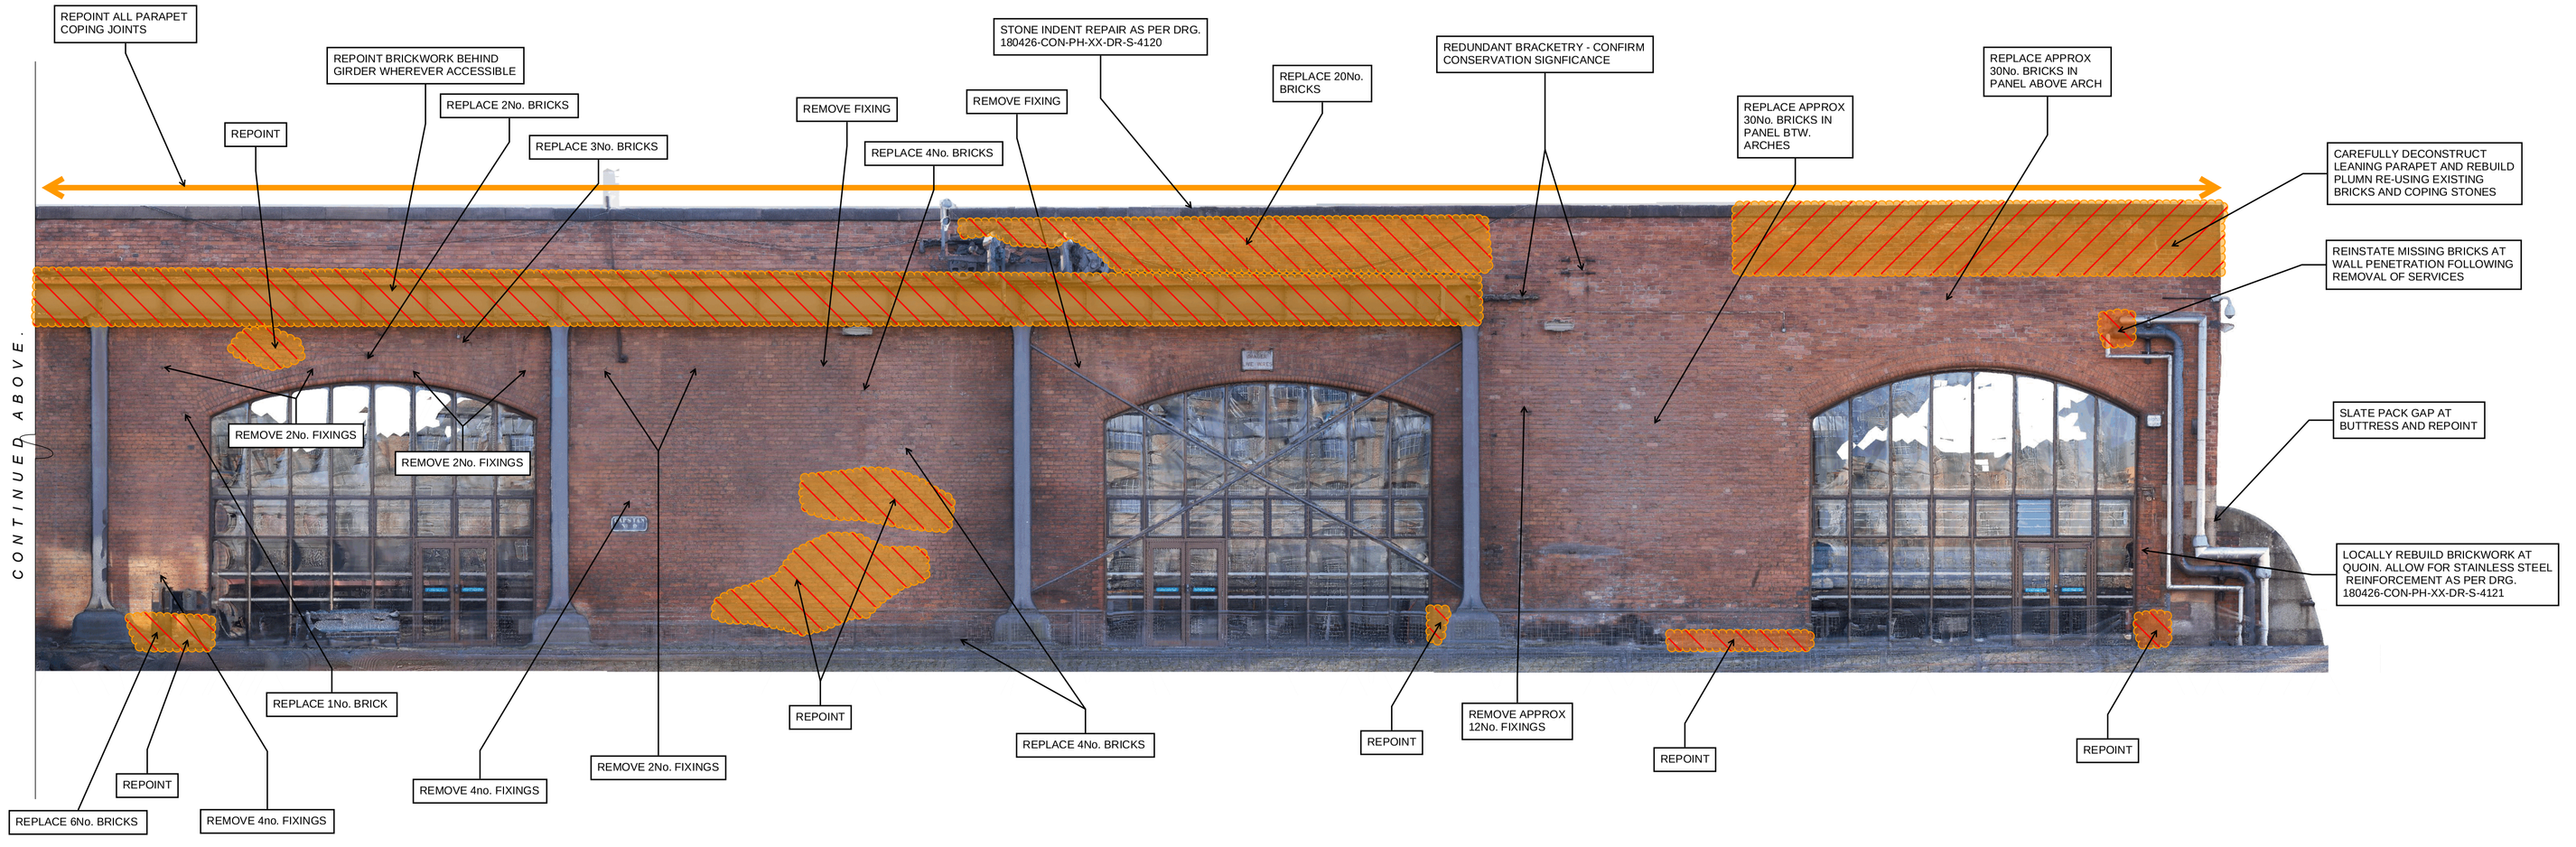
Title
Power Hall Repairs
North Elevation (External)

- A number of isolated bricks have previously been replaced, particularly on the north elevation. Little attempt has been made to achieve good colour and textural matches in the new materials and replacement might be considered, however further damage to surrounding bricks is possible during this process and we would not recommend proceeding in this way.
