Project
SCIENCE & INDUSTRY MUSEUM MANCHESTER

Title
POWER HALL ROOF REPAIRS TIMBER DECAY PLAN (WEST)

Drawing No
180426-CON-PH-RF-DR-S-1025

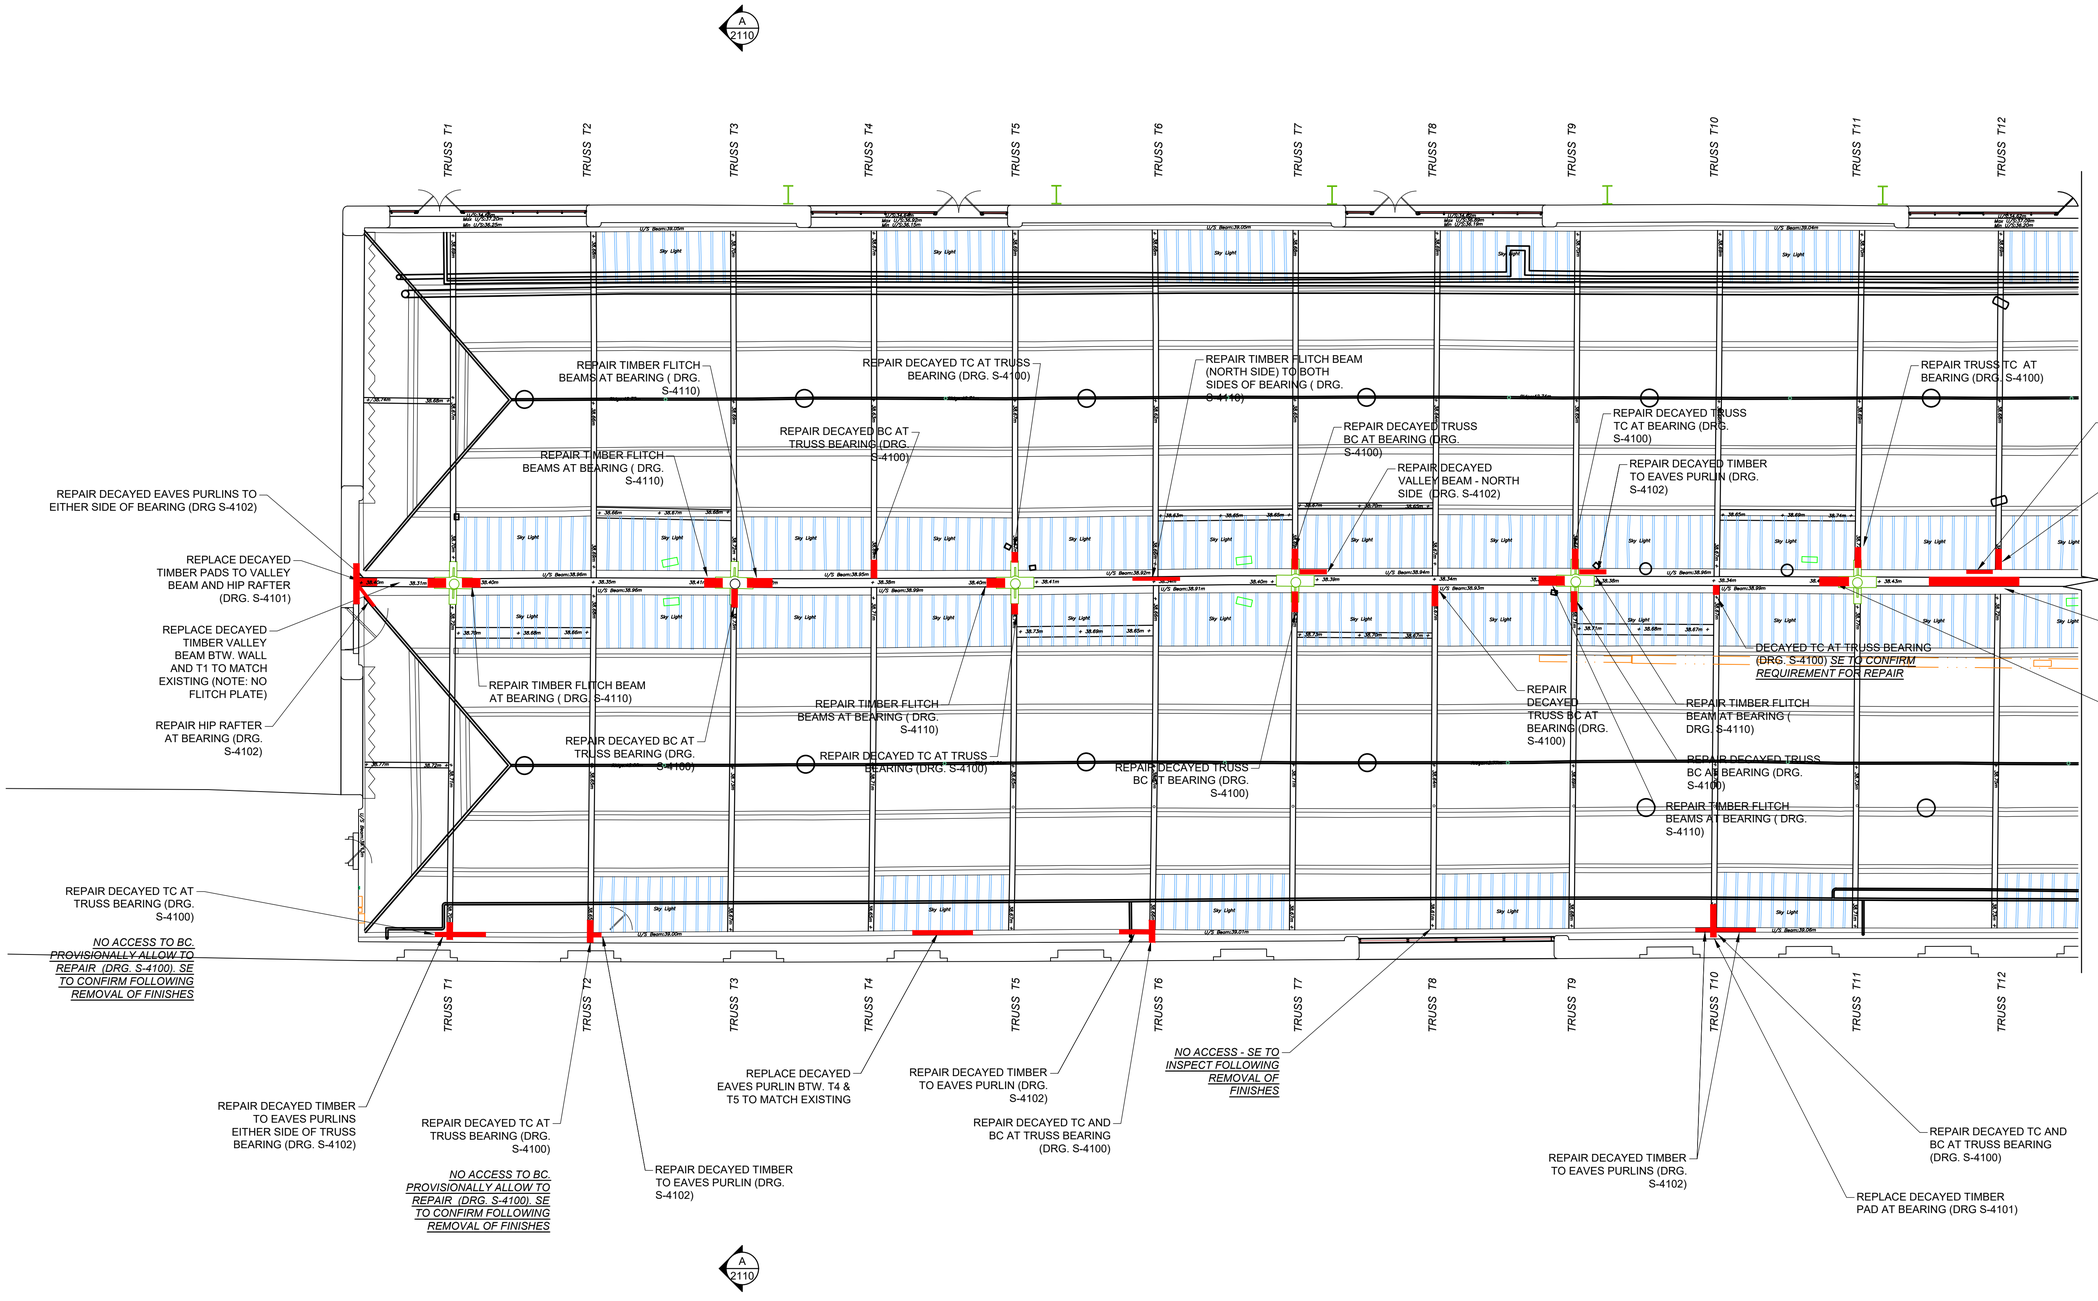
4. LOCATIONS OF TIMBER REPAIRS ARE INDICATED IN RED ON THIS DRAWING FOR EASE OF IDENTIFICATION AND CORRESPOND GENERALLY WITH RED PAINT MARKINGS ON SITE MADE BY HUTTON & ROSTRON TO INDICATE DECAY LOCATIONS AND APPROXIMATE EXTENT.

6. WHERE REPAIRS TO THE TIMBER FLITCH BEAMS AT THE CENTRAL VALLEY ARE SHOWN, REPAIRS TO THE WROUGHT IRON PLATE MAY ALSO BE REQUIRED. IN EACH CASE, THE SE TO INSPECT FOLLOWING REMOVAL OF DECAYED TIMBER. PROVISIONAL ALLOWANCE FOR LOCALISED BOLTED OVERPLATING AS PER DR-S-4110 SHOULD BE SEPARATELY MADE ON A PRO RATA BASIS.

5. THESE MARKINGS ON DRAWINGS AND ON SITE ARE FOR GUIDANCE ONLY AND ARE NOT TO BE TAKEN AS MEASURED QUANTITIES FOR TIMBER REPAIR/REPLACEMENT. REFER ALSO TO CONISBEE DRAWINGS S-4100, 4101, 4102 & 4110 FOR TYPICAL REPAIR DETAILS.
