COLLYHURST VILLAGE
MANCHESTER

PHASE 2
ENVIRONMENTAL INVESTIGATION, RISK ASSESSMENT AND OUTLINE REMEDIATION STRATEGY

Job Number: LKC 20 1120
Date: January 2021
Client: Far East Consortium International

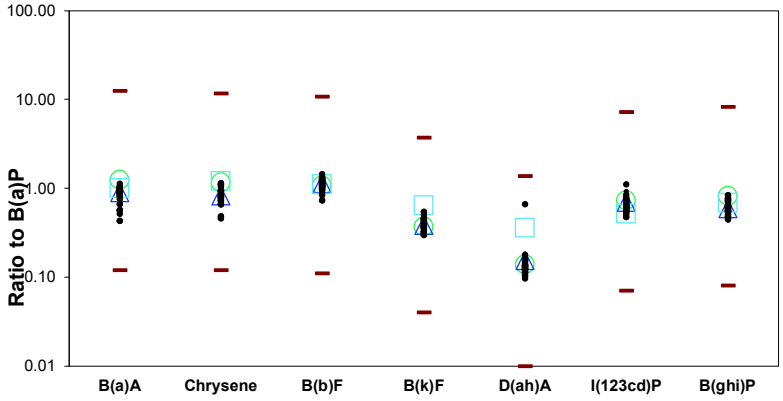
Graph 5-1: The ratio of PAH to B(a)P in soil for all available data at the site based on 45 samples (where values were >LOD to allow the calculation of a ratio).

Graph 5-1 summarises the study site data with respect to how the ratios of carcinogenic PAHs relate to B(a)P, within the confidence limits provided in the HPA document.

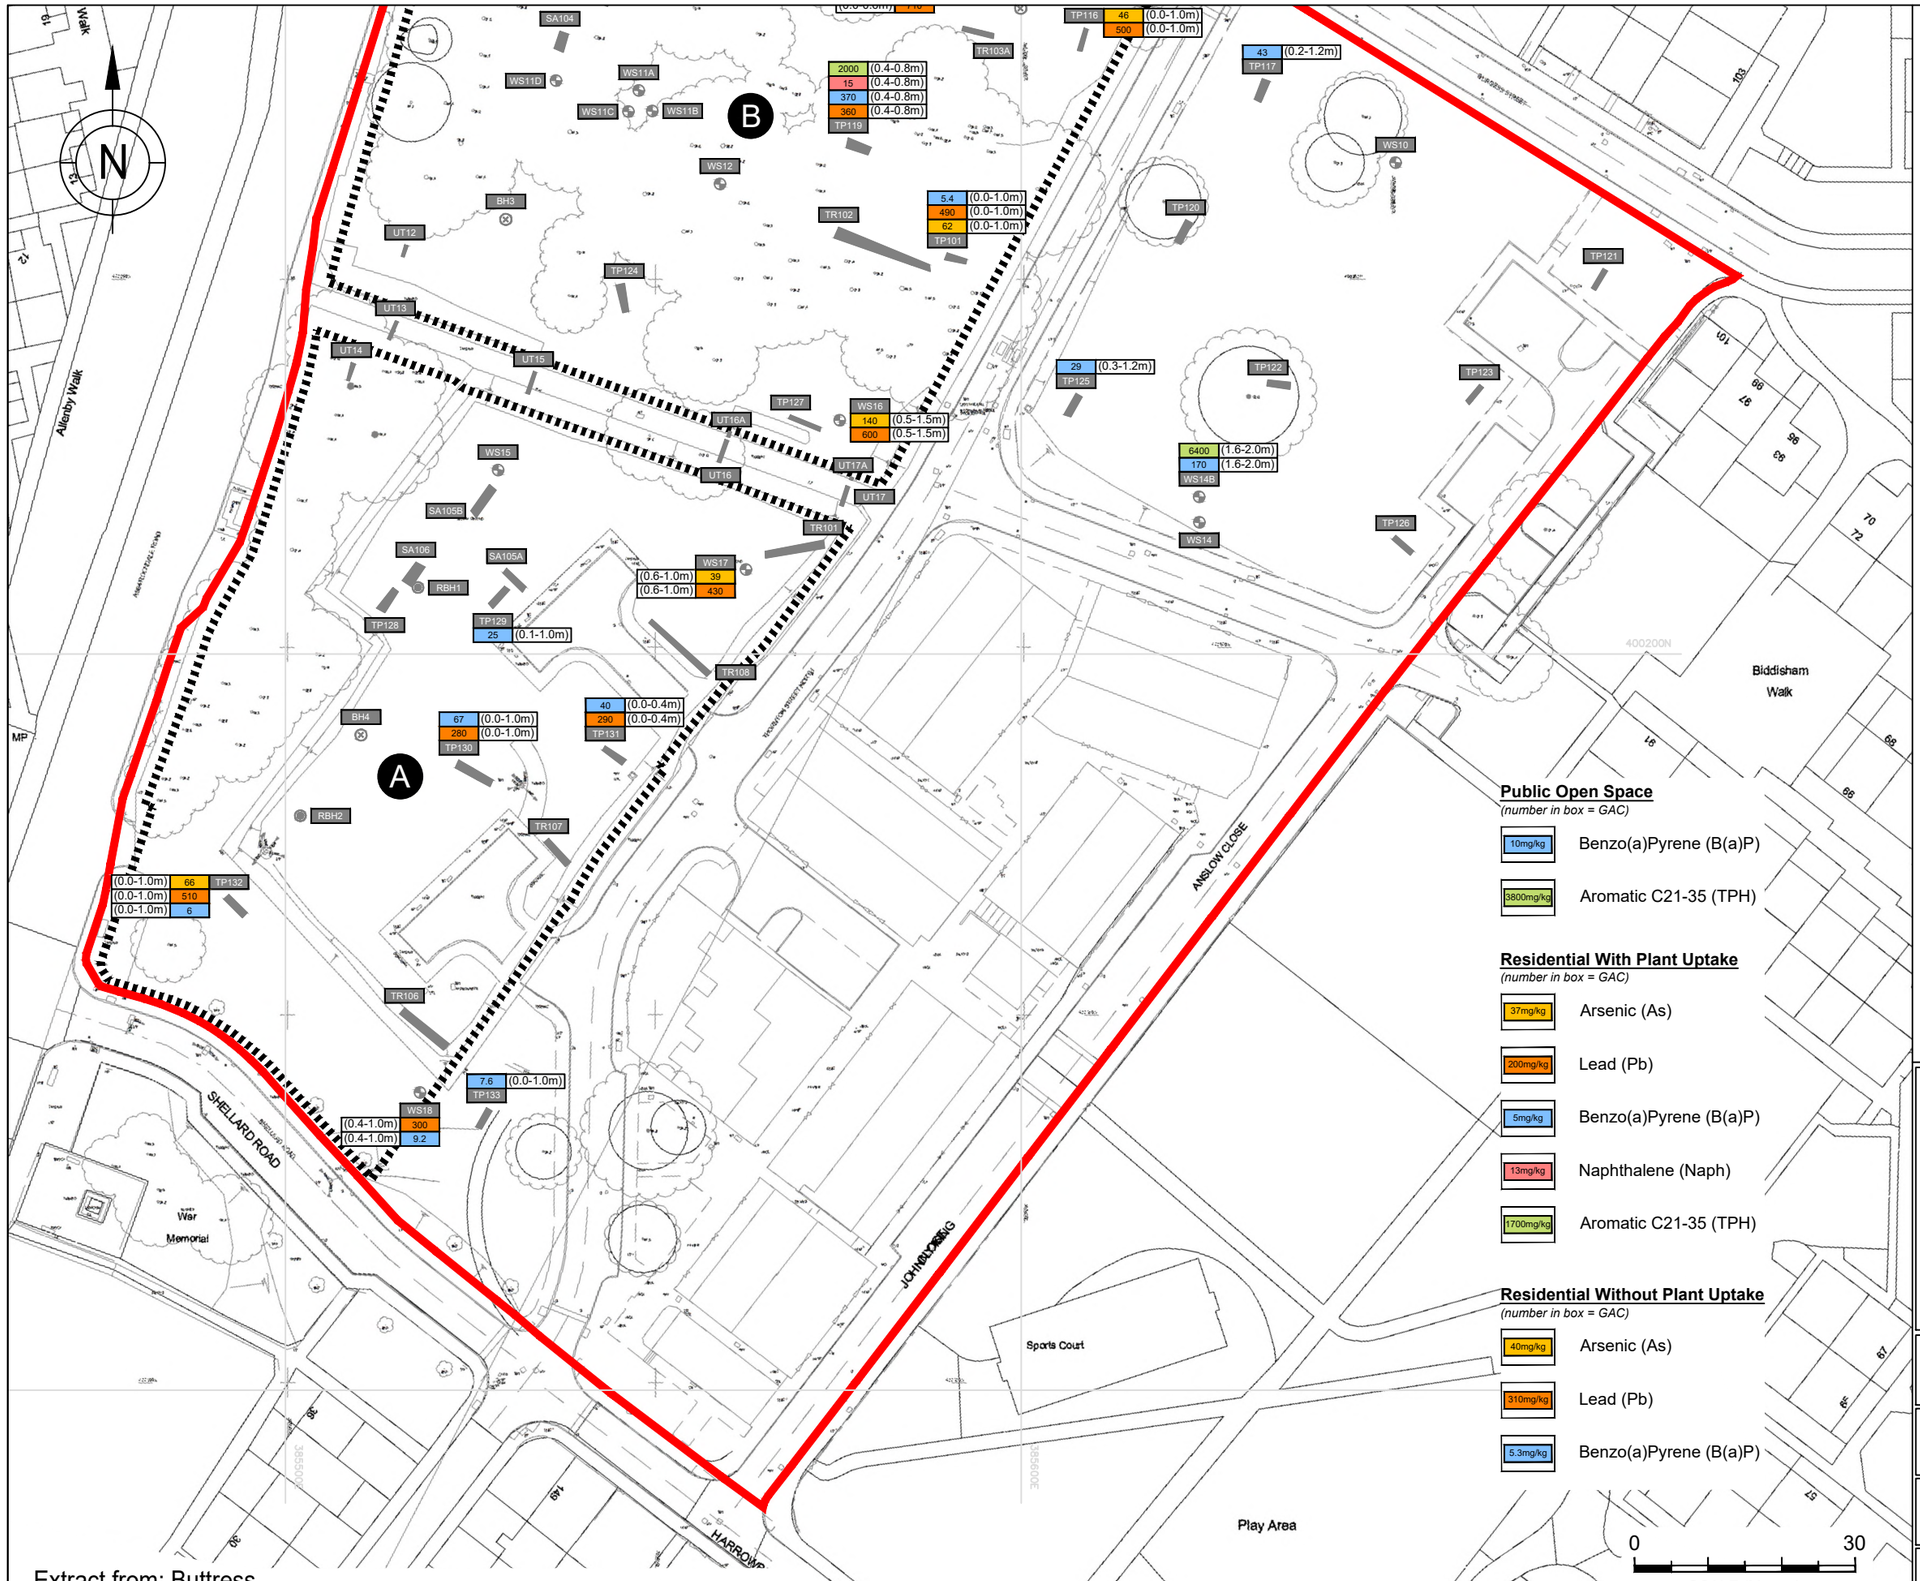
consequence, a moderate risk is given. Precautionary gas protection measures in line with CS2 are recommended in buildings in proximity to WS16, as shown in Figure 6, due to consistent carbon dioxide >10%v/v (but <15%v/v).

Pollutant Linkage	Pathway	Receptor	Contaminant	Probability	Consequence	Risk	Assessment
PL3	– Inhalation of gas. – Migration through permeable strata and preferential pathways. – Explosion in confined spaces (methane only).	– Current residents. – Future residents. – Buildings. – Offsite land users.	- Carbon dioxide (Area of Plot B)	Low Likelihood	Severe	**Moderate (Localised)**	– Elevated carbon dioxide identified (max. 16%v/v) in area of former infilled reservoir. Sufficient evidence to uprate the east of Plot B to CS2 from CS1. – **Recommendation:** Gas protection measures in line with CS2 required in the east of Plot B (see Figure 6).
