Co-op Live, Manchester

Verification Report for Drilling and Grouting Treatment of Mine Workings

BRA-BHE-XX-XX-RP-CG-0007

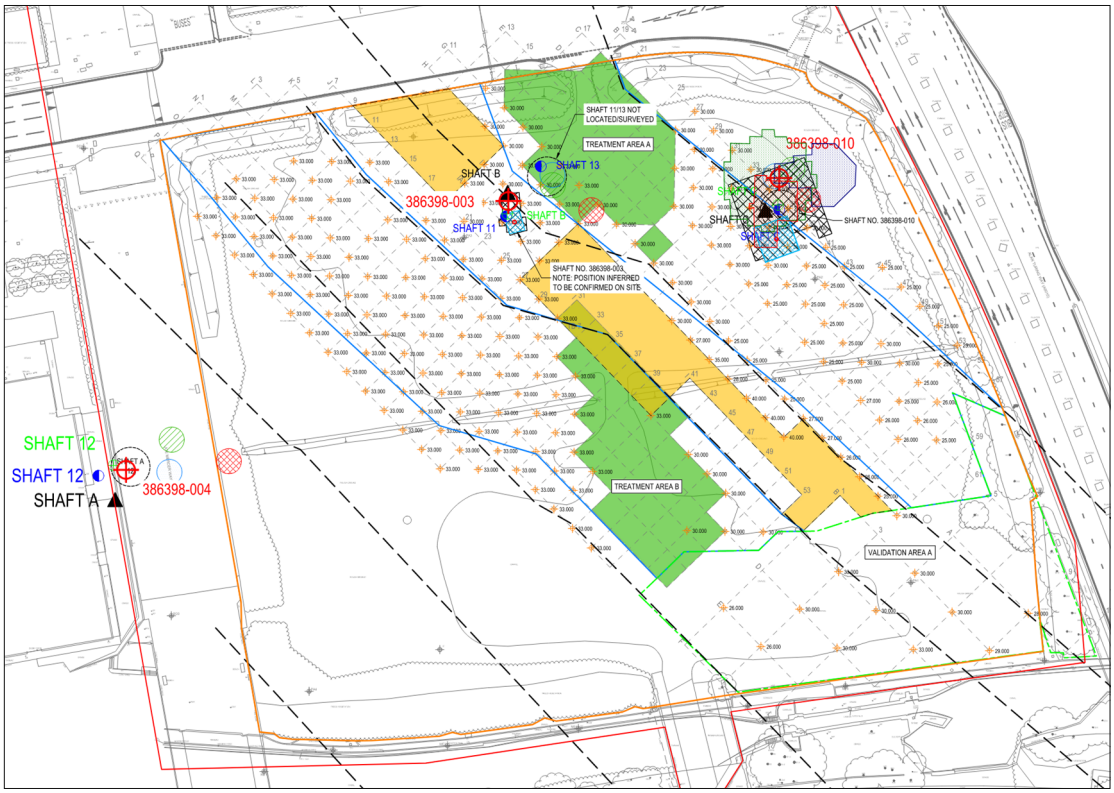
Figure 3-1 Plan showing BWB grout works and historical mine search areas, presented in full within Appendix A

- Records indicate that the Bradford Four Foot and Bradford Three Quarters seams have previously been grouted across part of the site (see Figure 3-1). The previous grouting and validation work ([10], [9]) will include treatment up to 30mbgl identifying two seams of coal.

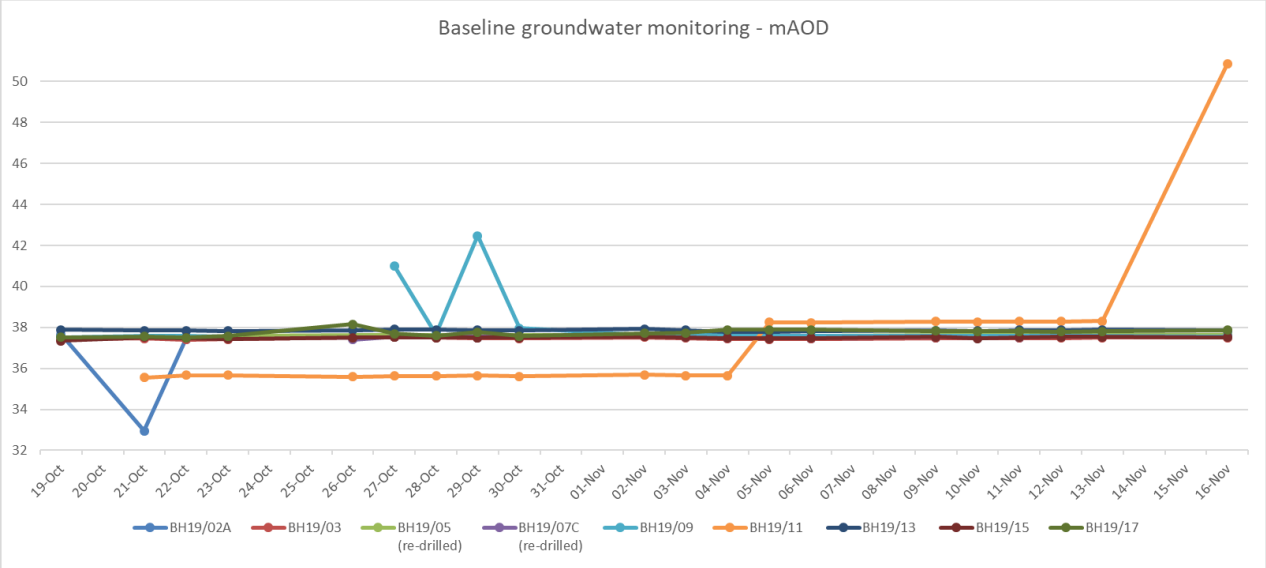
Figure 4-1 Baseline groundwater monitoring

Two locations had to be re-drilled prior to the groundwater monitoring commencing, to replace the damaged monitoring wells already on site, these were BH19/05 and BH19/07C. BH19/07c did not detect any water during the initial reading taken on 23rd October and the base was recorded as 18mbgl. The Contractors confirmed this borehole was drilled and installed to 25mbgl so returned to site and cleared the base of the well. Thereafter the base of the well was generally recorded at 24.2mbgl and groundwater levels were typically consistent with those recorded elsewhere on site.

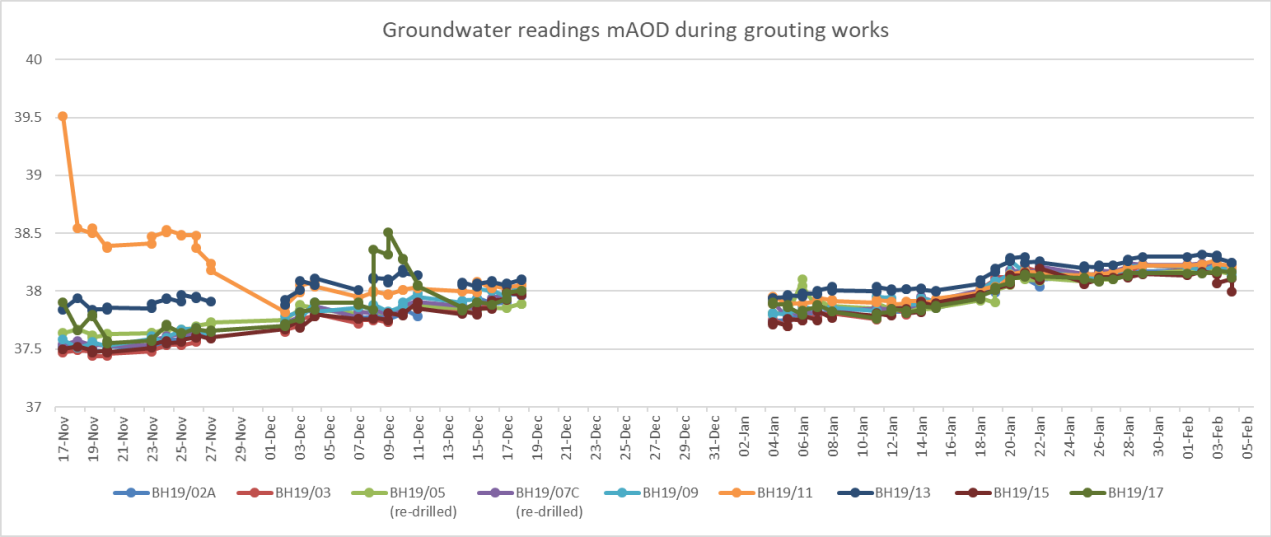
Figure 4-2 Groundwater monitoring during grouting works

Initially there were some variable groundwater readings associated with BH19/11, and again across multiple wells following installation of the raised cap covers. Overall, groundwater readings did not change significantly with a slight upward trend of <1.0m. The period of monitoring took place during heavy rainfall which was reflected in the monitoring data. There was no indication of local groundwater rise associated with grouting activity. The groundwater levels in the Coal Measures remained below the culvert level (downstream +41.7mAOD and upstream +42.9mAOD [data recorded in 2008]) throughout the grouting programme.
