OUR TOWN HALL PROJECT

| DRAWING TITLE | MOSAIC AND TERRAZZO REPAIR LEVELGF - NORTH PRINCESS ST ENTRANCE |
| DRAWING NO. | OTH-PUR-TH-GF-SKE-A-3001 |

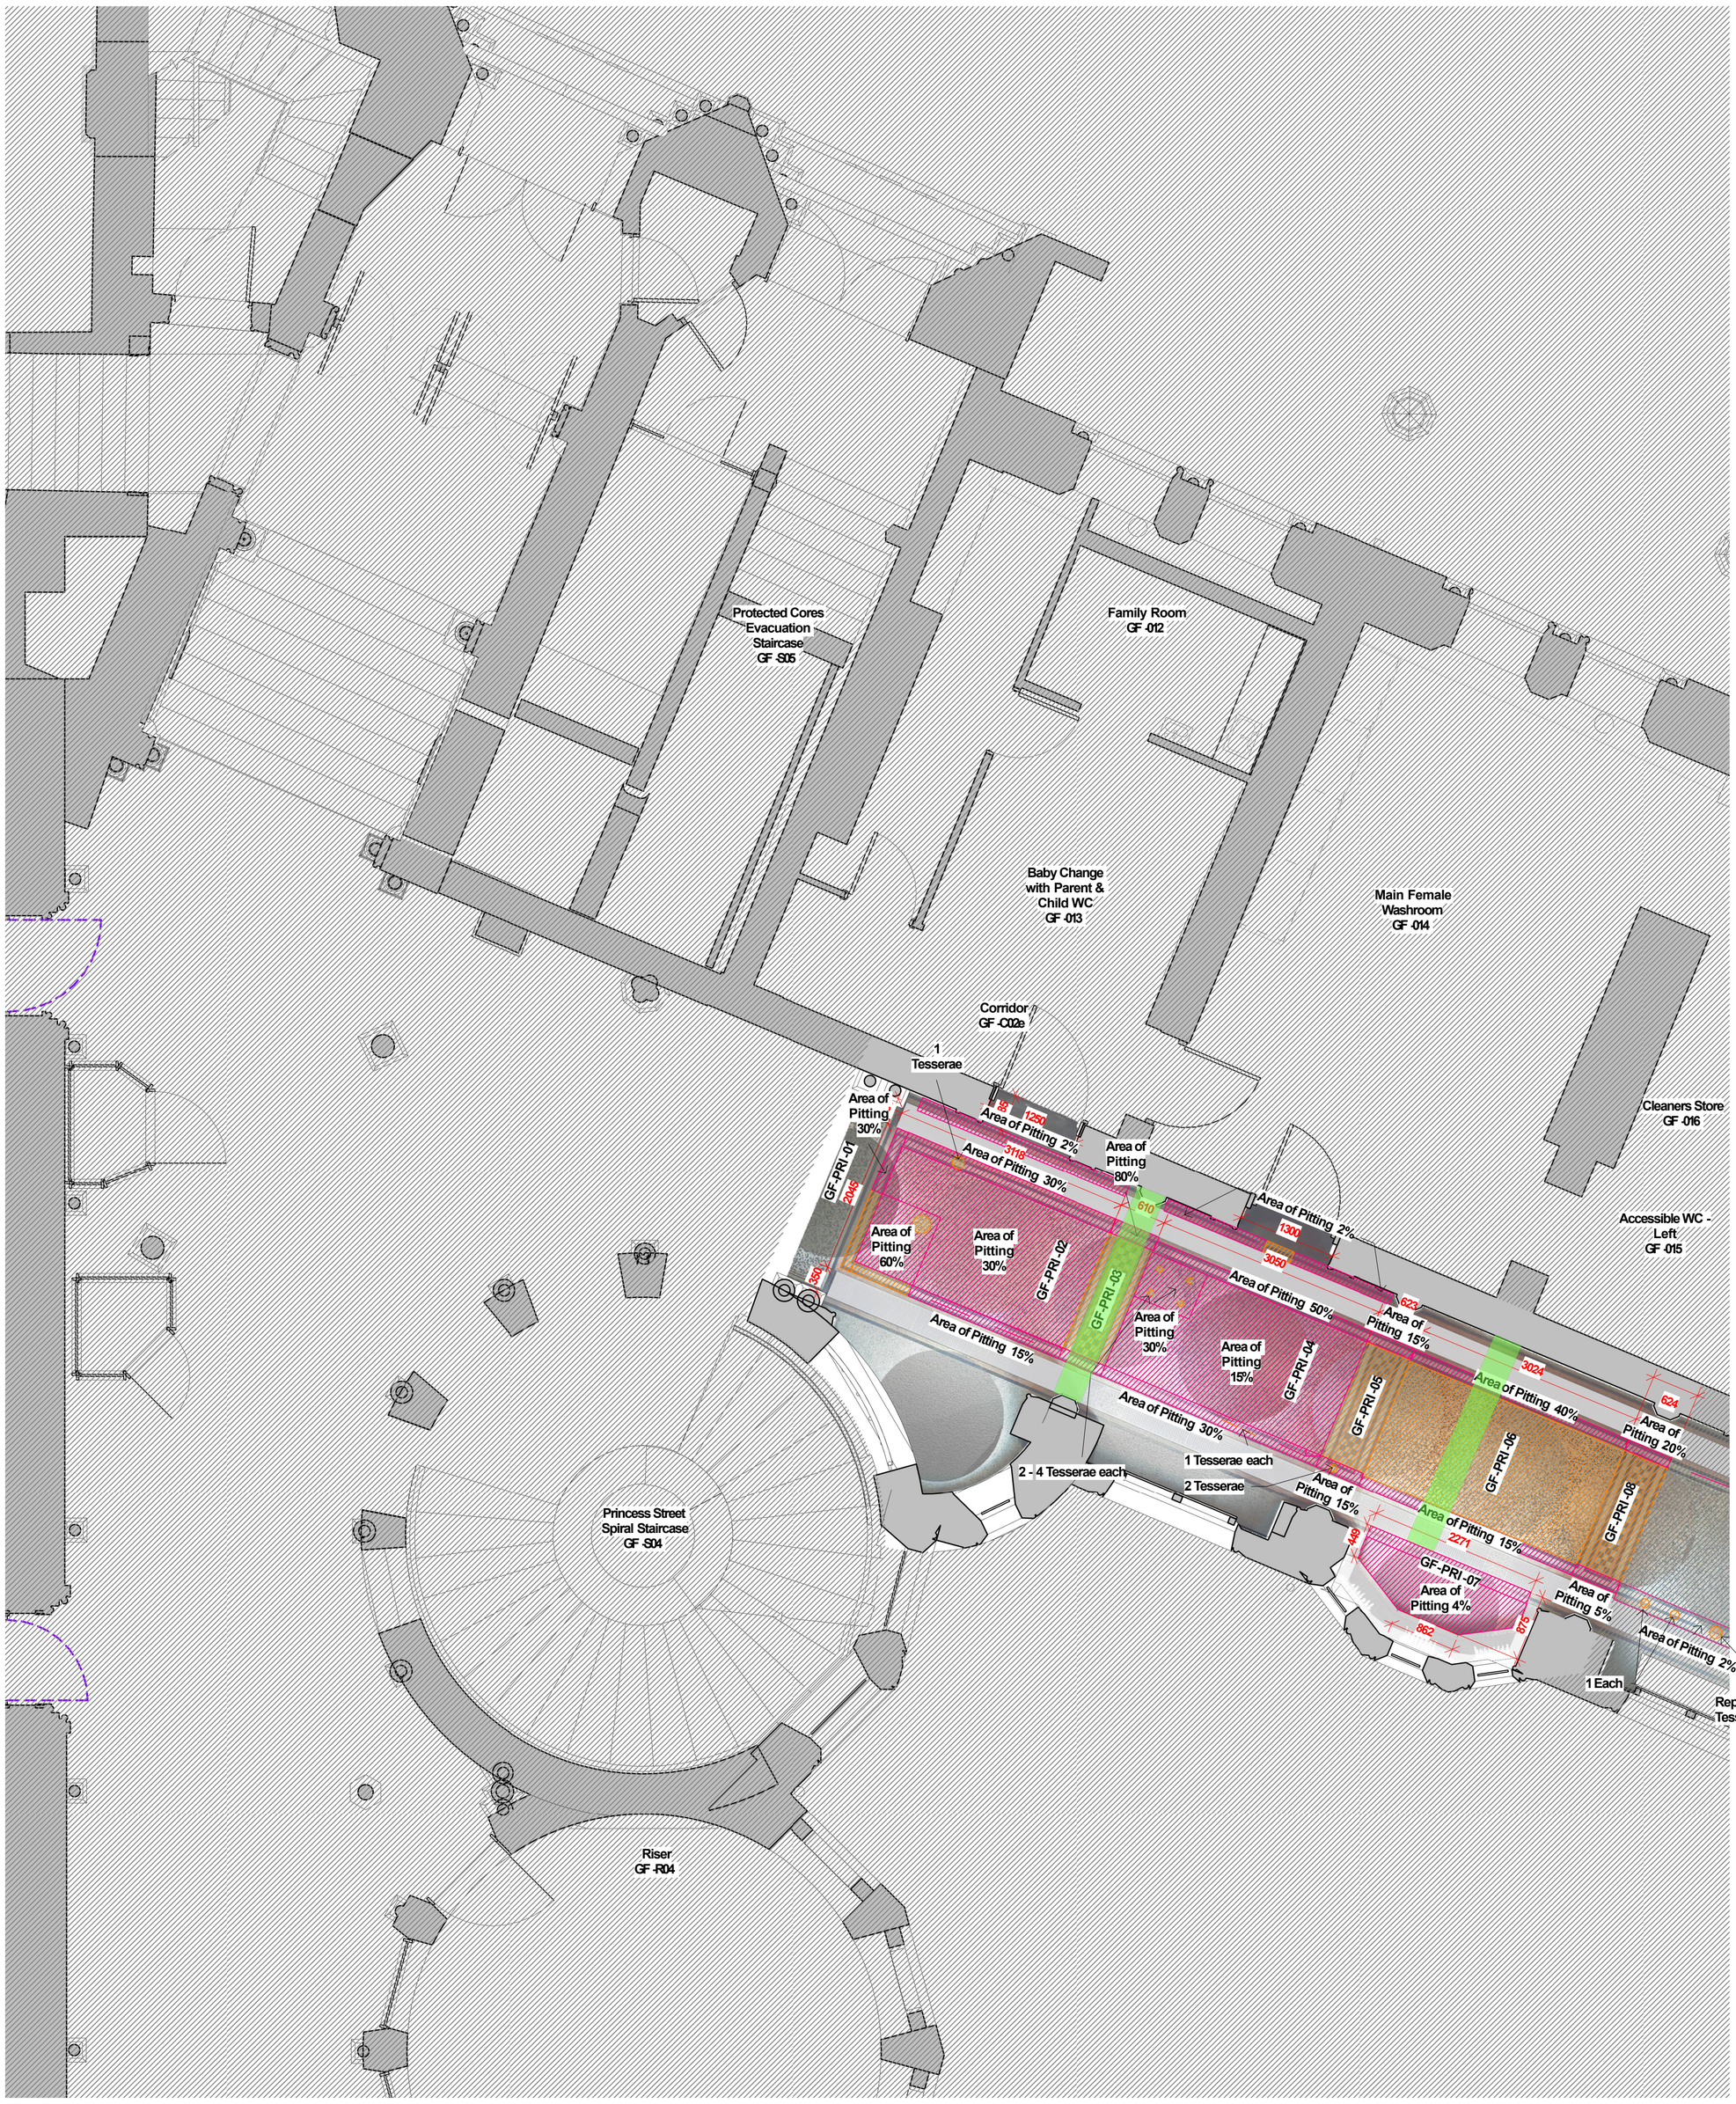
1 **MosaicRepairsPlan- GF - NORTH PRINCESS ST ENTRANCE**
1 : 50

**Area of Pitting 2%**

Suspected type 8 header detail location at level LG

- Removal of existing material (worn tesserae, failed grout, non matching previous repair, areas of cracking) and replacement with new tesserae, feathered into existing.
  NBS M40 120A
- Removal of existing material (areas of cracking wider than one tesserae's width) and replacement with new tesserae, feathered into existing.
  NBS M40 120A
- Rake out existing mortar, clean void and infill with new lime mortar cement.
  NBS M40 119B
- Rake out existing mortar in areas of cracking, clean void and infill with new lime mortar cement.
  NBS M40 119B

For the mortar repairs (pink hatched areas), allow for 100% of areas defined by the hatches to be repaired, except where a percentage figure is shown. In these locations allow for that percentage of the area defined by the hatch to be repaired.

- New mosaic trench. Refer to OTH-PUR-TH-ZZ-DWG-A-5635 for details.
  Removal of mosaic to follow NBS M40 120A
