1 **Mosaic Repairs Plan - GF - NORTH PRINCESS ST**
1 : 50

OUR TOWN HALL PROJECT
PURCELL
Project Office, Town Hall, MANCHESTER M60 2LI
+44 (0) 7970 097 432
www.purcelluk.com

PROJECT STATUS	RIBA STAGE 4
CLIENT	MANCHESTER CITY COUNCIL
PROJECT	OUR TOWN HALL
DRAWING TITLE	MOSAIC AND TERRAZZO REPAIR LEVEL GF - NORTH PRINCESS ST
SIZE & SCALE	A1: As indicated
DRAWING STATUS	FOR INFORMATION
JOBNUMBER	236959
DRAWING NO.	OTH-PUR-TH-GF-SKE-A-3002
REV	-

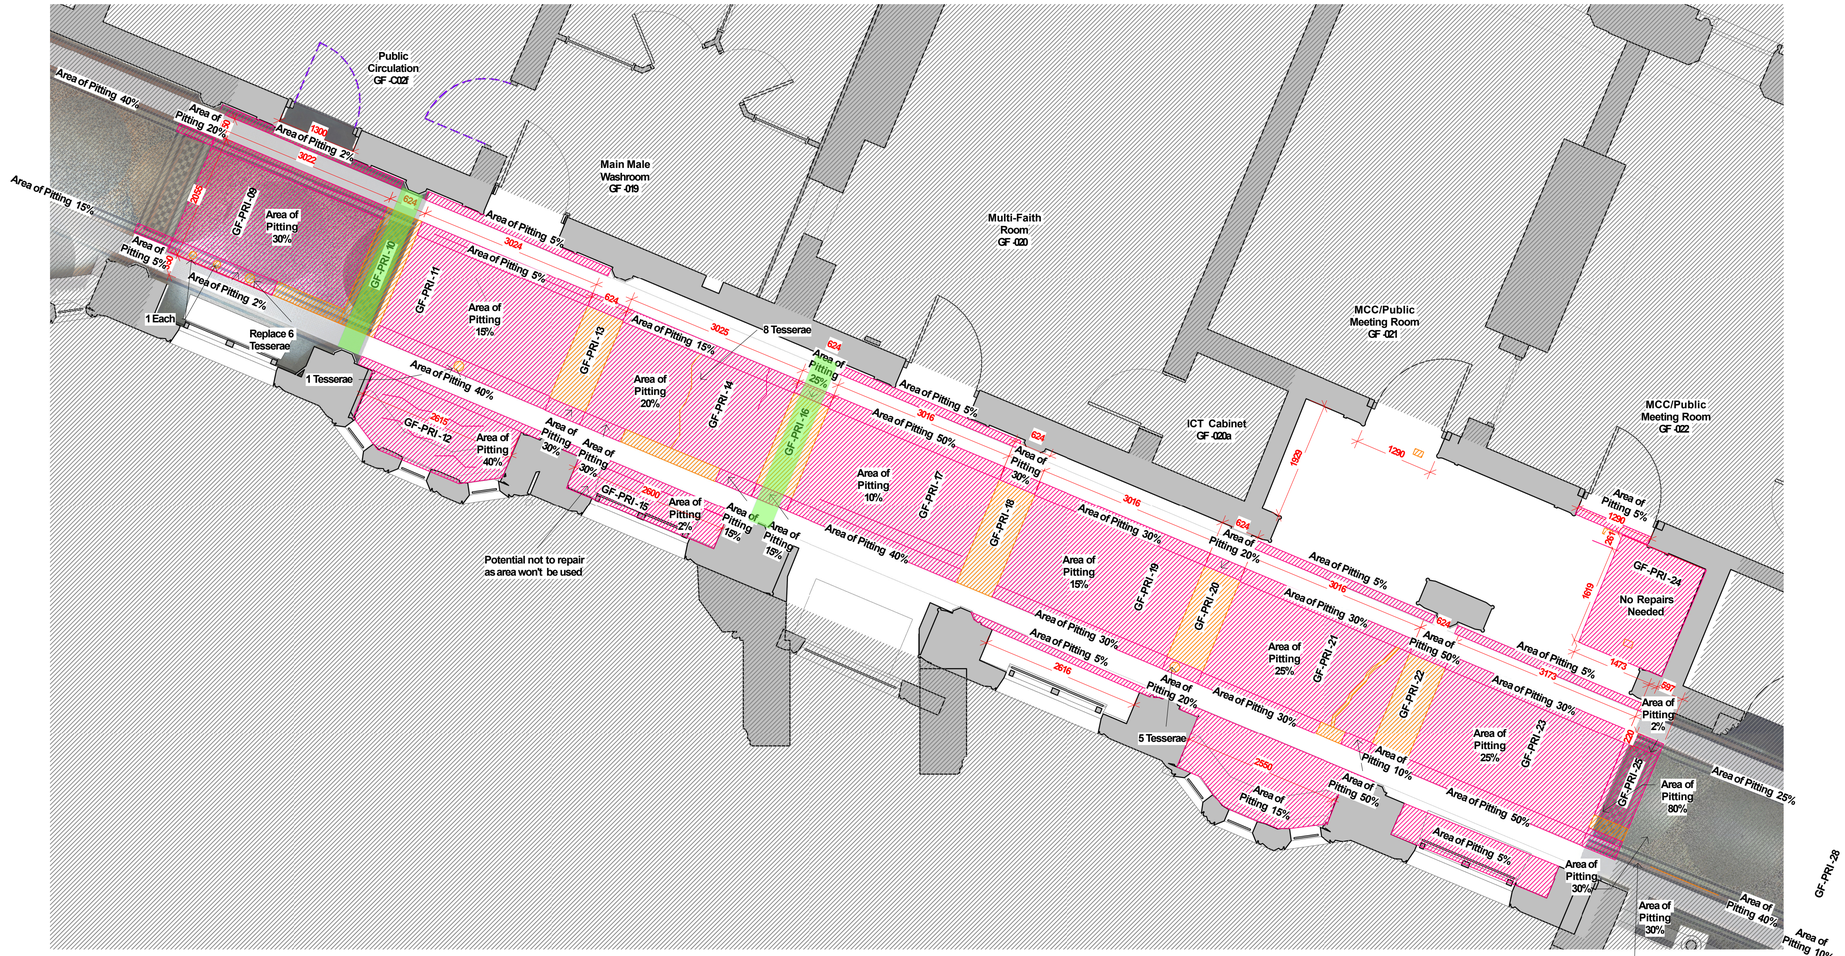
Suspected type 8 header detail location at level LG

Area of Pitting 2% — For the mortar repairs (pink hatched areas), allow for 100% of areas defined by the hatches to be repaired, except where a percentage figure is shown. In these locations allow for that percentage of the area defined by the hatch to be repaired.

- Removal of existing material (worn tesserae, failed grout, non matching previous repair, areas of cracking) and replacement with new tesserae, feathered into existing.
  NBS M40 120A
- Removal of existing material (areas of cracking wider than one tesserae's width) and replacement with new tesserae, feathered into existing.
  NBS M40 120A
- Rake out existing mortar, clean void and infill with new lime mortar cement.
  NBS M40 119B
- Rake out existing mortar in areas of cracking, clean void and infill with new lime mortar cement.
  NBS M40 119B

- New mosaic trench. Refer to OTH-PUR-TH-ZZ-DWG-A-5635 for details.
  Removal of mosaic to follow NBS M40 120A
