Lanes Group PLC

DOMIS TIB ST POST CLEANSE

23 March 2020

Lanes Group - Drainage CCTV Inspection report

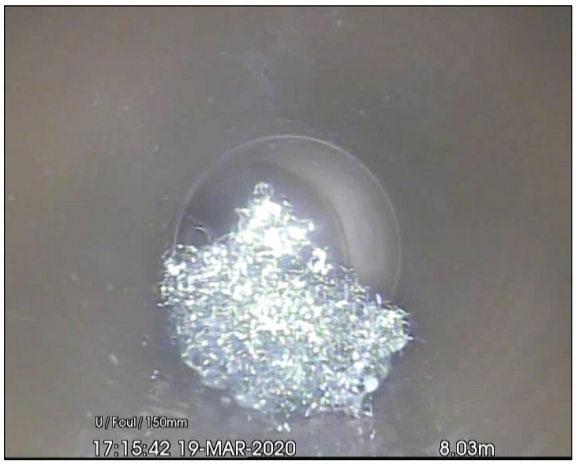
City:	Road Name:	Date :	Section number :	Asset Size(mm):
Manchester	Tib Street	22/03/2020	11	150 mm

Photo: 311322032020110010_A.jpg
8.03m, Other obstacles, other , from 4 to 9 o'clock, 40% cross-sectional area loss

Photo: 411422032020110102_A.jpg
8.9m, Hole in drain/sewer, at 3 o'clock

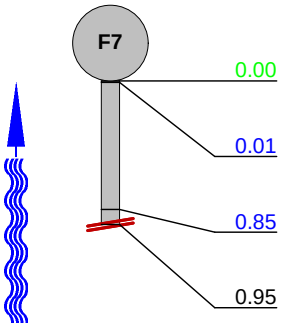
0.00	Start node type, manhole, reference number : F7	(Constr) 0
	0.01	Water level, 5% of the vertical dimension	(Serv) 0
	0.85	Line deviates left	(Serv) 0
	0.95	Survey abandoned Remarks: Unable to pass bend	(Misc) 0

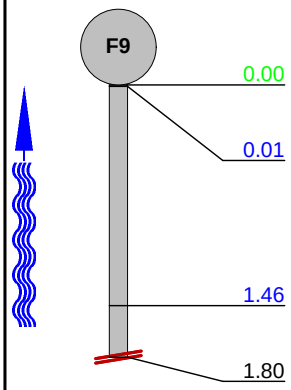
0.00	Start node type, manhole, reference number : F9	(Constr) 0
	0.01	Water level, 5% of the vertical dimension	(Serv) 0
	1.46	Line deviates up	(Serv) 0
	1.80	Survey abandoned Remarks: Unable to pass bend	(Misc) 0

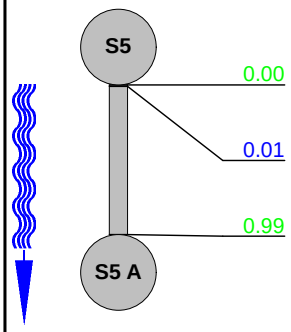
0.00	Start node type, manhole, reference number : S5	(Constr) 0
	0.01	Water level, 5% of the vertical dimension	(Serv) 0
	0.99	Finish node type, manhole reference number: S5 A	(Constr) 0

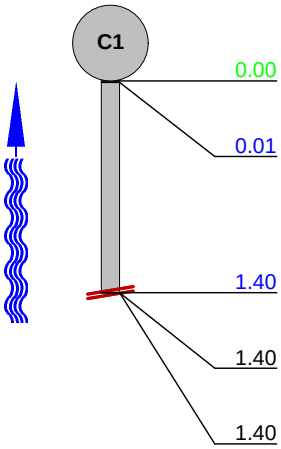
0.00	Start node type, manhole, reference number : C1	(Constr) 0
	0.01	Water level, 10% of the vertical dimension	(Serv) 0
	1.40	Line deviates down	(Serv) 0
	1.40	General remark Remarks: Line seems to be a syphon or major back fall	(Misc) 0
	1.40	Survey abandoned Remarks: Syphon/back fall	(Misc) 0
