47 PETER STREET - PHOTO SURVEY

MANCHESTER CITY CENTRE

NOVEMBER 2019

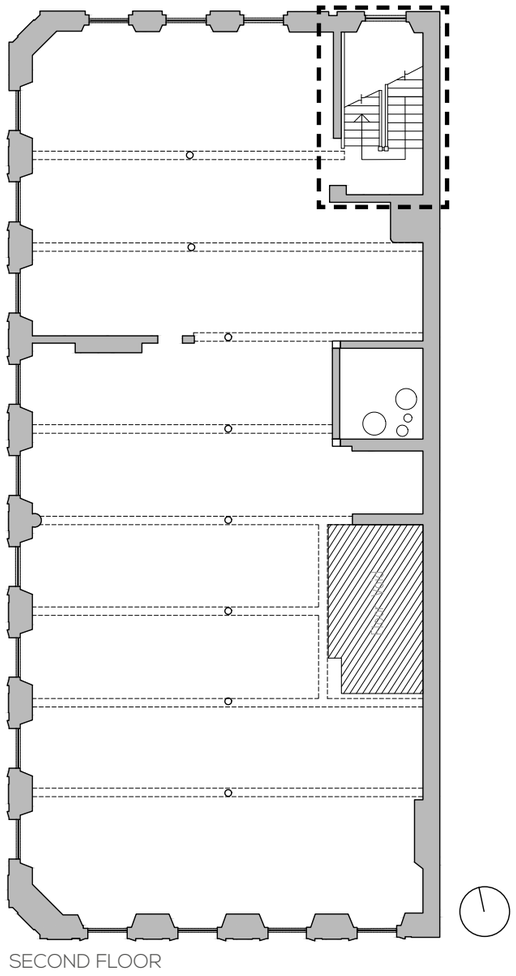
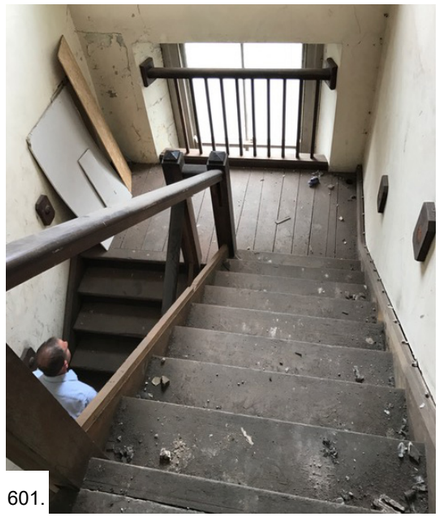
501. View of third floor stairwell void from the second floor.
502. View of the second floor stairwelll void.
503. View of the first floor stairwell void from the second floor.
504. View of the first floor stairwelll void.
505. View of the second floor stairwell void from the third floor.
506. View of the second and third floor stairwelll void.

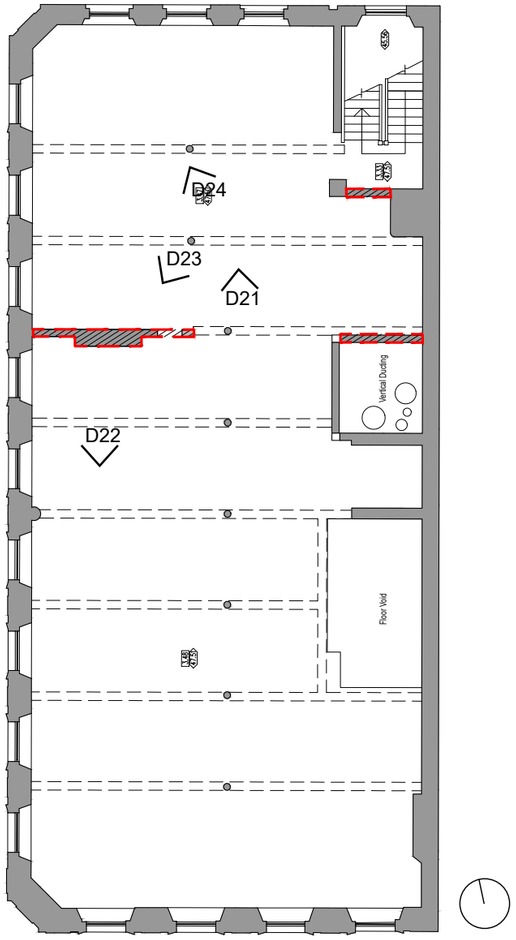
Removal of existing internal brick wall. This wall is possibly not original to the original building evidenced by existing timber beams that cantilever beyond the supporting column and redundant pad stones in the external wall. The wall is to be replaced by a new timber beam spanning between the columns and external walls, all to match existing.

Removal of the wall adjacent to the rear staircase.
