Dantzic - Methodology for removal of existing lintels from level 9 windows

Russells Construction

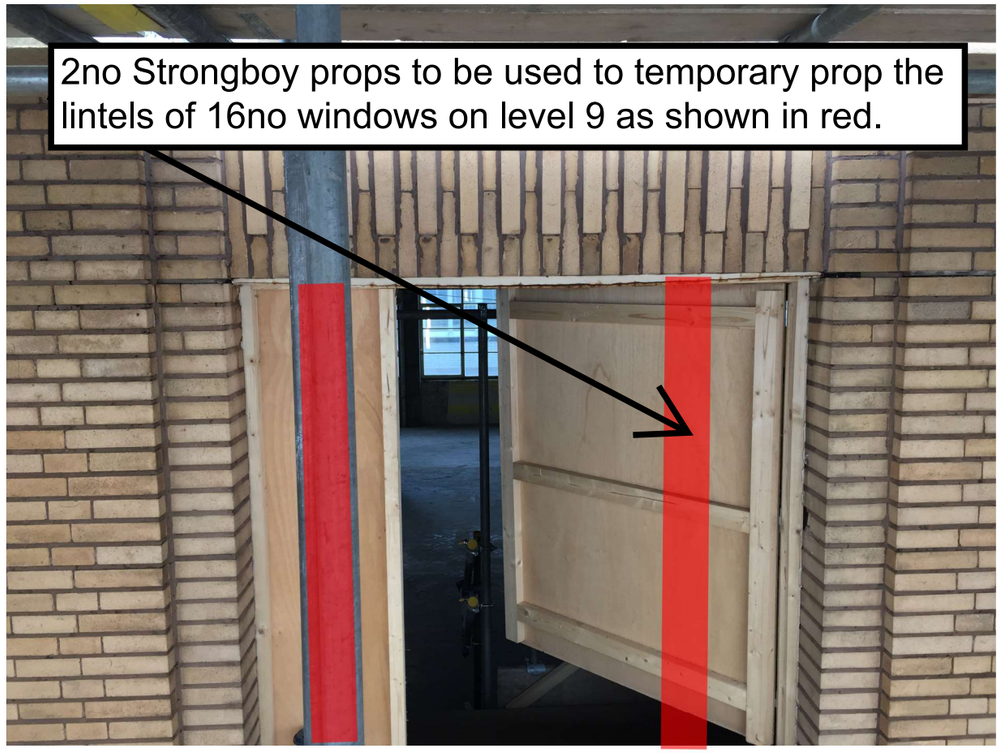
Photograph of window head

Photograph of defective lintel

Rusting and sagging angle lintel to be removed once temporary propping is in place. To be replaced with angle lintel of similar size (tbc once one is removed). Replacement lintel will be stainless steel to avoid a repeat of the corrosion. These will be primed and painted RAL9001 to match windows. See full survey for extent of problem.

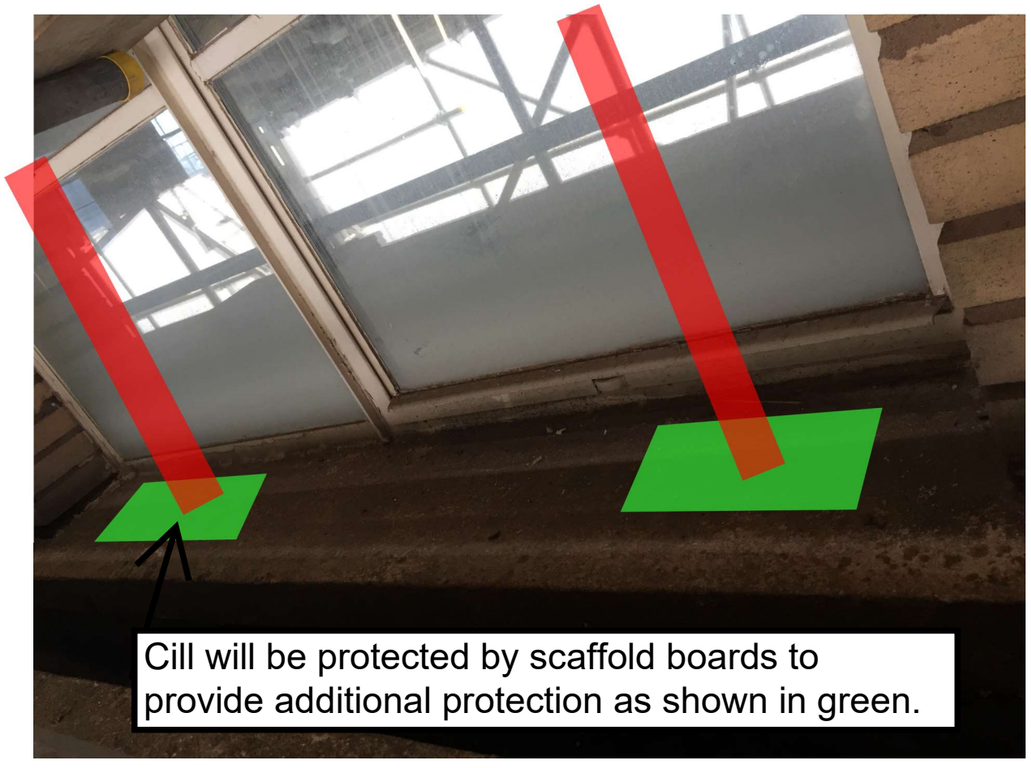
Photograph of defective mortar joint

Photograph of window cill
