Dantzic - Methodology for removal of existing lintels from level 9 windows - Full survey - Page 1 of 3

RCL DANTZIC HERITAGE MARK UP - 008 - FULL SURVEY

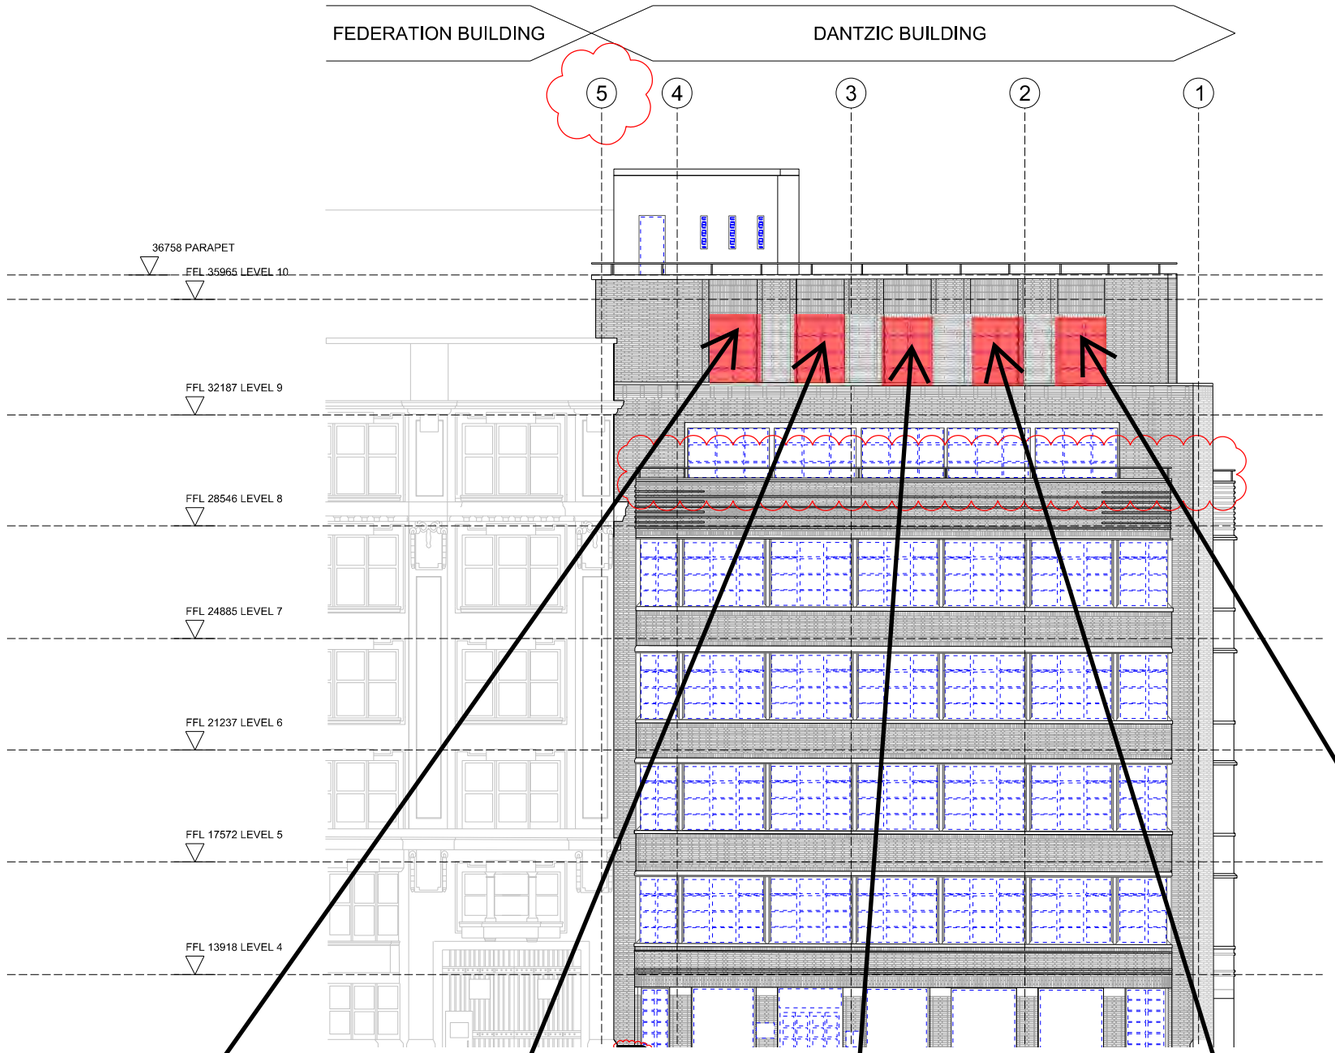
Window 9.01 - 20mm - Approx sag 7mm

Window 9.02 - 21mm - Approx sag 8mm

Window 9.03 - 16mm - Approx sag 3mm

Window 9.04 - 15mm - Approx sag 2mm

Window 9.05 - 15mm - Approx sag 2mm

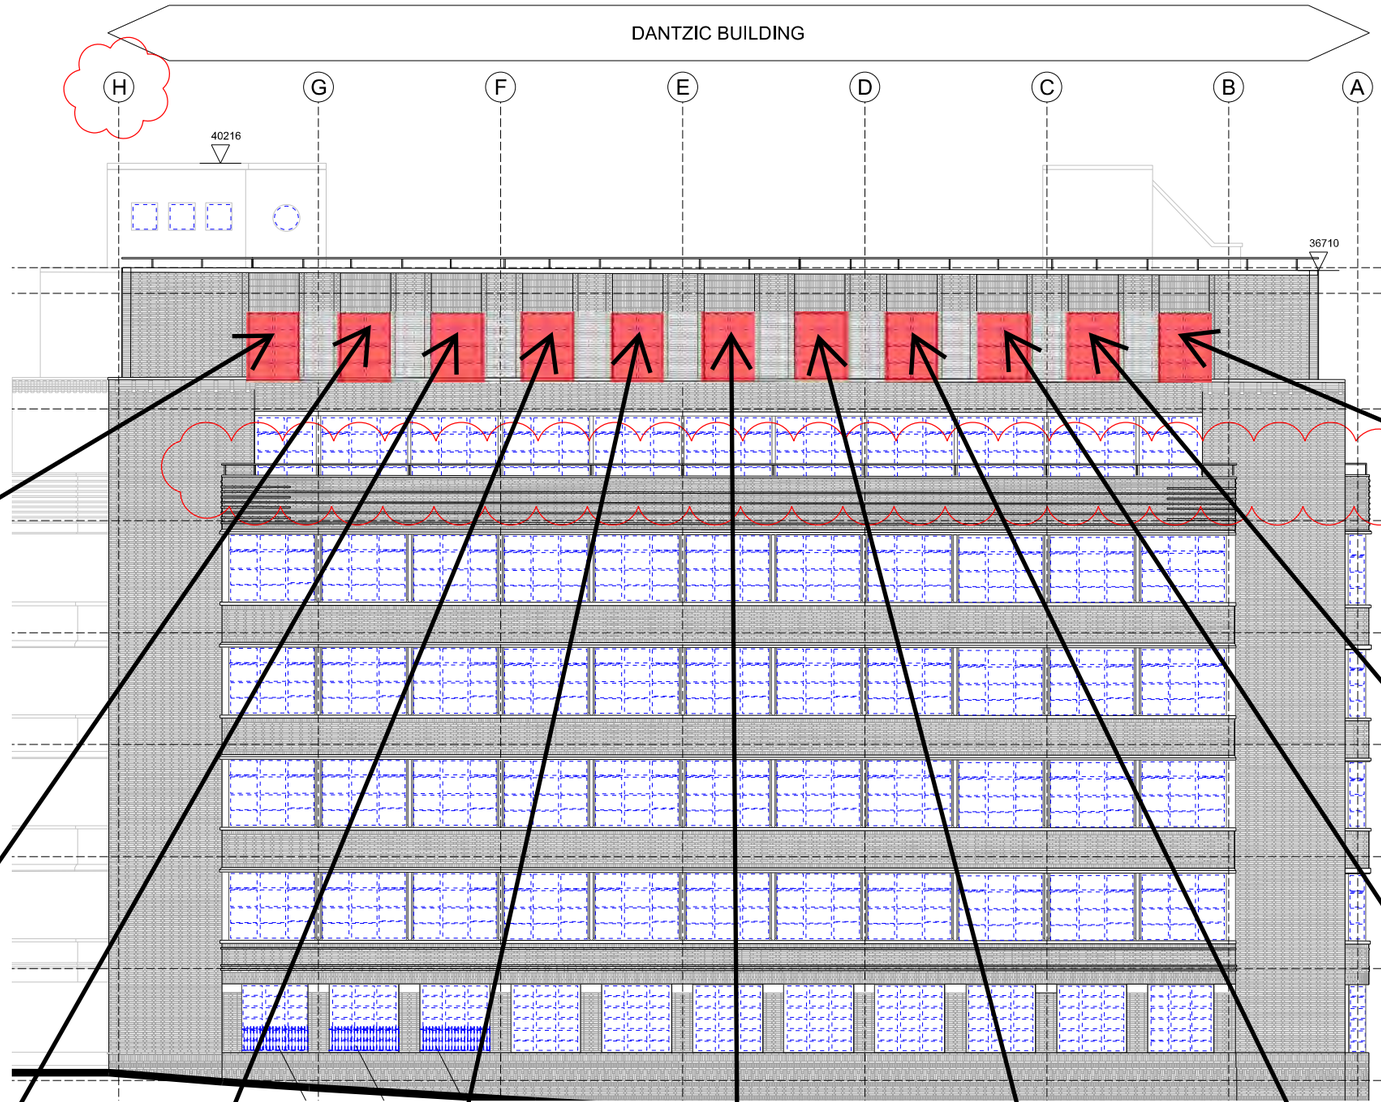
Window 9.06 - 17mm - Approx sag 4mm

Window 9.07 - 20mm - Approx sag 7mm

Window 9.08 - 30mm - Approx sag 17mm

Window 9.09 - 24mm - Approx sag 11mm

Window 9.10 - 20mm - Approx sag 7mm

Window 9.11 - 28mm - Approx sag 15mm

Window 9.12 - 24mm - Approx sag 11mm

Window 9.13 - 23mm - Approx sag 10mm

Window 9.14 - 22mm - Approx sag 9mm

Window 9.16 - 30mm - Approx sag 17mm

Window 9.15 - 26mm - Approx sag 13mm

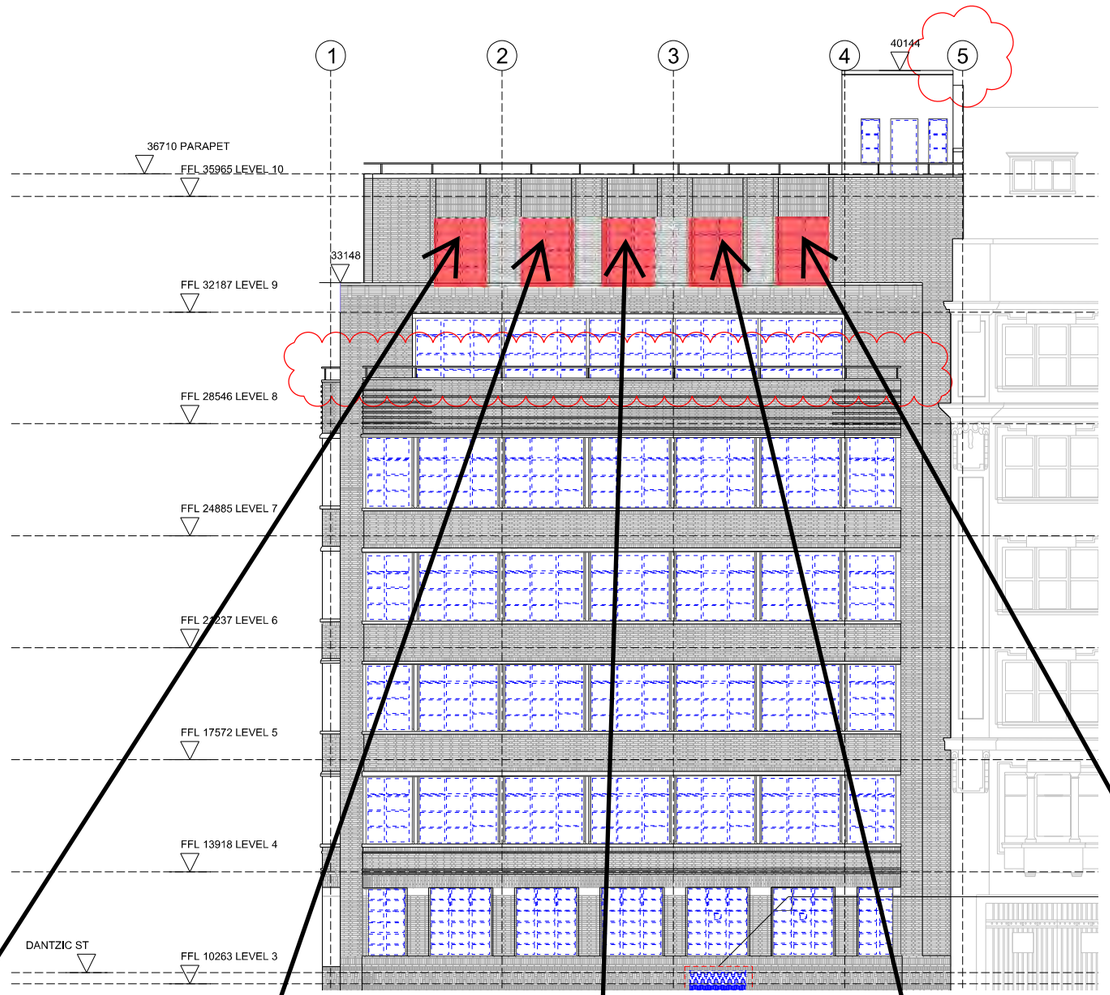
Window 9.17 - 20mm - Approx sag 7mm

Window 9.18 - 14mm - Approx sag 1mm

Window 9.19 - 23mm - Approx sag 10mm

Window 9.20 - 13mm - Approx sag 0mm

Window 9.21 - 14mm - Approx sag 1mm
