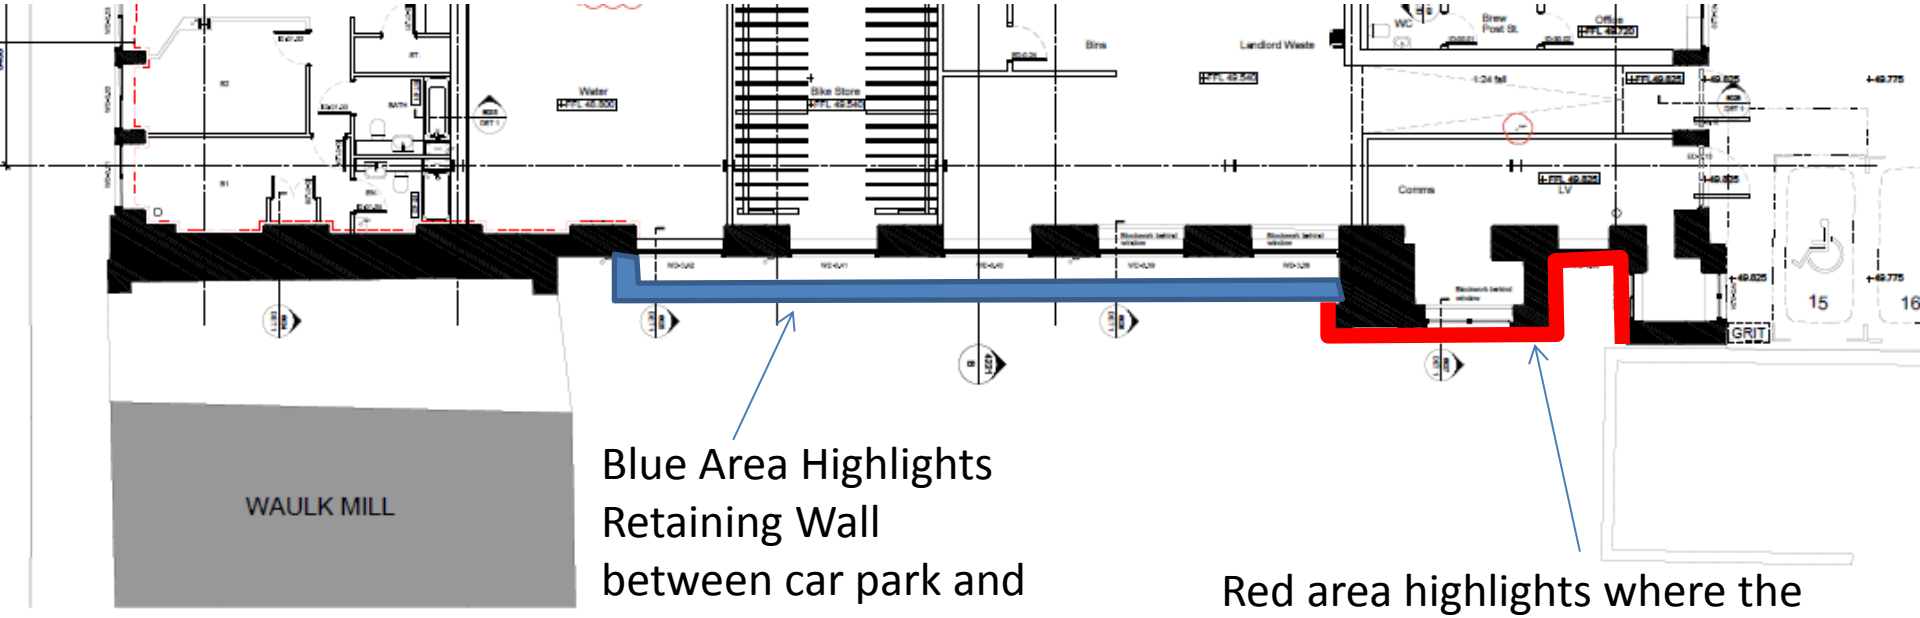
Blue Area Highlights Retaining Wall between car park and NLM

Red area highlights where the New Little Mill Walls & Windows have been used as a retaining wall.

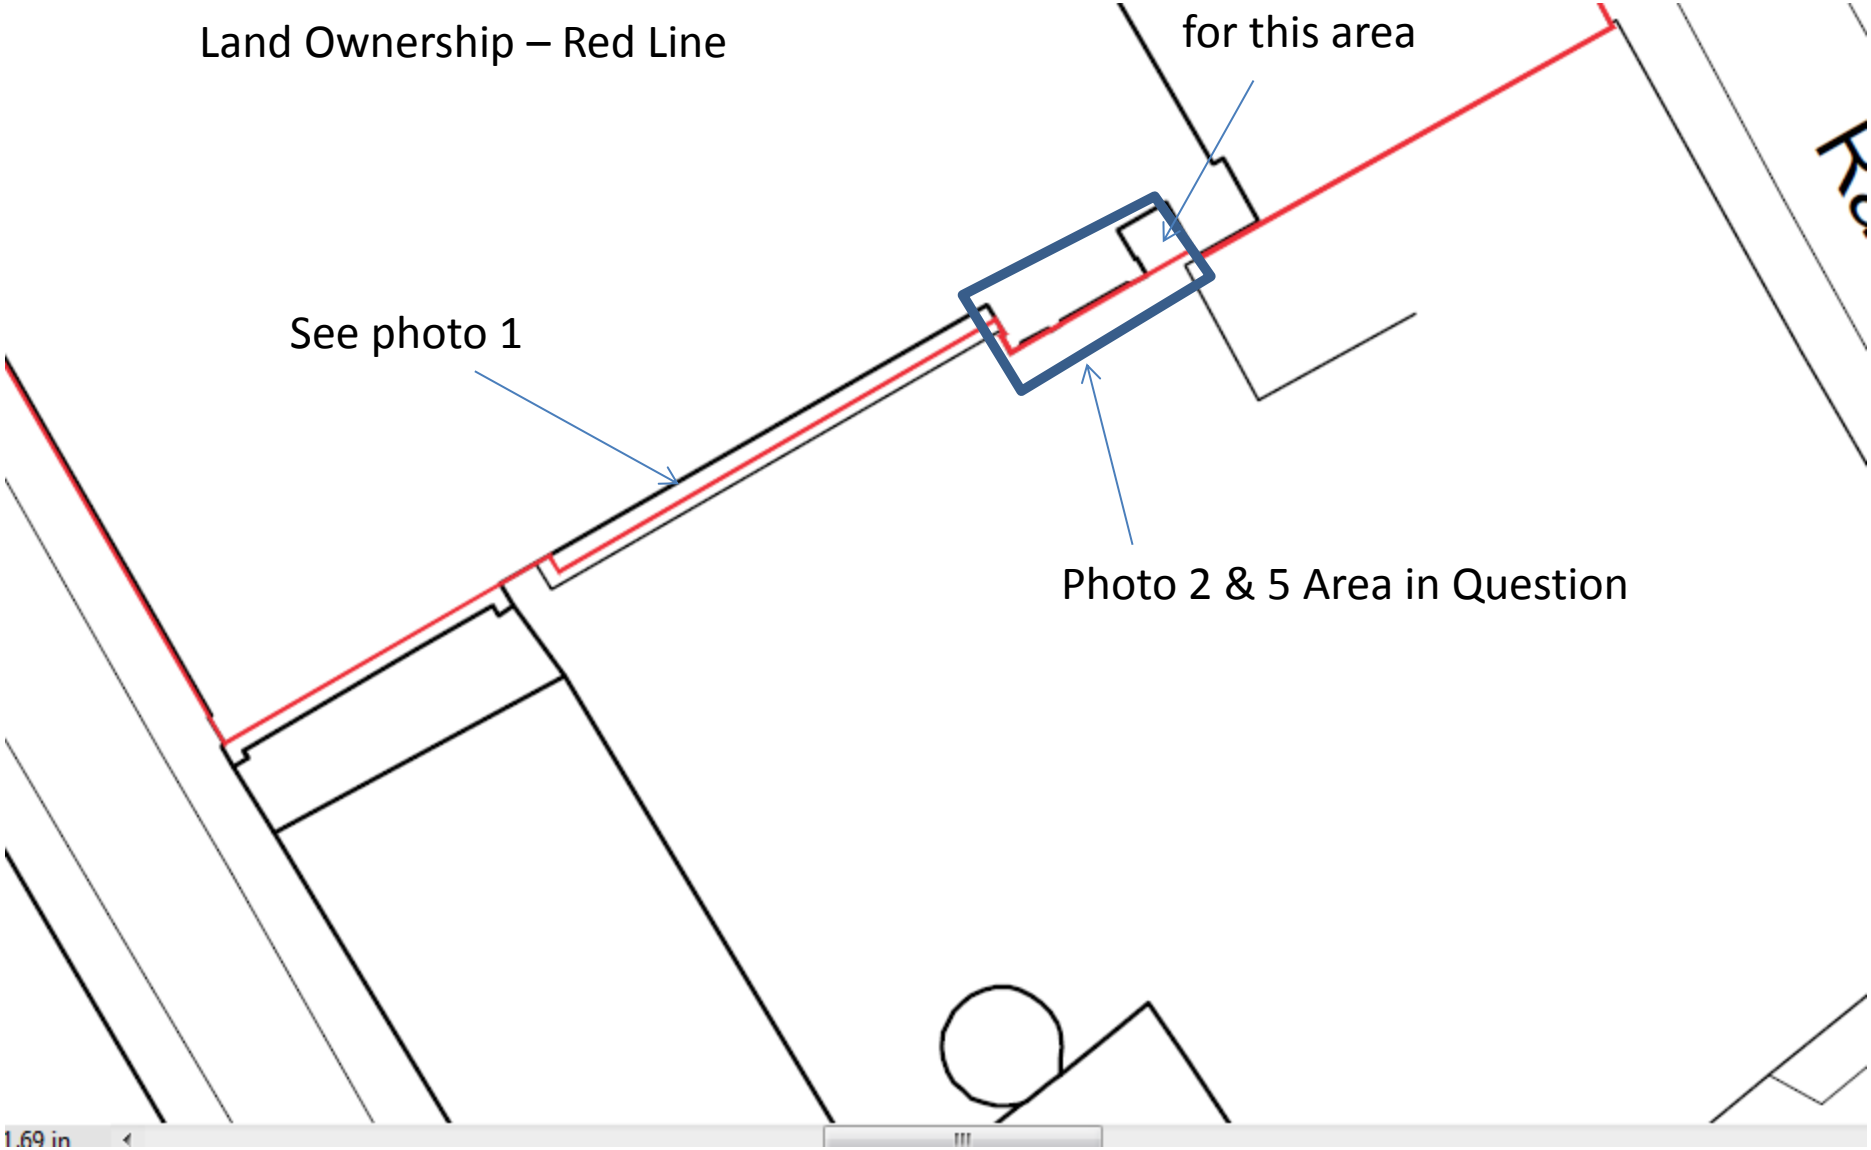
Photo 1

Retaining Wall Built between NLM & Waulk Mill GL's 3-6

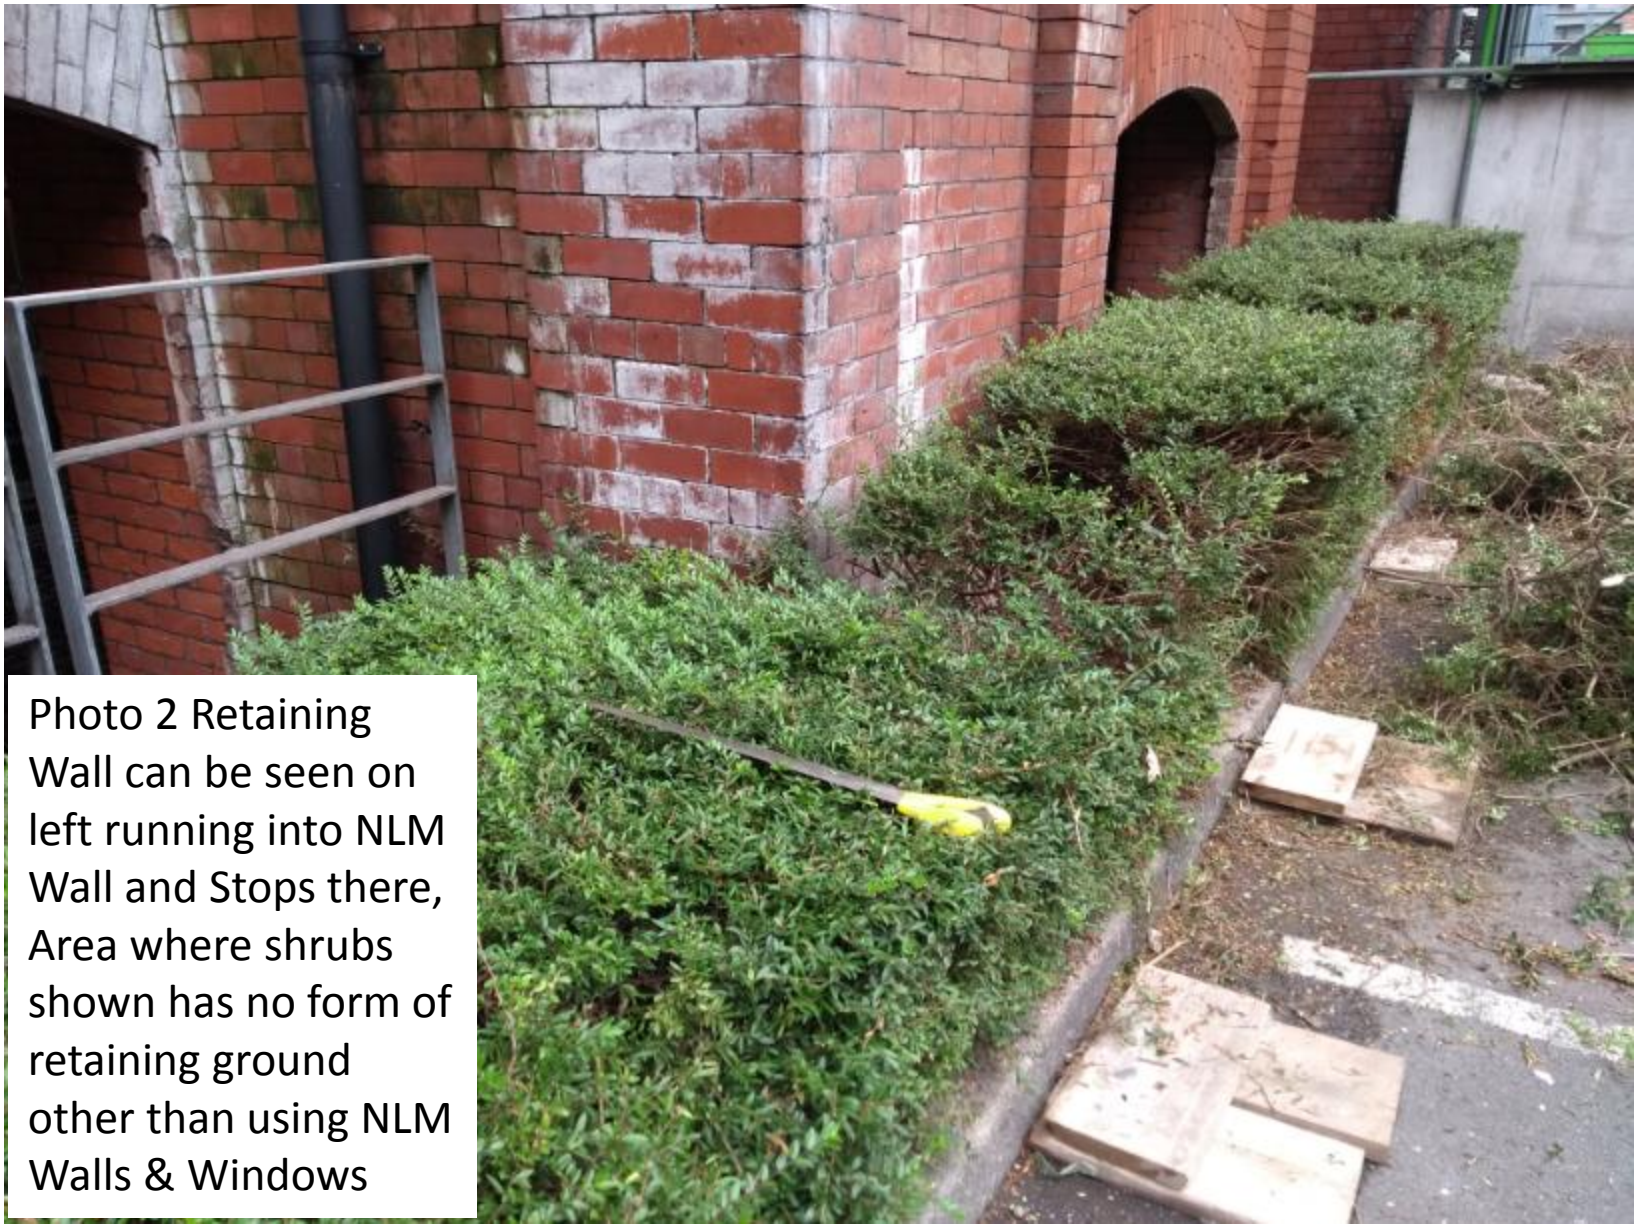
Photo 2 Retaining Wall can be seen on left running into NLM Wall and Stops there, Area where shrubs shown has no form of retaining ground other than using NLM Walls & Windows
